TEST OF T14 FEED MECHANISMS FOR 20MM GUN AN-M2(U) ARMY
AIR FORCES WASHINGTON DC 23 NOV 43 XA-AAF

FINAL REPORT

TEST OF T14 FIELD MECHANISMS FOR 20MM GUN AN-M2

Serial No.: 2-43-91 No. of Pages: 5 Date: 23 November 1943
AAF Board Project No. (M-5) 23

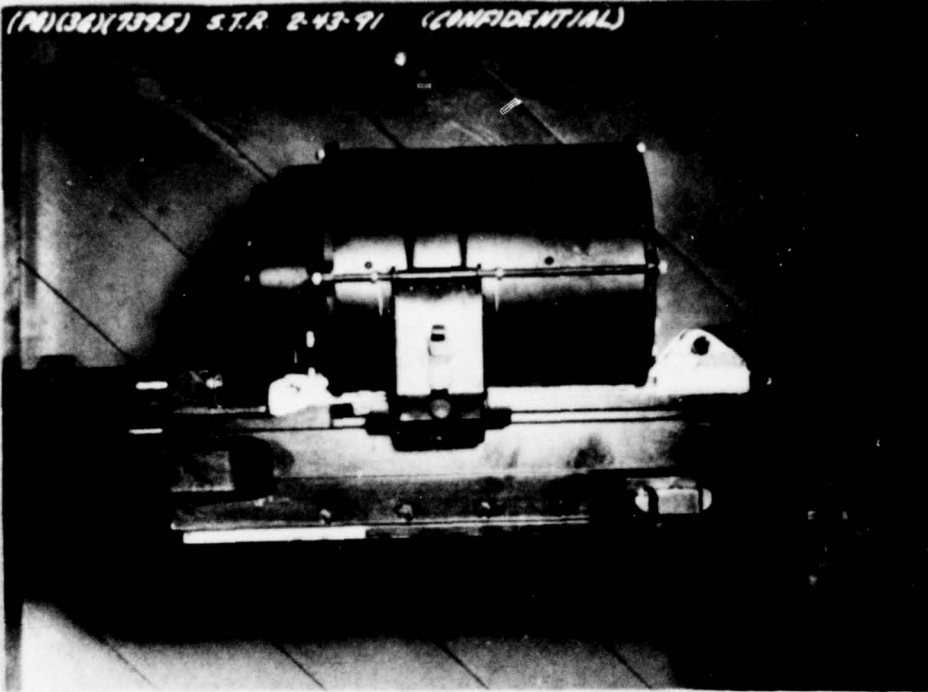
(70)(36)(7395) S.T.R. 2-43-91 (CONFIDENTIAL)

Side view of
Standard AN-M1
feeder.

These two (2) photo-
graphs show the con-
trast in size of the
AN-M1 and T-14
feeders.

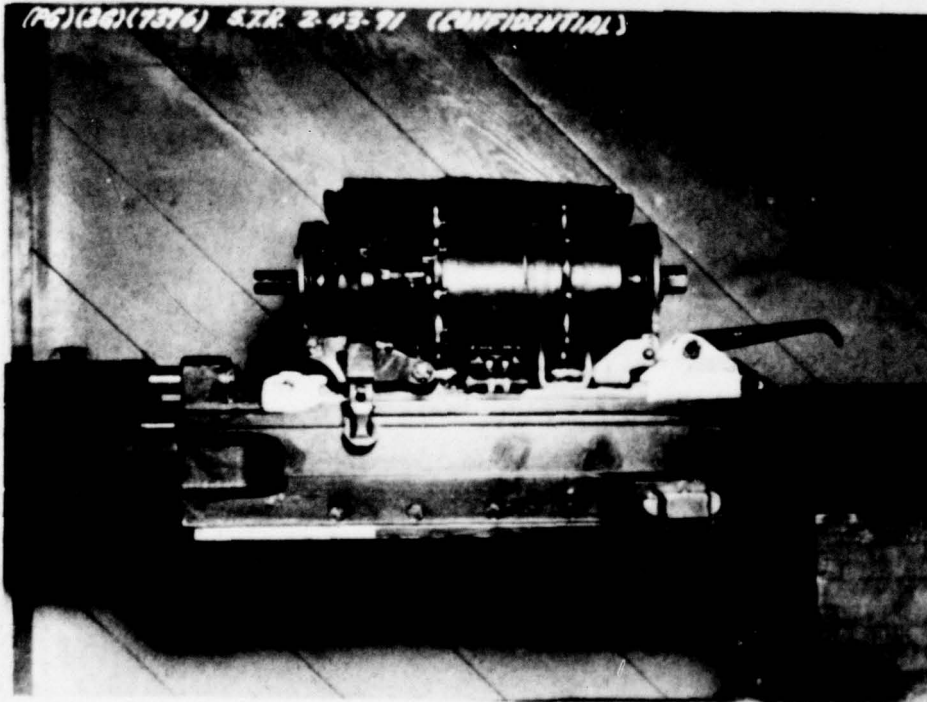
(76)(36)(7396) S.T.R. 2-43-91 (CONFIDENTIAL)

Side view of T-14
feeder.

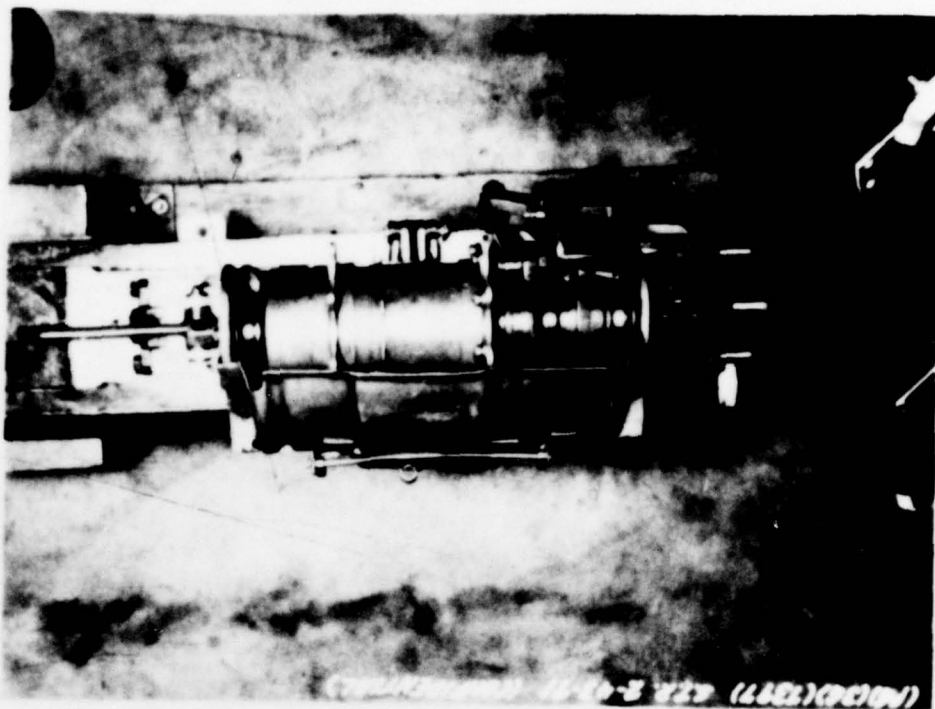
(P6) (S6) (7397) STR 2-43-91 (CONFIDENTIAL)

Top view of T-17 feeder.

These two (2) photo-
graphs show the contrast
in size of the AN-M1
and T-17 feeders.
