INSTALLATION RESTORATION PROGRAM PHASE 2  
CONFIRMATION/QUANTIFICATION STAGE 1 BERGSTROM AFB TEXAS  
VOLUME 1(U) RADIAN CORP AUSTIN TX 27 APR 87

INSTALLATION RESTORATION PROGRAM  
PHASE II - CONFIRMATION/QUANTIFICATION  
STAGE I - FINAL REPORT  
VOLUME I

BERGSTROM AIR FORCE BASE, TEXAS 78743

Final Report, March 1984 - August 1986

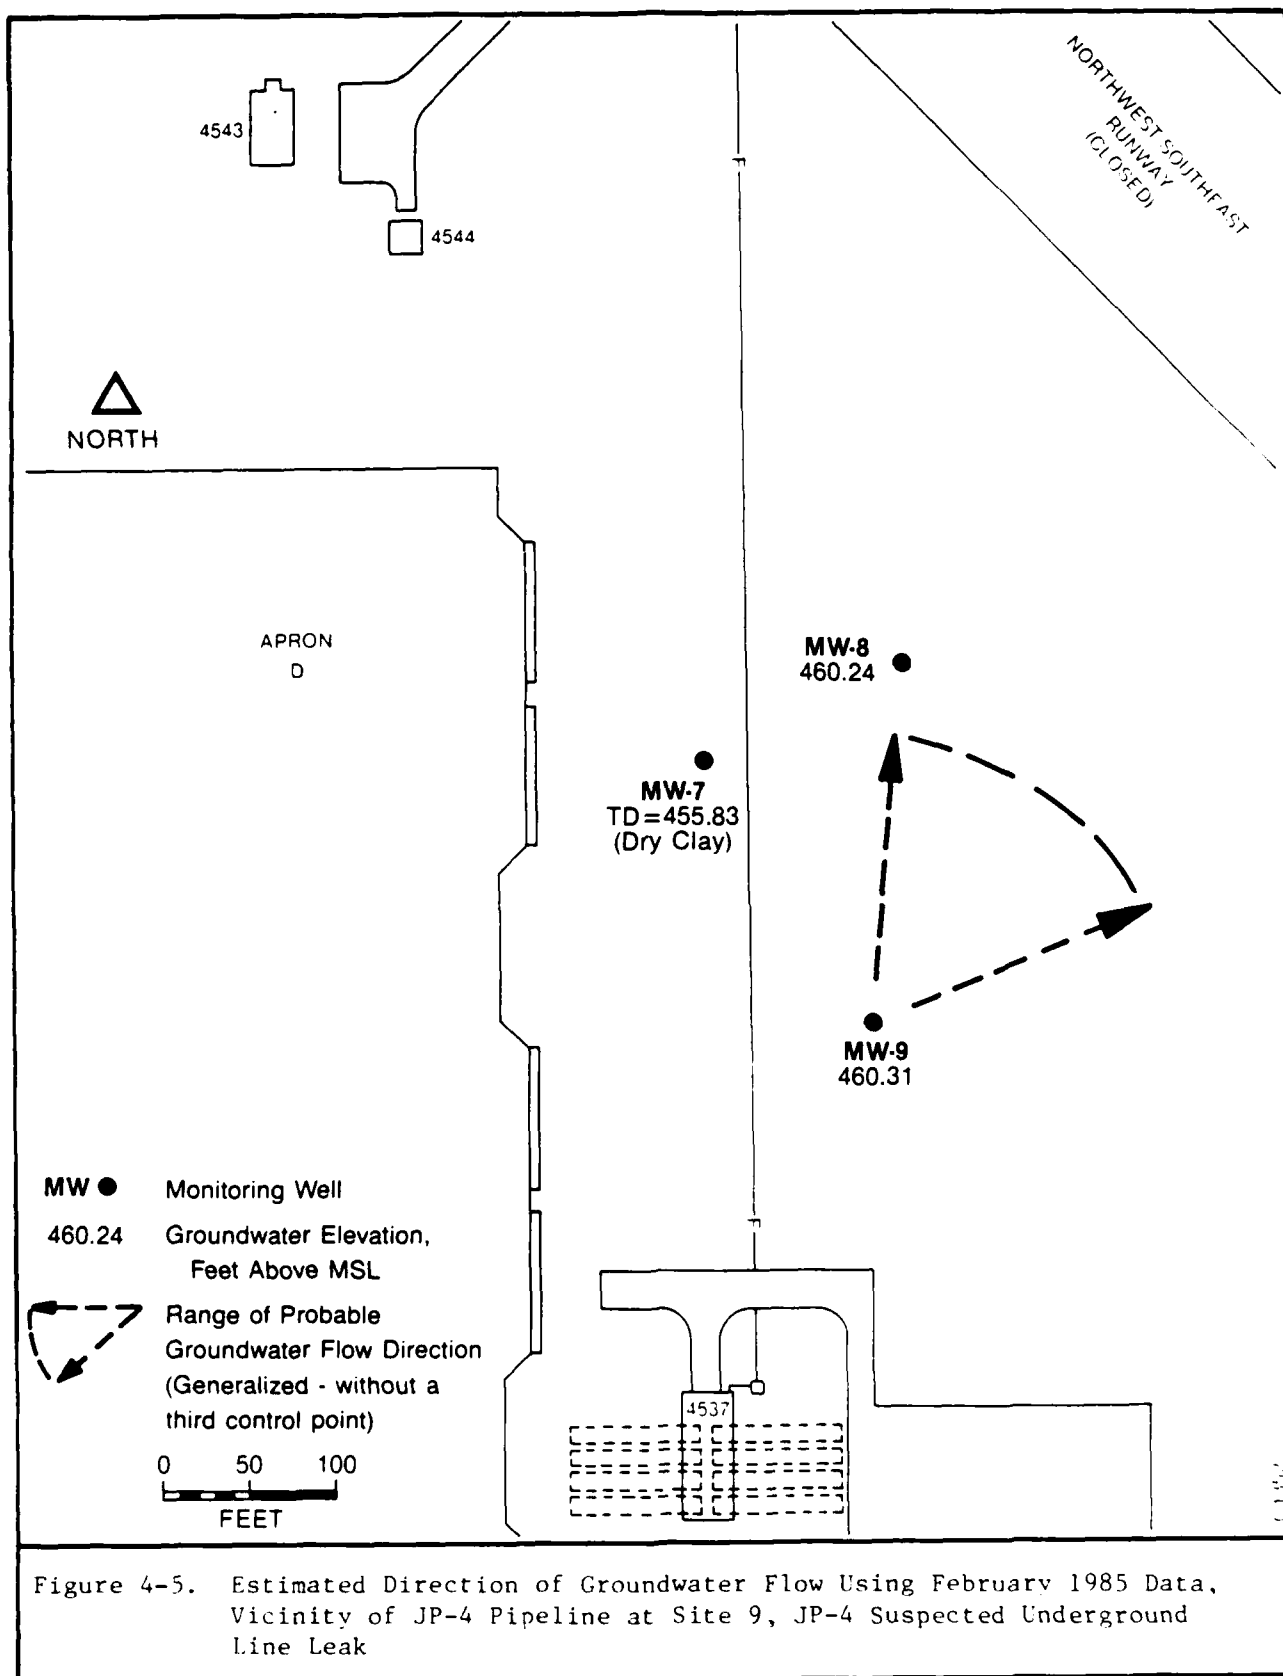
Groundwater was found in the sands and/or gravels that overlay the Taylor Formation at Monitoring Wells 8 and 9. Monitoring Well 7 was drilled completely through clay to a depth of 35 feet and was dry. The composition and shape of the deposits at monitoring wells 8 and 9 indicate the existence of an old river channel. This channel is a potential pathway for the migration of fuel. The direction of groundwater flow cannot be accurately determined with only two groundwater elevation points; however, based on existing data (Figure 4-5), the flow should move in a general direction from MW-9 towards MW-8 or a southerly to northerly direction. Normally, three groundwater level elevations are needed to accurately define a flow direction. Although only two control points were available (i.e., MW-8 and 9) the third point (M-7) had dry conditions well below (i.e., approximately 15 feet) the water levels at MW-8 and 9. The water level at MW-9 was higher than at MW-8.

which indicates a groundwater gradient towards MW-8. But without a third control point with a water level, the flow direction can only be generalized as shown in Figure 4-5. Chemical analysis performed on groundwater samples from these monitoring wells showed (MW-8 and MW-9) no compounds detected using EPA Method 602. Precipitation occurred prior to groundwater sampling, and water filled the utility vault next to the low-point drain.
