| REPORT DOCUMENTATION PAGE | | | | Form Approved<br>OMB No 0704-0188<br>Exp Date Jun 30, 1986 | |
|---|---|---|---|---|---|
| 4. PERFORMING ORGANIZATION REPORT NUMBER(S)<br><b>Technical Report REMR-CS-16</b> | | | 5. MONITORING ORGANIZATION REPORT NUMBER(S) | | |
| 11. TITLE (Include Security Classification)<br><b>Repair of Dam Intake Structures and Conduits: Case Histories</b> | | | | | |

REPAIR OF DAM INTAKE STRUCTURES AND CONDUITS:  
CASE HISTORIES

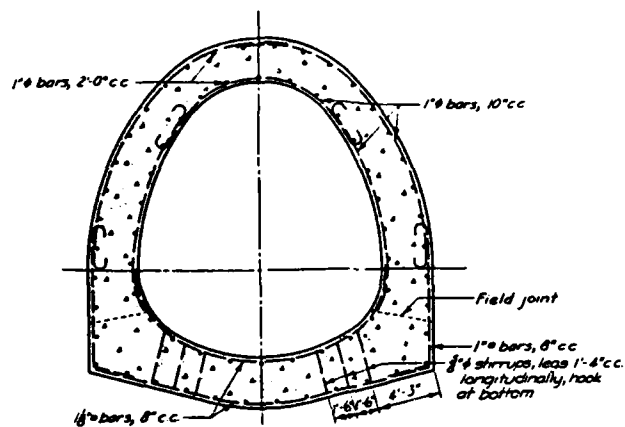
10. It appears that the omission of water stops in the invert is the major contributing factor in the leakage and associated deficiencies observed at the monolith joints of the conduit. During the early operations of the outlet works, leakage was observed at the upstream joints between monoliths 1 and 7. Leakage continued after remedial grouting in 1950 and was accompanied by loss of foundation material and differential movement. Movements of 0.04 ft or greater were reported in 1969 for monolith joints 3/4, 6/7, 9/10, and 10/11. Also reported were spalling and missing filler at various joint locations. Remedial grouting of all conduit joints was performed in 1970. In 1974, a sinkhole developed in the embankment above the downstream end of the conduit near the west edge of the toe road. This sinkhole was cleaned out and backfilled with sandy clay after an investigation concluded that the sinkhole had developed from earlier foundation material losses through openings which were grouted in 1970. Leakage continued and remedial grouting was performed in 1977. In total, leakage has occurred to varying degrees at all monoliths

Figure 1. Typical conduit section, Arkabutla Dam

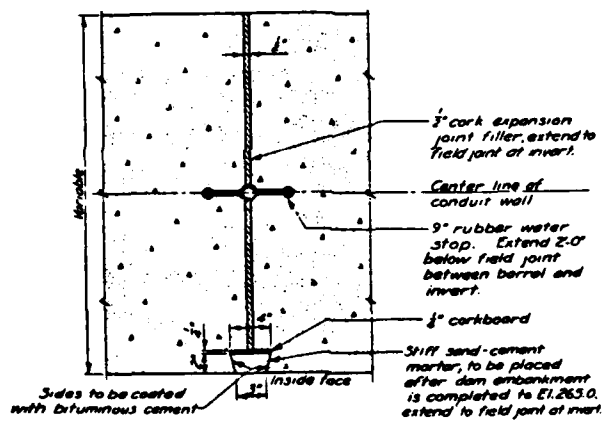
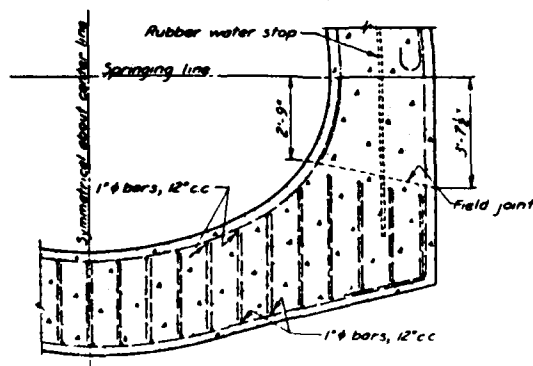
Figure 2. Waterstop location in joint, Arkabutla Dam

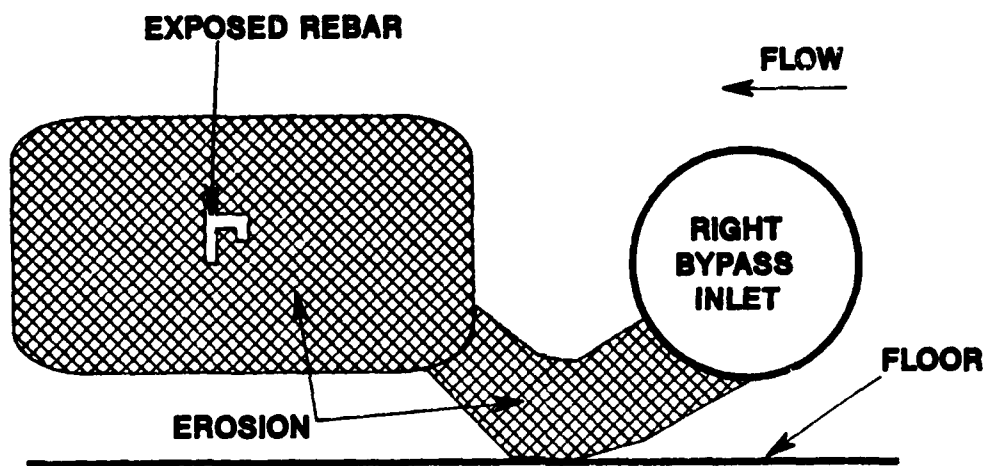
103. During a 1980 inspection, erosion damage was observed in the surface of the concrete in the two gate passages and transition of the outlet works. In the right passage, cavitation damage had occurred immediately downstream of the bypass outlet (Figure 26). The eroded area was approximately 6 ft long, 3 ft wide, and 8 in. deep at the deepest point with exposed reinforcing bars. In the left passage, cavitation damage (Figure 27) had also occurred immediately downstream of the bypass outlet and was approximately 4 ft long and 2 ft wide with a maximum depth of about 4 in. Abrasion damage had occurred in the transition between end of the passages and the beginning of the conduit. The damage consisted of two eroded areas downstream of the

Figure 26. Sketch of cavitation damage in wall of right passage, Cave Run Dam, 1982

104. 1982. Cavitation-erosion-damaged concrete in the right gate passage of the outlet works was repaired in November 1982 by district personnel using SikaTop 122, a two-component, prepackaged, acrylic mortar, manufactured by Sika Corporation of Lyndhurst, New Jersey\*. The repair was terminated after the mortar failed to set. Inspection of the product containers revealed that no expiration dates were present. It was suspected that the shelf life for the mortar used had been exceeded and, therefore, was the cause of the product's failure to set. The Sika Corporation agreed to replace the undated material. It should be noted that all employees involved complained of minor headaches caused by product fumes and lack of ventilation.

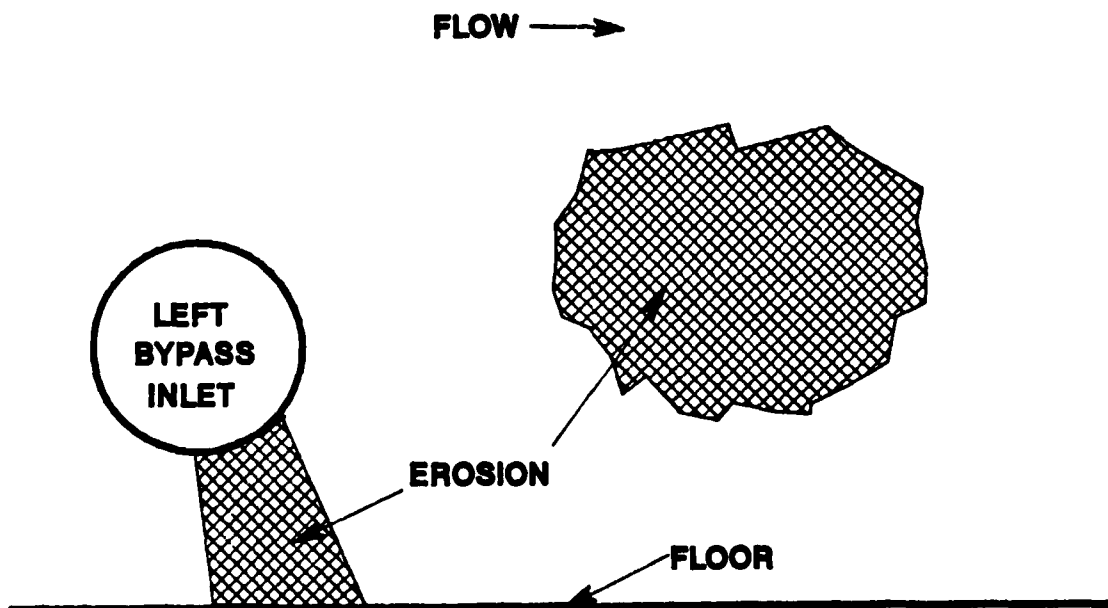
Figure 27. Sketch of cavitation damage in wall of left gate passage, Cave Run Dam, 1982

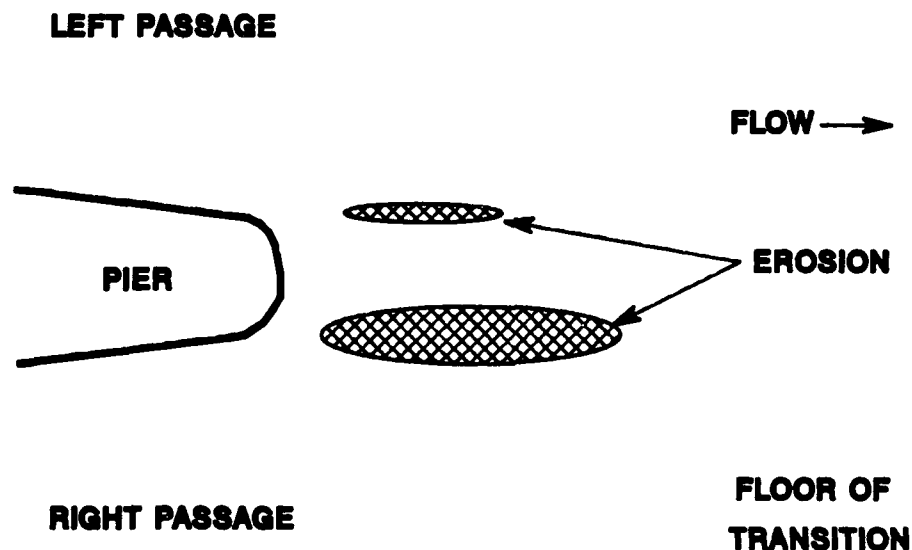
Figure 28. Sketch of abrasion damage in floor of transition, Cave Run Dam, 1982

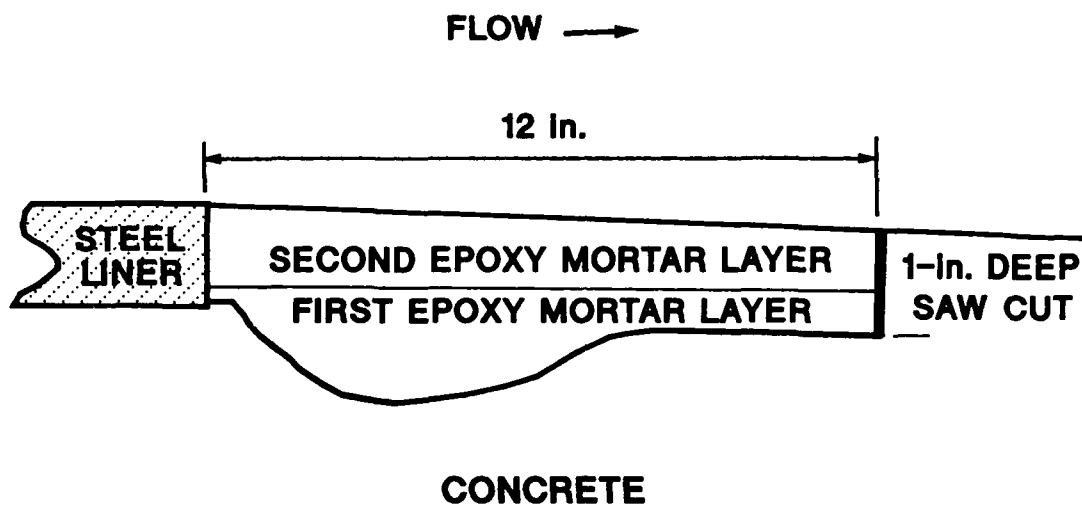
196. In May 1985, 21 months later, the patch was inspected. The epoxy mortar surface had settled or flowed, before hardening, to about 1/4 to 3/8 in. below the level of the steel. It appeared that the bond was still intact and that the mortar surface had little sign of wear.

Figure 45. Repair immediately downstream of steel liner, Milford Dam
