HUMAN FACTORS ASSESSMENT: M9 ARMORED COMBAT EARTHMOVER (ACE)

Gregory S. Krohn  
Essex Corporation

April 1988

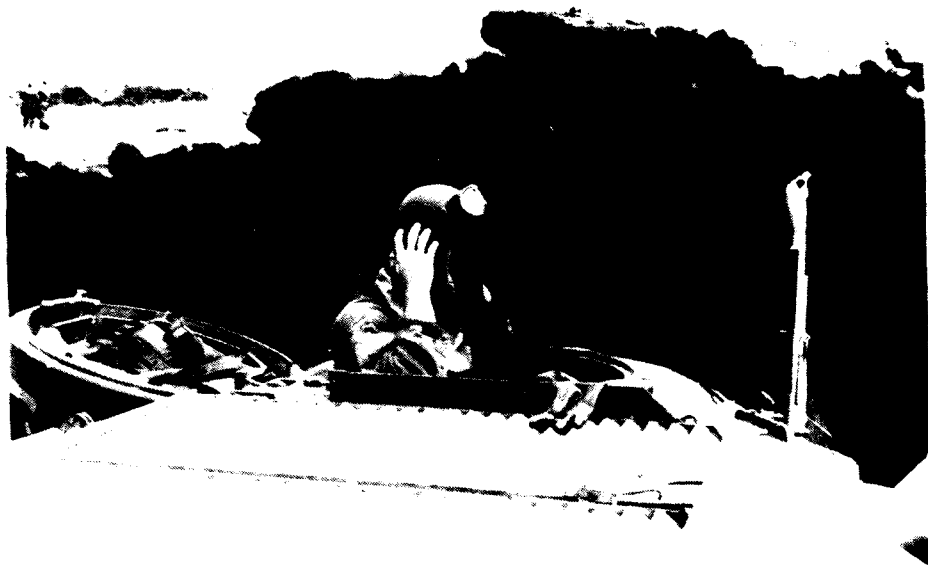
Figure 16. The operator trying to fit the earcups of the CVC helmet while wearing the MOPP mask and hood.

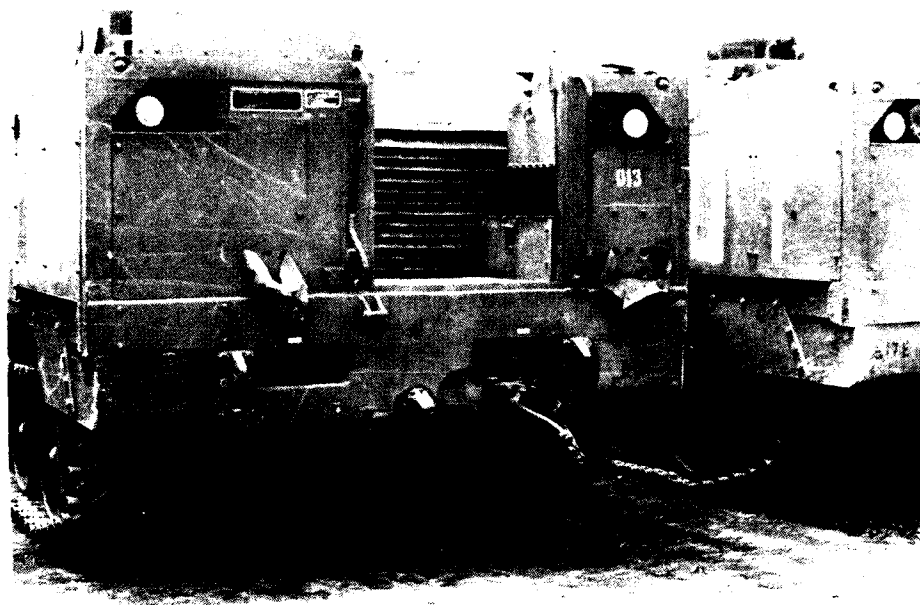
Implications for the Operator and the Equipment: Stowed equipment on the rear of the vehicle was frequently damaged by collisions with objects to the rear of the vehicle. Stowed equipment on the rear deck of the vehicle was affected by the high engine temperature. The stowed equipment blocked the air flow and affected the efficiency of the cooling system. Stowage locations that are difficult to access increase the time it

Figure 18. The damage to the rear of the vehicle. (The winch cable, the rear steps, the jerry can holders, and the handrails are broken.)

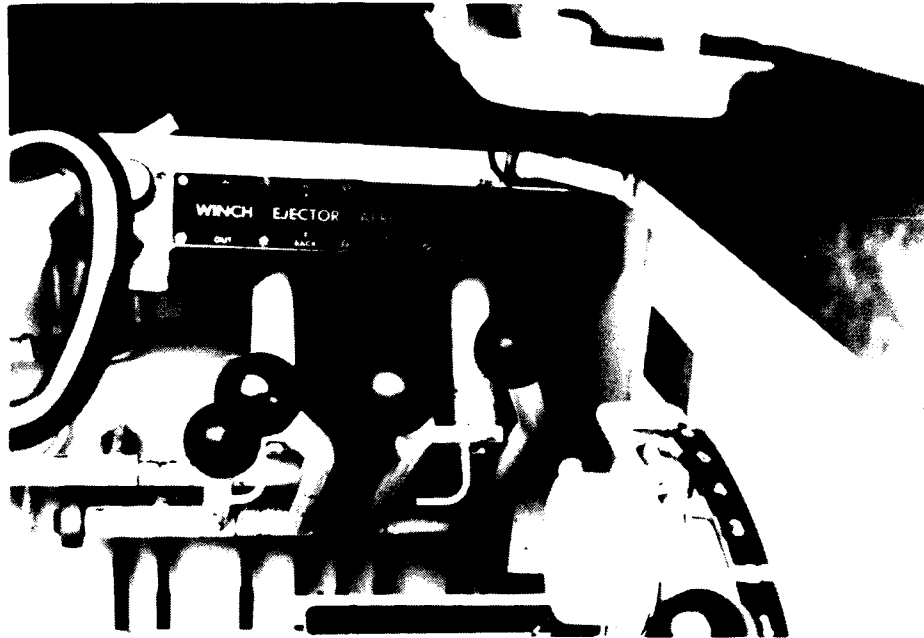
Figure 21. The bilge pump lever (furthest to the right) and the bilge pump light was above the lever but cannot be seen.

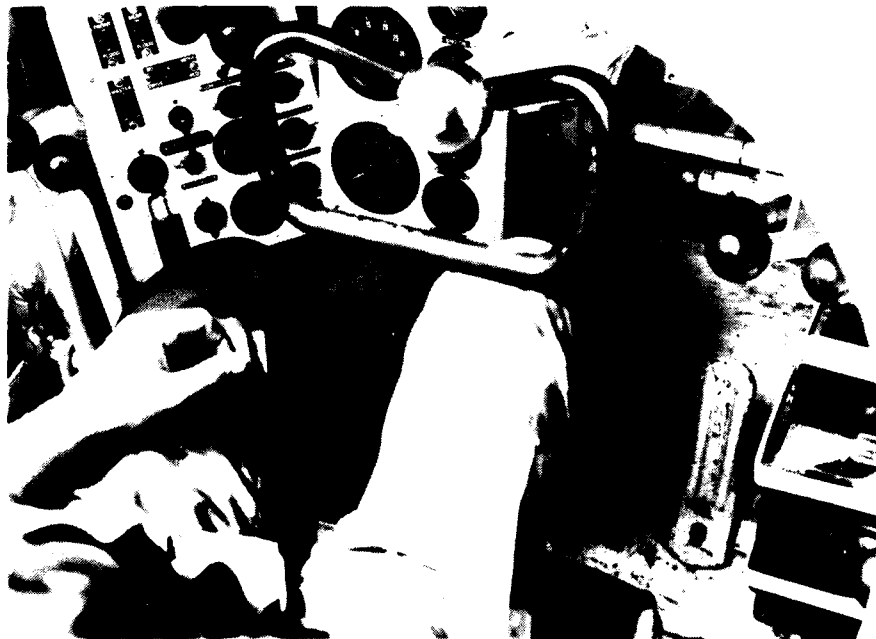
Figure 22. The operator's foot and leg position when using the brake pedal.

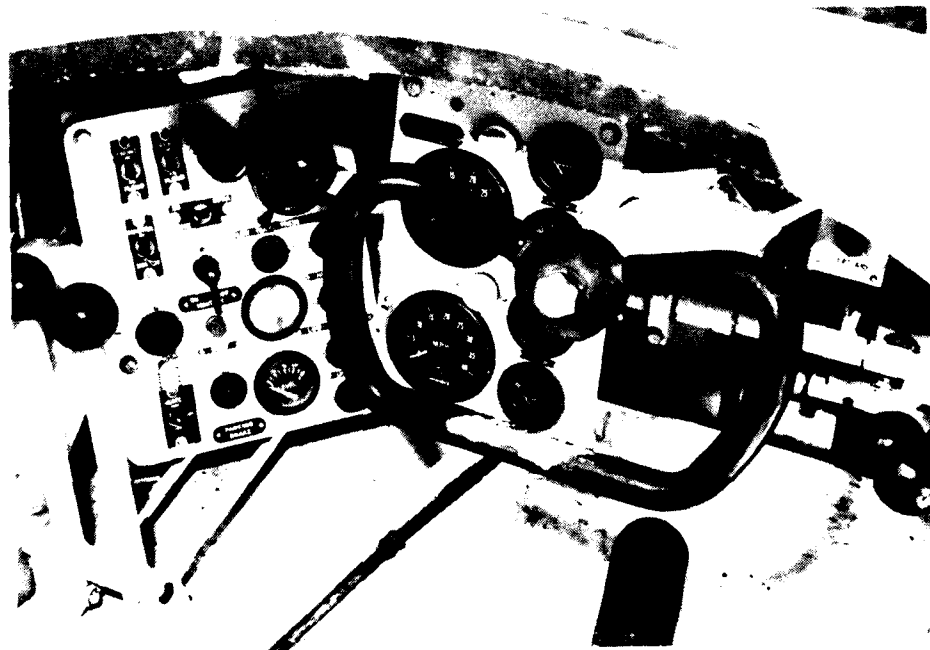
Figure 24. The operator's displays without colored operating ranges.

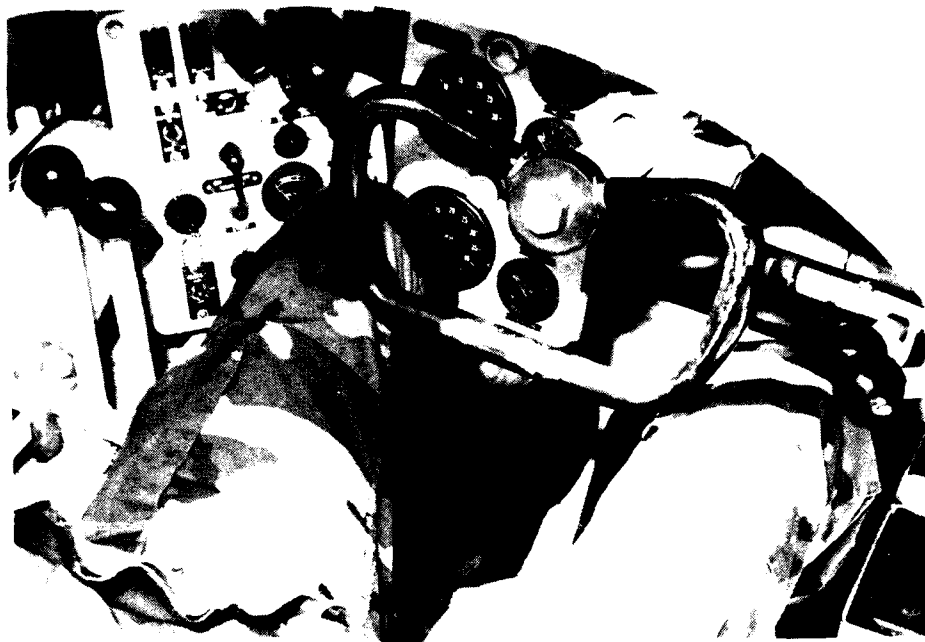
Figure 26. The operator's legs interfering with the steering control.

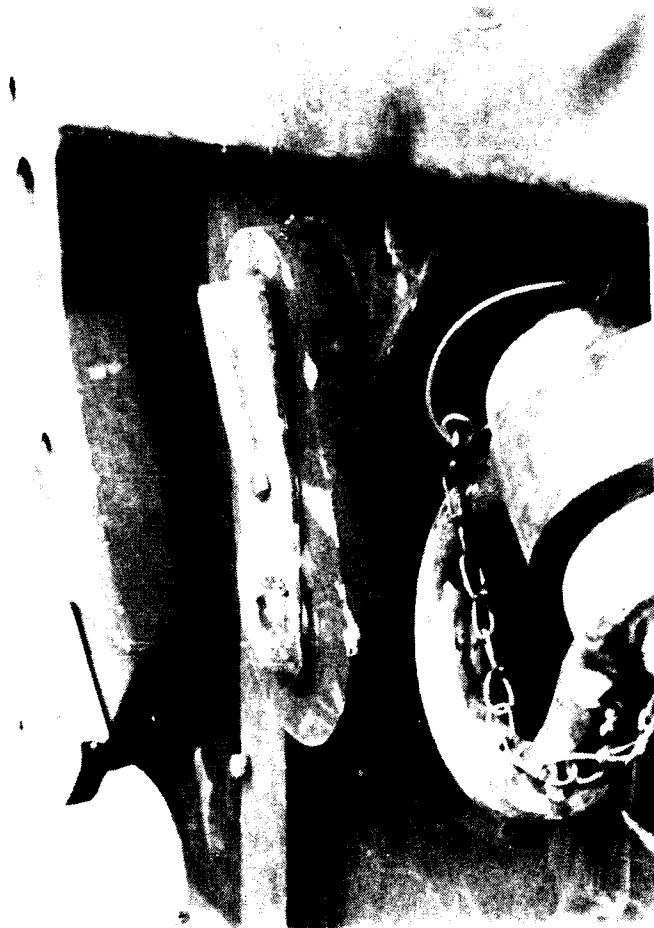
Description of the Deficiency: Figure 27 shows the apron lock pin with marks from hammering on the lower portion of the oval plate. All of the operators reported that the two apron pins, securing the left and right apron to the hull, were driven in and out of place using hammers. The fit of the lock pins into the openings was too tight for easy removal. Continued hammering deformed the pins adding to the problem.

Figure 27. The oval plate of the apron lock pin and hammering marks.

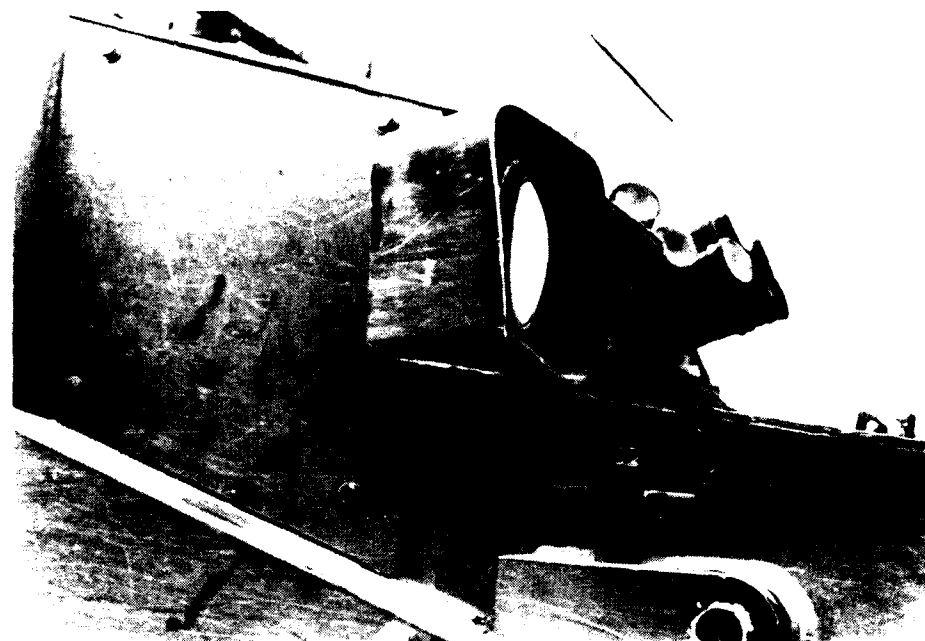
Figure 30. Damage to the floodlight guard

1. Place the side mounted floodlights in protected locations more inboard on the vehicle than the present locations. Perhaps, floodlights could be located inboard at a greater height on a removable stand or fixture.
2. Add lights meeting the requirements of the Army Secure Lighting Program.

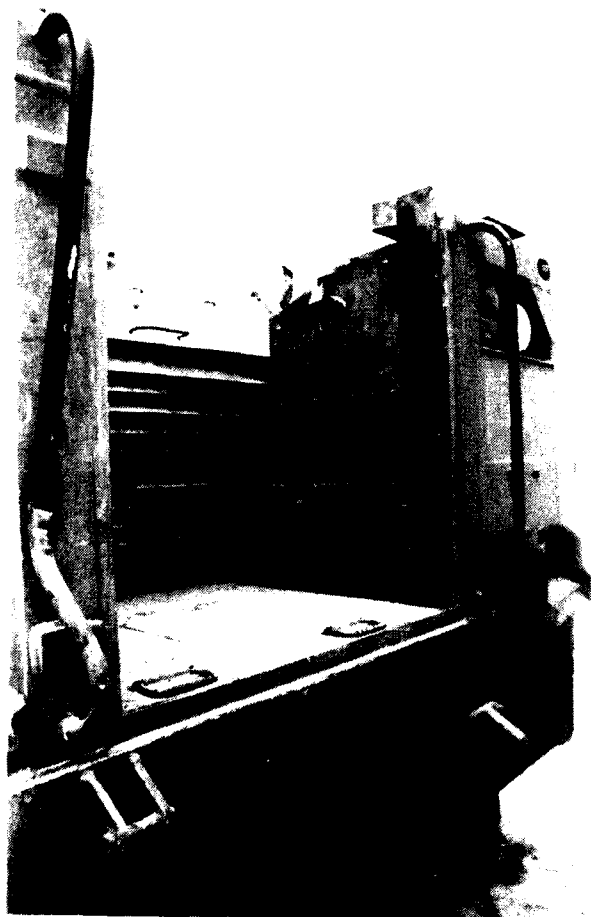
Figure 52. The location of the battery box below the radio box and behind the radiator grille.

Potential Solutions: The radio and batteries may need to be relocated. High temperatures generated by the muffler and radiator damaged the equipment during the test. If the hatch and driver's station are reconfigured, the radio might be placed in the driver's station and the battery box might be located above the fuel tank.

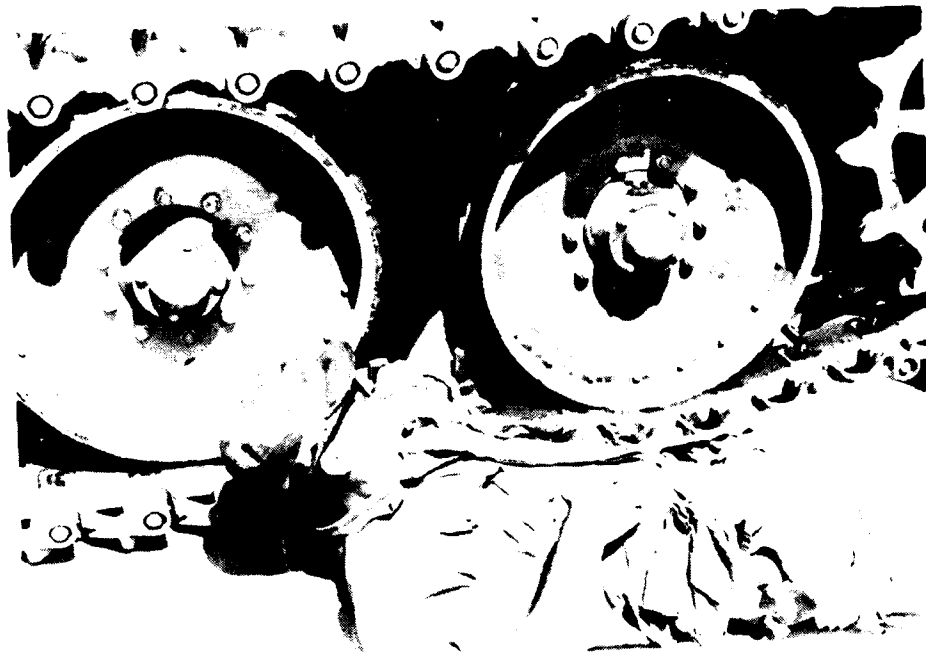
Figure 53. A mechanic reaching between the roadwheels to position the dog bone jack.

1. Use the hydraulic jack only on hard paved surfaces.
2. Modify the dog bone jack to make it self-standing during positioning of the vehicle. This might be done by adding a hinged bipod to one side of the jack. The bipod would angle outward from the jack and wedge into the ground, creating a tripod of the jack.
