TECHNICAL REPORT CERC-88-4

# EFFECTIVENESS OF EXPEDIENT LEVEE-RAISING STRUCTURES

Experimental Model Investigation

April 1988

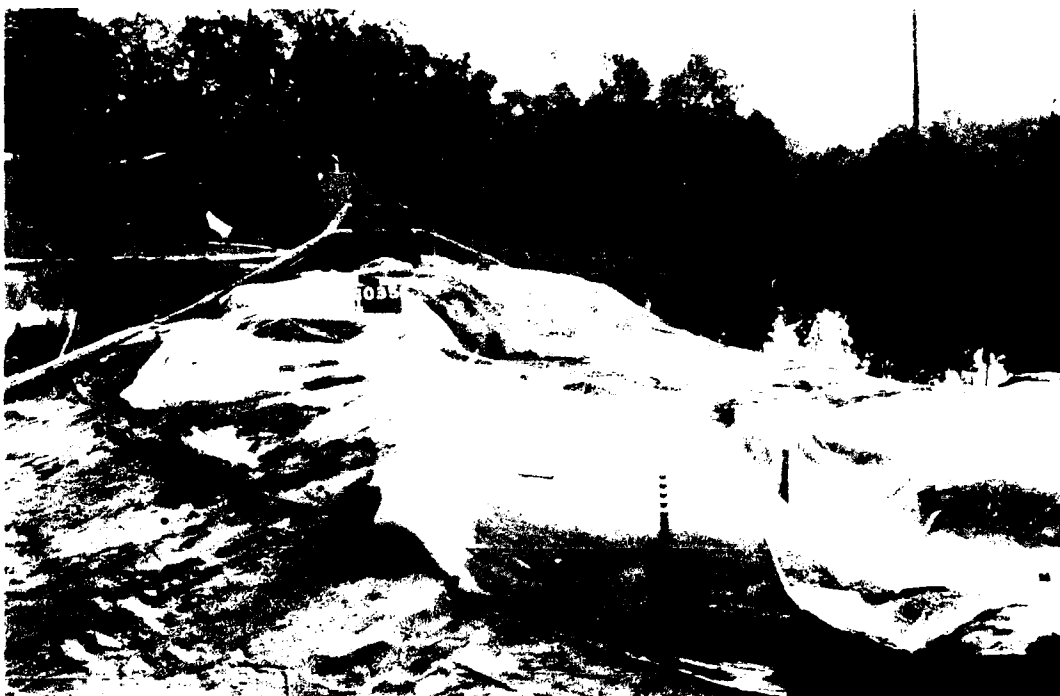
below the breach elevation. Photos 30 and 31 show the condition of the test section after the small basin was drained. The structure was uncovered (Photo 32), and a cross-sectional sounding was made through the breach in the structure (Plate 6).

Photo 30. Riverside view of Section 2-2 after 34.5 hr of wave action at the 1.0-ft water level

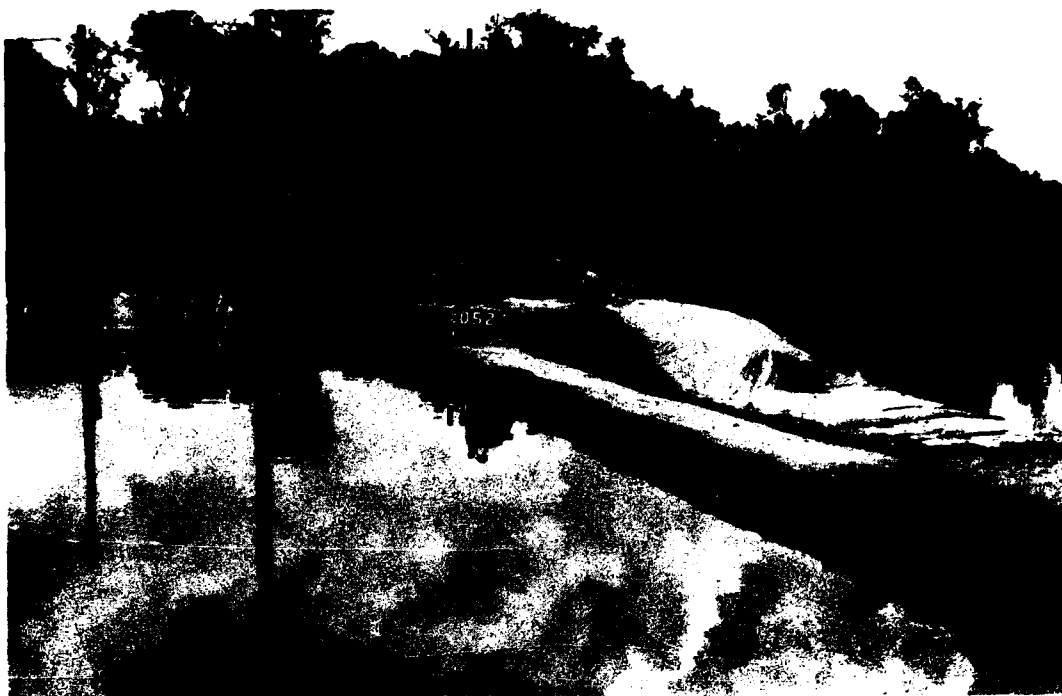
Photo 37. Riverside view of Section 2-3 after 2.5 hr of wave action at the 1.0-ft water level

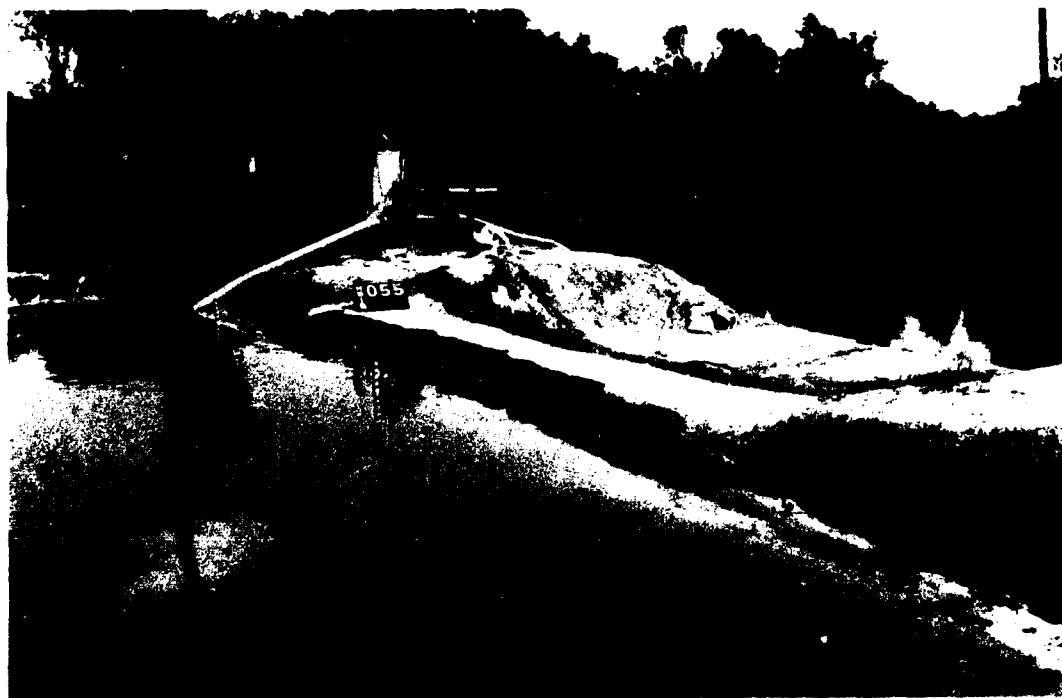
Photo 38. Riverside view of Section 2-3 after 10.5 hr of wave action at the 1.0-ft water level

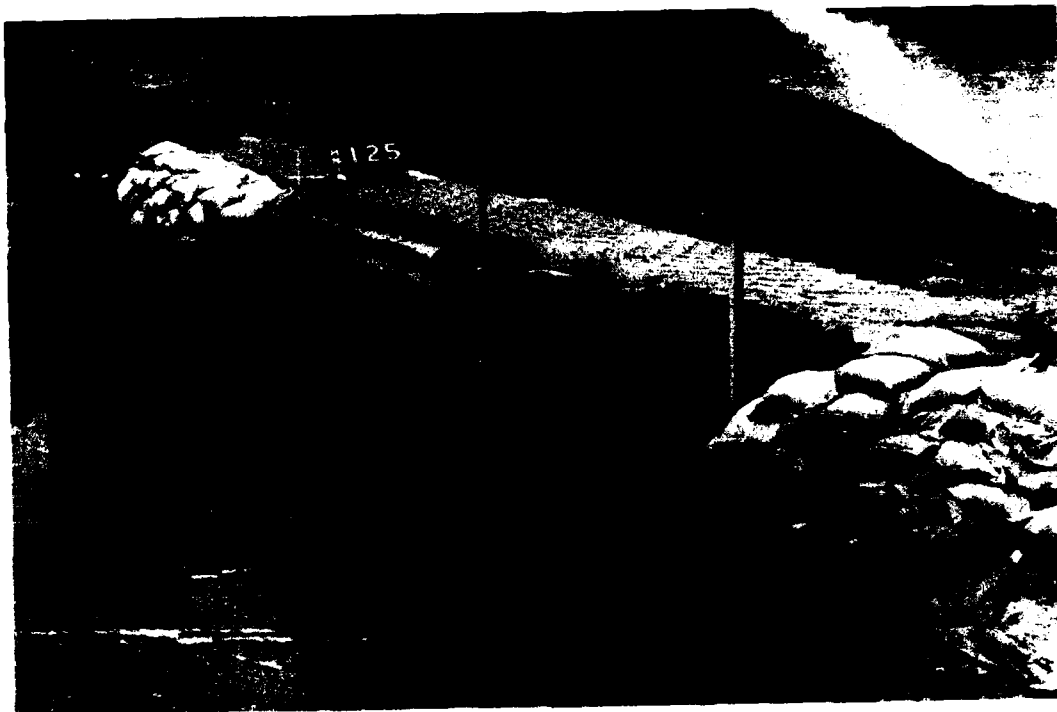
39. Section 4-2 was exposed to 24, 96, and 24 hr of 1.0-, 2.0-, and 3.0-ft static differential heads, respectively. The structure performed quite well for all conditions, allowing only minor amounts of seepage to reach the landside toe. The test section did sustain increasing degrees of damage corresponding to the increases in static differential head. Immediately after flooding to the 1.0-ft depth, the sand fill subsided from 1/2 to 2-1/2 in. in the outside top cells in the middle of the riverside of the test section and 1/4 to 2 in. along the entire outside top row on the landside of the test section. The subsidence was a combined effect of consolidation of the sand in the cell columns due to saturation in the lower lifts and loss of sand in areas where the cells in successive lifts did not line up exactly. The cells with either burlap or filter fabric between lifts showed no subsidence of the sand fill. All damage had subsided prior to raising the static differential head to the 2.0-ft level. At the end of the 2.0-ft static head the seepage had increased slightly in the middle of the test section, but all damage had ceased (Photos 96-100).

Photo 96. Riverside view of Section 4-2 at the end of the 2.0-ft static differential head

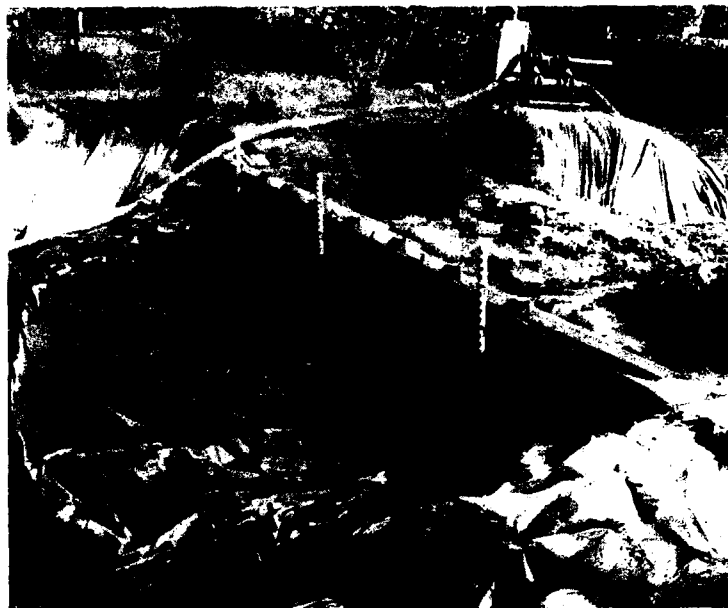
Photo 161. Riverside view of Section 4-3-C at  
end of test

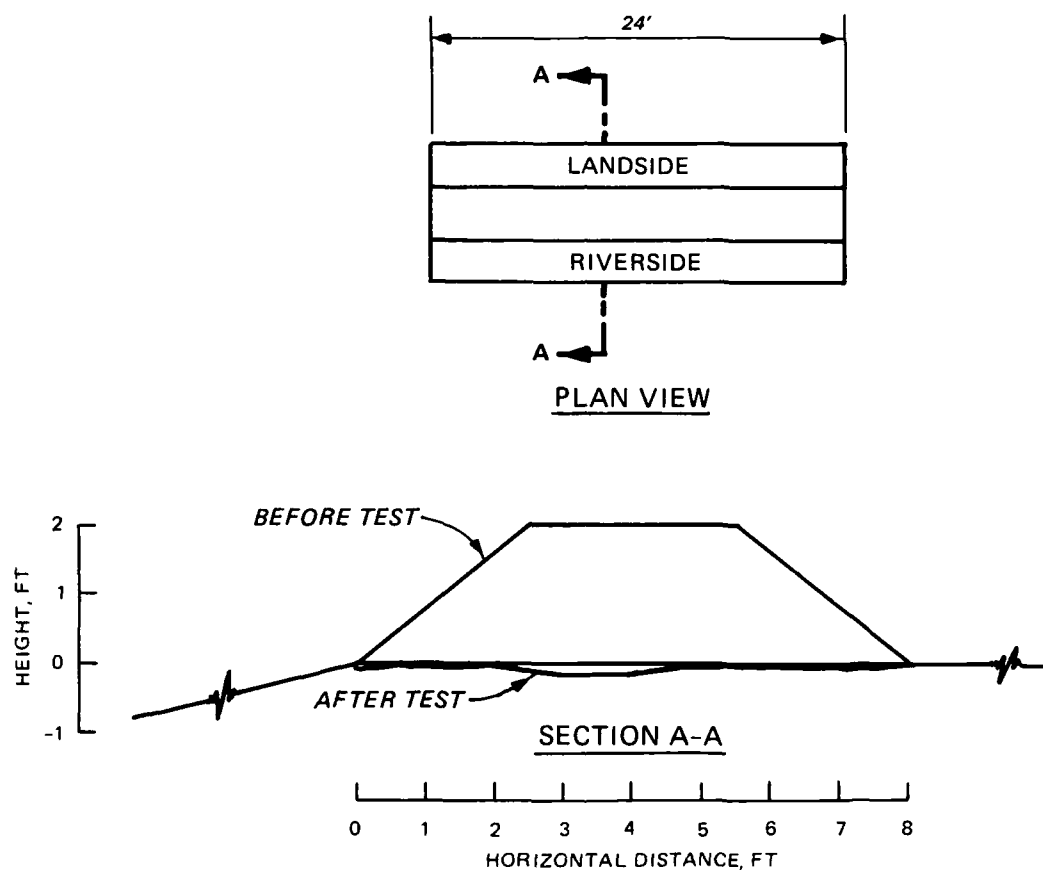
SECTION 2-3  
BEFORE AND AFTER TEST \*  
CROSS SECTIONS  
(1.4-FT WATER LEVEL)

\*AFTER 0.62 HR OF WAVE ACTION AT THE 1.4 FT WATER LEVEL
