MTL TR 88-6

# METALLURGICAL EXAMINATION OF A DIAPHRAGM - LOCKUP CLUTCH PISTON

VICTOR K. CHAMPAGNE, Jr.

April 1988

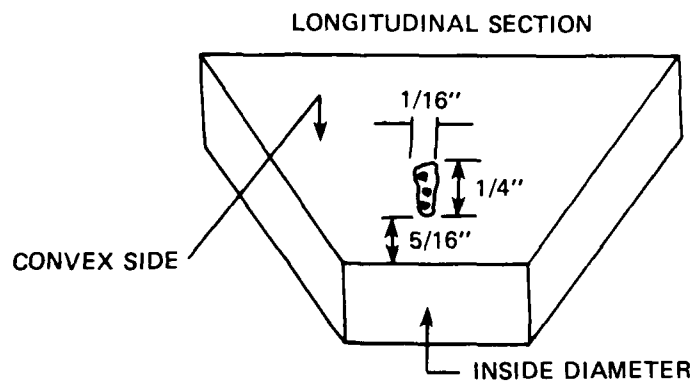
There was, however, one unusual feature observed while examining the microstructure of one diaphragm. Another type of structure was discovered outside the fracture region of one longitudinal section as illustrated in Figure 8. This structure was much coarser in appearance than the predominate tempered martensite and contained large white facets, as shown in Figure 9. The structure was located approximately 5/16" away from the edge of the inside diameter and was approximately 1/4" long and 1/16" wide. The region where the structure existed did not experience any cracking and was not in close proximity to any cracks. Microhardness measurements were taken within this area and are listed adjacent to Figure 8. The readings obtained did not differ from those measured of the surrounding microstructure listed in Table 3. An energy dispersive spectroscopy (EDS) analysis was performed within regions of the "coarser" microstructure to determine if it may have been formed as a result of a nonhomogeneous material. The test did not reveal any foreign elements or impurities. The structure could be a high temperature transformation product. There was no evidence found during this investigation that could relate the formation of the "coarser" microstructure to the cause of cracking.

Figure 8. Illustrates the approximate location of the unusually etched area.

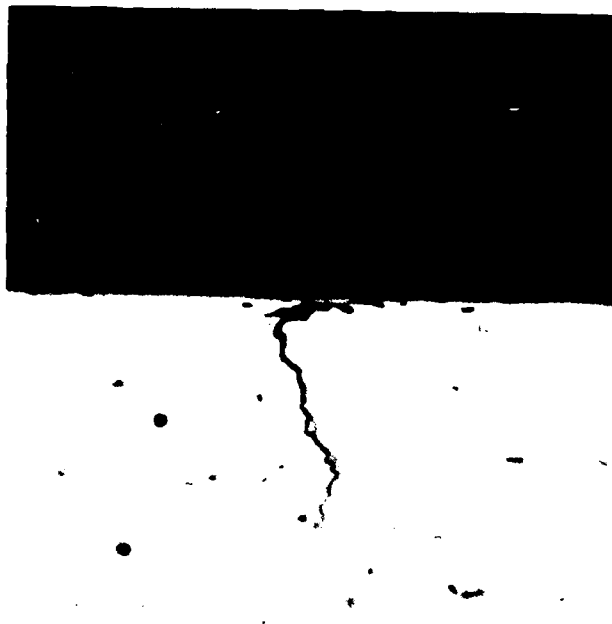
While examining the surfaces of cracked regions, it was found that cracking was sometimes associated with inclusions and other discontinuities in the material. Figure 15 reveals such an instance. Here a crack has originated at the surface irregularity. This small defect acted as a stress concentration area and when the stress parameters of the material were exceeded, a crack initiated here. Figure 16 shows the presence of inclusions over the entire surface of a longitudinal section. In many areas, cracks were found propagating through inclusions and in other instances cracks had originated at sites occupied by inclusions. Some of these were identified as manganese sulfide inclusions. Figure 17 illustrates representative results obtained from an EDS analysis performed on three different regions (see Figure 16 for exact locations).

Figure 15. Transverse section showing a crack that initiated at a surface irregularity, Mag. 1000X.

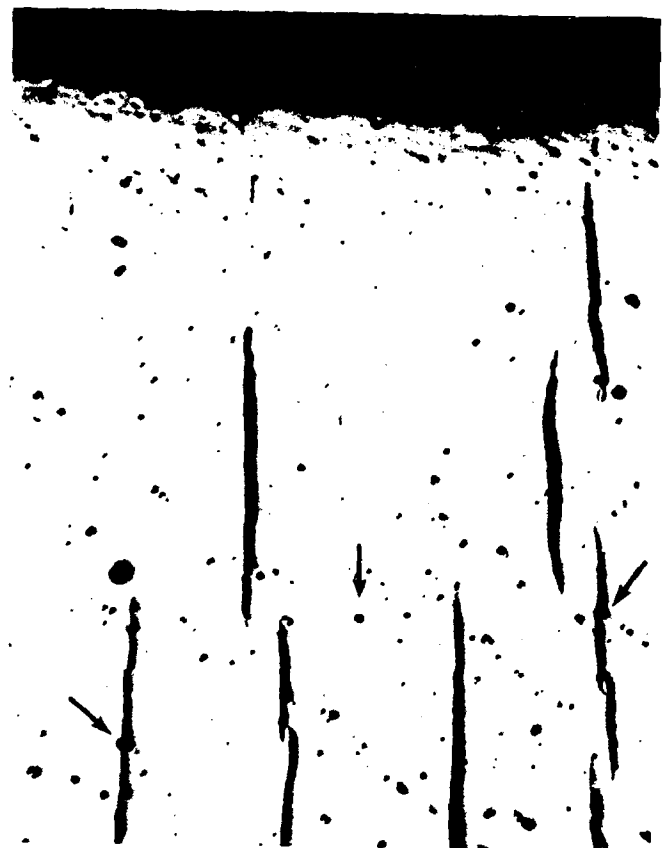
The typical spectra from these regions show large amounts of Fe, S, and Mn. Transverse fracture toughness and ductility can be decreased by these inclusions. Fatigue crack propagation characteristics of the material and corrosion resistance are also adversely effected.<sup>5</sup> It was concluded that although these inclusions may have contributed in some instances to the cracking observed, they are not the primary cause, since many of the cracks examined were not associated to any extent with these inclusions and the material itself was not considered a "dirty steel."

Figure 16. Longitudinal section reveals inclusions within the material, Mag. 500X.

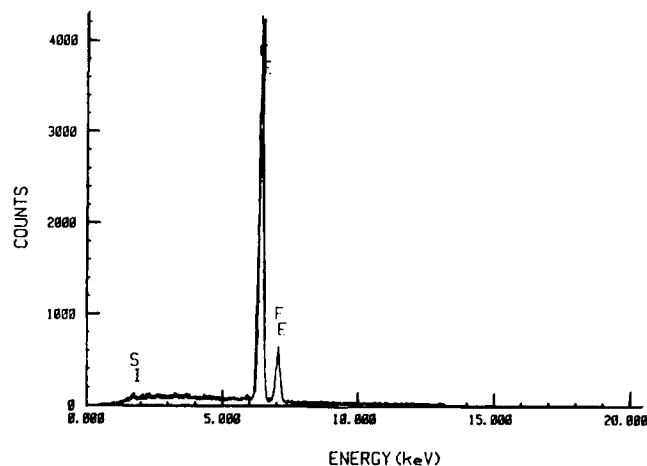
The fracture surfaces of the cracks were examined by EDS. Figure 24 is an example of one fracture showing the areas which were investigated. Figure 25 shows representative results of the spectra obtained in areas 1 and 2 near the crack origin. Large amounts of Fe were detected, along with a trace of Si. There were no

Figure 25. Fractograph and corresponding EDS spectra representative of areas 1 and 2 of Figure 24, Mag. 500X.
