US Army Corps  
of Engineers

| REPORT DOCUMENTATION PAGE | | | | Form Approved<br>OMB No 0704 0188<br>Exp Date Jun 30 1986 | |
|---|---|---|---|---|---|
| 4 PERFORMING ORGANIZATION REPORT NUMBER(S)<br><br>Miscellaneous Paper SL-88-6 | | | 5 MONITORING ORGANIZATION REPORT NUMBER(S) | | |
| 11 TITLE (Include Security Classification)<br><br>Condition Survey of Locks and Dam 3, Monongahela River | | | | | |

CONDITION SURVEY  
LOCKS AND DAM 3  
MONONGAHELA RIVER

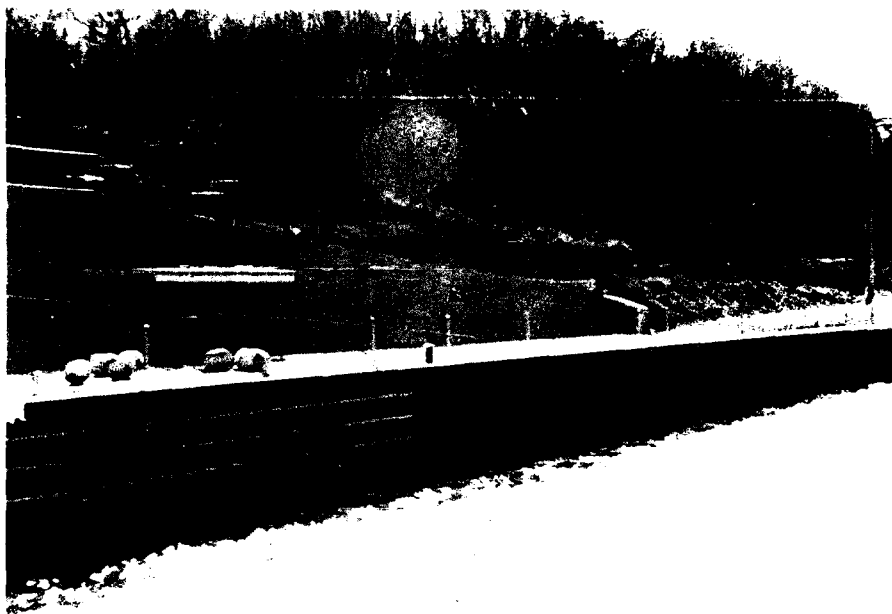
a. Monoliths L-23 to L-18

7. Some of the top surface concrete appeared new while a majority of the surface concrete appeared to be old concrete. The new concrete was in good condition with minor signs of weathering while the old concrete consisted of 60 percent severe scaling and 10 percent very severe scaling. Spalling of concrete was observed in about 20 percent of the monolith joints. A longitudinal crack ran along the top of the guide wall.

8. Vertical surfaces were repaired with shotcrete. The monoliths are armored with the exception of two or three. The shotcrete is severely scaled or spalled in 11 monoliths. The remaining monoliths have medium to light scaling. Small spalls exist in all monolith joints with a high concentration 2-3 ft\* above the water level.

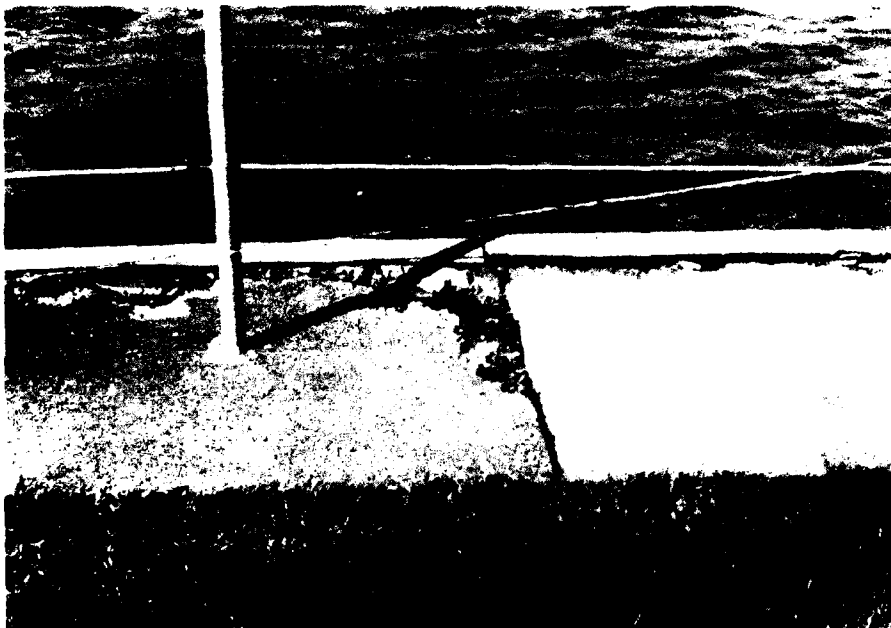
c. Typical top surface

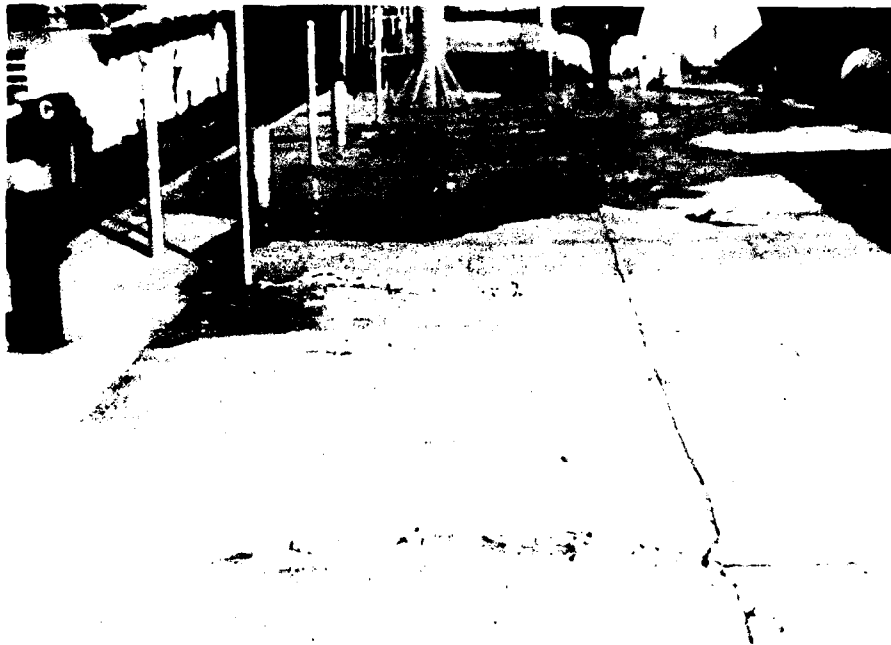
a. Adjacent to power house

b. Upstream of power house

Figure 2. Surface repairs of spalling near power house

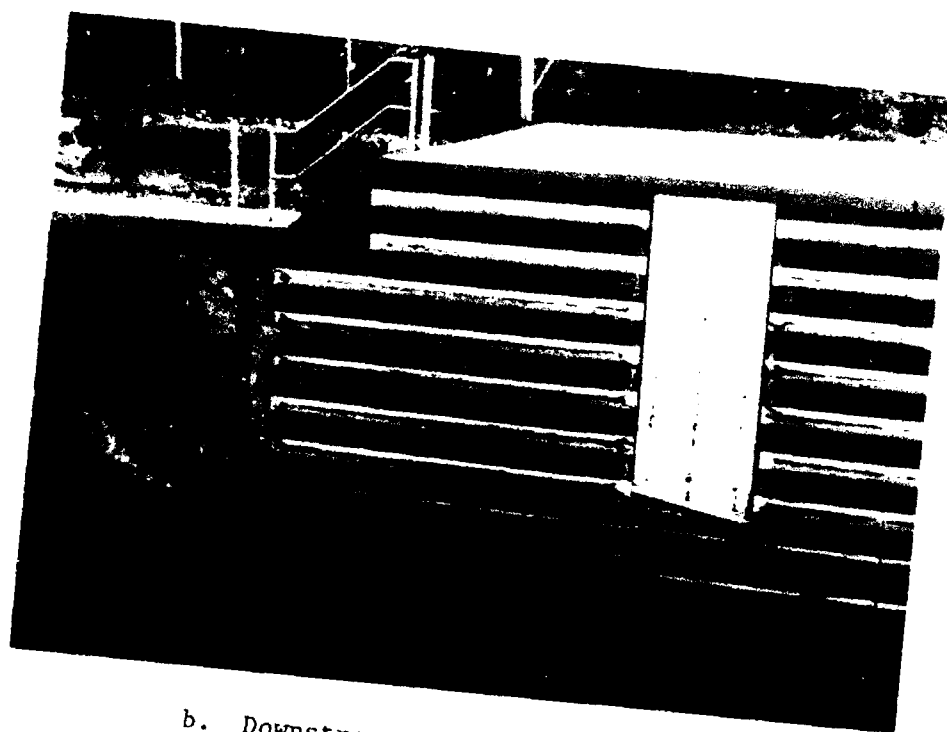
13. Some small spalls had developed at all monolith joints in the lower guide wall. The disaggregation of the shotcrete was most severe at or near the lower pool elevation. Peeling and delamination of shotcrete were evident where the shotcrete was applied to a thickness of less than 1 in.

14. Scaling of the surface was evident with 30 percent very severely scaled, 50 percent severely scaled and 20 percent moderately scaled. A few diagonal and vertical cracks were observed. Cracking was generally infrequent and did not tend to be open. Some shotcrete was spalled due to barge impact, but this spalling was localized.

15. The top surface of the lower guide wall generally contained medium scaling with some large spalls at the end of the wall. Numerous fine transverse cracks propagated across the wall. These cracks could be traced down the vertical face of the wall as the cracks were reflected through the shotcrete surface.

a. Monoliths 48 to L-62

b. Downstream of lower gate recess

Figure 3. Lower guide wall

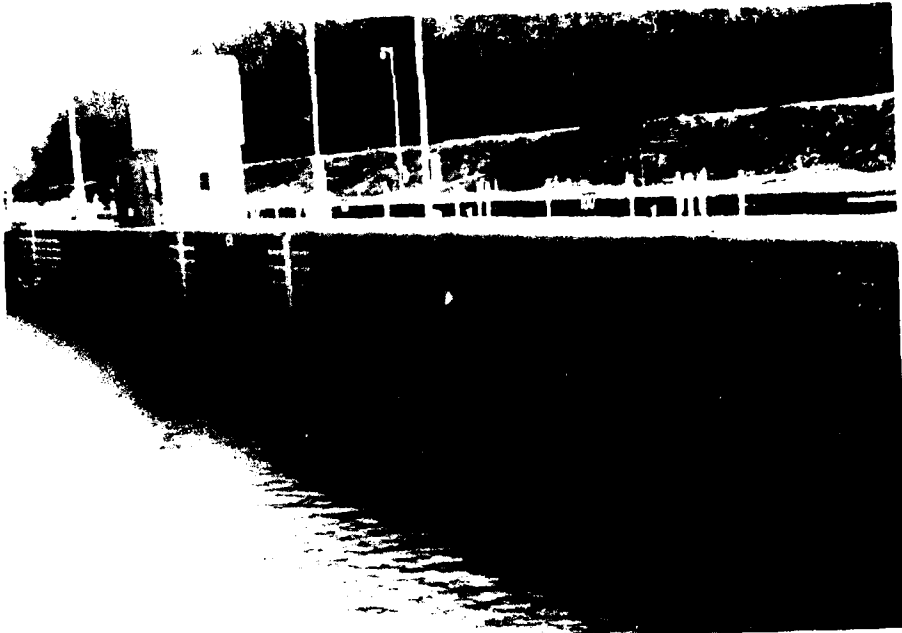
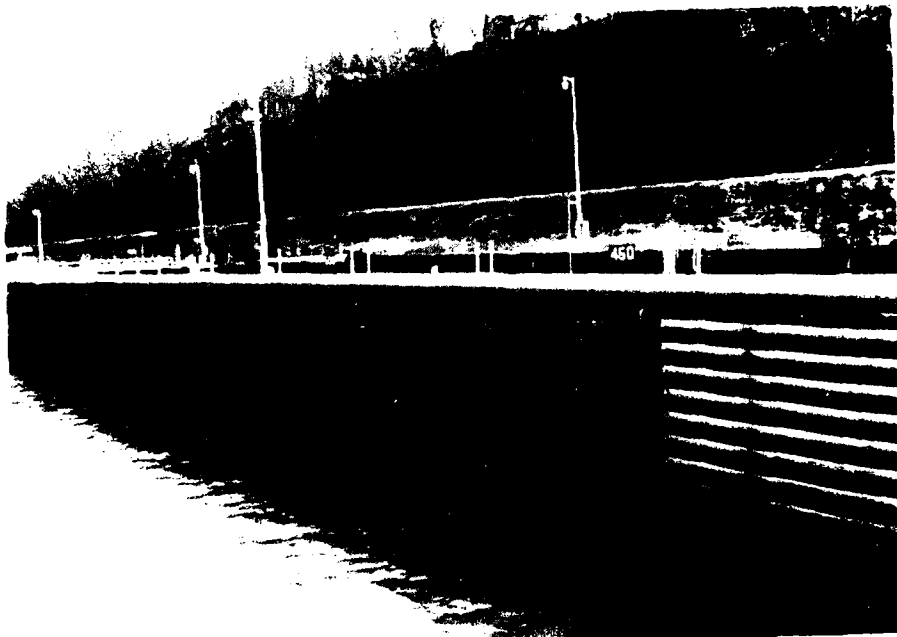
20. The river face of the middle wall in the river chamber showed light to medium scaling. An estimated 60 percent of the wall had light scaling and approximately 40 percent had medium scaling. Small spalls were present at monolith joints with few horizontal and vertical cracks on the vertical face. There were several large areas where exposed reinforcing steel was observed. These areas were approximately 1 ft deep or more and probably were honeycombed areas developed during refacing of the wall. The top 18 in. of the surface concrete had vertical cracks with efflorescence. It also contained some fine horizontal cracks with efflorescence.

Figure 7. Middle wall river face

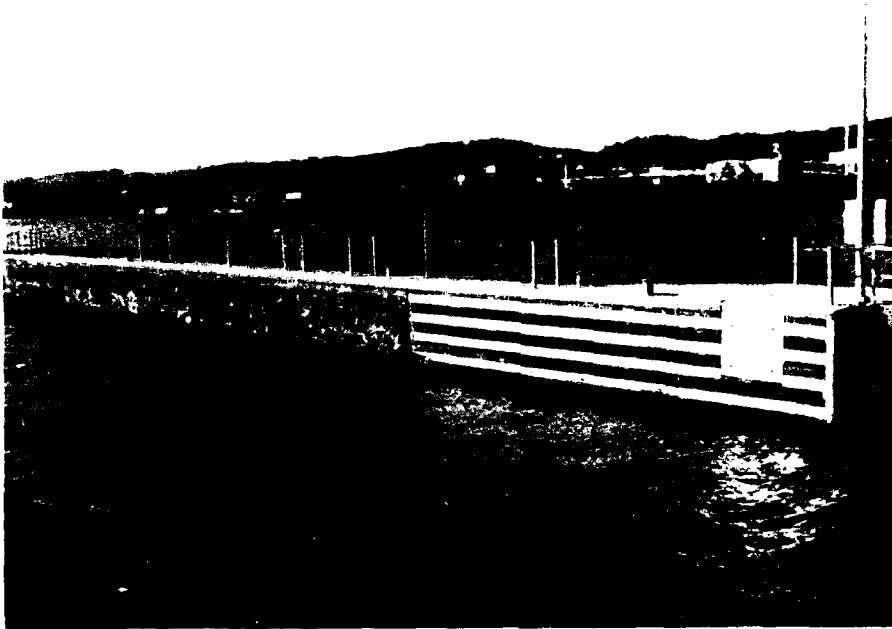
23. The land face was resurfaced using shotcrete application. Forty percent of the shotcrete showed signs of delamination exposing some reinforcing steel. Sixty percent of the surface had medium scaling. Original concrete is exposed in several areas at the upper pool elevation. The shotcrete that was placed during the 1978-1980 rehabilitation work has dropped off the wall in these areas; thickness of missing shotcrete is 3 in. Large spalls were observed at the ends of the guard wall where barges had impacted the wall.

Figure 8. Concrete in the upper guard wall land face (continued)

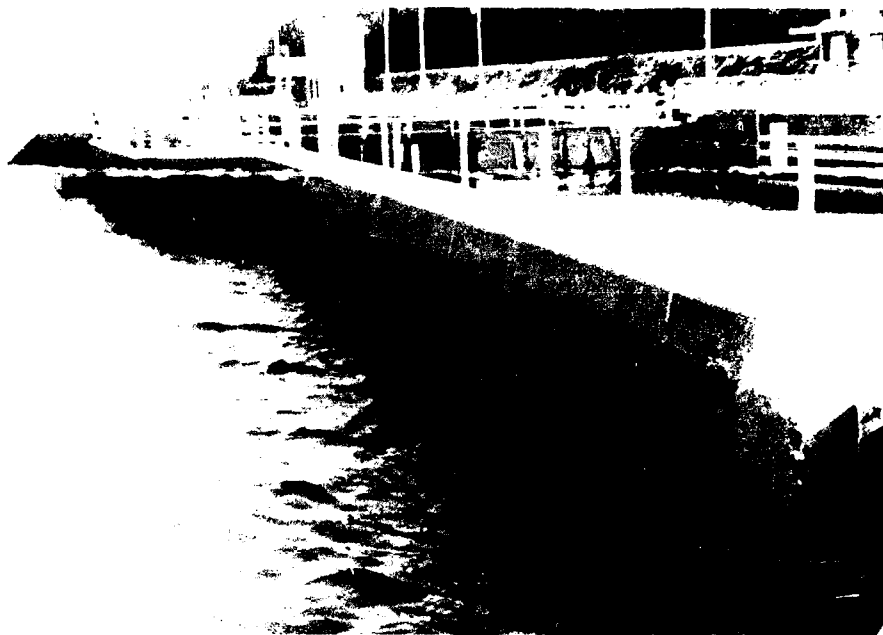
28. The river wall river face was repaired using shotcrete from the top of the wall to the water level. A work flat was tied to the wall near the upper gate and a closer look was taken at the repair near the upper pool elevation. Some 3-ft deep voids that were not repaired were observed. The shotcrete was scaled to 0.5- to 0.75-in. depth. Some reinforcement and mesh were exposed.

Figure 10. River face, river wall
