MISCELLANEOUS PAPER NO. 2

# CONDITION SURVEY OF LOCK NO. 2 MONONGAHELA RIVER

August 1968

Approved by DEPARTMENT OF THE ARMY  
US Army Engineer District, Pittsburgh  
Pittsburgh, Pennsylvania 15222-4136

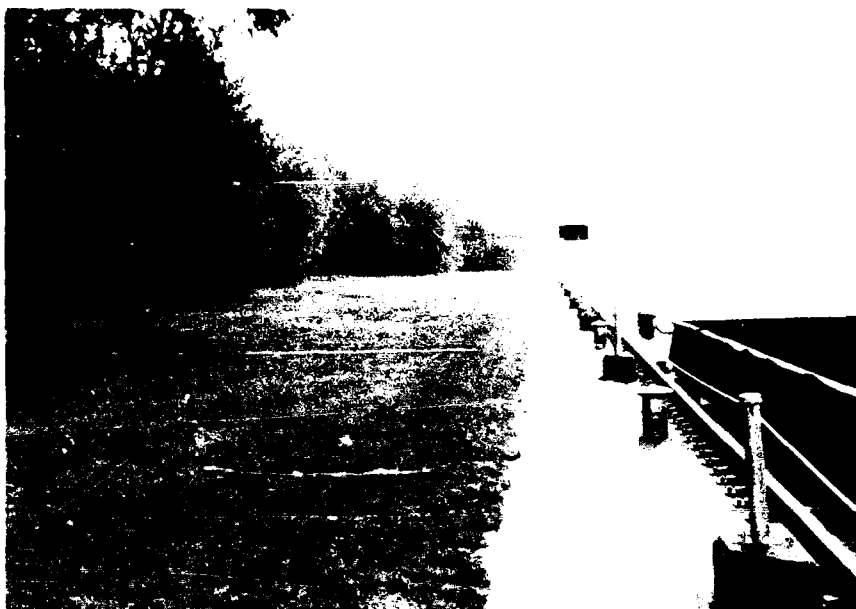
9. The backfill from monolith 15 to monolith 24 is below the top of the guide wall while the backfill from monolith 25 to monolith 29 is above the top of the wall as it is for the rest of the guide wall. It is grassed and shows no signs of any depressions (Figure 1). There are fine-to-medium transverse cracks\* at one-third points between the monolith joints. Surface

Figure 1. Grassed area behind upper guide wall

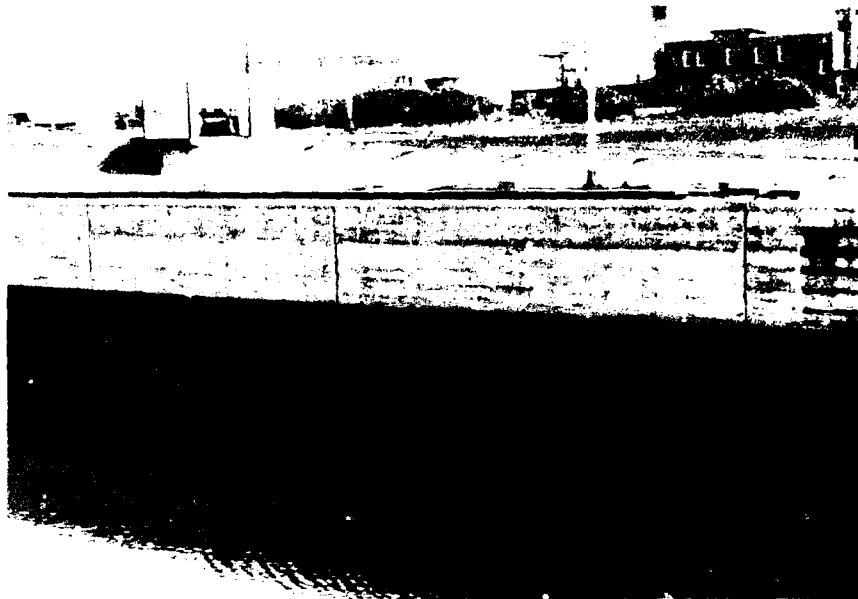
12. River face. The surface is generally in good condition. Below the upper pool elevation there is some minor spalling of the monolith joints. Surface above the upper pool shows 20 percent exposed aggregate and small joint spalls (Figure 2).

Figure 2. River face of the land wall, large chamber

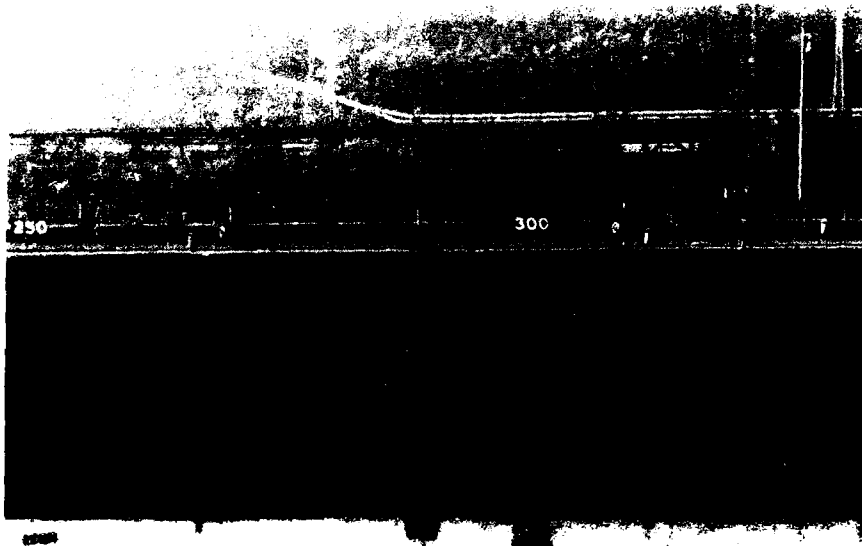
16. Land face. The concrete above upper pool elevation is in good condition. The concrete below the upper pool elevation contained approximately 5 percent severely scaled concrete and approximately 30 percent lightly-scaled concrete. Severe spalling was present along the monolith joints (Figure 5).

Figure 5. Severe spalling along monolith joints in land face of middle wall

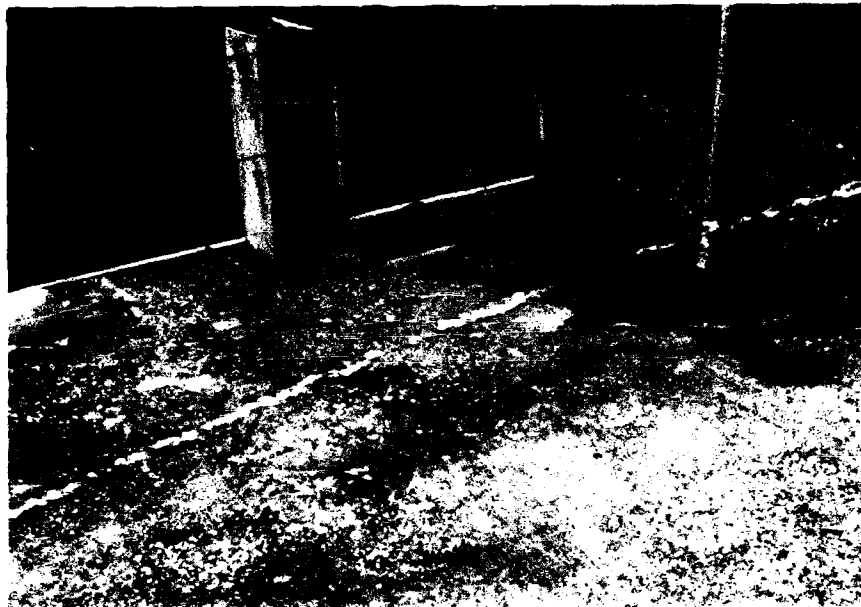
Photograph A17. Cracking near gate recess monolith R-12 of river wall

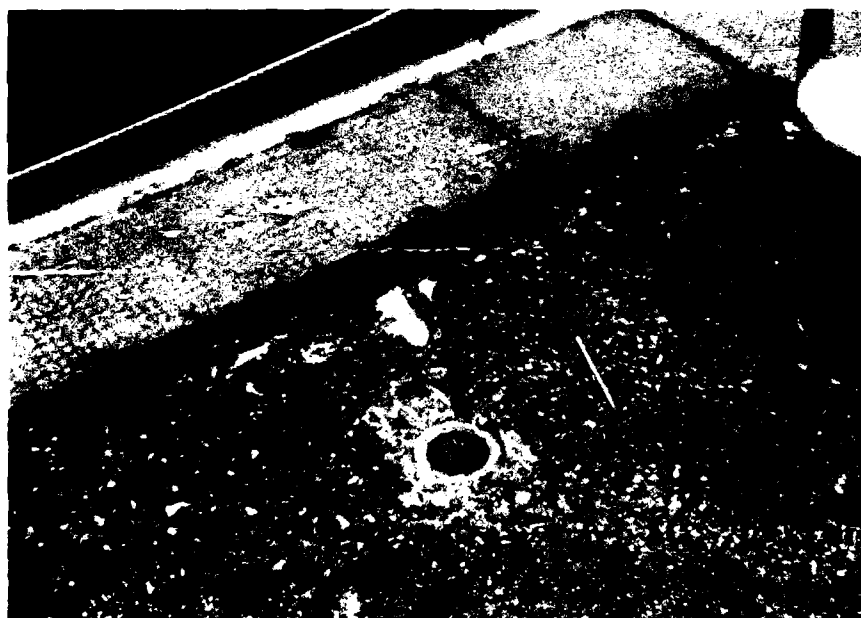
Photograph A18. Top of monolith R-13 river wall near upper gate recess

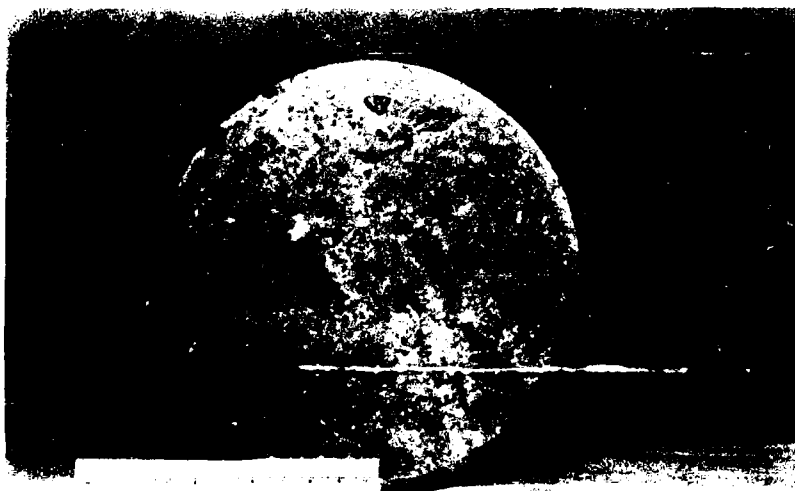
Photograph C3. Surface concrete at L-1. The surface concrete is in good condition

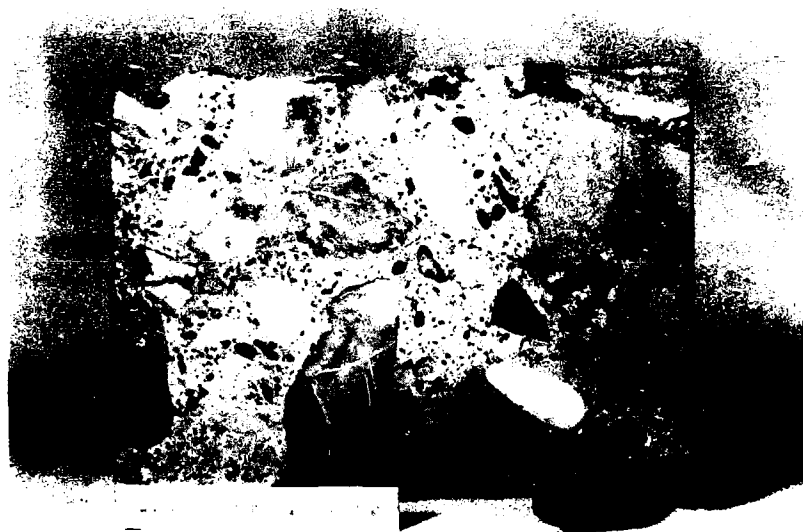
Photograph C4. Concrete from R-4. Hairline cracks are through coarse aggregate and paste. Note the reaction rim around the aggregate at the bottom center. The texture of this aggregate is crystalline dolomite with a matrix of fine-grained calcite

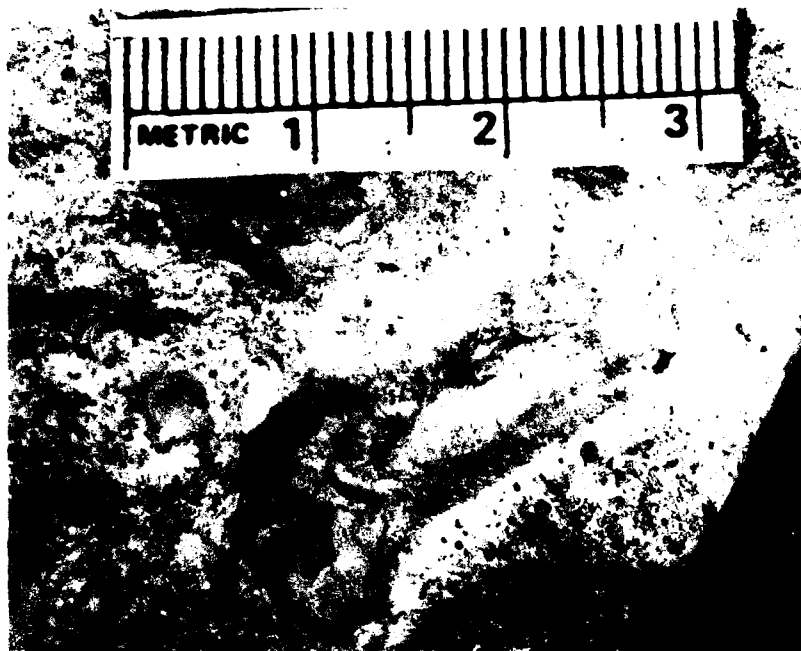
Photograph C6. Concrete from R-4. Note the white powder around the coarse aggregate. The composition of the powder is calcite, aragonite, and vaterite
