# RETROGRESSIVE FAILURES IN SAND DEPOSITS OF THE MISSISSIPPI RIVER

Report 2

EMPIRICAL EVIDENCE IN SUPPORT OF THE  
HYPOTHESIZED FAILURE MECHANISM AND  
DEVELOPMENT OF THE LEVEE SAFETY  
FLOW SLIDE MONITORING SYSTEM

PART II: CASE HISTORY OF THE CELOTEX BATTURE AND LEVEE FAILURE OF  
30 JULY 1985

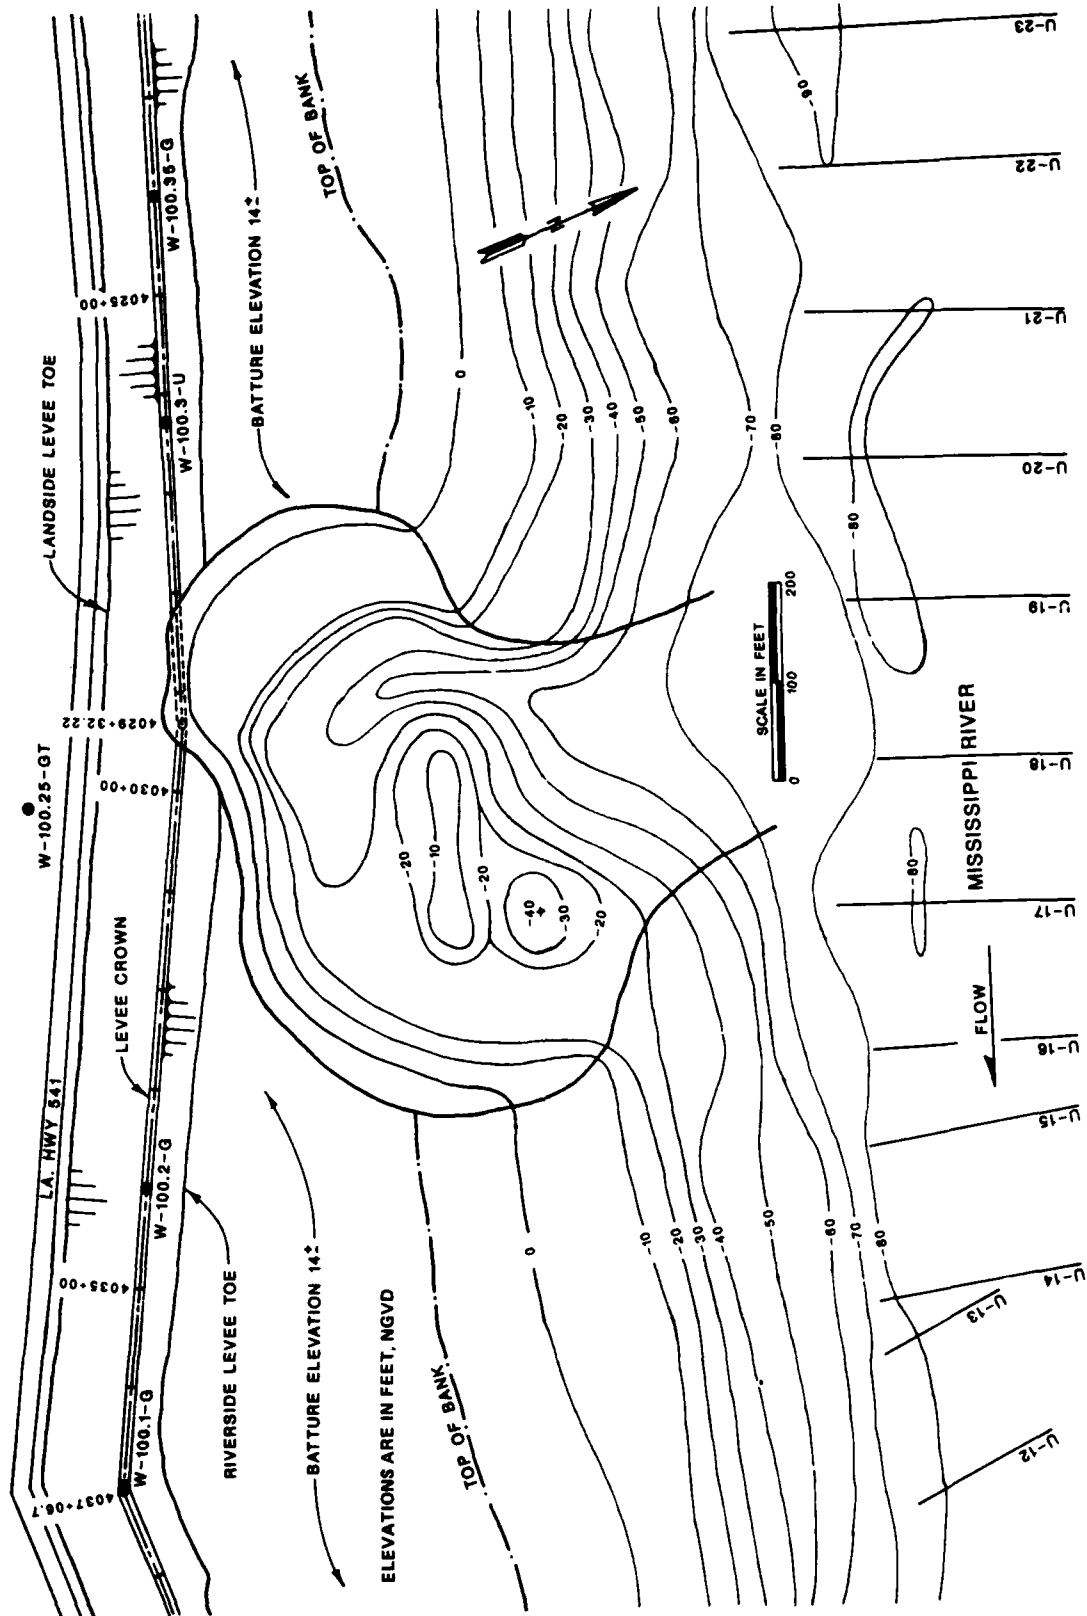
Figure 5. Contour map of the Celotex batture and levee failure

10. The author employed the Fathometer surveys and the boring information within the failure area to produce the contour map shown in Figure 5. Sections are plotted in Figure 6. Three-dimensional microcomputer images of the failure are given in Figures 7 and 8. The plan and sections of the failure reveal the bottleneck plan view and relatively flat bottom slopes typical of a flow slide. The line of borings taken between Greenville Bend revetment ranges U-18 and U-19 for the purposes of determining if overburden remained in the scar proved to be a fortuitous accident with respect to their position in revealing some important aspects of the failure's appearance as well as suggesting a sequence of events to be addressed later. This circumstance emphasizes the need that surveys of future flow slides be done in greater detail so that quality contour views can be constructed. Survey range lines should never be more than 100 ft apart and should extend to the thalweg. Portions of failures above water should also be surveyed after the fashion necessitated by the repair method for Celotex. The surveys should be initiated as close to the failure event as practicable even if the failure is only to be graded and revetted or even if the failure is in unrevetted bank. Such quality physical pictures of flow failures are now especially important data to help eliminate any doubts about predictions of potential batture loss included in the flow slide bank monitoring system to be discussed in the next part of this report. Simple microcomputer software is available to draw contour maps and three-dimensional views which can be rotated and sectioned at will.

15. In studying the plan and sections of Figures 5 and 6, respectively, the author conjectures as to a possible sequence of events. From the plan view of Figure 5, the failure has the appearance of dual lobes with a main body of the more symmetrical nature of a flow slide and a lobe in the landward, upstream portion (upper right portion of the plan view) which represents the involvement of the levee section and has the U-shape of a typical shear failure. A line of borings was logically taken straight out riverward from the center of the levee slide between revetment ranges U-18 and U-19 to investigate the presence of overburden material remaining in the failure scar. Those borings coupled with the Fathometer surveys of ranges U-18 and U-19 indicate that a narrow trench considerably deeper than the remainder of the failure existed along the line of borings. It would appear likely that the overburden material encountered lay only in that trench as indicated in the section of Figure 6. The other evidence of probable overburden remaining in the scar is the mound shown in Figures 5 and 6 between revetment ranges U-17 and U-18 which may have been a top stratum chunk which broke away but was not carried out into the river. From the section of Figure 6 for range U-17, it is shown that the "depression" to the riverward side of the chunk is in conformance with the general "bowl" elevation of the failure. The computer images of Figures 7 and 8 make this more evident. It is feasible that, at some time during the progress of the main failure, scour conditions also triggered a deeper additional outflowing which may be evidenced by the trench between ranges U-18 and U-19. That secondary flow may have produced instability in the top stratum and levee resulting in a shear failure and the movement

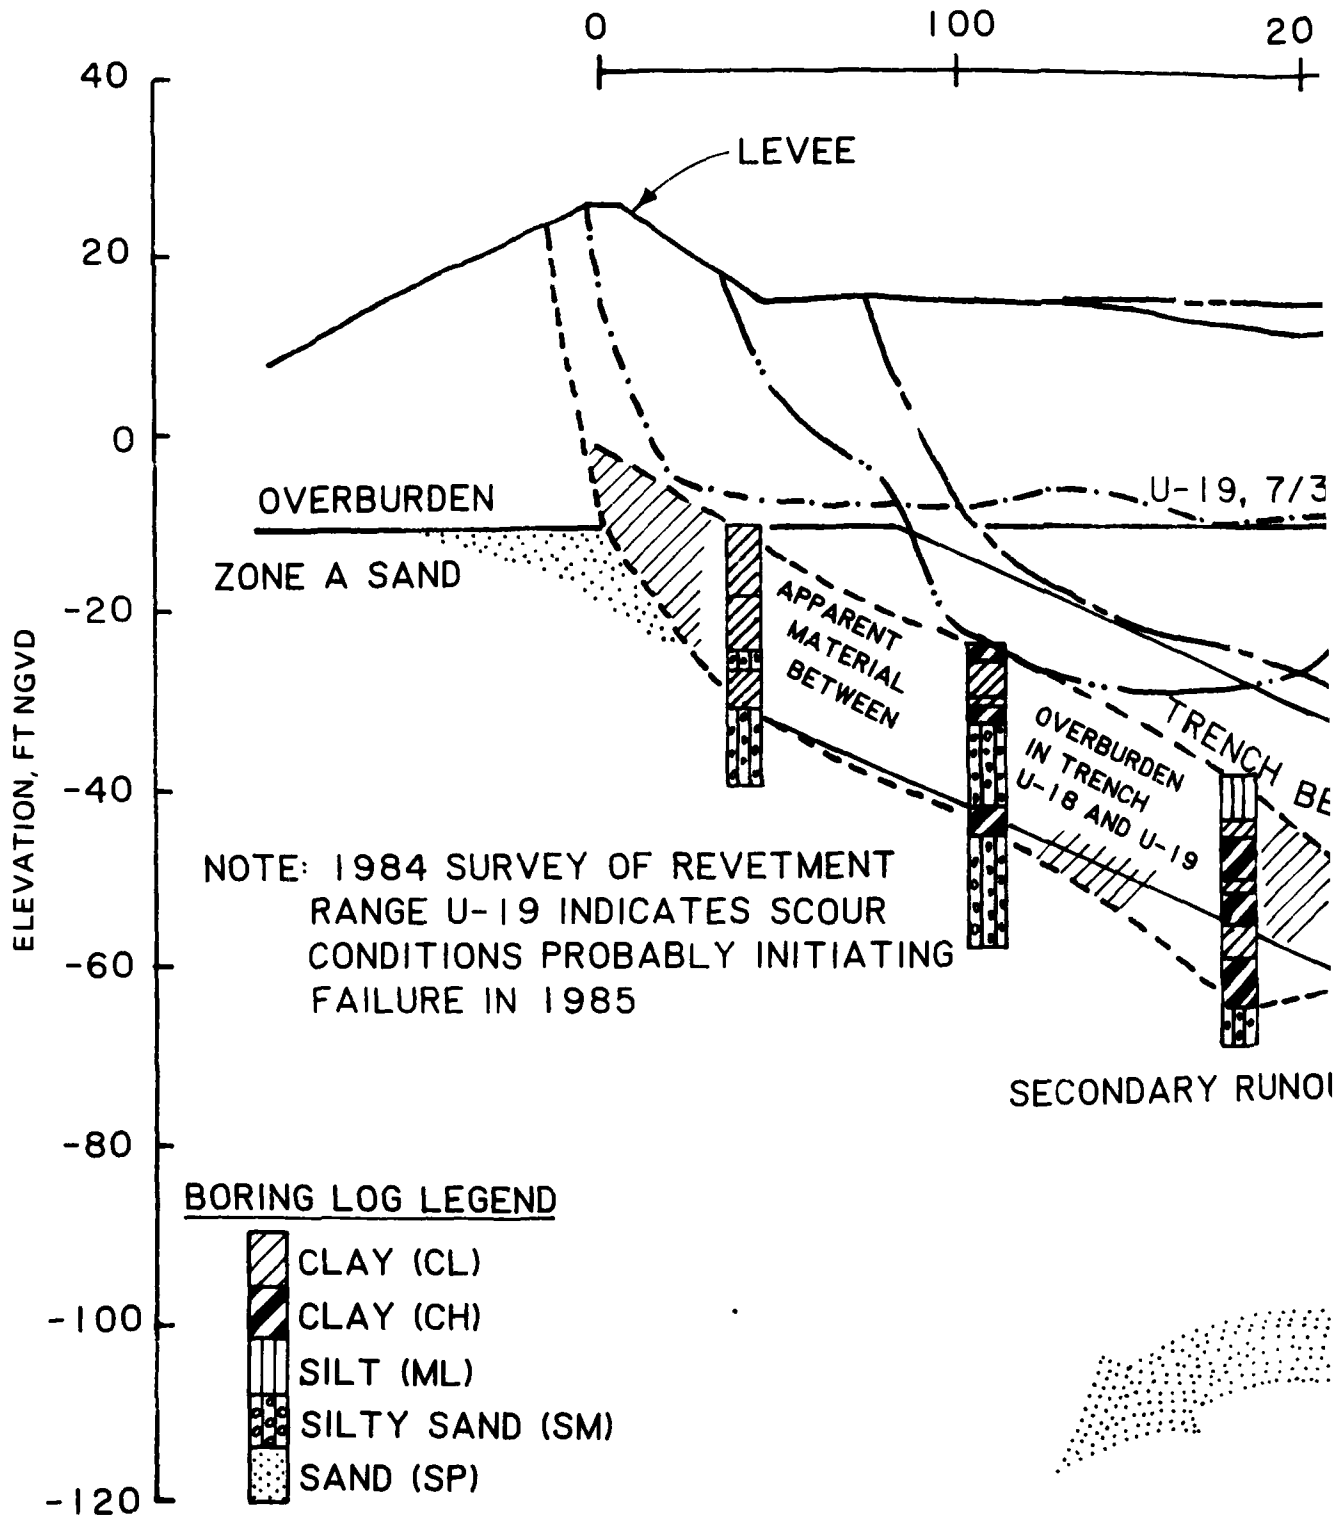
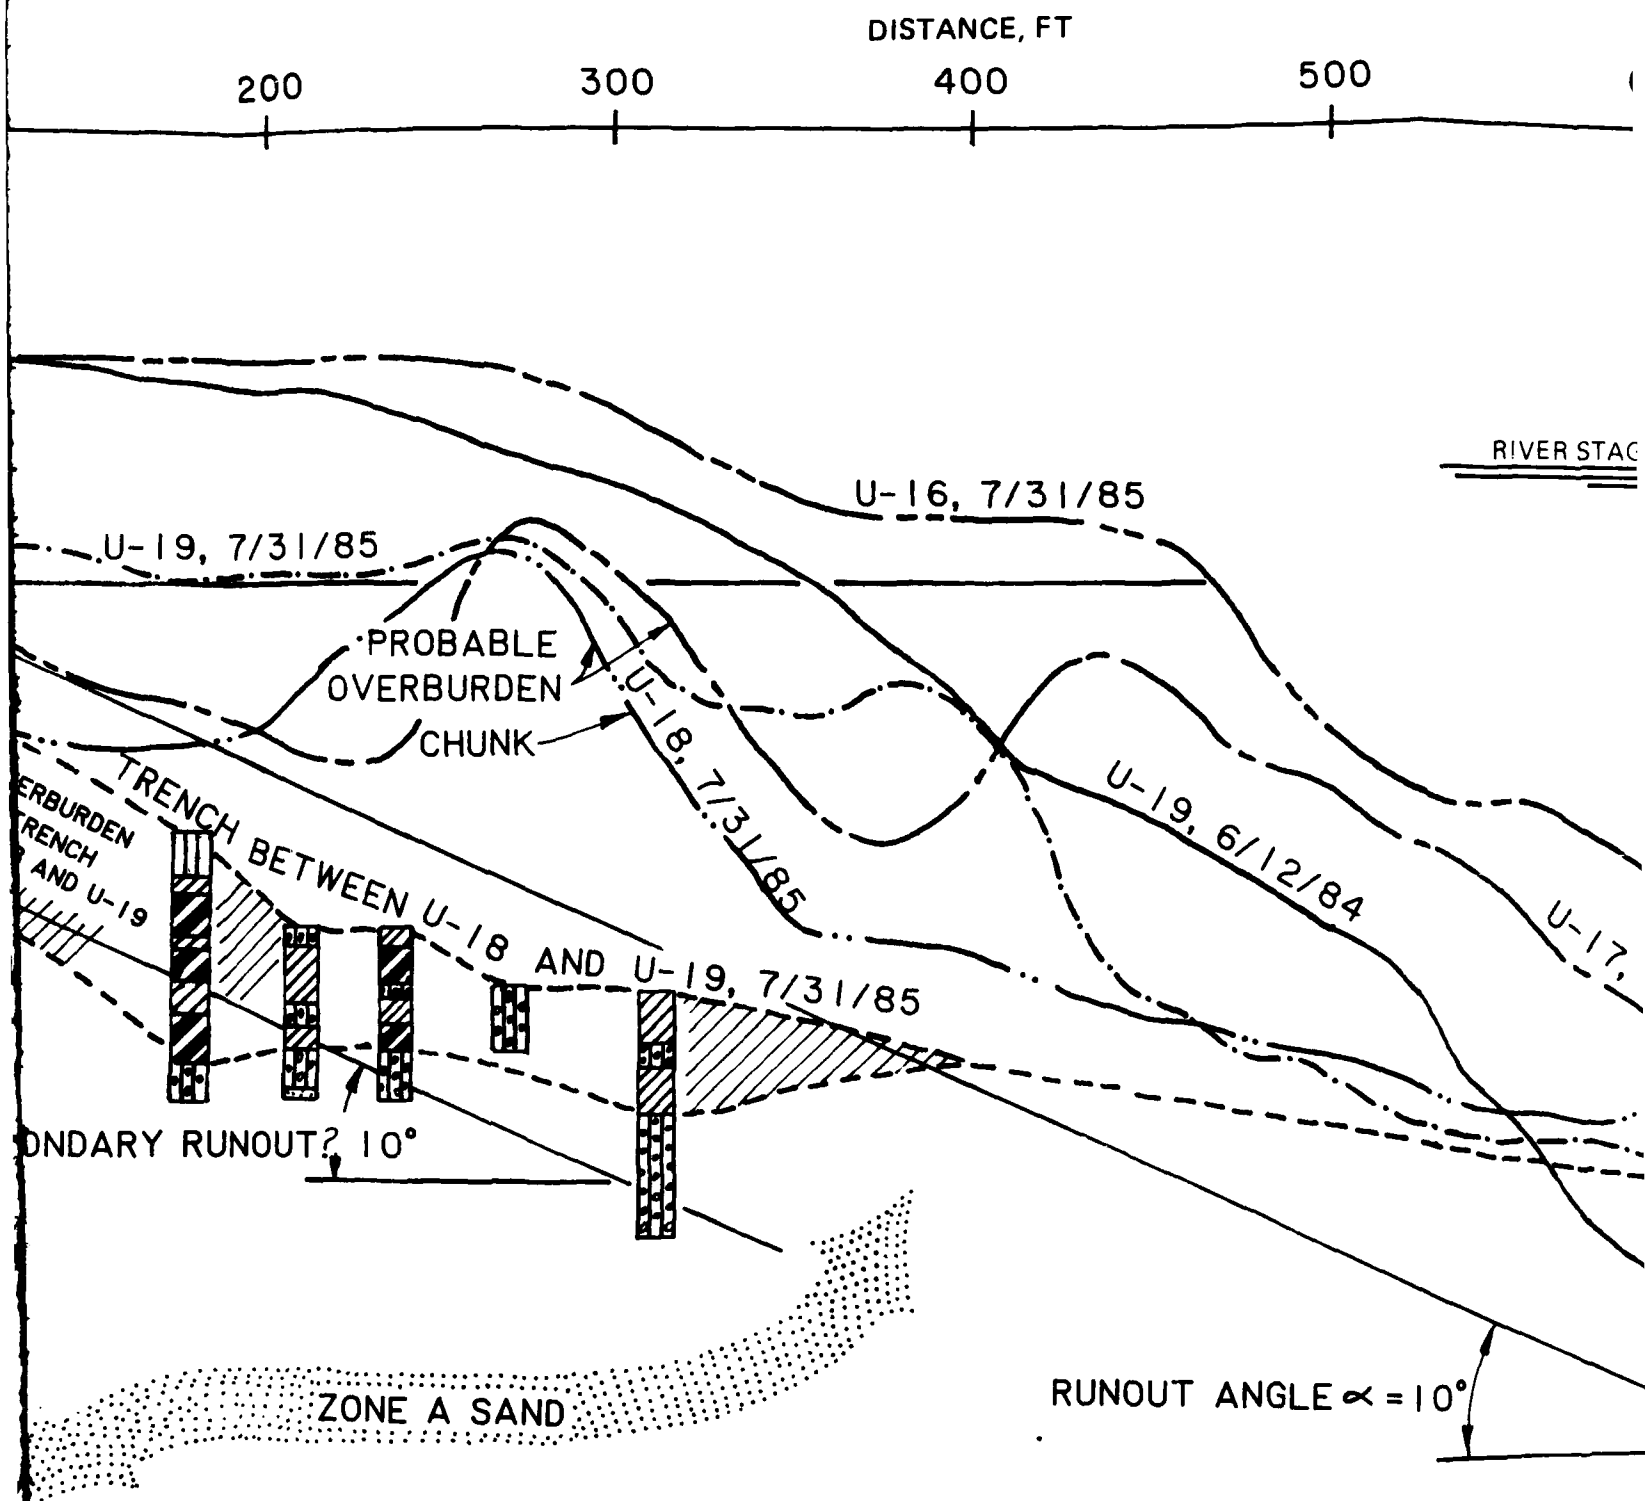
Figure 6. Cross sections of the Celotex failure

22. Turning back to the sections of the Celotex failure of Figure 6, two important observations are as follows:

- a. Assuming that the scour which triggered the failure in 1985 was similar to that seen in the 1984 survey at revetment range U-19, the projection of a 10-deg runout angle from that trench closely conforms to the extent of batture loss. It must be remembered that the runout angle is a sand failure parameter so that projection of the angle is up to the base of the overburden. A failure slope in the overburden can conservatively be taken as 45 deg, i.e., treating the overburden as a clay failing in unconsolidated, undrained shear ( $Q$  strength,  $Q = 0$ ). This overburden failure slope will usually be conservative with respect to batture loss because it has been commonly observed that overburden scarps in flow slides are nearly vertical in a significant upper portion. There is no mystery behind the near vertical upper portion of overburden scarps because tension cracks of considerable depth would form as a section of overburden is undercut and cantilevered by the outflow of underlying sand. The thinner the overburden, the more likely the scarp will be near vertical. Secondary mass instability in the overburden is always possible depending on its strength profile and the presence of any bank loadings such as the levee.

- b. The trench of the Celotex failure between revetment ranges U-18 and U-19 presents an intriguing possibility. A 10-deg runout angle also fits the average bottom slope of the trench. This may represent a "clean" runout as previously postulated during which there was resedimentation in the area of the scour which triggered it and some scour modification.

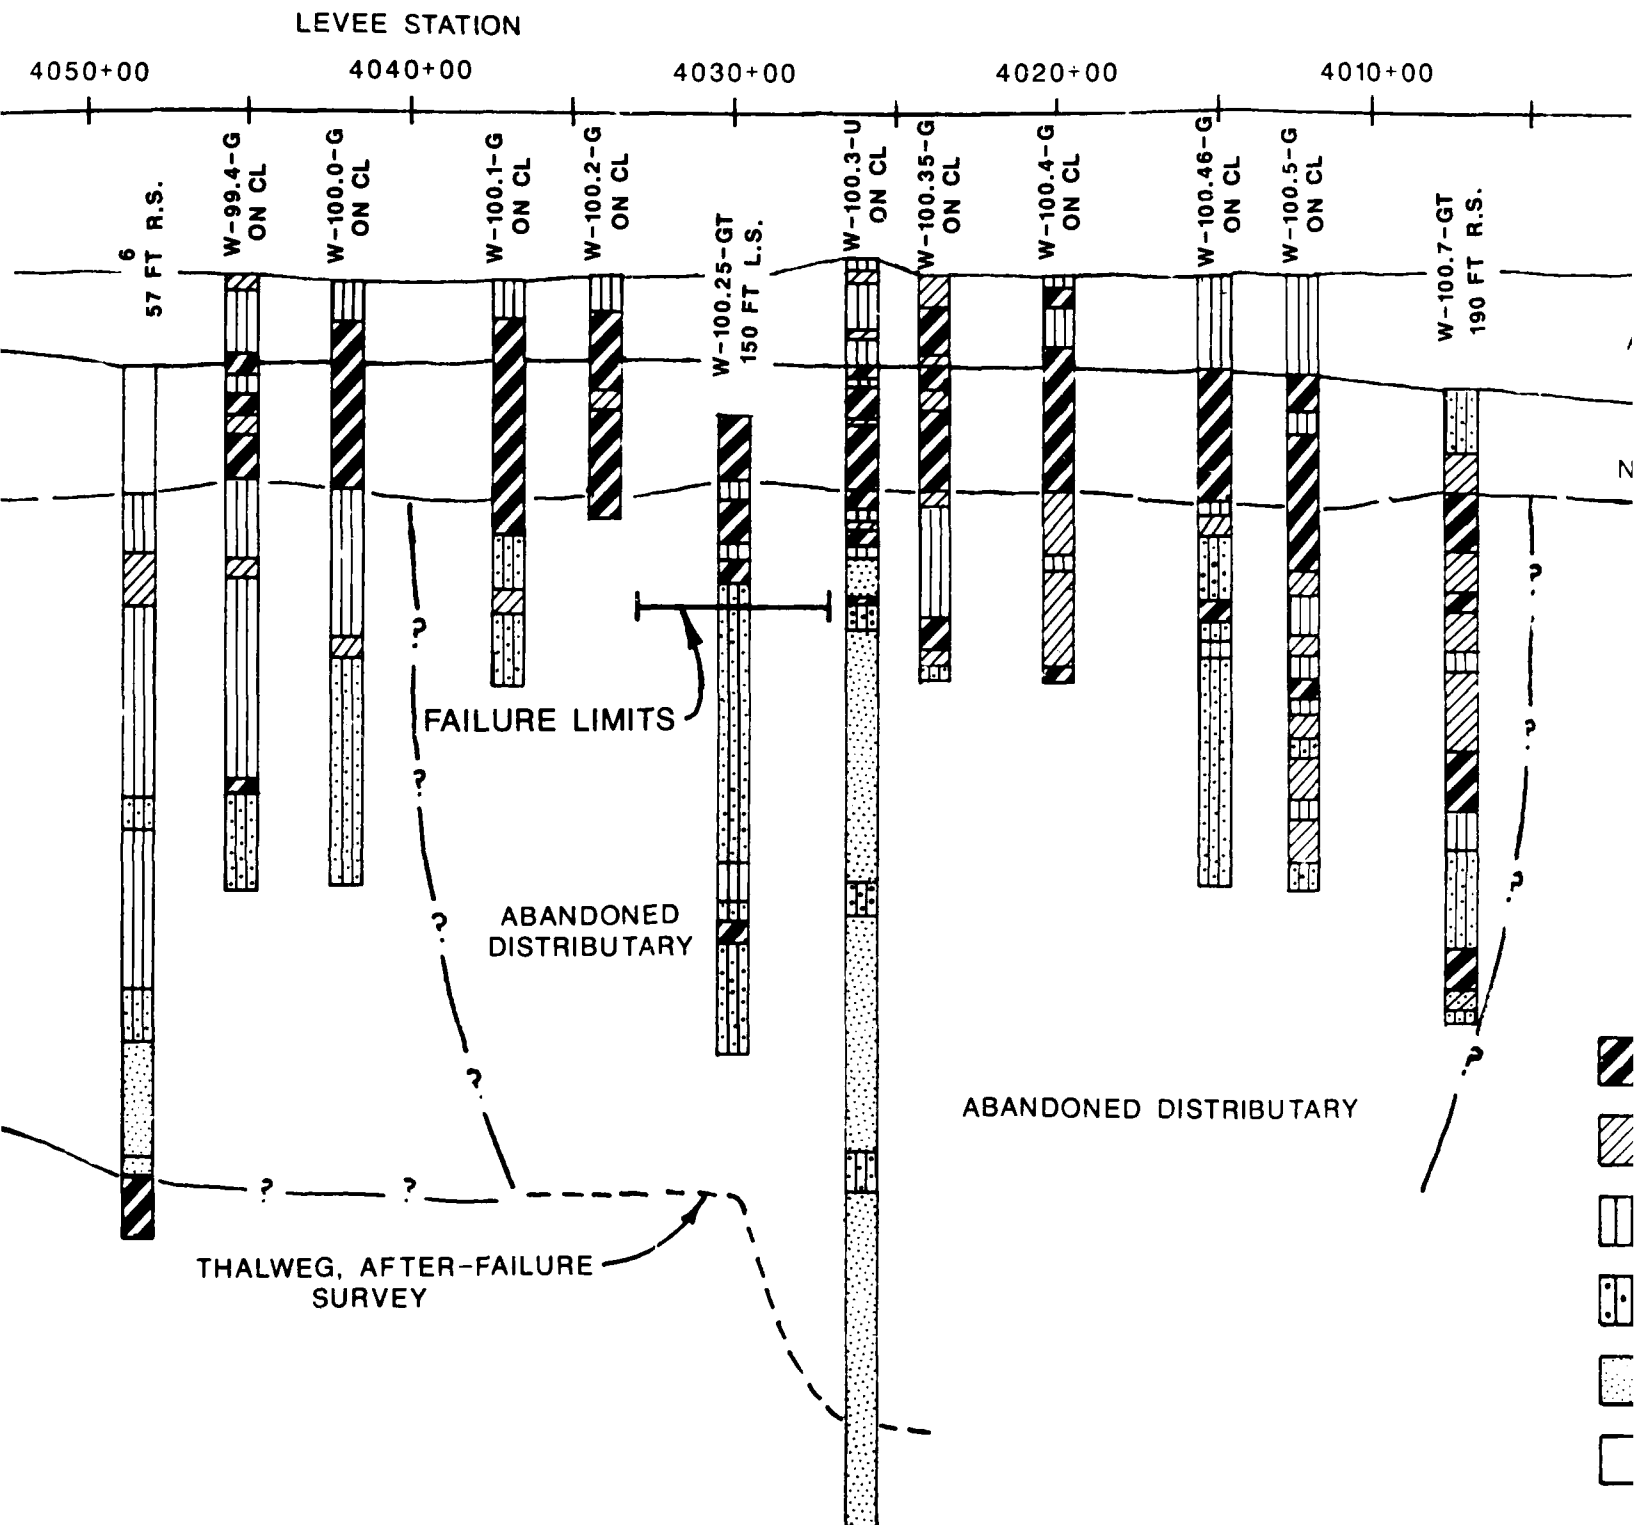
Figure 9. Soil profile along the bank reach containing the Celotex failure site

13. At the time of failure, the most recent hydrographic surveys of the riverbank reach including the Celotex failure site were those sections run during June 1984. The bank section seen at that time for revetment range U-19 is shown in Figure 6. Evident from that section is the presence of a significant scour trench at the toe of the bank slope. The other sections taken during that same survey indicate that the trench ended less than 200 ft downstream before reaching revetment range U-18. It is possible to track the trench upstream in the 1984 survey into the "permanent," deep scour pool situated in the Greenville Bend. It is conjecture that the scour trench existed at revetment range U-19 on the day of failure. However, on the strength of all the evidence to date regarding the triggering of flow failures, it is believed that the trench was present, and that severe scour produced an

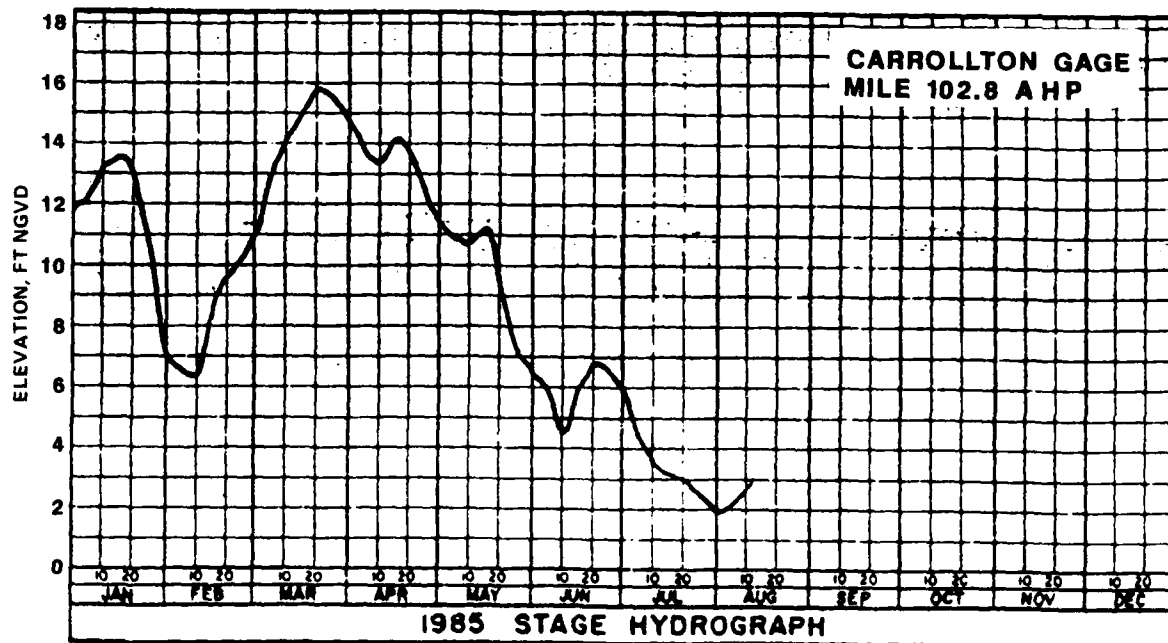
Figure 10. 1985 Mississippi River stage through the period of the Celotex failure

12. The stage hydrograph for the Mississippi River based on the Carrollton gage (about 2.5 miles upstream of the failure location) is shown in Figure 10. On the day of the failure (30 July), the river had reached its lowest stage of the period at about el 2.0. The construction sequence for the batture and levee restoration given previously in paragraph 9 states that the river was on the rise during repair operations. The river had been on the fall prior to the failure since about 21 June at an average rate of only about 0.1 ft per day. Years ago, in the LMVD Potamology Investigations studies, seepage gradients in sands and silty sands resulting from such rates of falling stage were dismissed as playing a role in the general case of instability of Mississippi Riverbanks (Clough 1966) as well as in triggering of flow failure (US Army Engineer Waterways Experiment Station (USAEWES) 1950).

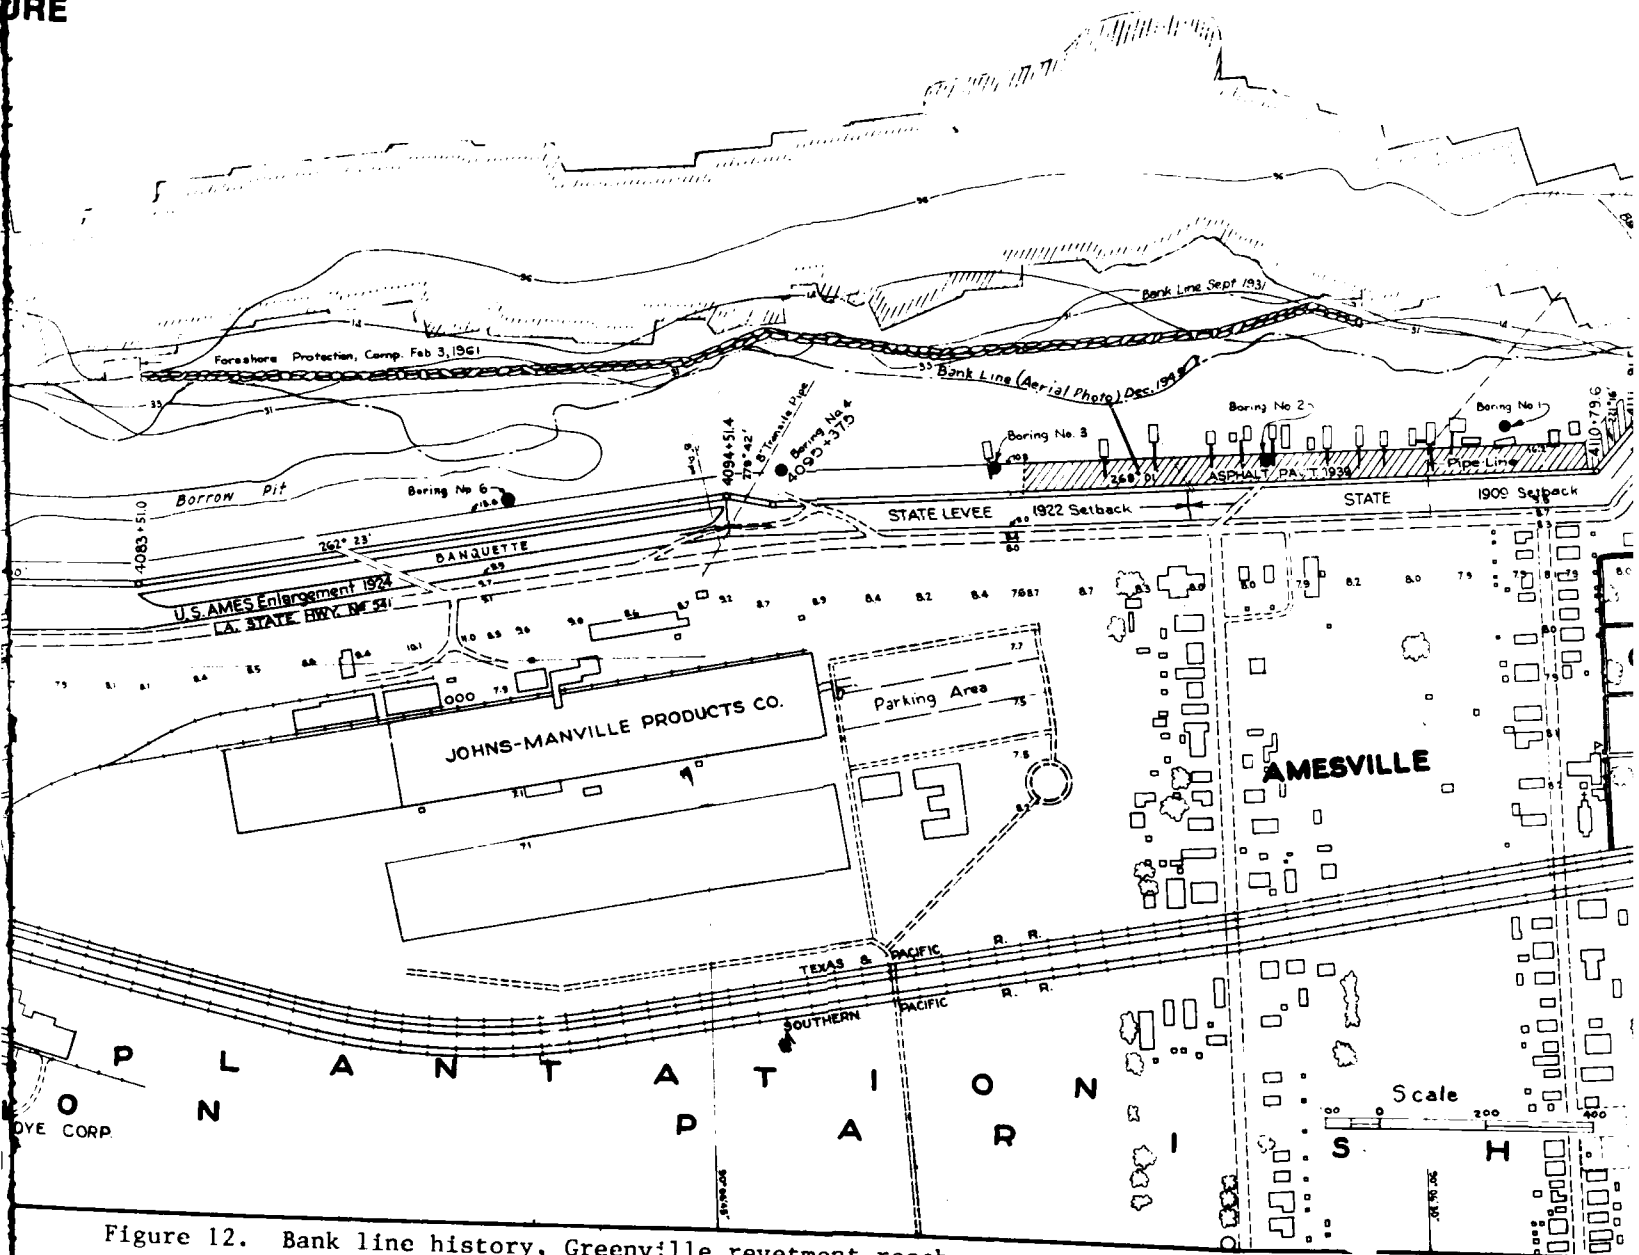
Figure 12. Bank line history, Greenville revetment reach

16. The history of the bank line along Greenville Bend revetment reach is shown in Figure 12 (file map, New Orleans District). The bank line in 1949 was determined from aerial photos. Earlier bank lines were established by ground surveys. The most apparent observation is that a major bank failure area existed in 1896 precisely at the Celotex location. In addition, looking downstream, other scallops are seen in the bank line over the years. In 1901, 1909, and 1922, setbacks were constructed in front of Amesville, LA, and the old General Alcohol Co. indicating the severity of bank losses during those times. A major failure highly likely to have been a flow slide because of the proportions of the batture loss is indicated in the 1900 bank line in front of the alcohol company complex. The 1973-1975 Mississippi River hydrographic survey shows a scour pool at this location. There is reason to believe that the bank loss patterns indicated by the old bank line data can be expected in the future all along the abandoned channel/point bar reach. The aerial photographs given as Figure 3 were taken in 1977 during an extremely low water period. Although small and difficult to see in the photographs, a scallop did exist at the Celotex failure location at that time. Other larger scallops are evident in Figure 3 in the downstream direction in various places in the point bar deposit. Of particular concern to the author is the very sharply defined scallop seen in the photograph just in front of the down stream end of the long, narrow complex of the Johns-Manville Co. (upper center of photo). The location corresponds to revetment ranges D-2 to D-3. Given the much smaller scallop preexistent at the Celotex site, this larger scallop demands special attention since the overburden is very thin, and no more batture than at Celotex protects the levee.

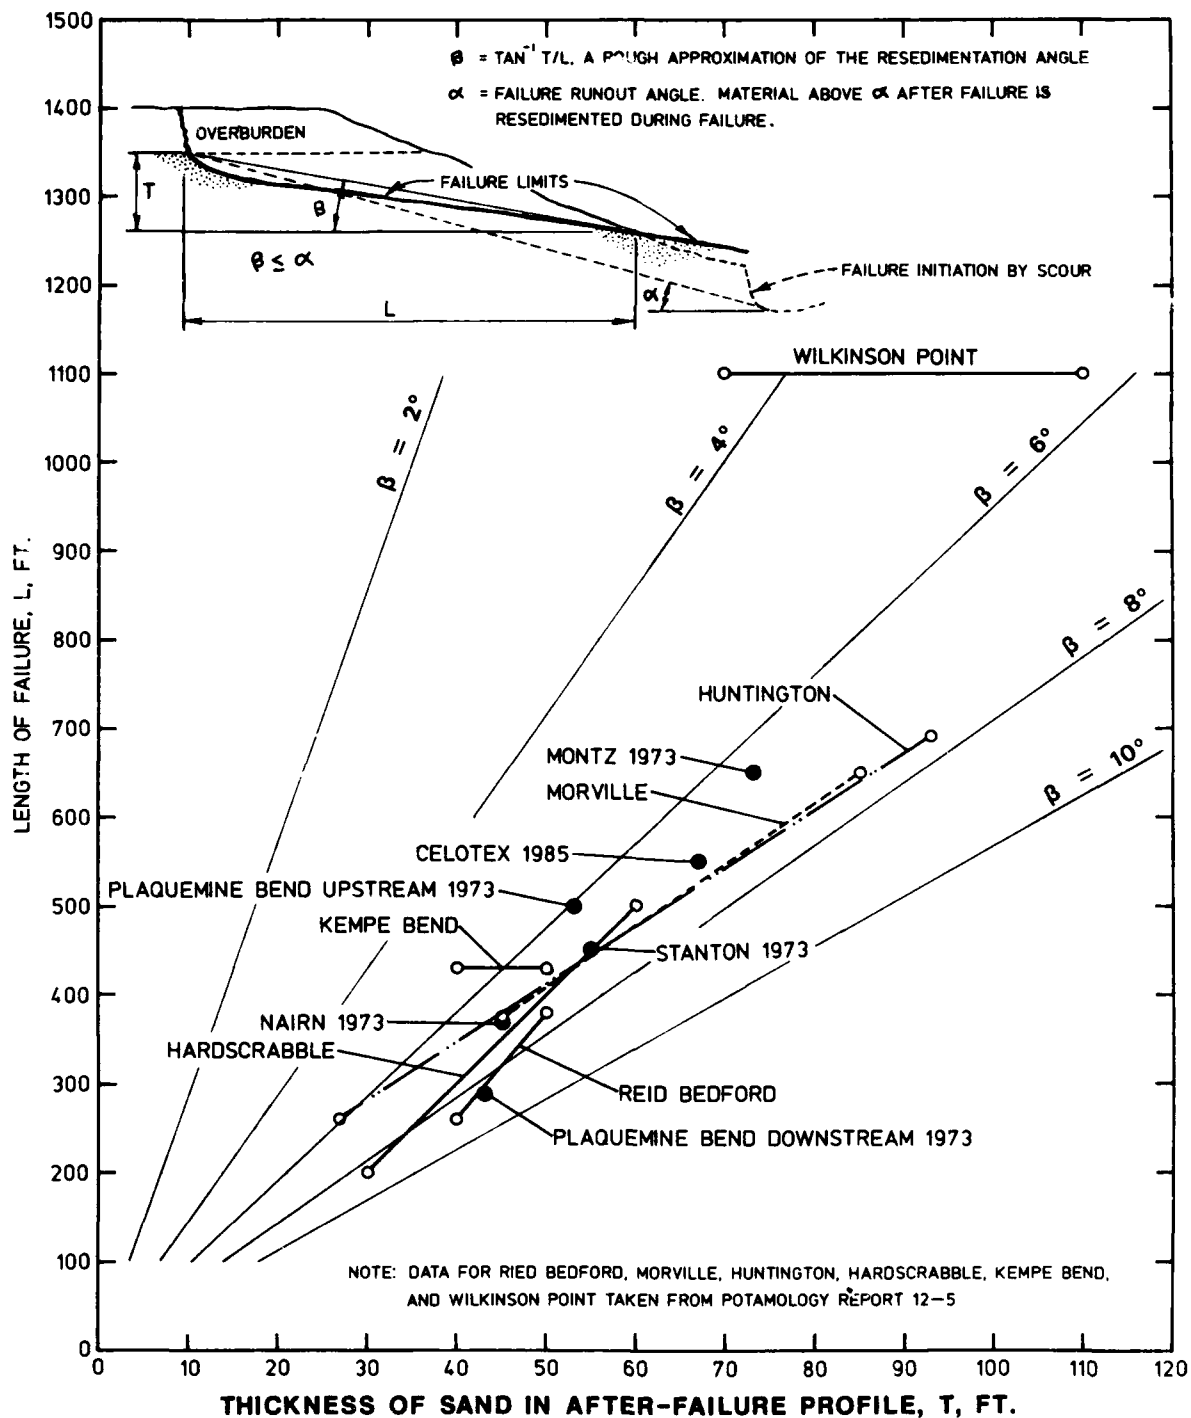
Figure 17. Estimation of a maximum value of runout angle  $\alpha$  from empirical values of resedimentation angle  $\beta$

21. The data of Figure 15 are plotted with data from the 1973 flow slides below Baton Rouge and the Celotex data in Figure 17. The parameters plotted in Figure 17 are explained in the inset on the figure. In keeping with the mechanism of failure illustrated in Figure 14, the beta angle,  $\beta$ , of Figure 17 is the approximate average slope of the resedimented material after failure. Note that in order for this to be true, the failure slope in the overburden must be relatively vertical as has been observed to be generally the case. If no major scour develops within the failure which removes material in excess of that involved in the retrogression mechanism,  $\beta$  must be less than or equal to the runout angle. If the failure proceeded with just the perfect assistance of scour such that every grain of sand raining off the retrogressing face and every piece of overburden were removed from the scar, then  $\beta$  would equal  $\alpha$ . In that special case, there would have been no resedimentation of any of the sand raining off the retrogressing face. It can be deduced from the sections of typical failures of record that with few exceptions some resedimentation does occur, and  $\beta$  is less than  $\alpha$ . This is because projections of the average  $\beta$  just do not conform to the concept of the scour pool/trench as the initiation point of failure. In other words, the projection of the average bottom slope of a typical failure would intersect the river bottom well out into the river and pass well above and beyond the scour pool/trench. The value of Figure 17 lies in the suggestion of a maximum

value for  $\beta$  and, therefore, a possible maximum value for  $\alpha$ . The author selects the maximum implied value of  $\alpha$  from Figure 17 to be 9 or 10 deg, say 10 deg, taken from the initiating point of scour. This is a valuable implication. However, does that 10-deg runout angle represent a maximum of a wide-ranging variable, or can it be taken as a representative value for all failures below Baton Rouge? It would be logical that a representative value is feasible because the range in Zone A gradations is not a broad one.
