AEFA Project No. 87-25

## EVALUATION OF THE IMPROVED OV-1D ANTI-ICING SYSTEM

April 1988  
Final Report

AVIATION ENGINEERING FLIGHT ACTIVITY  
Edwards Air Force Base, California 93523-5000

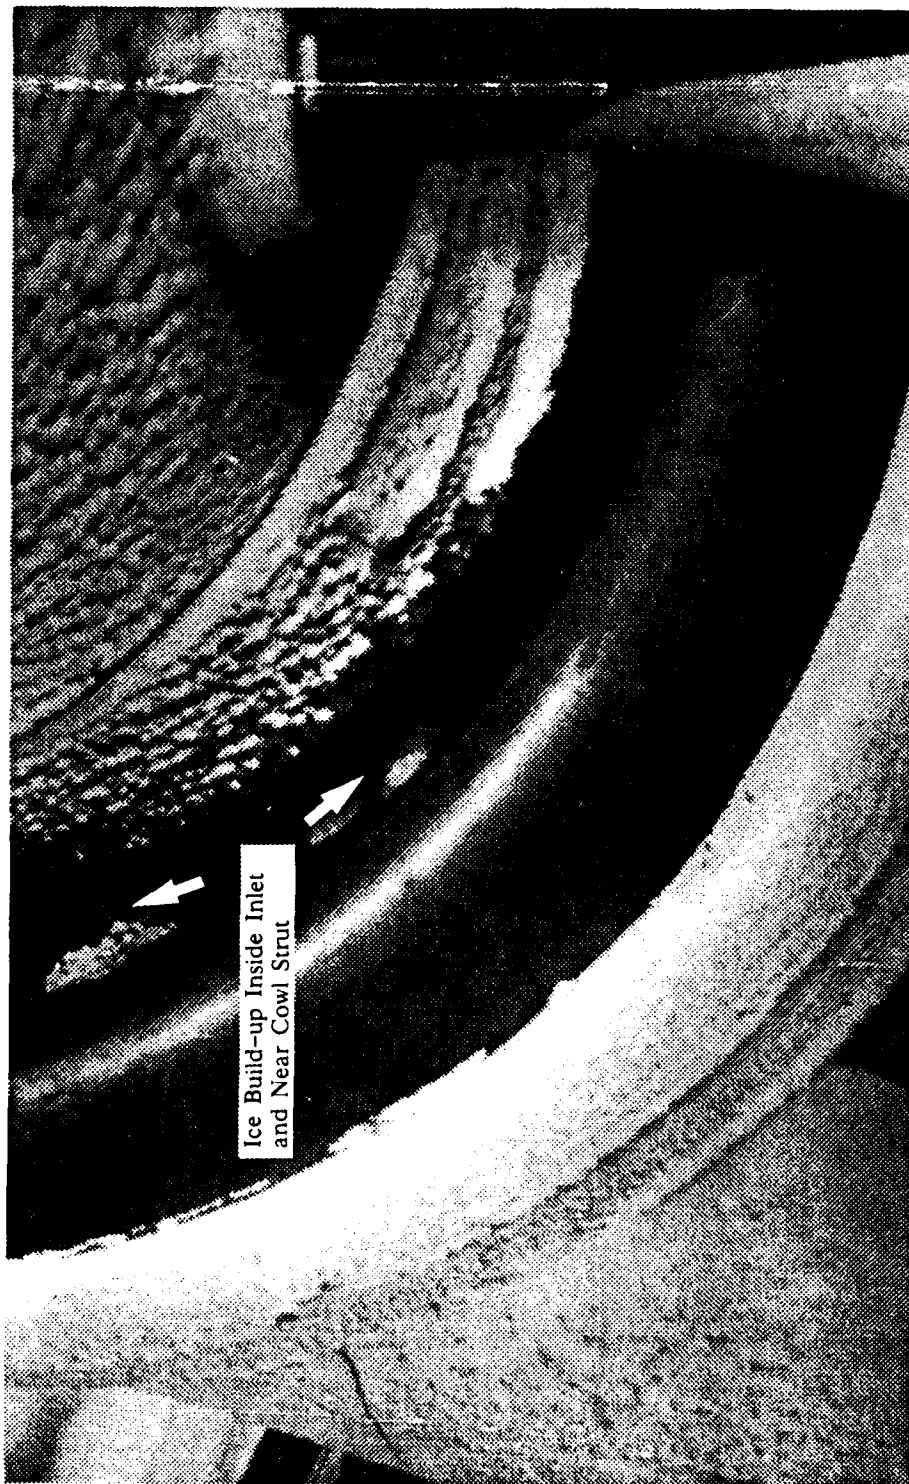
Figure E-5. Right Engine Cowl  
Conditions: Avg LWC = 0.63 gm/m<sup>3</sup>  
Avg OAT = -19.0 DEG C

Ice Build-up Inside Inlet  
and Near Cowl Strut

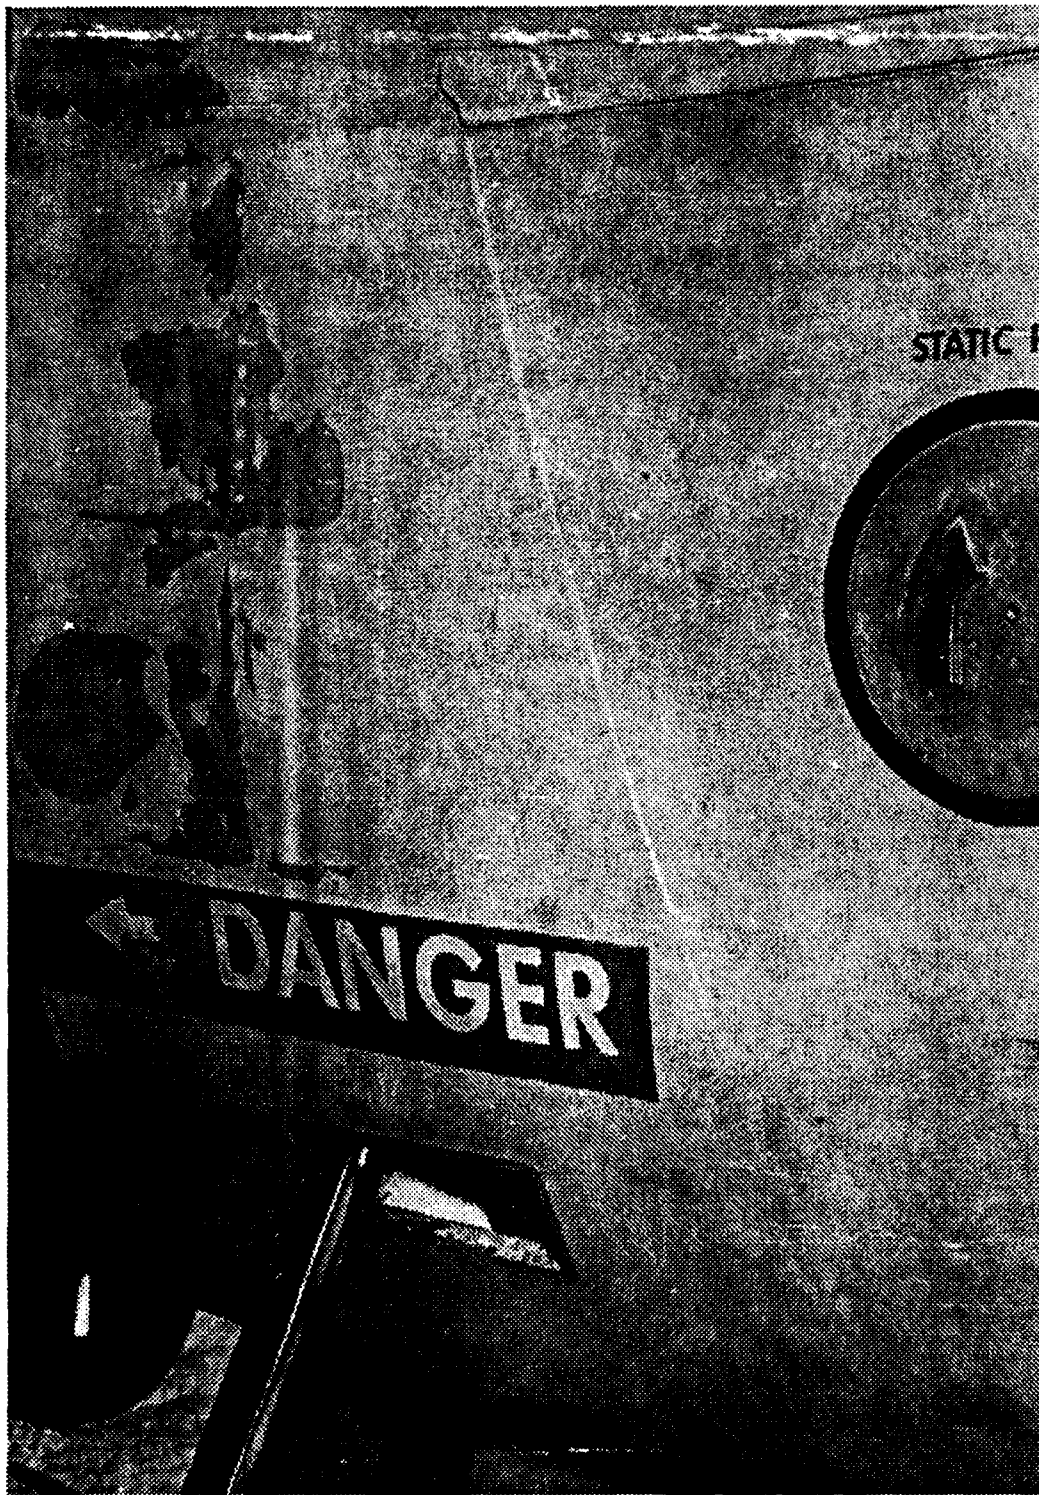
Figure E-6. Fuselage Damage from Ice Shedding

20. Propeller ice sheds occurred in all of the icing conditions tested. Ice departing the blades frequently hit the fuselage empennage or fuel drop tanks. Figure E-6 depicts fuselage damage resulting from propeller ice sheds. Dents as large as 3/8 inch deep and 4 inches in diameter were observed on one drop tank (fig. E-7). Airframe and stores damage caused by ice shedding from the propellers is a shortcoming as discussed in paragraph 11.

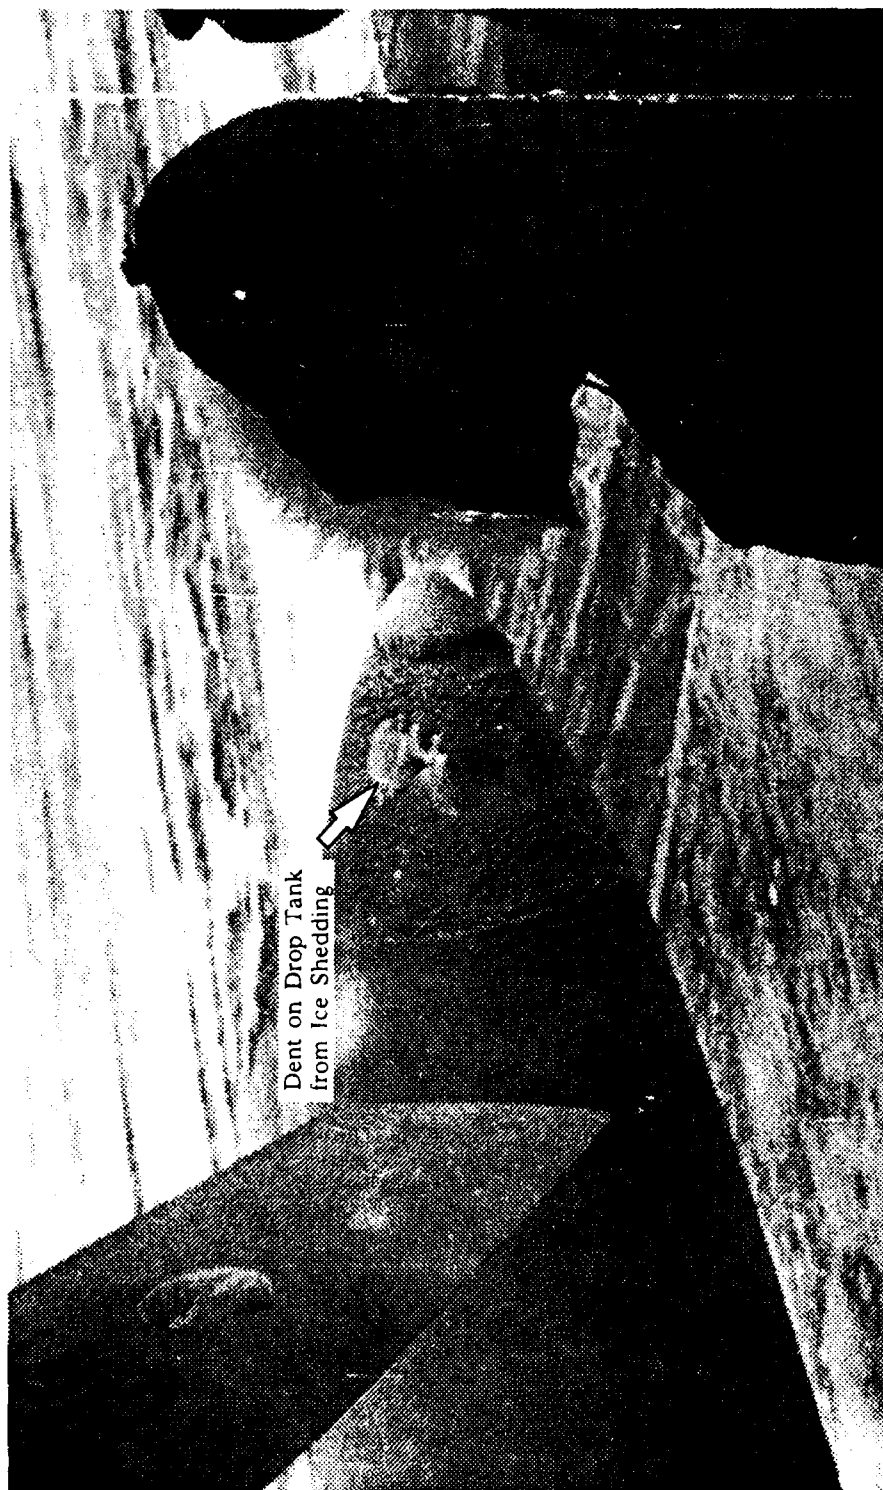
Figure E-7. Left Drop Tank

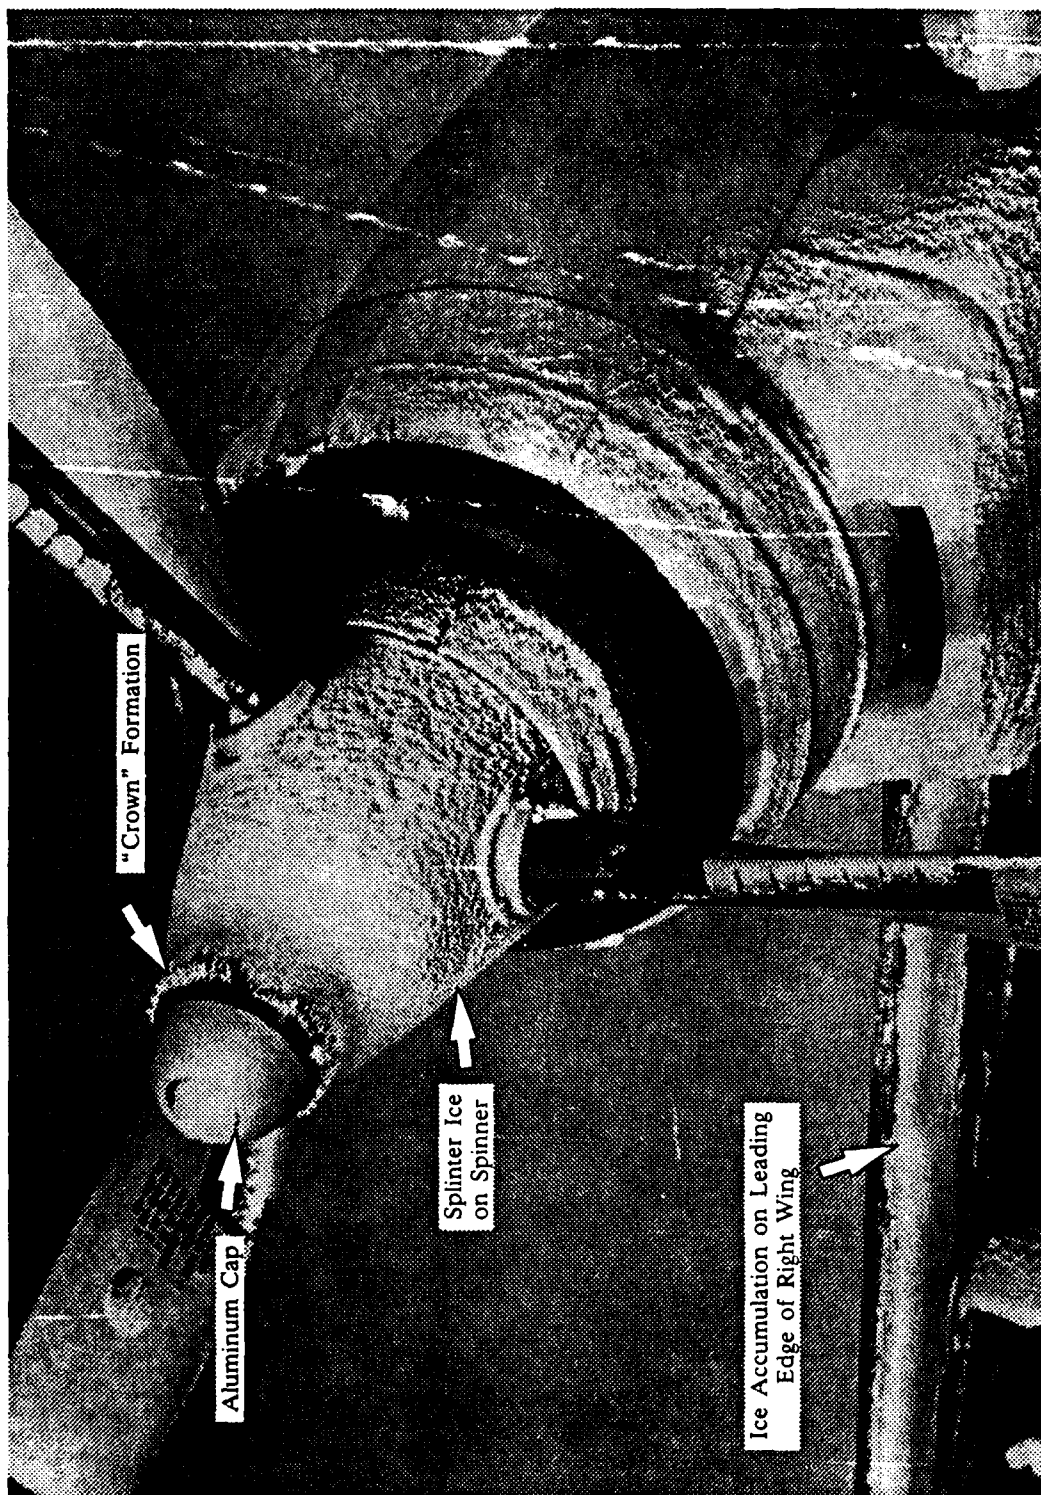
Figure E-8. Right Engine  
Conditions: Avg LWC = 63 gm/m<sup>3</sup>  
Avg OAT = -19.0 DEG C

12. The propeller spinner nose was anti-iced at the aluminum cap only (fig. E-8). During artificial and natural tests, the spinner accreted ice in a donut or crown shape which was observed during one shed to go down through the propeller and away from the engine inlet area. Spine type splinter ice formations started growing on the spinner portion just aft of the "crown" and accumulated to a depth of 1/2 to 1 inch with the higher (0.5) LWC's and lower (-15 degrees C) temperatures (fig. E-8). Grumman analysis showed that any accretions on the spinner aft of the aluminum cap would be thrown out of the engine inlet area by centrifugal force and, therefore, was not considered to be an ingestion hazard to the engine. No ice from the propeller nose and spinner was observed being ingested by the engine.

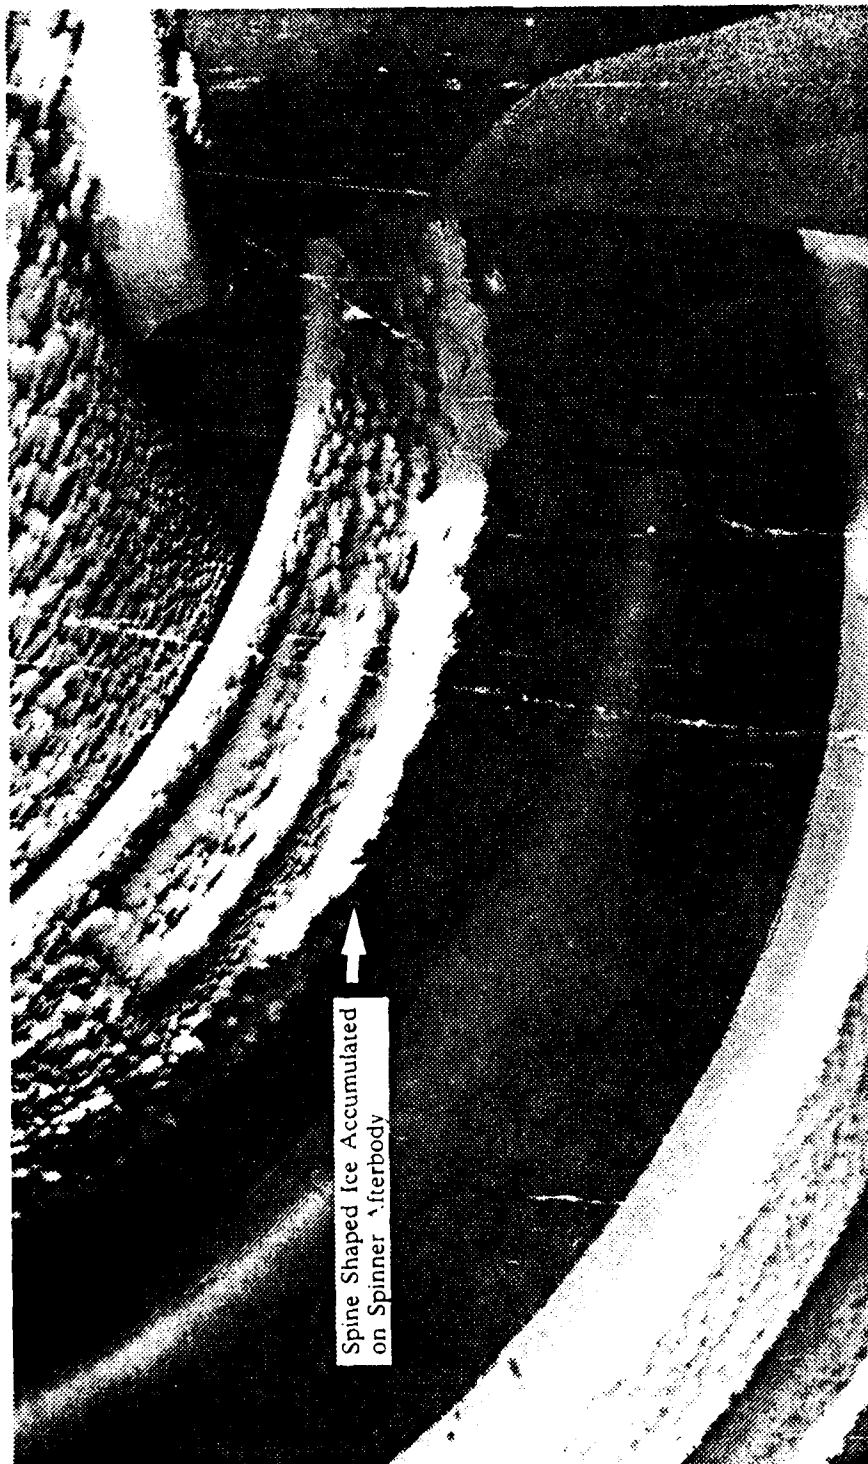
Figure E-9. Spinner Afterbody of Right Engine  
Conditions: Avg LWC = 0.63 gm/m<sup>3</sup>  
Avg OAT = -19.0 DEG C

13. Spine shaped ice accreted on the spinner afterbody on the bottom portion from the 4 to 8 o'clock positions from the leading edge of the afterbody to approximately 6 inches aft (fig. E-9). During a natural icing encounter, ice accreted at the leading edge of the afterbody and grew forward to the point where it was impacted by the rotating propeller blade shank. When a section of the accretion was impacted by the propeller blade shank, it broke off and was ingested into the inlet and, therefore, is an ingestion hazard to the engine. The ice accretion and shedding characteristics of the propeller spinner afterbody in light and moderate icing conditions are a deficiency.

Spine Shaped Ice Accumulated  
on Spinner Afterbody

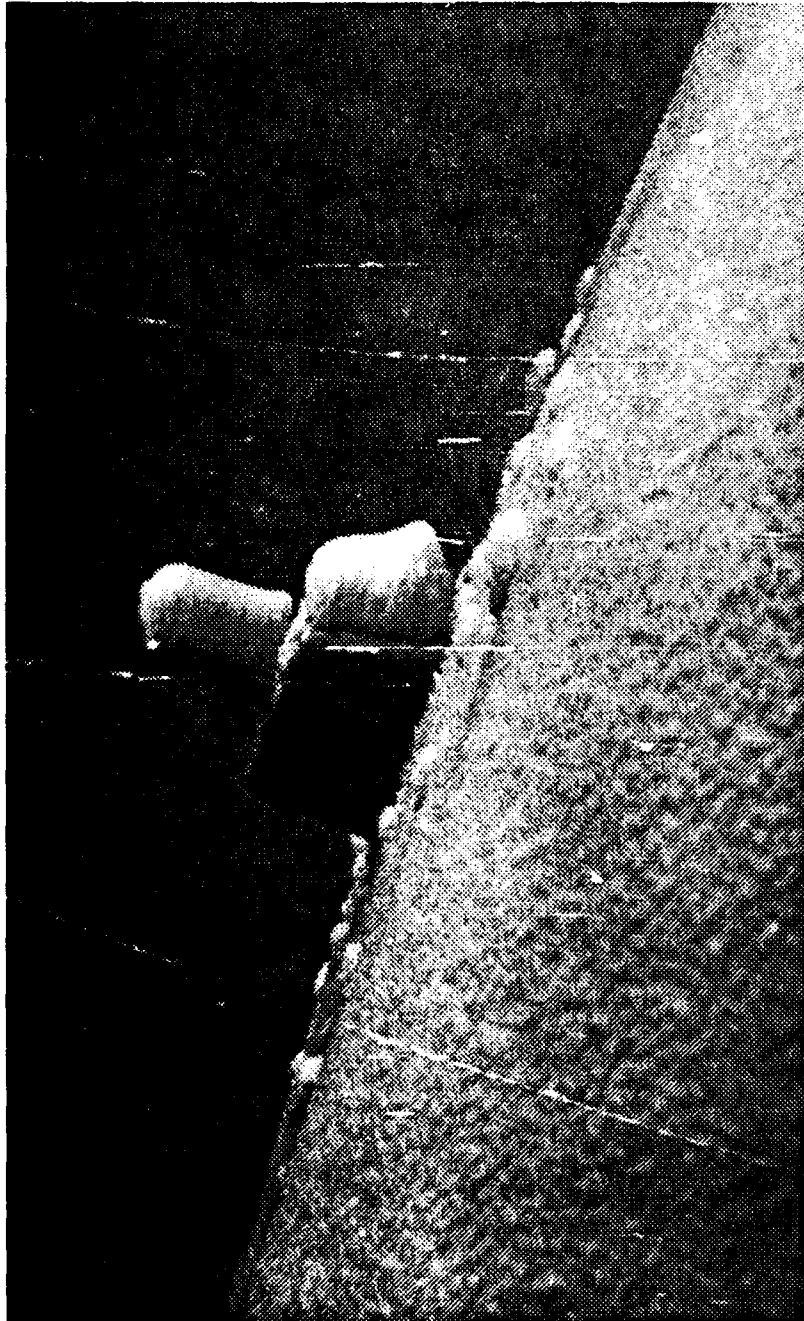
Figure E-10. Ice Accumulation on the Ice Detector Probe

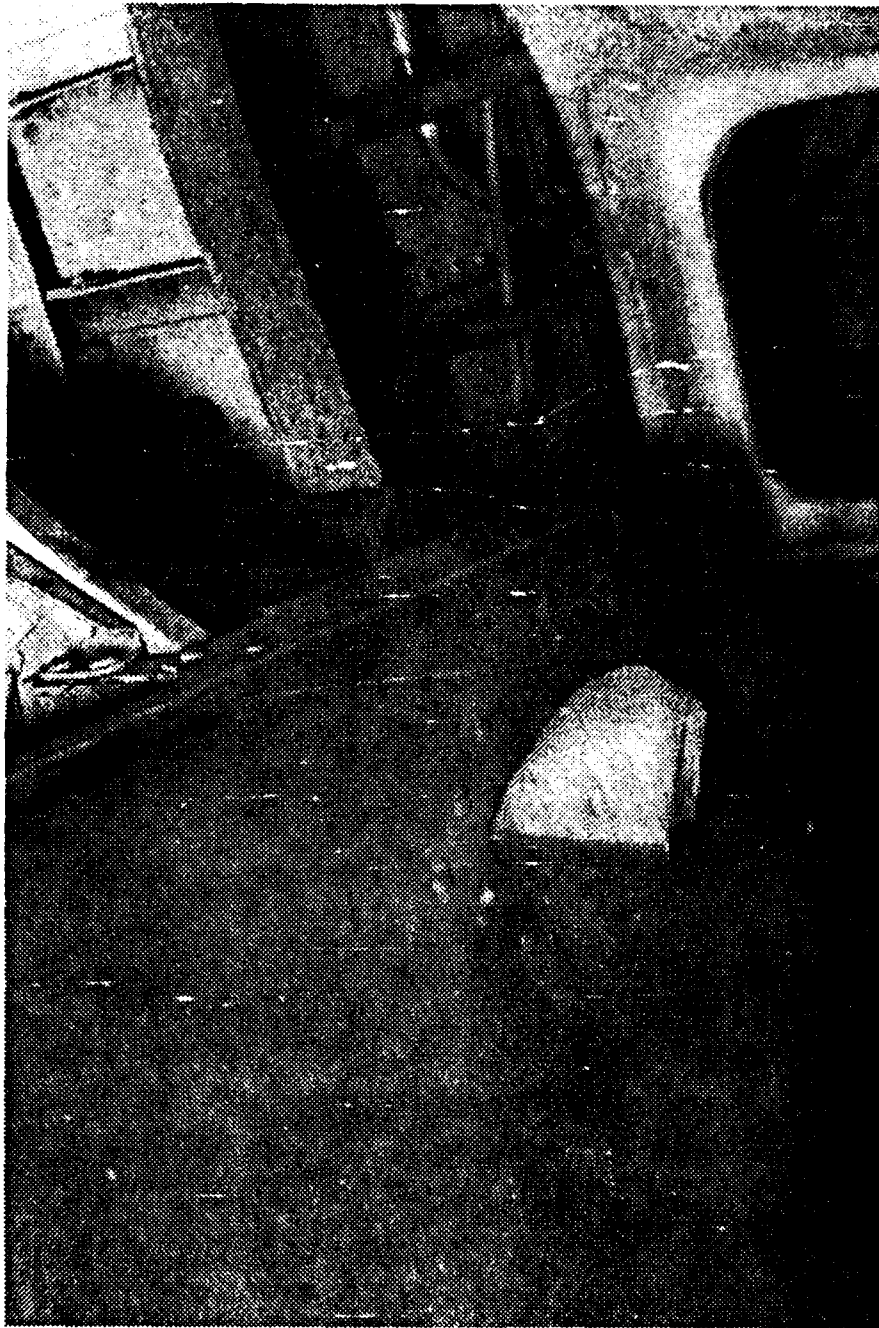
Figure E-11. Ice Accumulation on the Temperature Sensor

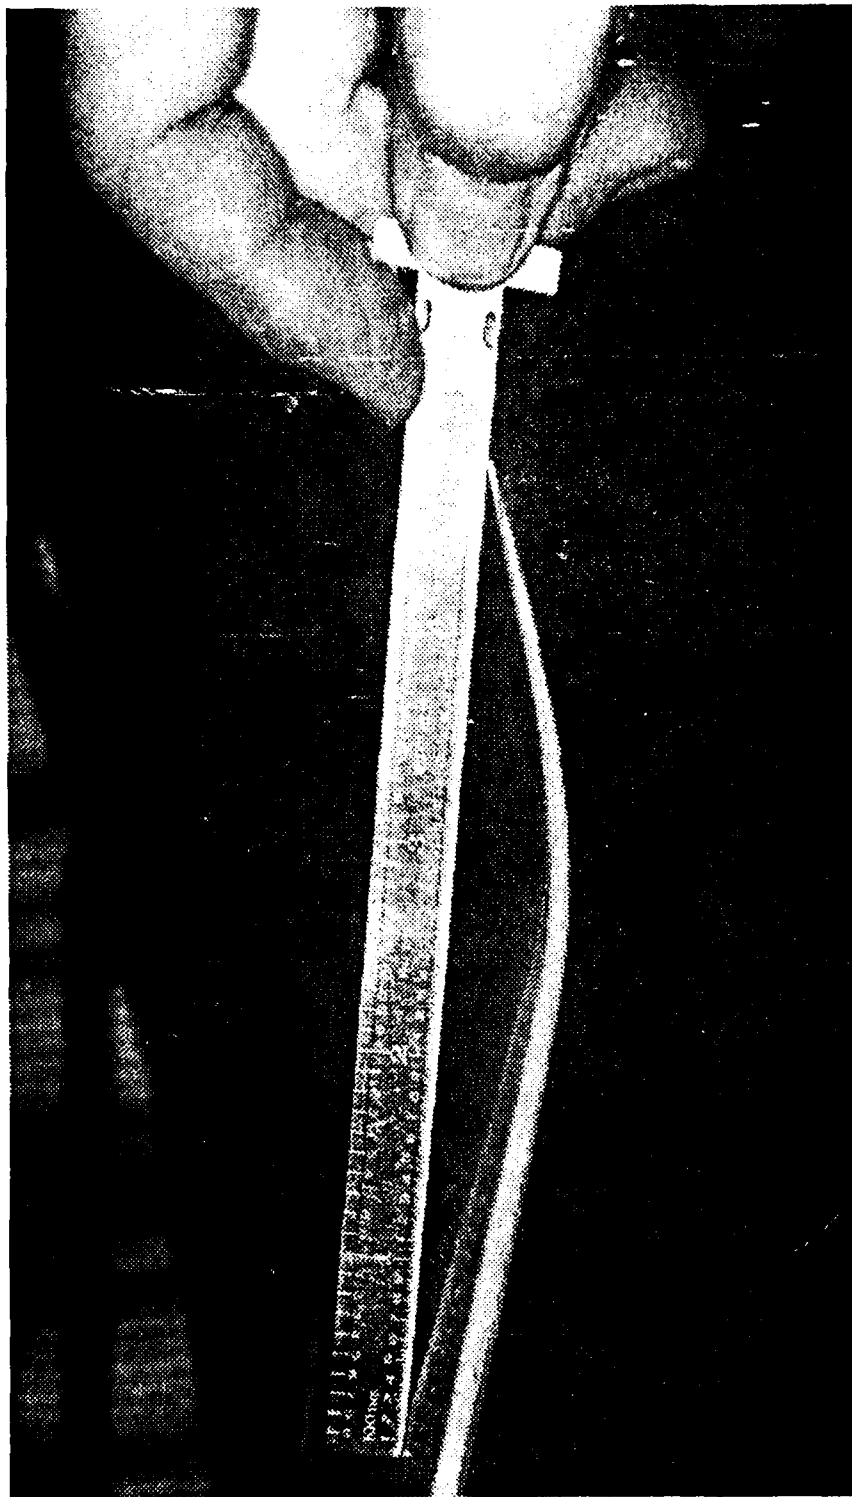
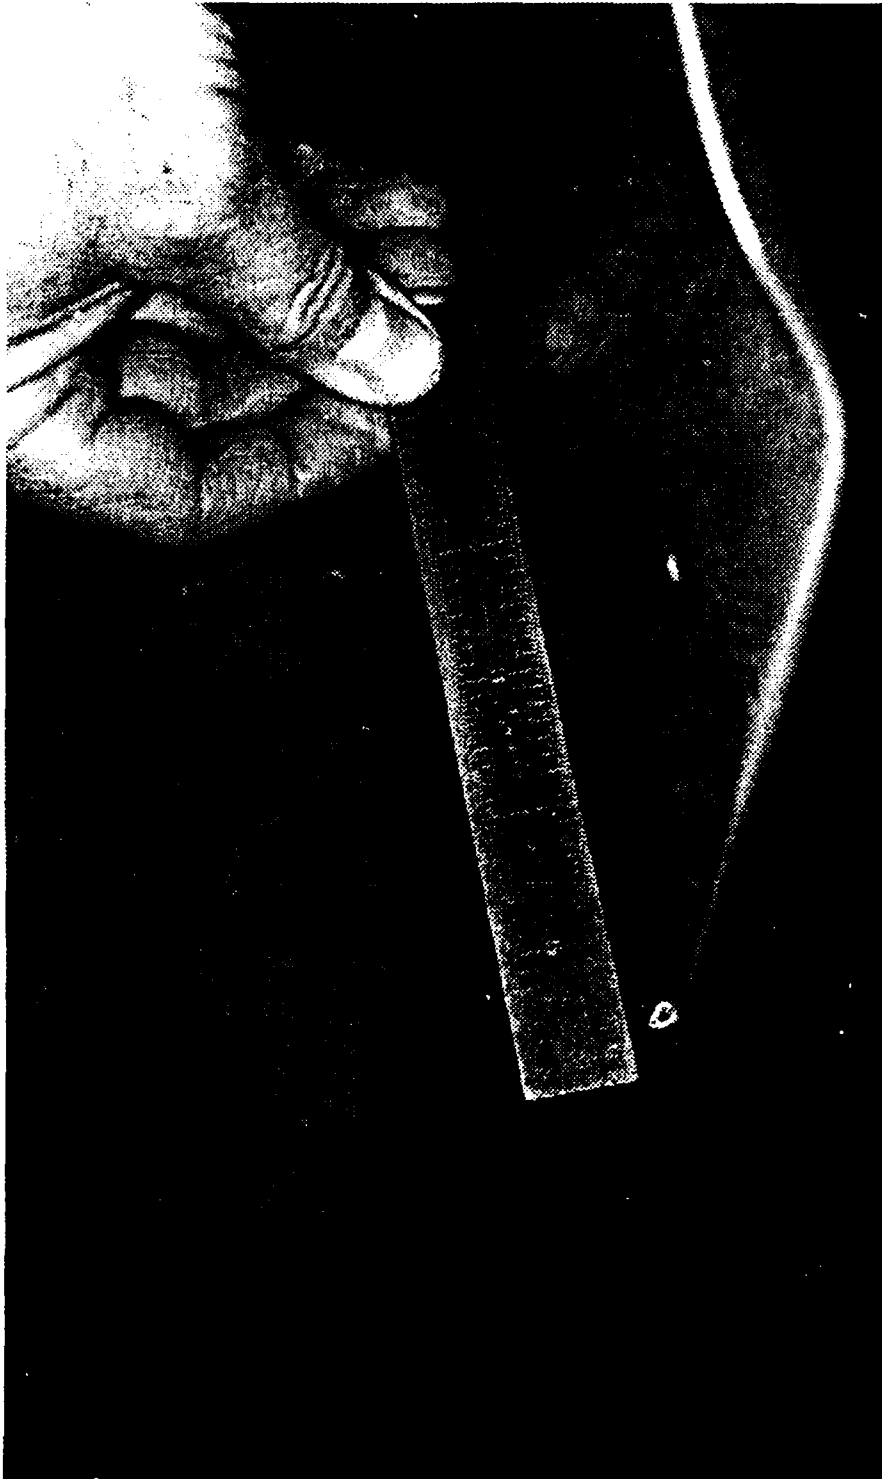
21. During a flight in natural icing conditions, a large chunk of ice, approximately 2 inches by 5 inches was observed to shed from the right windshield wiper arm and go through the right propeller, causing impact damage to one of the blades. The propeller blade damage is shown in figures E-12 and E-13. Ice accumulation on the left windshield wiper is shown in figure E-14.

Figure E-12. Propeller Damage

Figure E-13. Propeller Damage

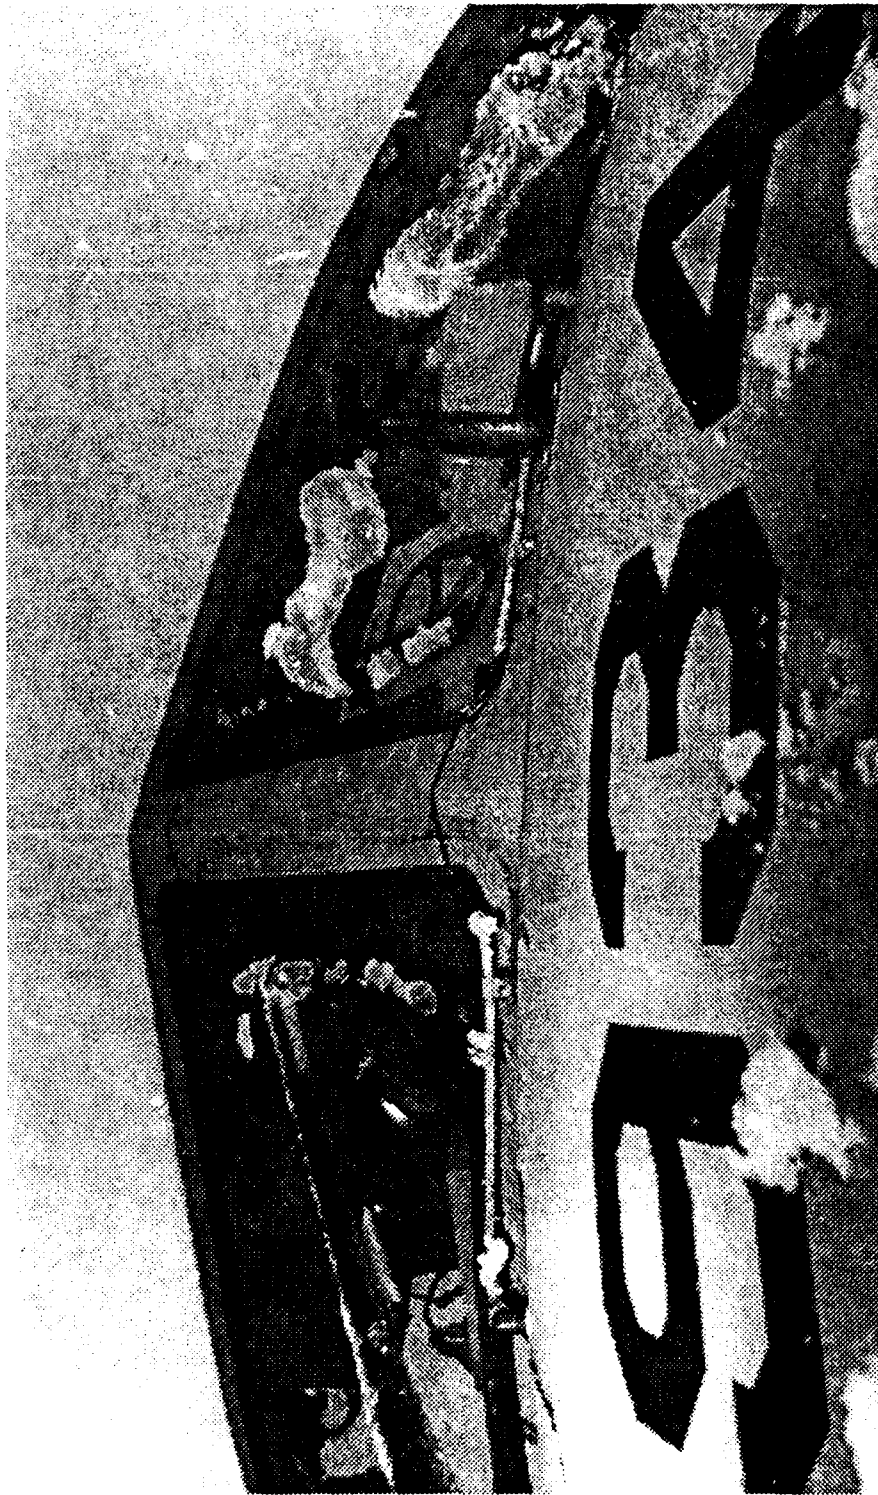
Figure E-14. Ice Accumulation of the Left Windshield Wiper

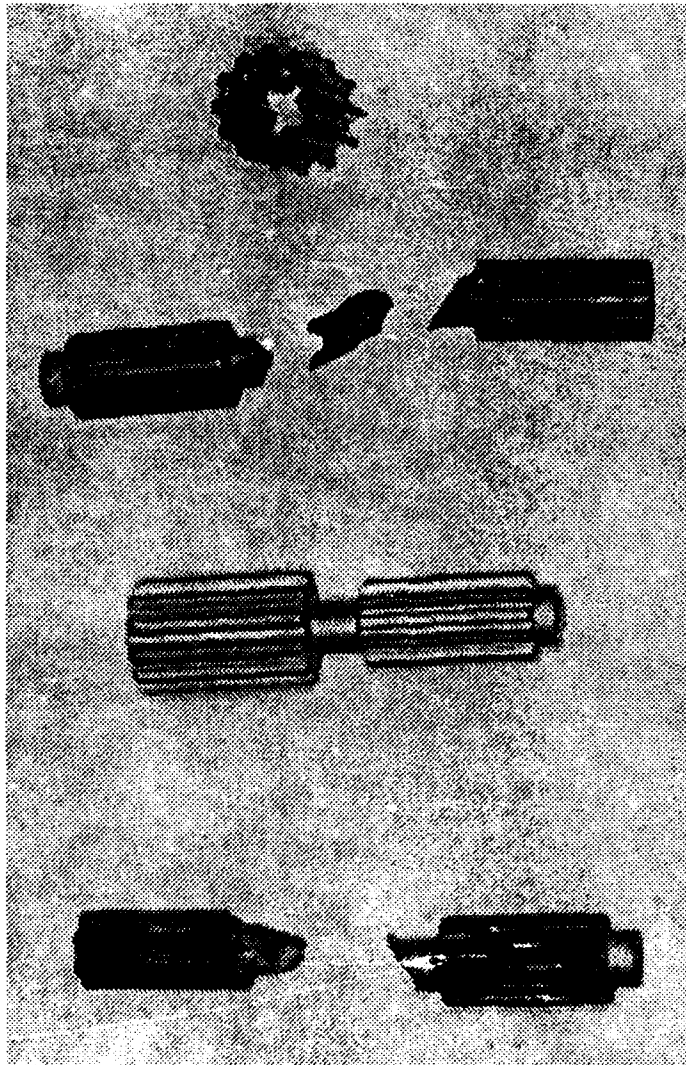
29. During the artificial and natural icing flight tests, a total of five AC generator drive shafts were sheared. This is the short shaft that connects the generator drive to the hydraulic pump drive shaft. Test Incidence Reports were submitted and a copy of each is included in appendix F. Figure E-15 shows the damaged shafts. GAC engineering believes the shafts to be too brittle to withstand the cycling loads imposed by the improved anti-ice system. The excessive number of AC generator drive shaft failures is a deficiency.

Figure E-15. Comparison of Damaged and Undamaged AC Generator Drive Shafts
