**Disorientation Accidents and Incidents  
in U.S. Army Helicopters**

**1 January 1980 - 30 April 1987**

**P. Vyrnwy-Jones**

**United States Army Aeromedical Research Laboratory  
Fort Rucker, Alabama 36362-5292**

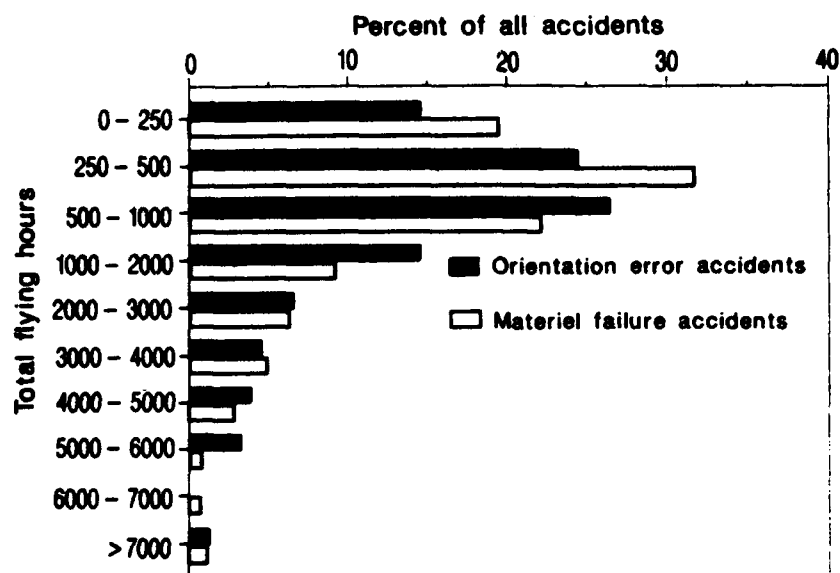
Total pilot flying hours and pilot instrument weather hours also are shown in Figures 1 and 2. These total hours are compared with the same data derived from pilots who were involved in helicopter accidents caused by mechanical failure which occurred during the same period of time. Data concerning flying experience for all U.S. Army aviators currently are not centrally collated. It is assumed those pilots involved in materiel failure accidents represent a reasonably accurate sample of the actual pilot flying and instrument flying experience in the entire U.S. Army aviator population. As can be seen by study of the graphs, the experience level in both groups is very similar, implying that total flying and instrument experience are not necessarily directly correlated with one's chances of being involved in an OE accident.

Figure 1. Percentage of all orientation error and materiel failure accidents expressed as a function of total flying experience.

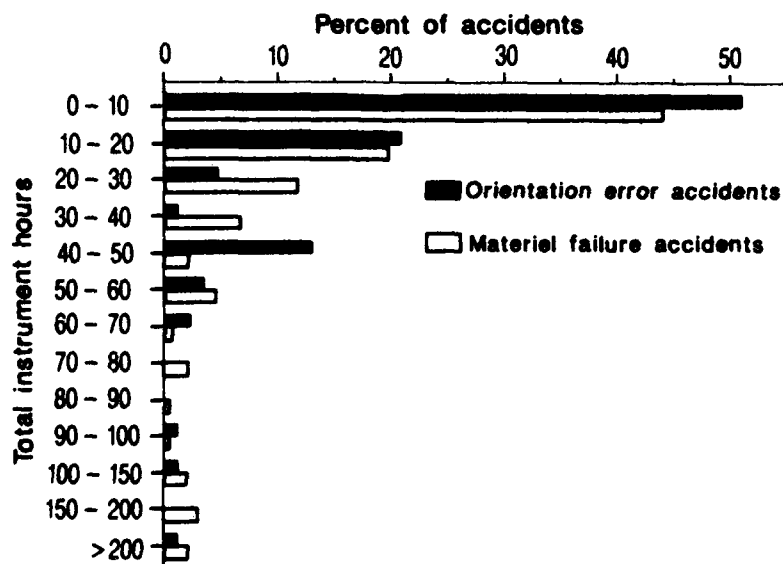
Figure 2. Percentage of all orientation error and materiel failure accidents expressed as a function of total instrument weather flying experience.
