Evaluation of Optical Materials Samples

FINAL REPORT

Prepared by:
University of Dayton
Research Institute
Dayton, Ohio 45469

JULY 1988

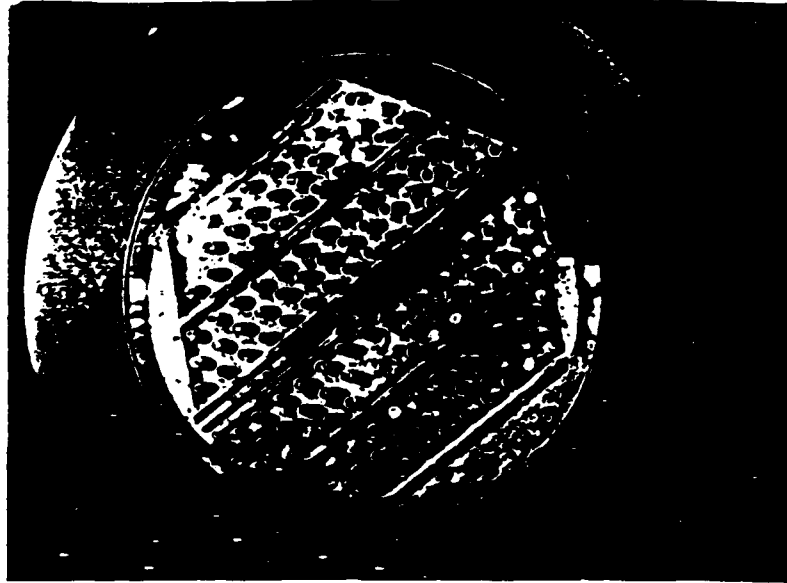
Figure 1. View of cooled mirror showing exposed faceplate support posts.

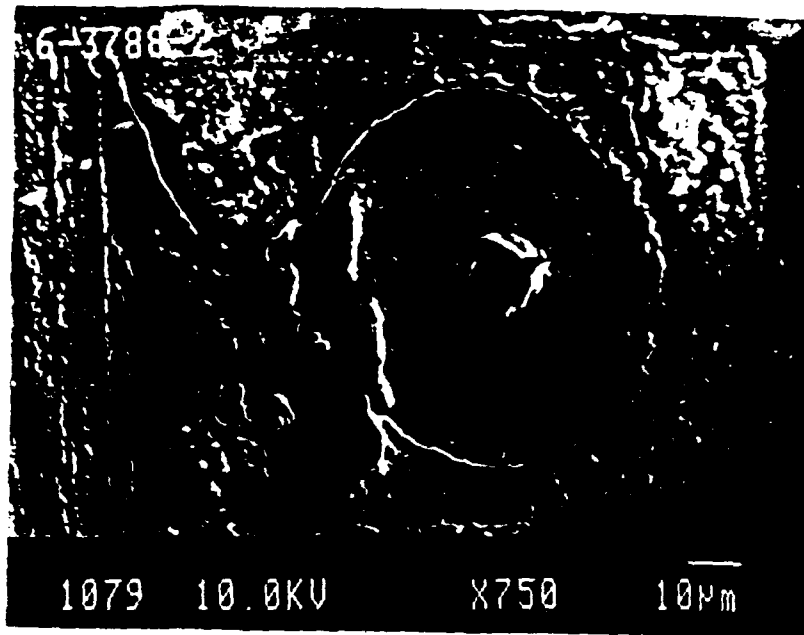
A sacrificial crater was selected to enable Auger instrumental parameters to be adjusted. After nearly one hour of rastering the electron beam over an area of interest, severe damage was noted as shown in Figure 3. Auger spectroscopy requires a sufficient focused electron beam with enough current to initiate a sufficient number of Auger events to enable detection. Beam currents on the order of 0.1 microamps or greater are usually required. This is well above what is ordinarily required for SEM/EDS analysis. It is not uncommon, therefore, to detect beam damage in radiation sensitive specimens. If a damage threshold can be determined, successful Auger analysis is accomplished by choosing parameters well below the critical current density. The current density can be greatly reduced by rastering the electron beam over a broad area compared to the actual beam diameter. The degree of damage observed in the rastered area shown in Figure 3 was totally unexpected. Our previous experience with ZnSe indicated that specimen charging could be a major problem but none was observed. The "melting", cracking, and blistering observed in Figure 3 were not observed in previous ZnSe studies.

Figure 3. Electron beam damage at crater #1. A 10 KeV electron beam at 2 microamps was rastered over a 125 micron by 88 micron region. Melting, blistering, and cracking damage is apparent.

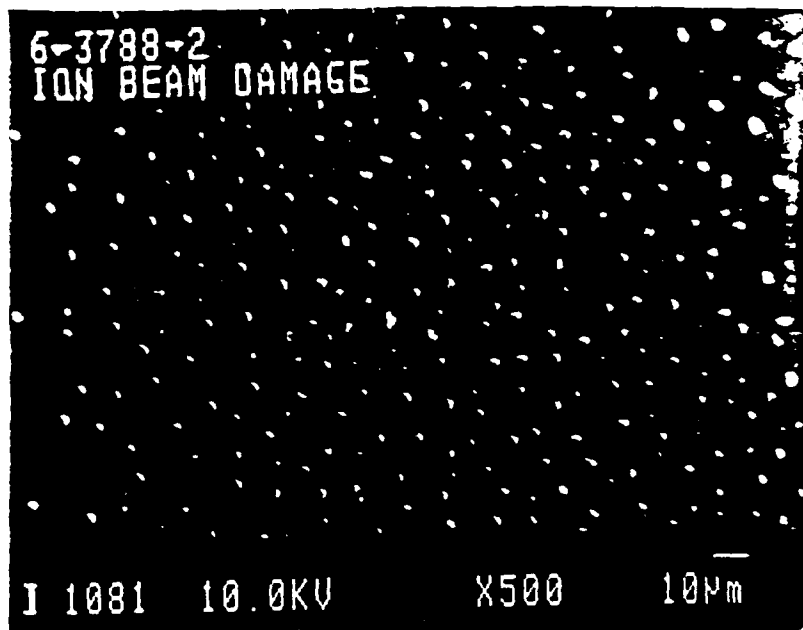
Figure 5. Damage blisters which resulted from 12.5 minutes ion beam sputtering at 2 KeV. The ion beam current density was at least 2 orders of magnitude lower than the electron beam current density used in Figure 2.

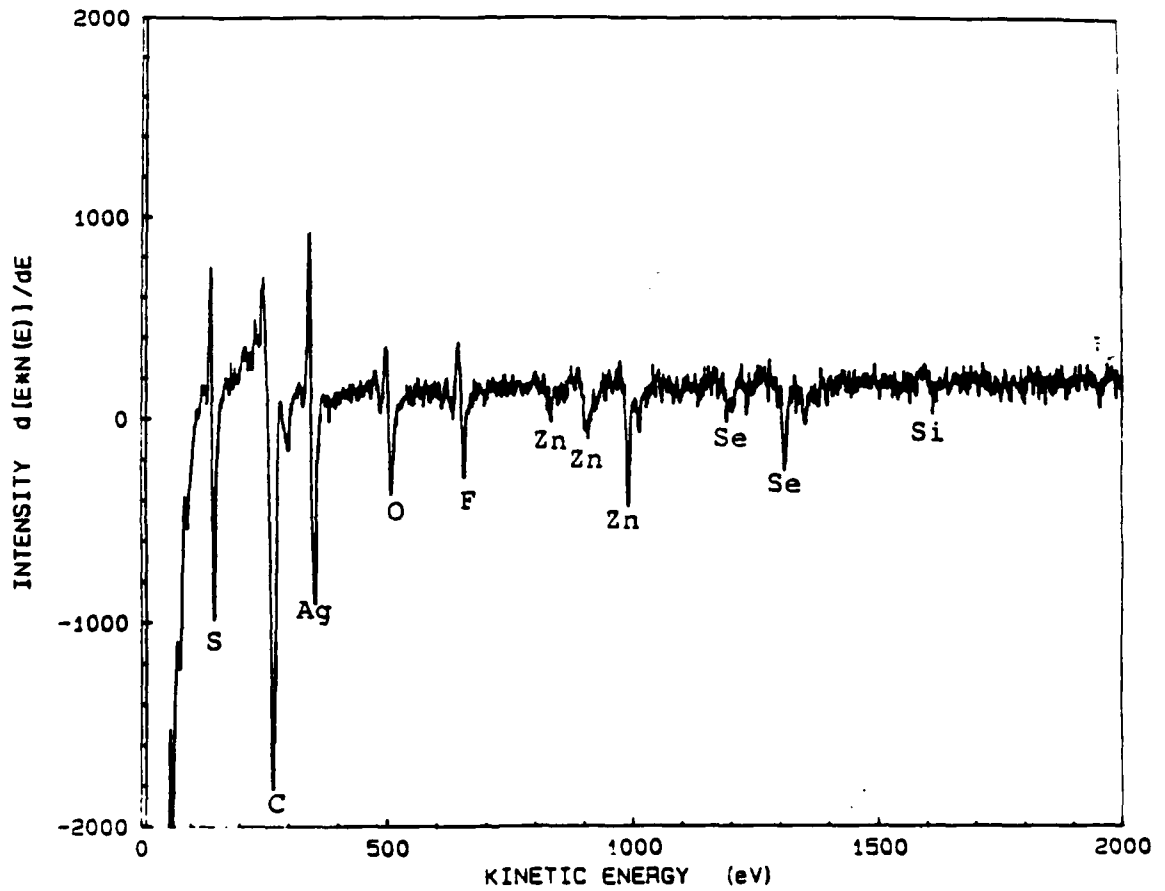
6-3788-2. DAMAGE DEBRIS WITHIN CRATER #2

Figure 7. An Auger spectrum from inside crater #2 just below the central pit. The absence of thorium is significant.

result of handling. Zinc and selenium are from the outermost optical coating. The presence of silver and fluoride along with the absence of thorium is curious.

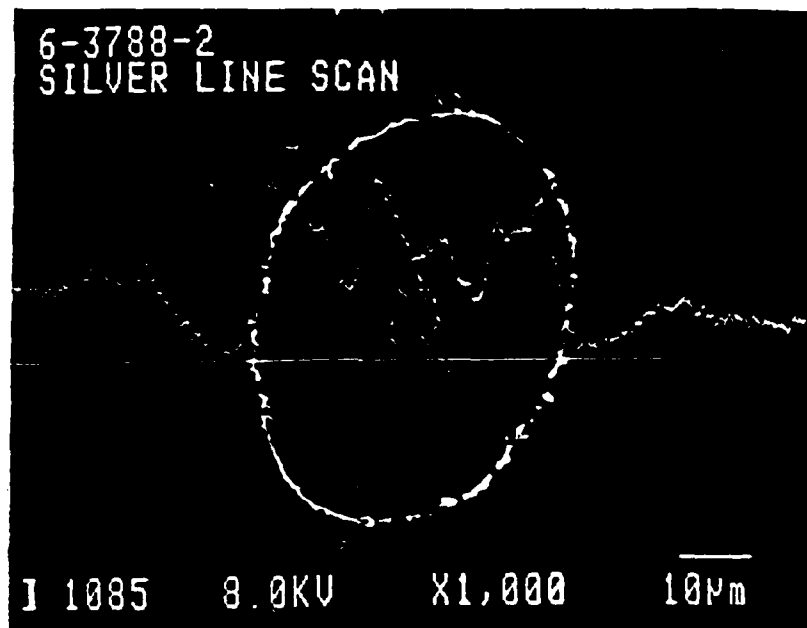
Crater #2 was ion sputtered for a sufficient period of time to remove the surrounding ZnSe layer. Figure 8 shows crater #2 with the ZnSe layer etched away. Auger line scan for silver is superimposed on this photograph along with the actual line which was scanned. It is evident that a ring containing a significant amount of silver forms the crater rim. Larger concentrations of silver are apparent within the crater than immediately outside. There is a halo region surrounding the crater edge about 10 microns wide where the silver level reaches a minimum. Beyond this the silver concentration again increases. We suggest that this could result from debris expelled from the crater during catastrophic failure. It is almost certainly not an ion beam effect. Auger spectra were acquired in regions (from Figure 8) to the left of the halo (Figure 9), on the rim of the crater (Figure 10), and in the crater below the center pit (Figure 11). Table 1 shows the elemental concentrations from these three regions in atomic percents.

Figure 8. Crater #2 after the ZnSe layer had been sputtered away. A silver Auger line scan is superimposed along with the actual line which was scanned. Silver is present in all but the 10 micron halo region immediately adjoining the crater rim.

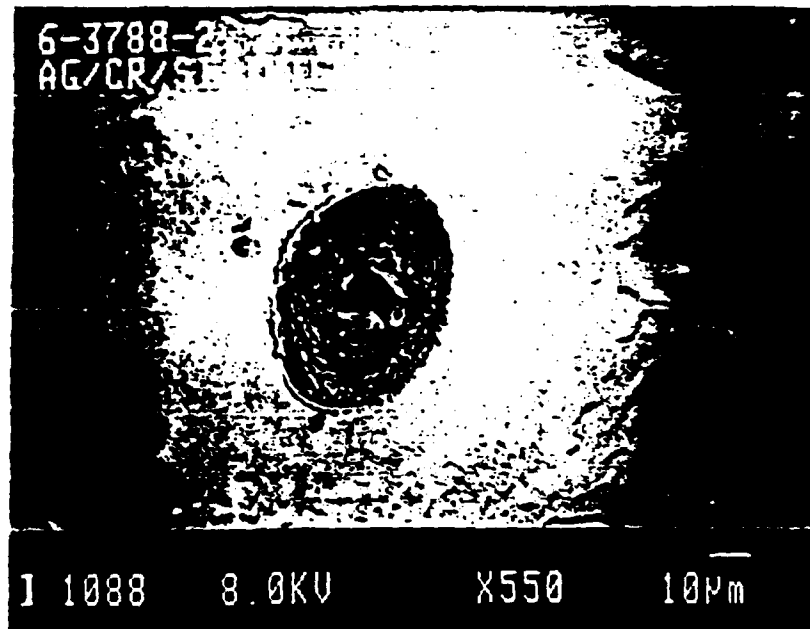
Figure 14 shows crater #2 at the silver/chromium/silicon interrace. Figure 15 is an Auger spectrum taken inside the crater rim. Silver,

Figure 14. A secondary electron image of crater #2 at the silver/chromium/silicon interface. There appears to be some blistering at the silver/thorium fluoride interface along the right edge and at the bottom of this micrograph.

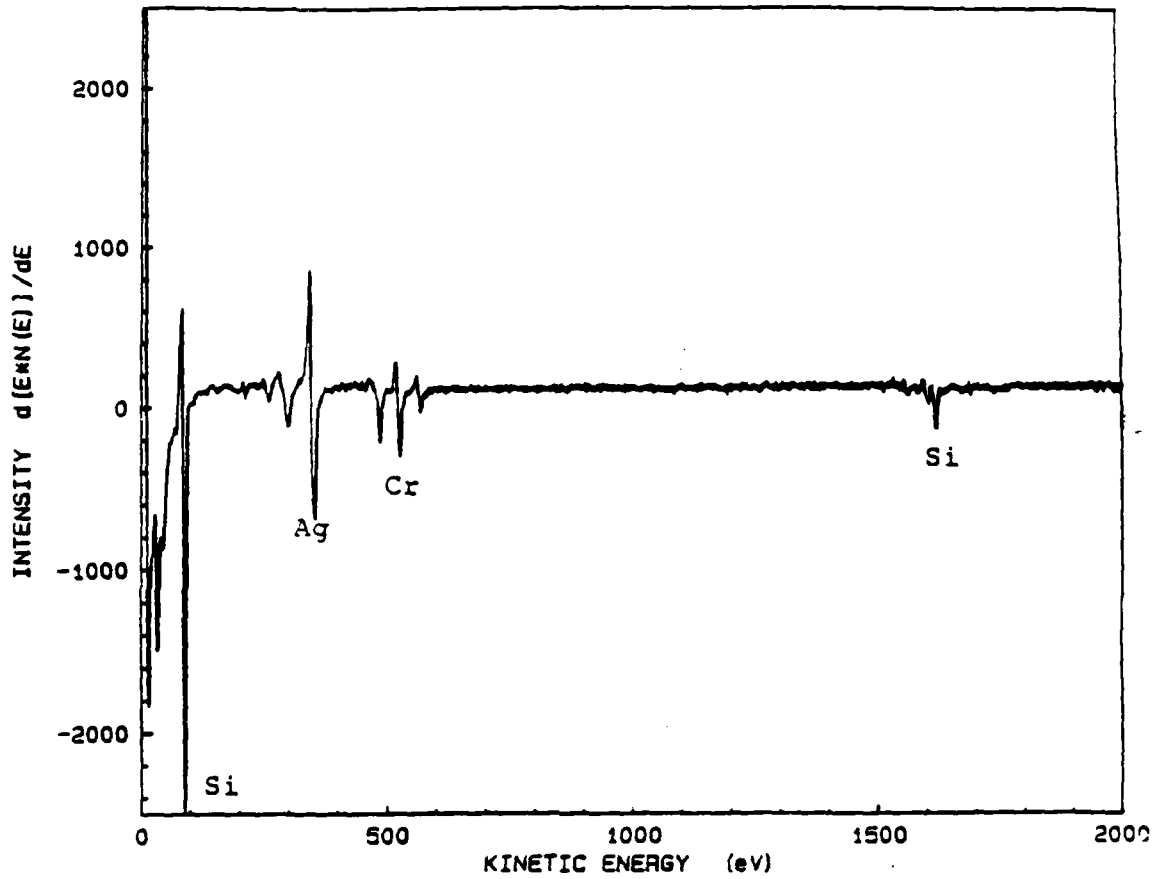
6-3788-2. AG/CR/SI INTERFACE IN CRATER #2

Figure 15. An Auger spectrum from within the crater rim just below the central pit. Silicon, chromium, and silver are present.

chromium, and silicon are present. The light colored region outside the crater is silver as shown by the Auger spectrum in Figure 16. It is interesting to note that silicon and chromium are seen within the crater and only silver is seen outside the crater even though both regions were sputtered for the same period of time. This suggests that most of the silver was expelled from the crater during failure. This is consistent with the Auger results. The gray region near the right and left hand edges of Figure 14 is the ThF_4 film. It appears that some blistering has occurred. Whether this is significant is unknown. This damage could very well be caused by the ion beam.

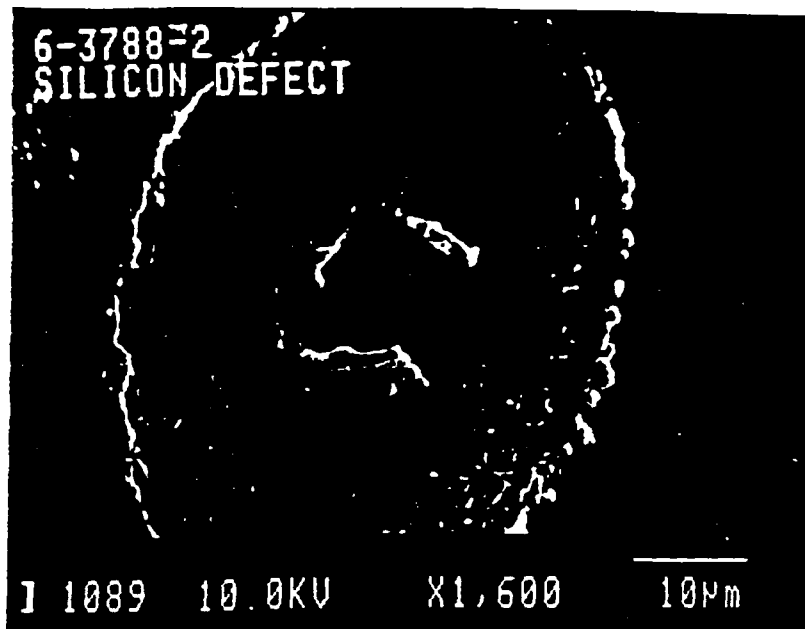
Figure 17 shows crater #2 with most of silver and chromium sputtered away. A feature in the center of this crater which could be a defect in the silicon is apparent. Further, roughness in the area within the crater rim suggests that the silicon substrate may have undergone localized melting during catastrophic failure.

Figure 17. Silicon substrate at the crater #2 site. A pit is observed at the center of this crater. If this defect was present before testing, it could have been responsible for the failure of this film at this site.

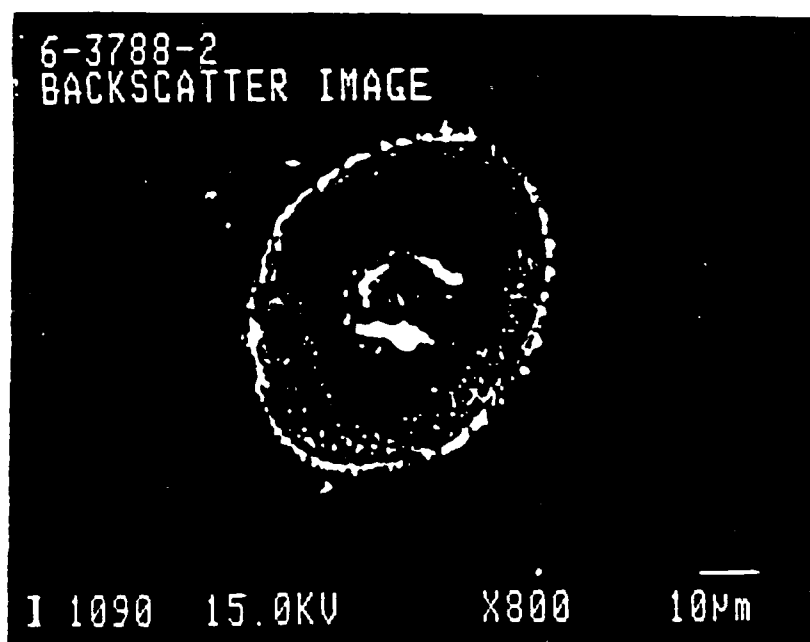
A composition backscatter electron image from crater #2 is shown in Figure 18. Heavier elements with larger backscatter coefficients appear bright whereas lighter elements appear darker in color. Auger spectra confirm that the light areas are rich in silver and chromium whereas the gray region is pure silicon.

Figure 18. Compositional backscatter electron image of crater #2 after sputtering. The bright regions indicate the presence of heavy elements (silver and chromium) whereas the neutral gray region indicates the silicon substrates.

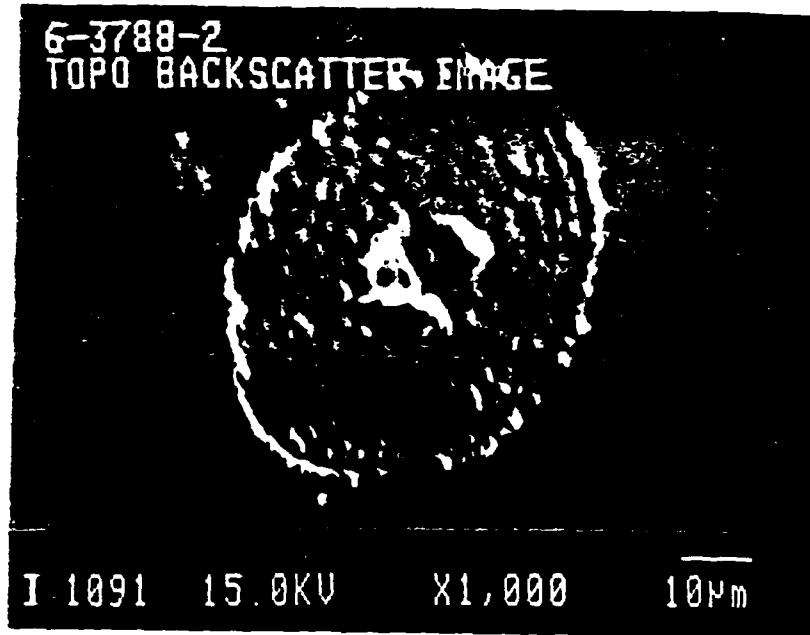
A topographical backscatter image of crater #2 is shown in Figure 19. The center defect, the silver rich crater rim, and the rough surface within the crater are clearly visible. The features at the upper left of the crater could be from expelled debris or possibly other subsurface defects. Defects in the silicon substrate such as a pits or subsurface voids could well serve as failure nucleation sites because of their inability to dissipate heat evenly. Cratering could then occur expelling debris from the

Figure 19. A topographical backscatter electron image of crater #2 after sputtering. This failure has changed the surface topography. It is not unreasonable to suspect that the failure originated at the central defect leading to subsequent localized melting of the silicon substrate and the optical coating overlayers.

inner most layers which would end up inverted within the crater debris near the rim. This cratering mode of failure would explain the presence of silver in the crater debris spectrum shown in Figure 7. Depending on temperatures during failure, localized melting of the silicon substrate could occur leaving an uneven surface after resolidification.

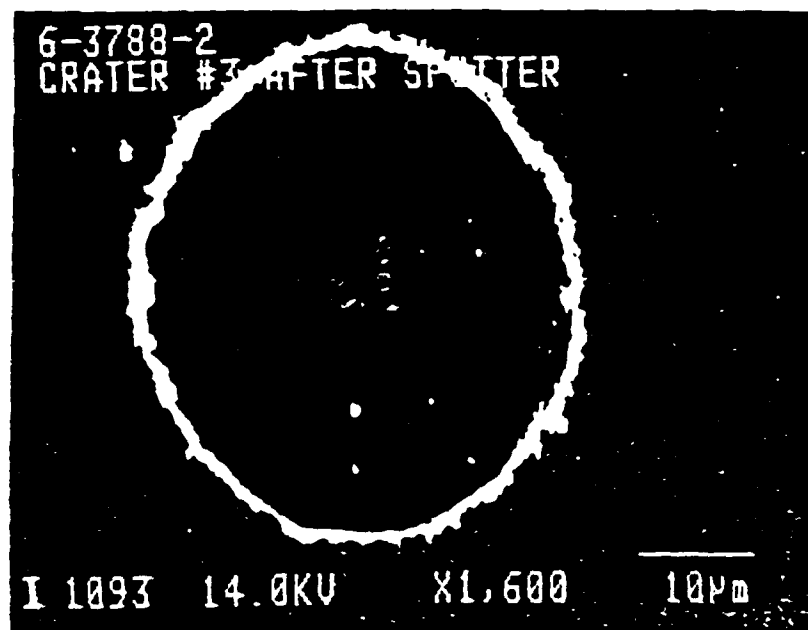
A second crater was sputtered (designated crater #3) to determine if a central defect in the silicon substrate could be detected. Figure 20 shows crater #3 with the ThF_4 and ZnSe layers sputtered away. Again, a silver rich crater rim is observed and a textured region within the rim clearly visible. A feature on the order of 1 micron in diameter is visible near the center of this crater. Figure 21 is an Auger spectrum from this central feature. Silver, chromium, and silicon are present and perhaps alloyed because of heat generated upon failure. Figure 22 is a topographical back-scatter electron image of crater #3. There is no evidence of a topographical defect at the center of this crater. It is quite possible, however, that if the substrate became hot enough to melt, any topographical submicron defect may have been smoothed over upon solidification. No evidence of aluminum oxide or any other polishing agent was found. This does not eliminate the possibility that embedded polishing agents could serve as failure sites. If residual polishing compounds caused the failure at crater #3, they may have been expelled with other crater debris or were present in amounts below the detectability limit of Auger spectroscopy. It is also possible that a subsurface void may have caused the damage seen in crater #3.

There is no clear evidence that the failures at craters 2 and 3 were caused by impurities in the optical films. We suggest that the crater

Figure 20. Crater #3 with the optical overlayers sputtered away. As with crater #2, a crater rim containing silver and chromium remains. There is evidence of a central defect. It also appears that melting and resolidification occurred within the confines of the crater rim.

failures observed on this specimen are related to substrate defects rather than film defects although this is conjecture on our part.

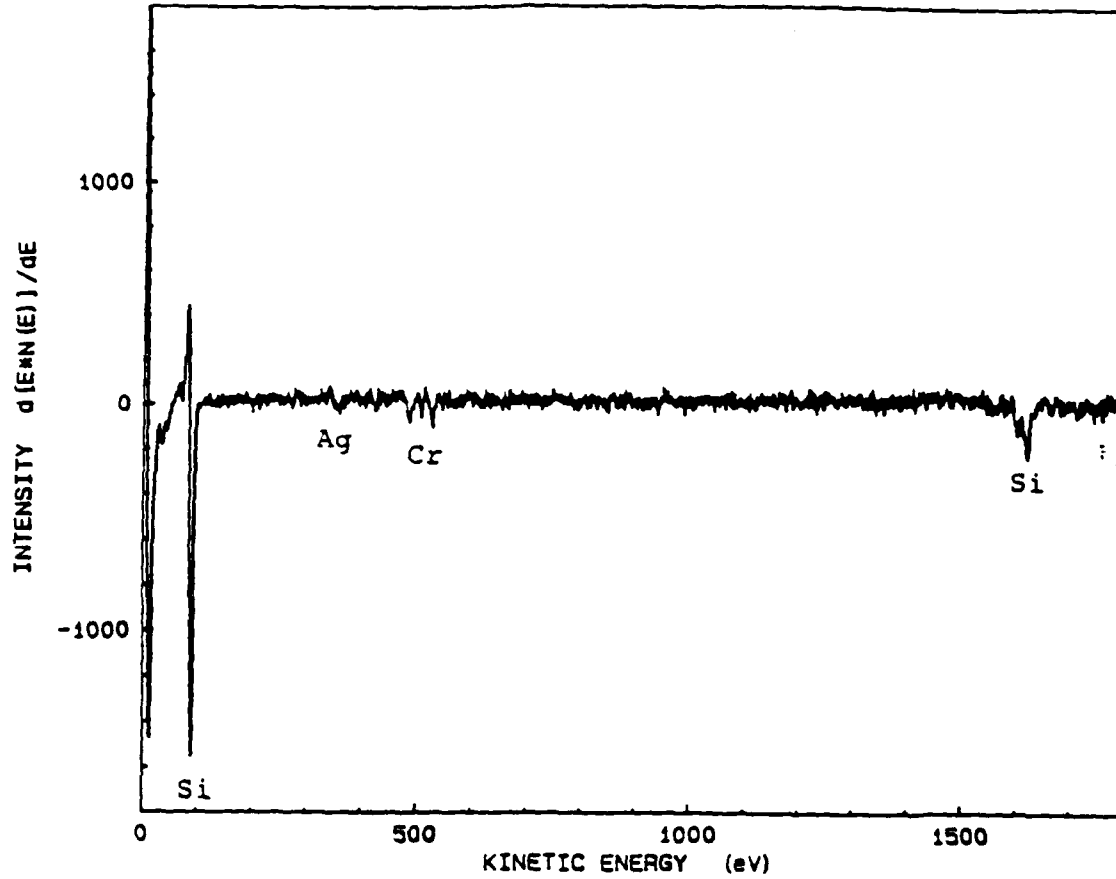
6-3788-2. CENTER FEATURE IN CRATER #3

Figure 21. An Auger spectrum of the central feature in Figure 20. Silver, chromium, and silicon are present and perhaps have alloyed as a result of heat generated during failure.

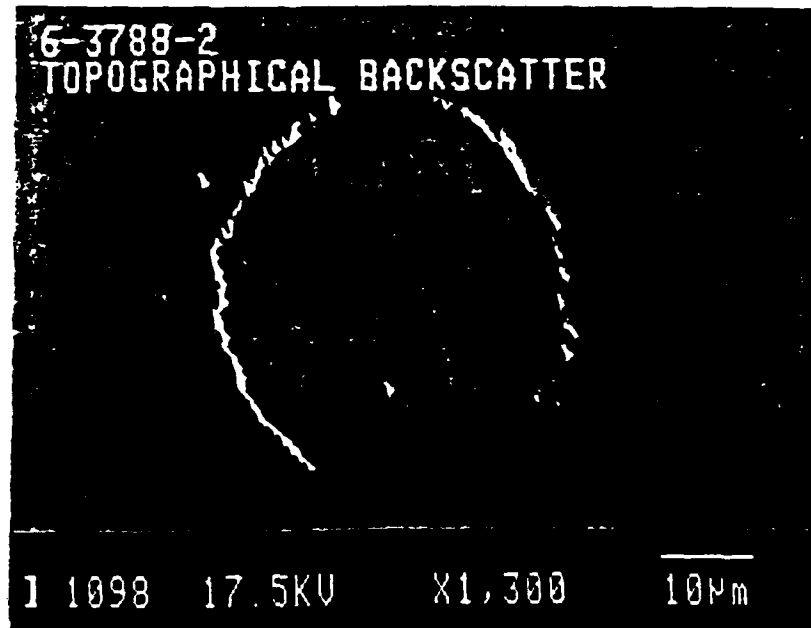
Figure 22. Topographical backscatter image of crater #3 after sputtering. The crater rim and the textured region within the crater are clearly visible.

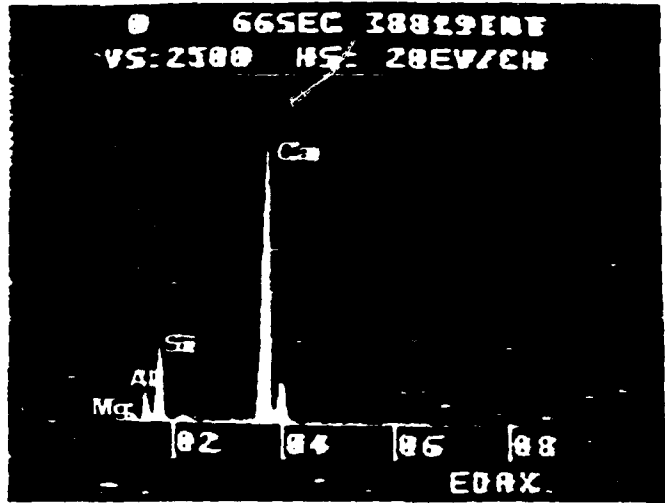
Figure 25. EDAX scan of porous SiC and contaminant showing the presence of Mn, Ca, Si, and Al.

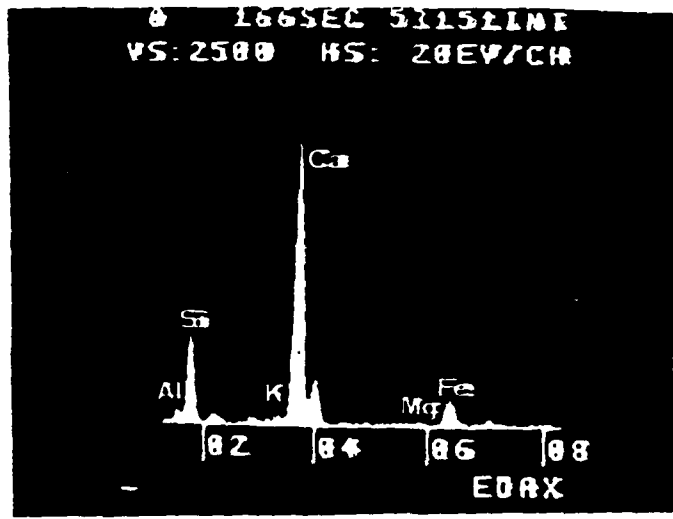
Figure 26. EDAX scan of porous SiC and contaminant showing the presence of Al, Si, K, Ca, Mg, and Fe.
