TECHNICAL REPORT REMR-CO-3

CASE HISTORIES OF CORPS BREAKWATER  
AND JETTY STRUCTURES

Report 2

SOUTH ATLANTIC DIVISION

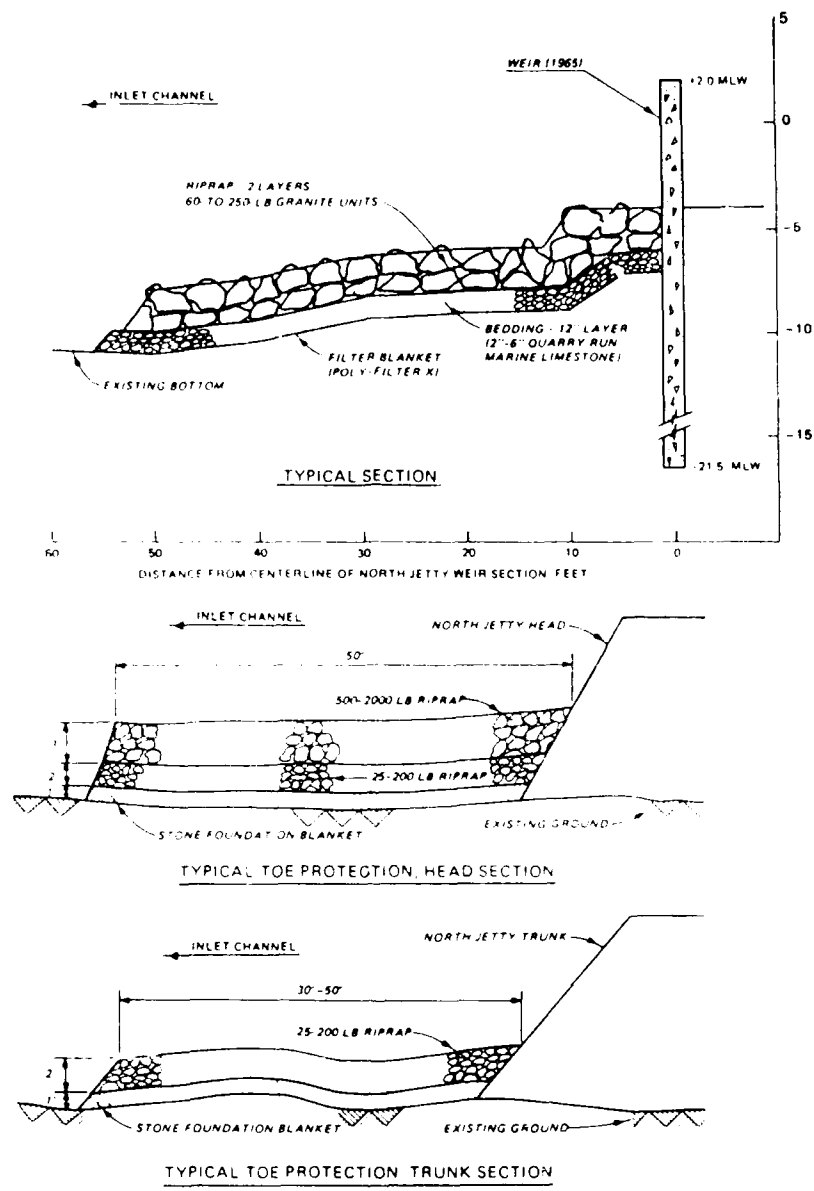
Figure 12. North jetty toe protection  
Masonboro Inlet

| Date(s) | Construction and Rehabilitation History |
|---|---|
| 1973-<br>1974 | Toe protection (Figure 12) was placed along the channel side of the 1,100-ft weir section because of continued movement of the navigation channel and the costs involved should a catastrophic failure occur (loss of sheet-pile sections resulting from scour and undermining). The toe apron was to be 50 ft wide with a 1-ft-thick foundation blanket of 2- to 6-in. stone overlain with a 2.5-ft layer of 25- to 250-lb riprap. Total cost of the repair was \$248,800. |

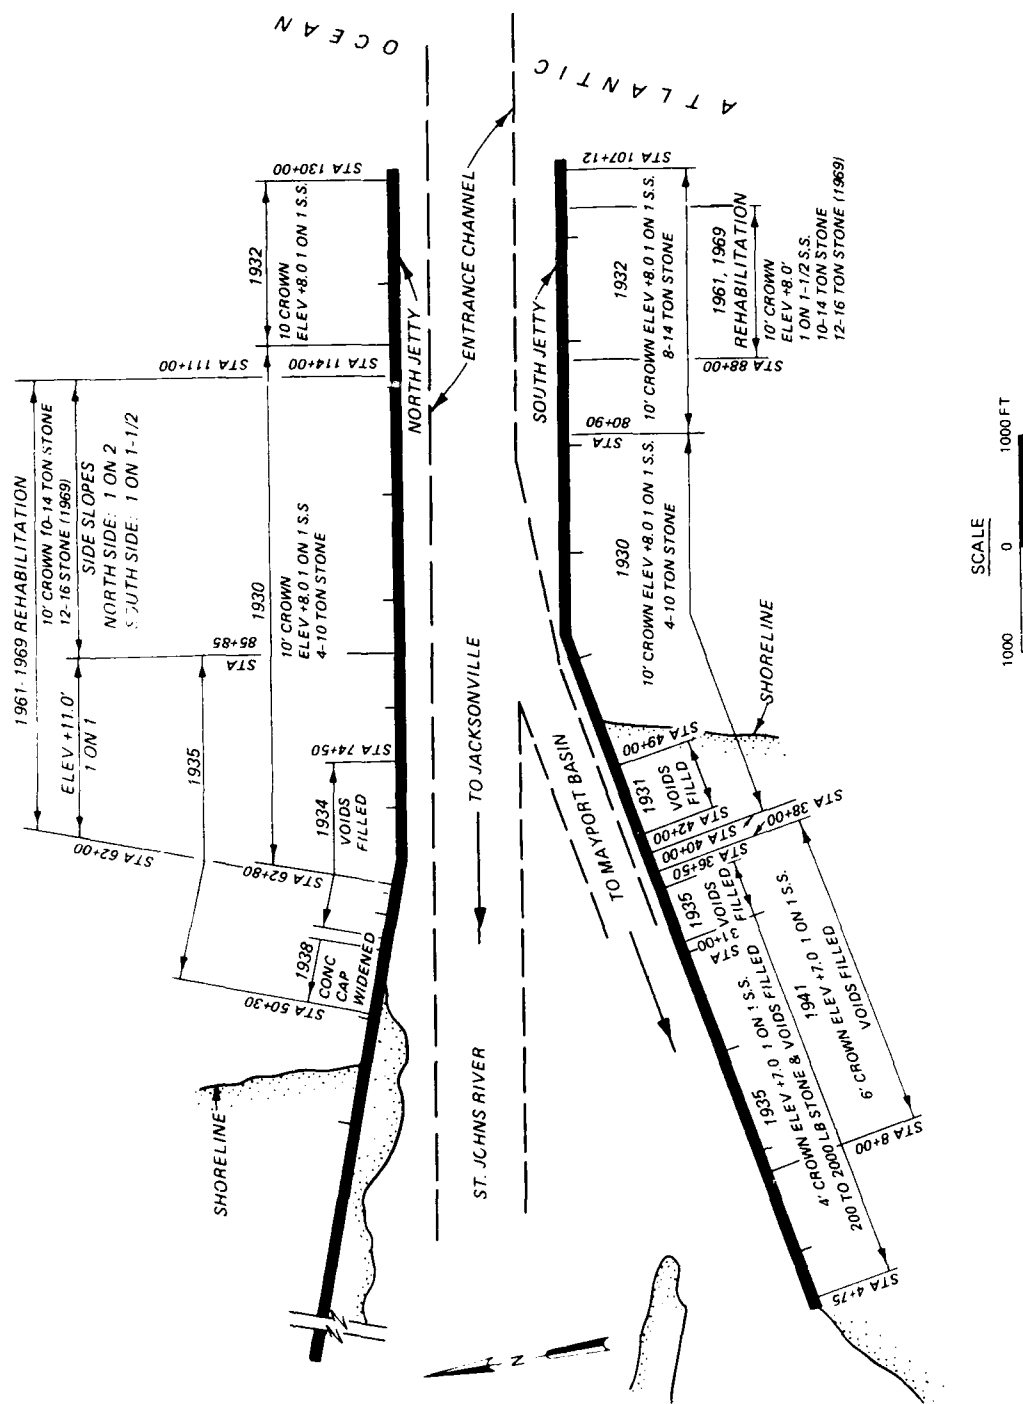
Figure 24. Plan view of cumulative repairs to Jacksonville jetties from 1930 to 1969

| Date(s) | Construction and Rehabilitation History |
|---|---|
| 1930 | Repairs were made between sta 62+80 and 114+00 of the north jetty with 29,700 tons of granite stone (Figure 24). Nine gaps with an average height of +4 to +5 ft mlw were raised to +8 ft mlw. The crest elevations on the outer 500 ft of the jetty were from -5 to -15 ft mlw. The south jetty was repaired between sta 40+00 and 80+90 with 26,600 tons of granite (Figure 25). Twenty major gaps with average heights of +3 to +5 ft mlw were raised to +8 ft mlw. The crest elevations on the outer 700 ft of the jetty were from +3 to -10 ft mlw. The stone size was from 4 to 10 tons with an average size of 6 to 8 tons. The crown width was 10 ft, and the side slopes were 1V:1H. Cost of the repairs totaled \$228,000. |

| Date(s) | Construction and Rehabilitation History |
|---|---|
| 1935 | Elevations on the north jetty varied from +6 to +14 ft mlw and on the south jetty varied from 0 to +14 ft mlw. Repairs were made to the inner portion of the south jetty, filling void spaces from sta -4+75 to 31+00 using 200 to 2,000-lb stone. From sta 31+00 to 36+50 the voids were filled between 0.0 and 4.0 ft mlw with smaller stone (less than 200 lb). This section was repaired using a 4-ft-crown width at an elevation of +7 ft mlw and 1V:1H side slopes (Figure 24). |
| 1940-<br>1941 | Repairs were made to the south jetty between sta 8+00 and 38+00 (Figure 24). Granite stone of 1 to 3 tons and 3 to 6 tons was placed on the inner 1,200 ft and outer 1,800 ft, respectively. Void filling stone of 50 to 150 lb was placed throughout the repair section. The design called for a 6-ft crown width at +7 ft mlw with 1V:1H side slopes. Sand overlying the jetty was to be removed before stone placement. Small stone was removed between 33+00 and 38+00 as required to allow placing of the cover stone to the design section with the removed stone subsequently used to fill voids. 21,800 tons of 1- to 6-ton stone and 4,800 tons of 50- to 150-lb stone were placed at a cost \$105,000. |
| 1961 | Rehabilitation made to the seaward end of the south jetty between sta 88+00 and 102+70 and the north jetty between sta 62+00 and 11+100 (Figure 24). Areas of deterioration from settlement and dislodgement of stone had occurred at the ocean ends and along landward portions of both jetties. Also, several portions of the north jetty concrete cap had been broken and displaced from the crown along with some of the underlying support stone. The major causes of settlement seemed to be slope flattening and the possibility of wave |

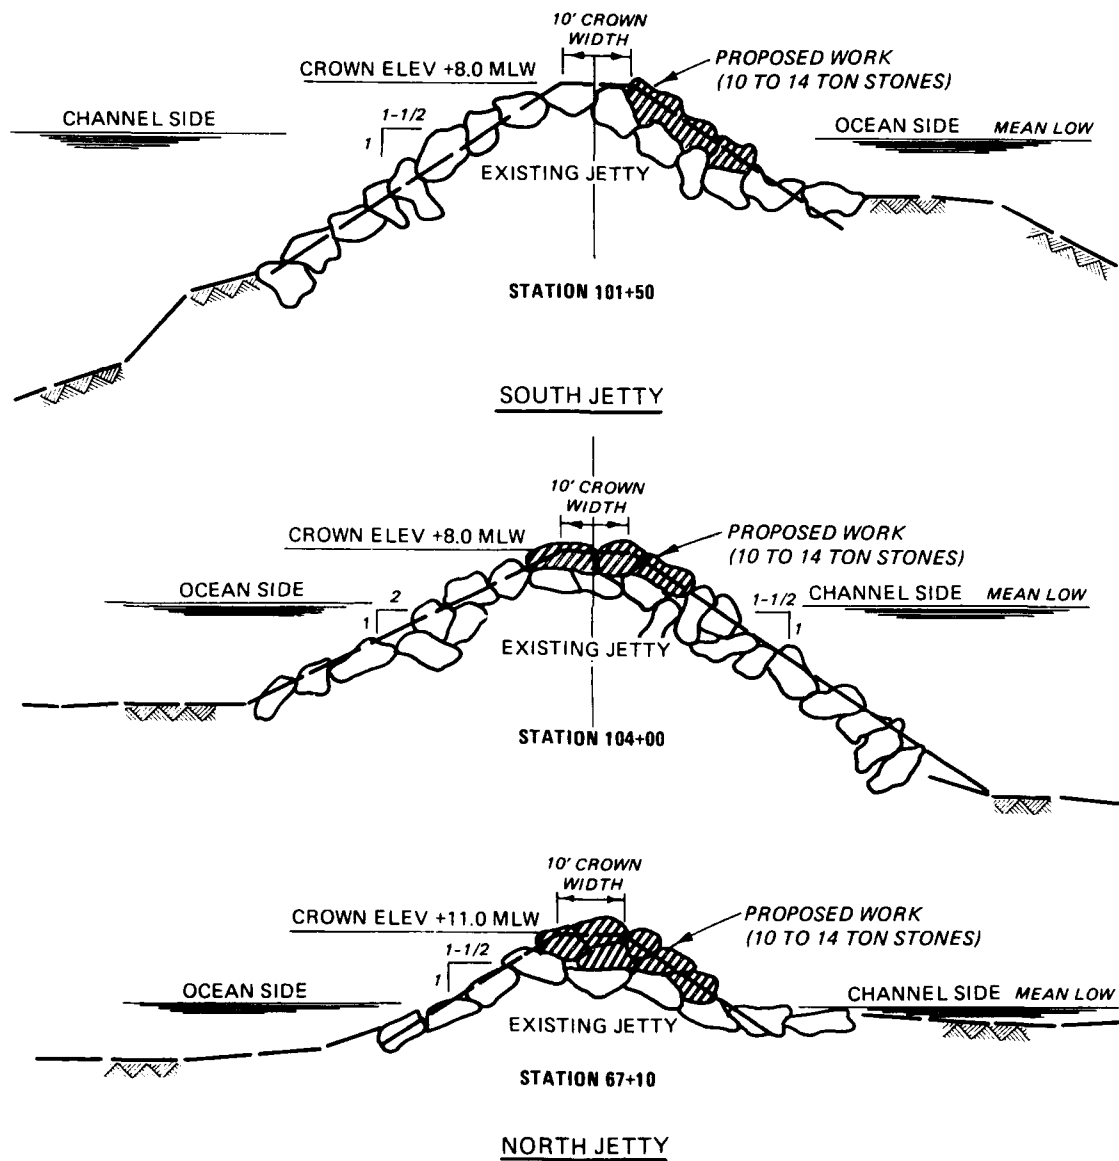
Figure 25. Typical 1961 repairs to Jacksonville jetties

| Date(s) | Construction and Rehabilitation History |
|---|---|
| 1969 | <p>Rehabilitation of jetties was carried out on approximately the same section as the 1961 repairs (Figure 25). Except for the use of 12- to 16-ton stone, the design sections were identical to those of 1961. The north jetty from sta 50+45 to 85+80 was built up to +11 ft mlw with 1V:1.5H side slopes and from sta 85+80 to 122+80 was built up to +8 ft mlw with 1V:2H and 1V:1.5H side slopes on the ocean and channel sides, respectively. The south jetty from sta 85+90 to 103+20 was built up to +8 ft mlw with 1V:1.5H side slopes. The crown width on all sections was 10 ft. Dislocation and consolidation of cover stone overlying smaller stone (below mlw) was thought to be the cause of jetty deterioration. The low areas to be repaired were wide which provided a good base to place new stone. Wave heights of 14 and 15 ft and Hudson's stability equation were used, similar to those in the 1961 design. A total of 21,500 tons of stone was placed at a cost of \$398,000. Inner areas of the jetties were not rehabilitated although in need of some repairs.</p> |

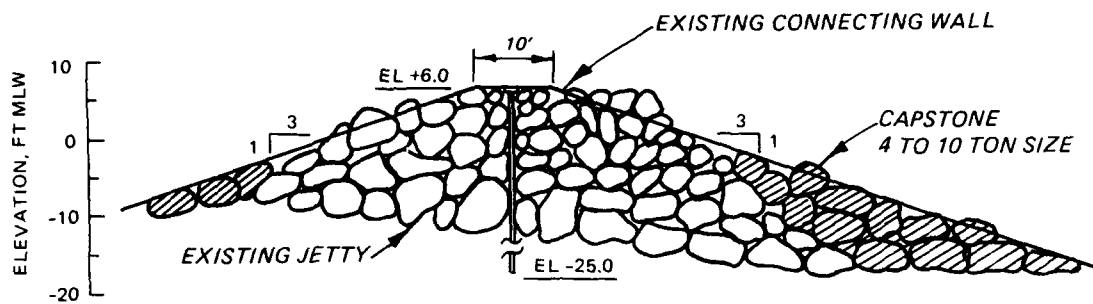
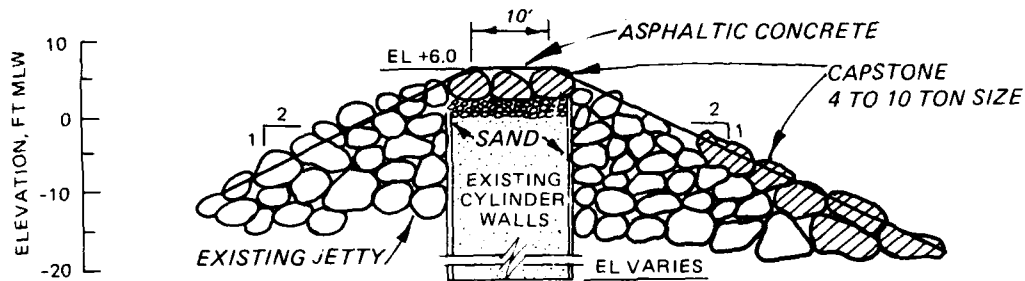
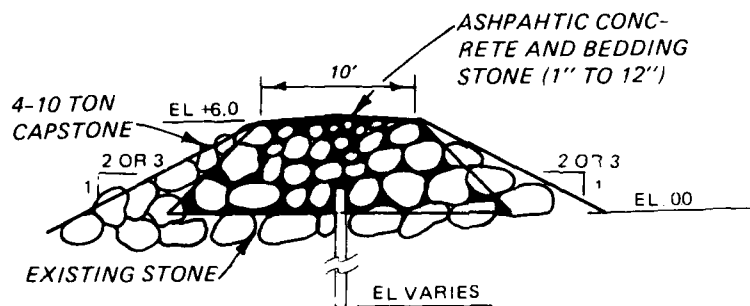
Figure 40. Typical 1969 jetty repair sections as Casey's Pass

| Date(s) | Construction and Rehabilitation History |
|---|---|
| 1985 | <p>The jetties are in good condition except for their head sections which are in need of some repair.</p> |
