USA-CERL SPECIAL REPORT M-89/02
November 1988

Assessment of the Structural Integrity of the People Center, Building 16, Chanute Air Force Base, IL

by
Pamalee A. Brady
James D. Prendergast

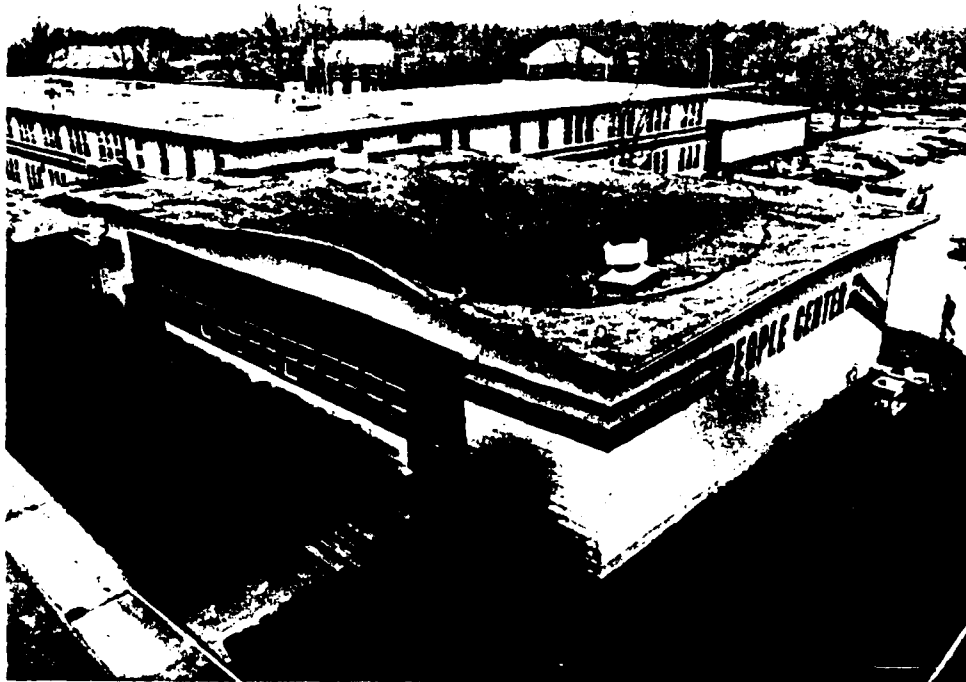
Due to the factors cited above, it is likely that the trusses deflected, the pitch became a depression, and rain and melting snow ponded on the roof. Ponding was observed the morning of the failure.

Figure 1. Ponding on the roof of Building 16.

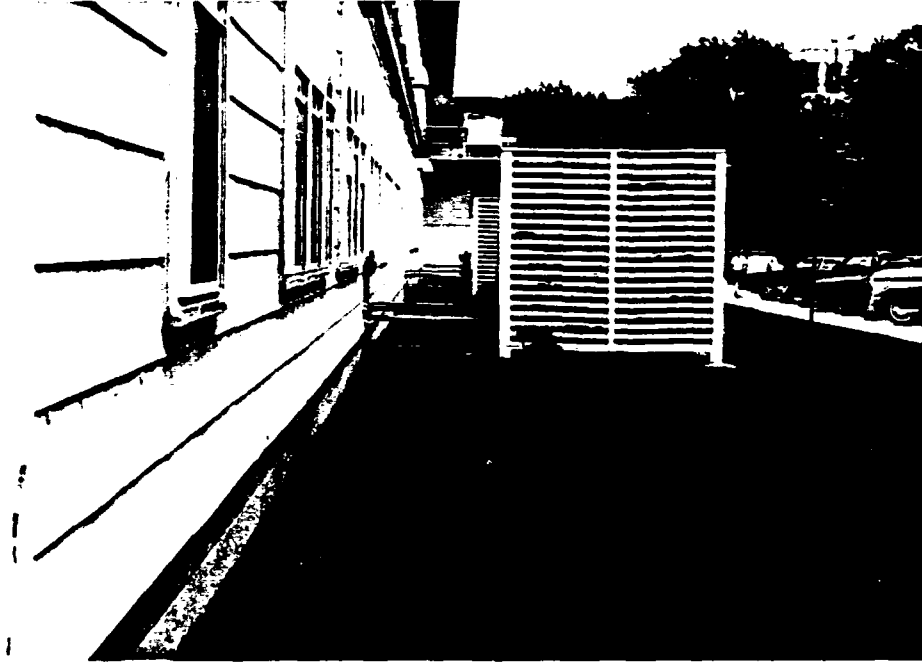
The building was inspected visually to assess the condition of the structural members, connections, and structural environment. A general inspection of the grounds and building exterior was conducted. In some areas, the ground surface around the structure is not sloped to drain water away from the building (Figure 12).

Figure 12. Ground slope around Building 16.

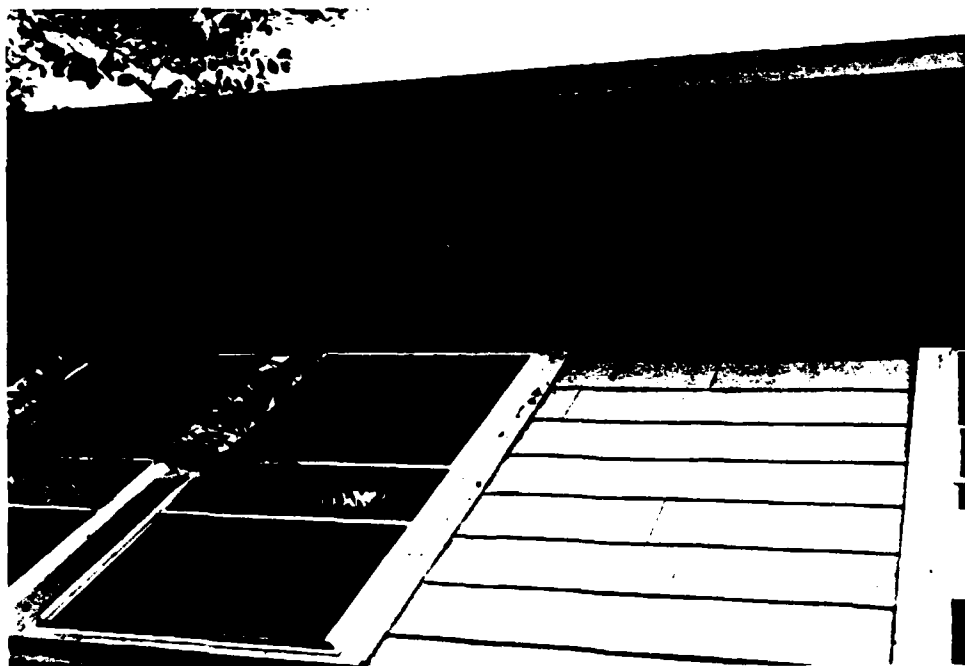
Figure 17. Underside of roof overhang on east side of north wing.

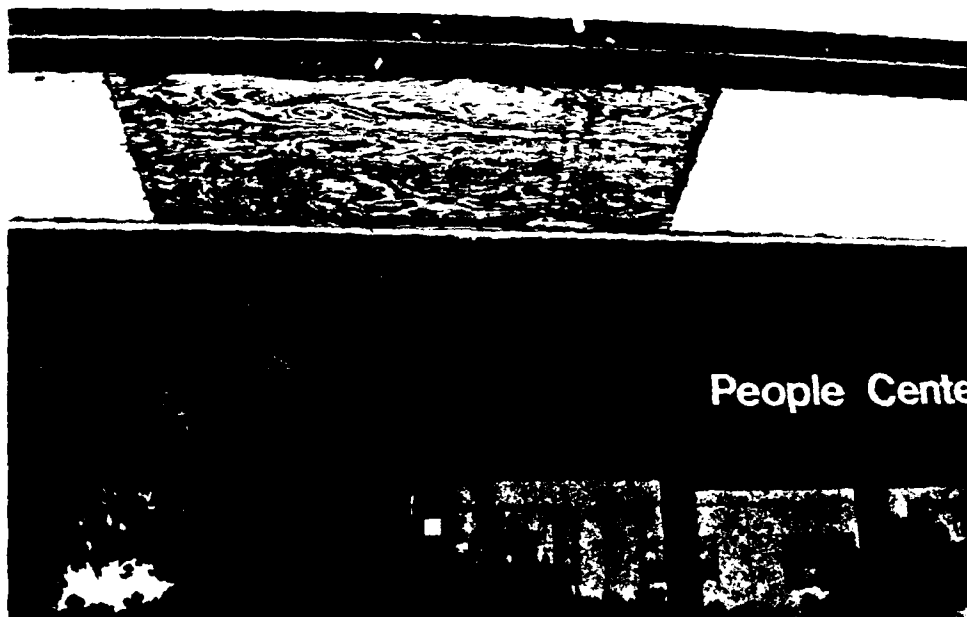
Figures 13 through 16 show the condition of the building elevations and roof overhang. Peeling paint was observed in the panels of wood sheathing on the underside of the roof overhang. This condition is typical around the building perimeter but is most pronounced on the east face. Here, water was observed dripping from the eave (Figure 17) and there is a depression in the ground underneath caused by dripping water (Figure 18). After a heavy rain, water also dripped from three roof locations along the south side of the west wing. These areas are directly over the window of Room 214, at the center window unit in Rooms 209 and 210, and between the first and second windows from the east end of Rooms 207 and 208. At the main entrance to the building on the south face, new plywood had been installed in the overhang and water stains could be observed (Figure 19).

Figure 19. Stained plywood at entrance to Building 16.

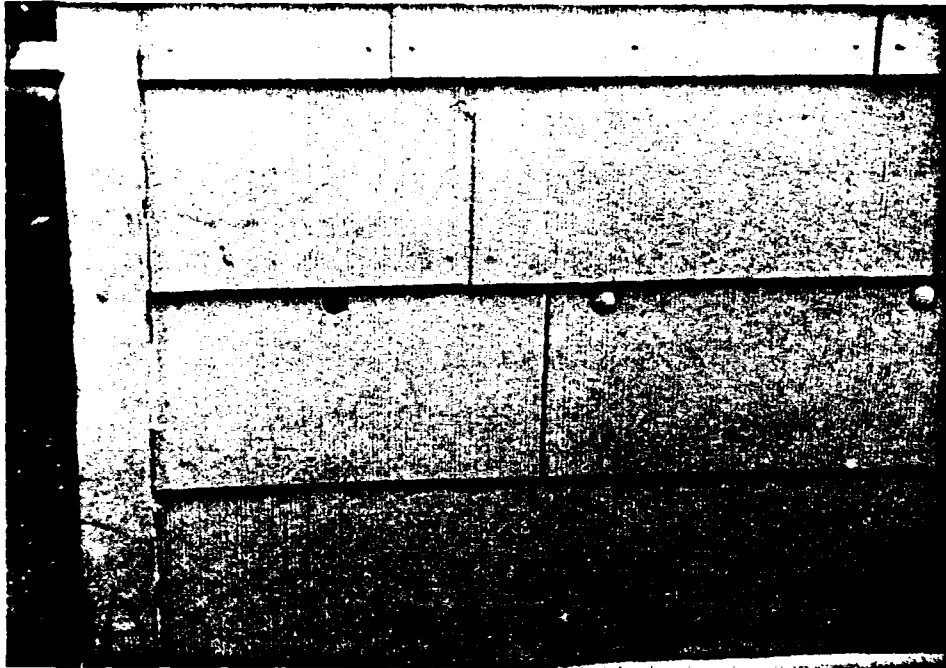
Some plugs are missing from holes in the building's exterior siding where the wall cavity has been filled. Figure 20 shows this condition.

Figure 20. Missing plug on exterior siding.

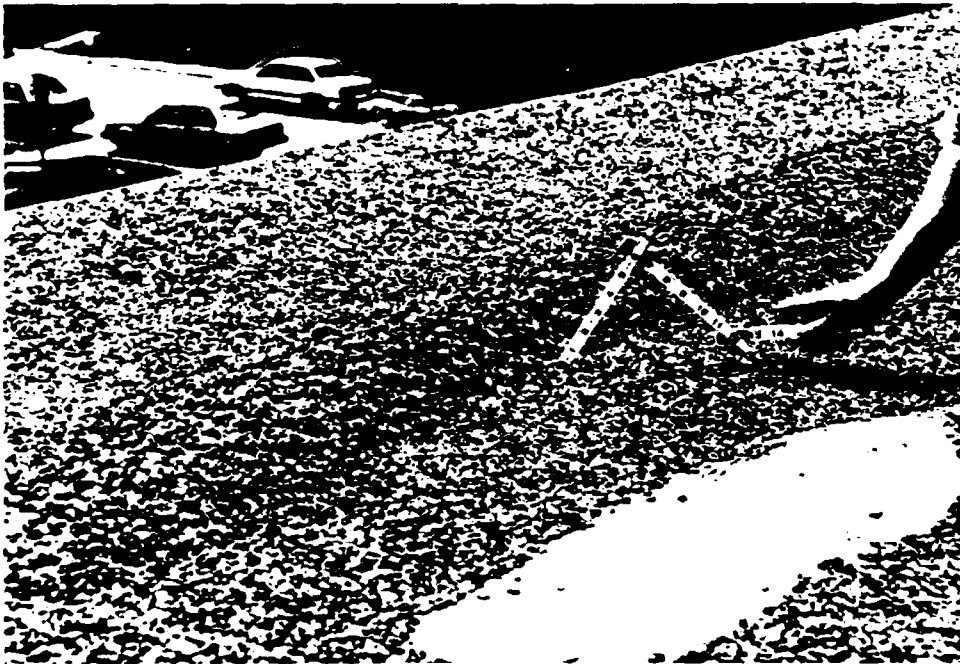
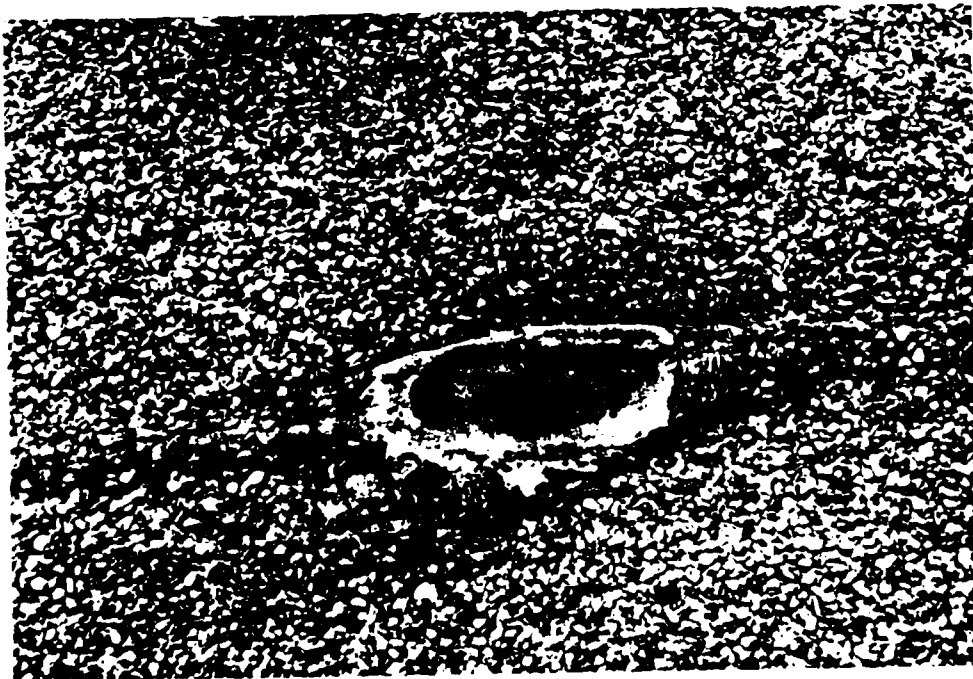
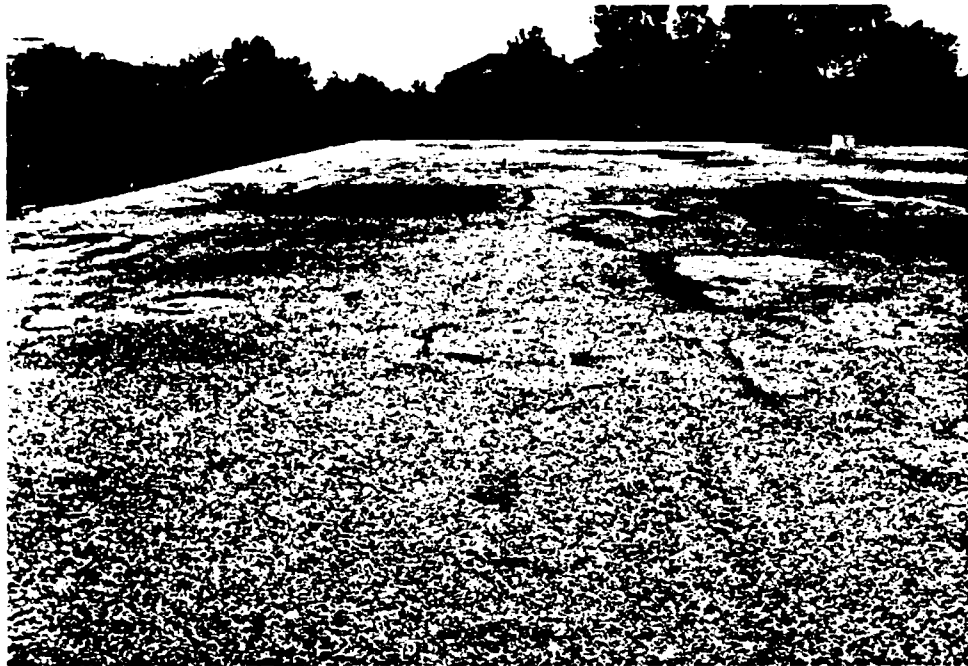
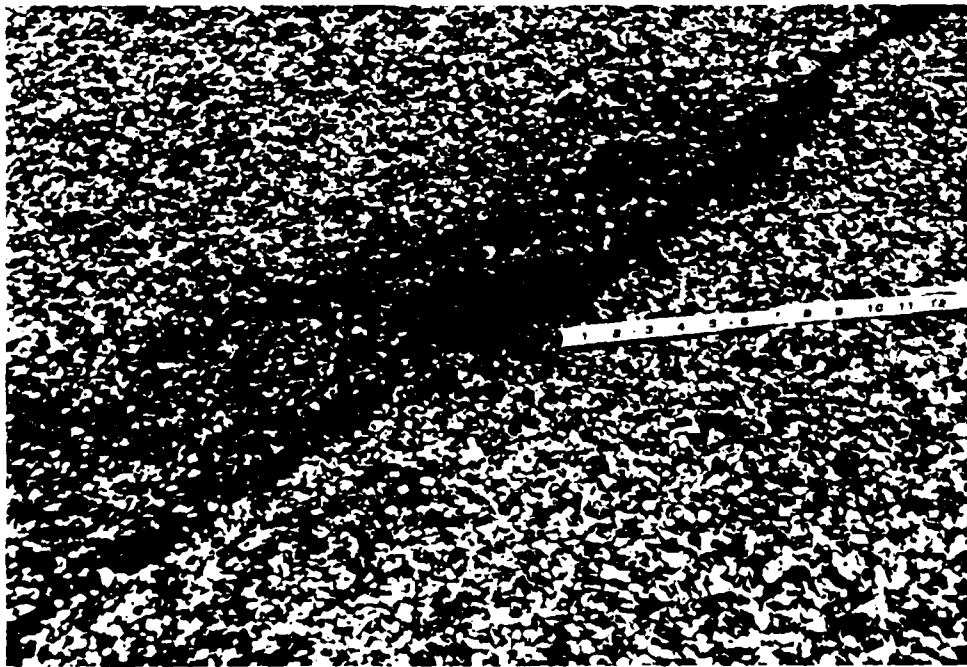
The roof survey indicated that several areas are significantly depressed such that ponding can occur and this observation was verified during the visual survey of the roof. The largest deflections in the roof surface are in the area between Lines 7 and 8 on the south side of the west wing and along the west side of the north wing, especially along Line 12, as was determined from the roof survey data. Dark pools of algae had formed in these and other depressed areas. Water could be forced from the roof overhang by stepping on its edge at the point above where the water was observed to be dripping on the ground. Bubbles in the roof surface were noted across the extent of the roof--especially along the line of the perimeter wall on the south side of the building (Figure 21). The roof on both wings had been patched in several locations (Figures 22 through 24) and unpatched tears in the roof surface were also noted (Figure 25).

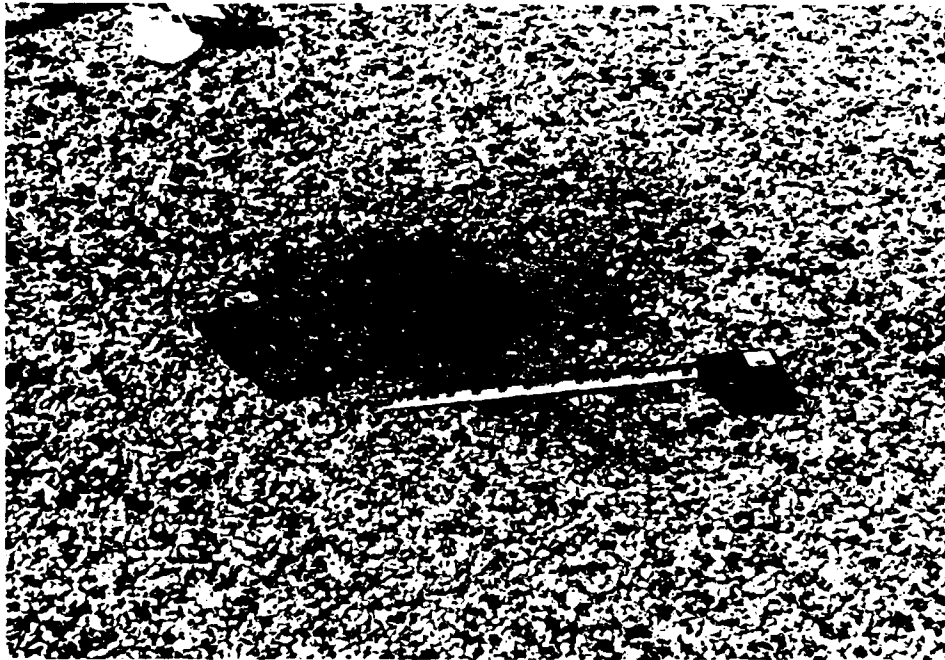
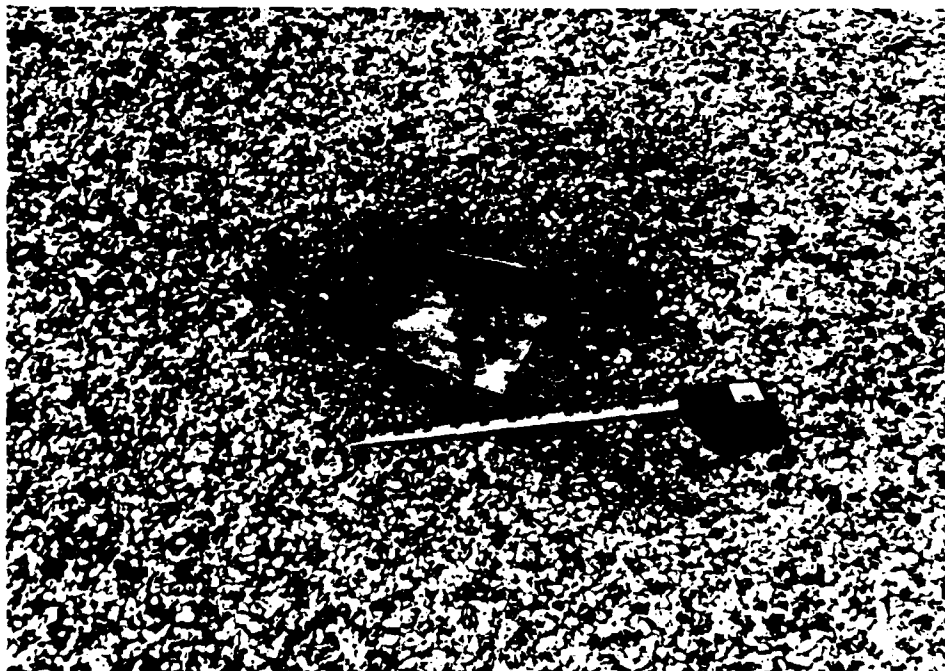
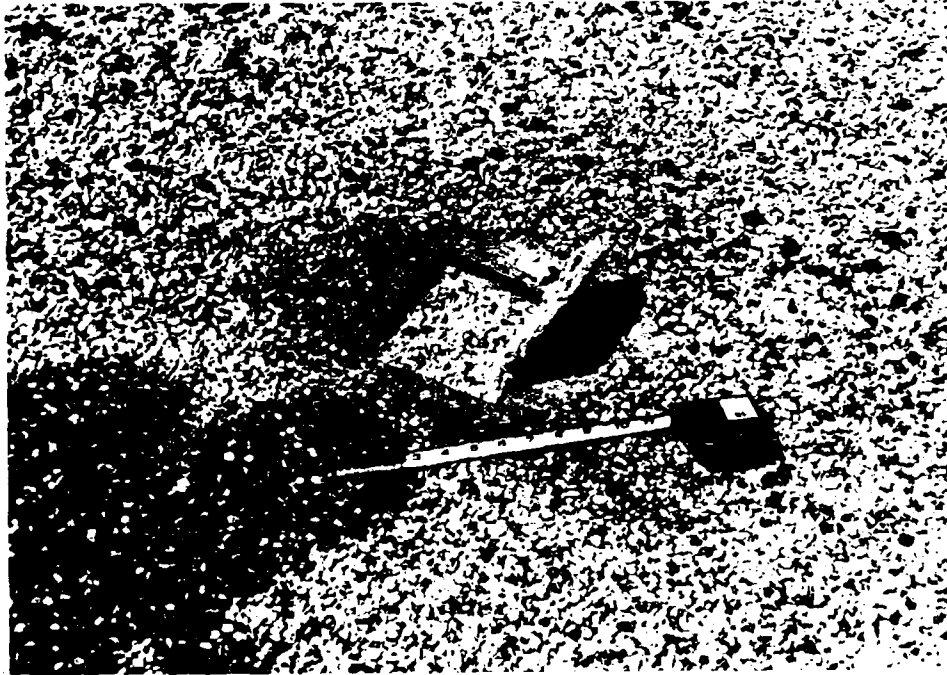
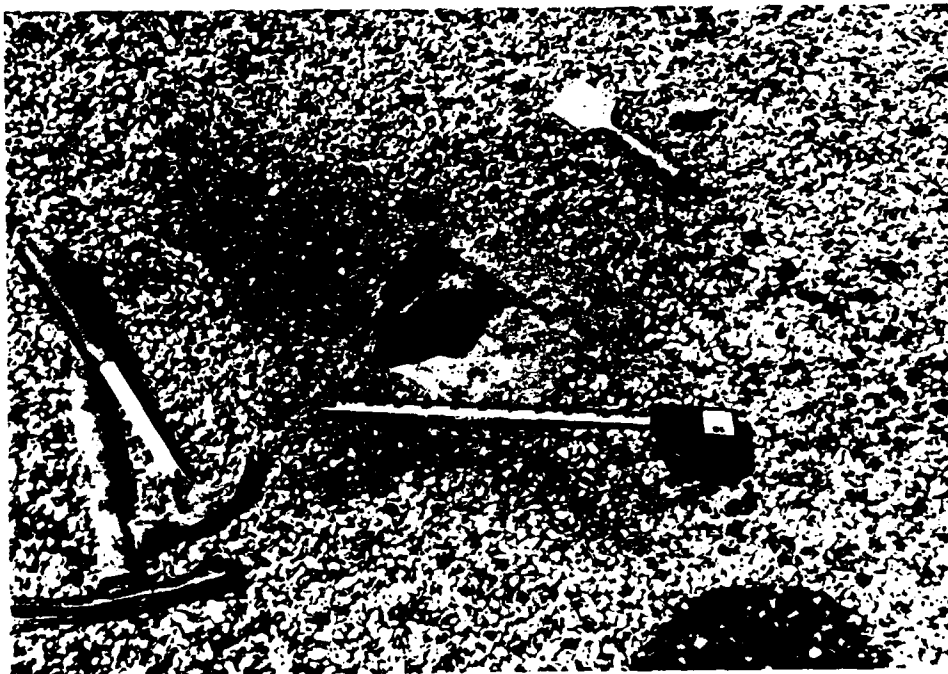
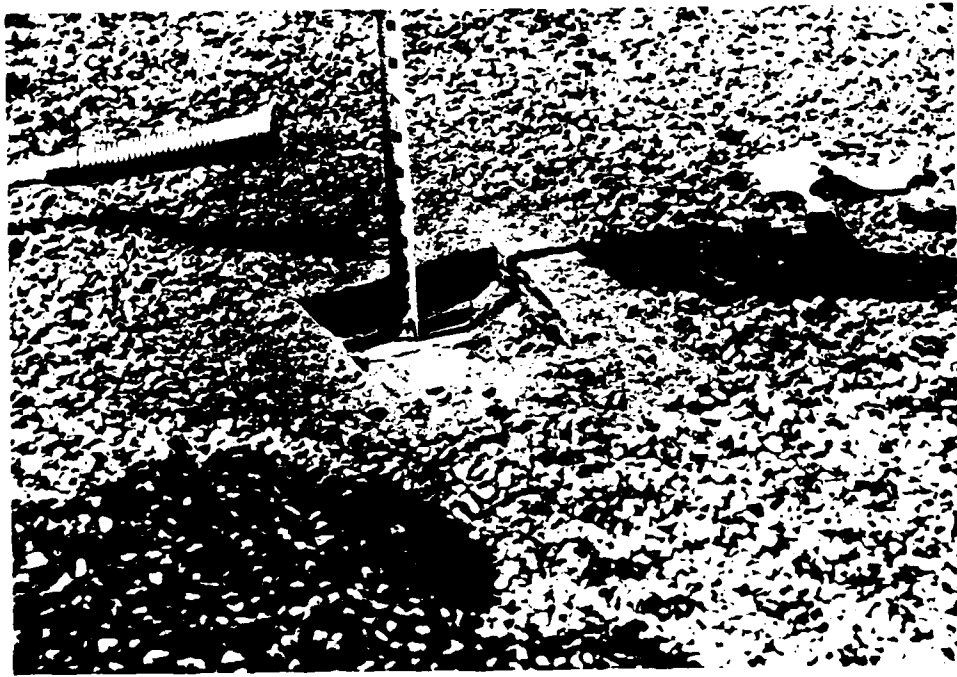
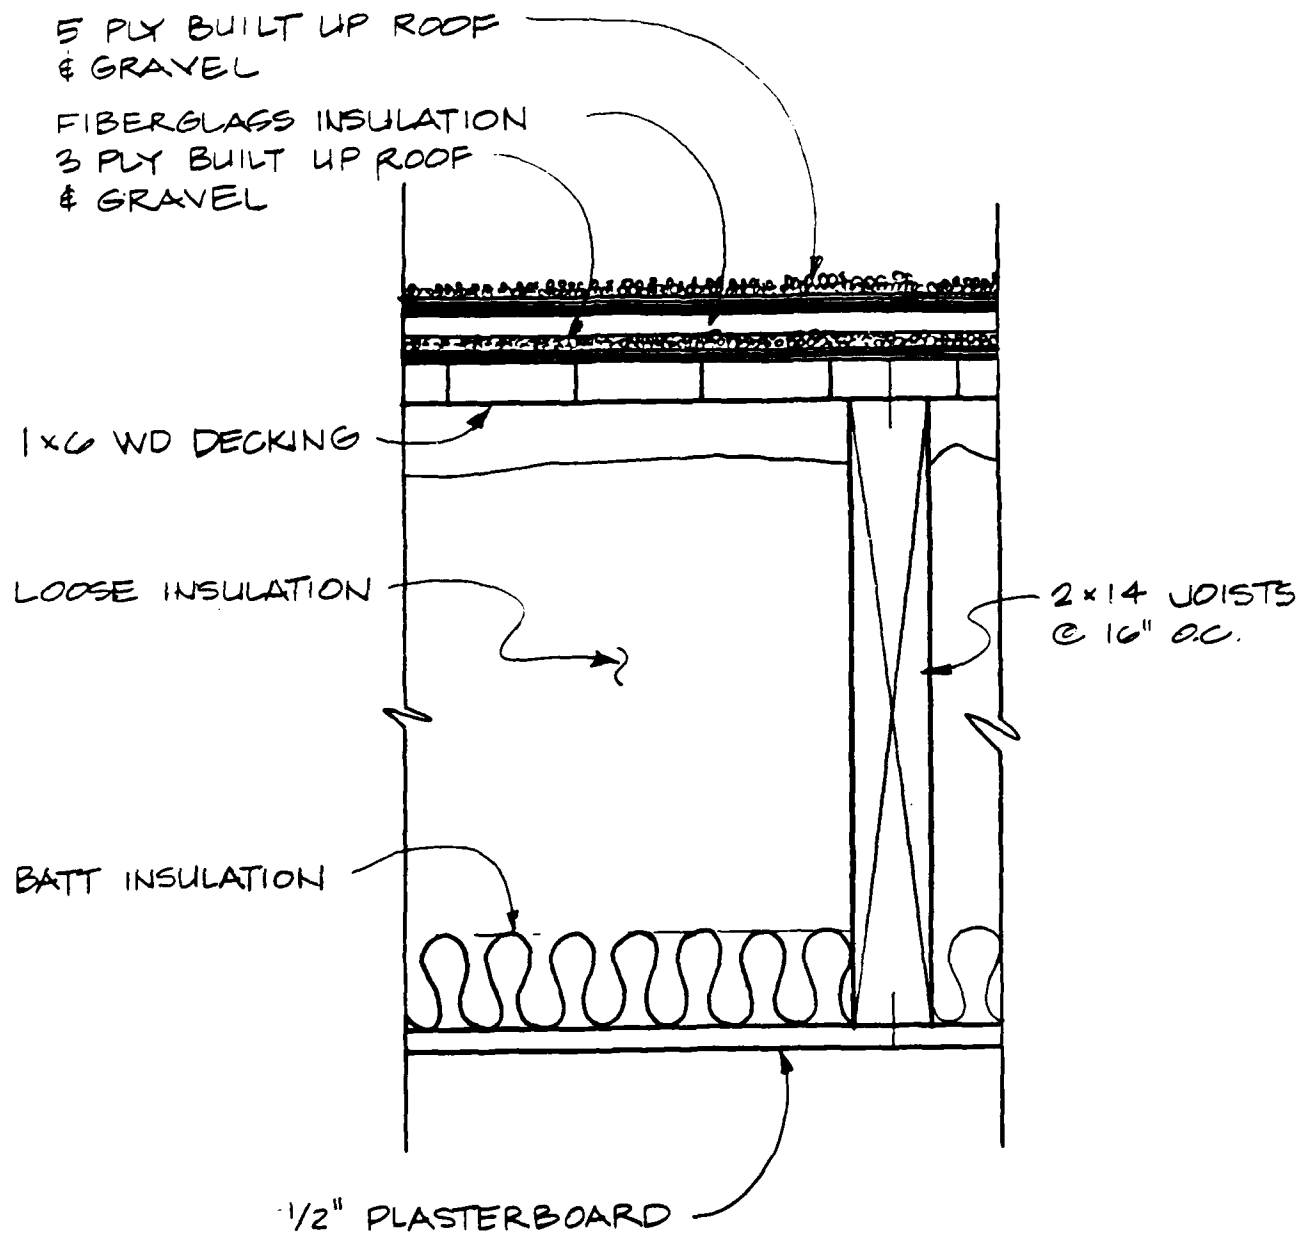
During another site visit, roof samples were taken in order to determine the number of roof membranes in place. Figures 26 through 31 show the exposed layers of the roof membranes. Two separate roofing systems were discovered. The uppermost system consists of gravel, 5-ply roofing, and approximately 3/4 in. fiberglass insulation. The original roofing system is constructed of gravel and 3-ply roofing. At this time, significant ponding was also observed on the roof (Figures 32 and 33). The metal flashing and gravel stop at the edge of the roof form a barrier about 3/4 in. to 1 in. higher than the roof surface. Consequently, the metal flashing and gravel stop contribute to the ponding problem by allowing an additional layer of water to accumulate on the roof.

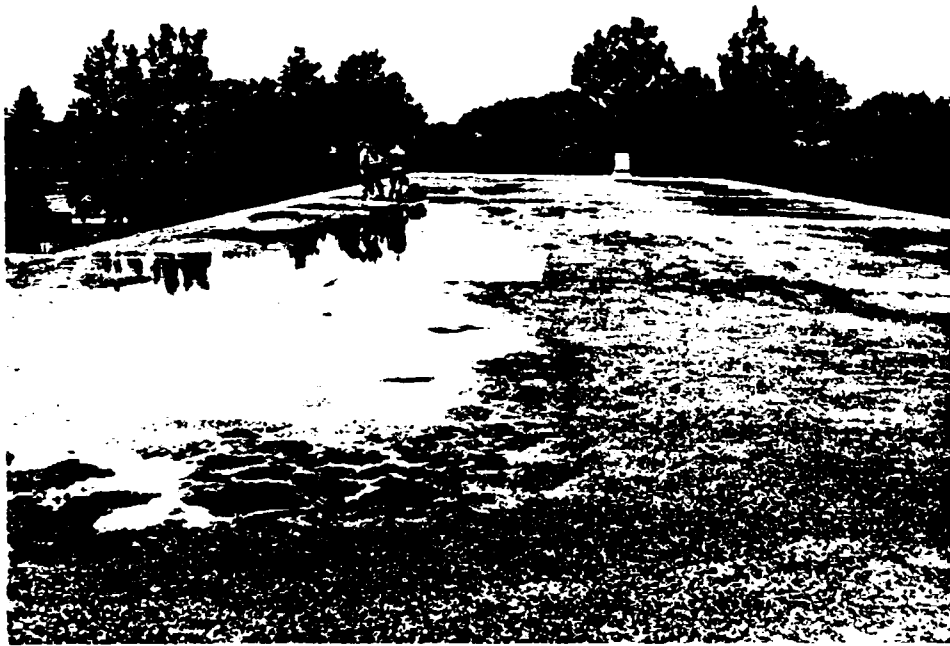
Figure 32. Poned water on south side of west wing.

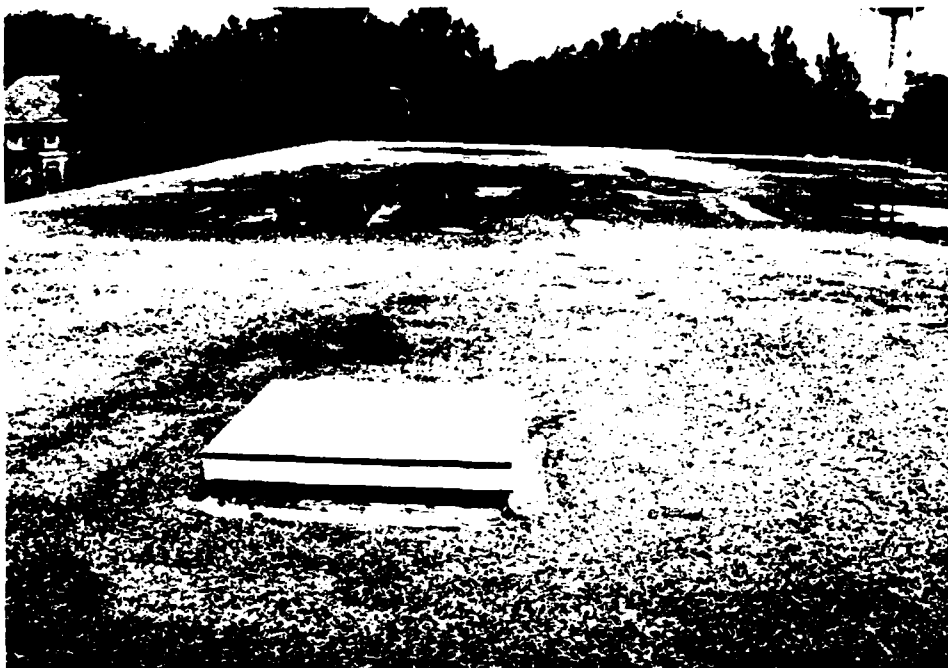
Figure 33. Poned water on west side of north wing.

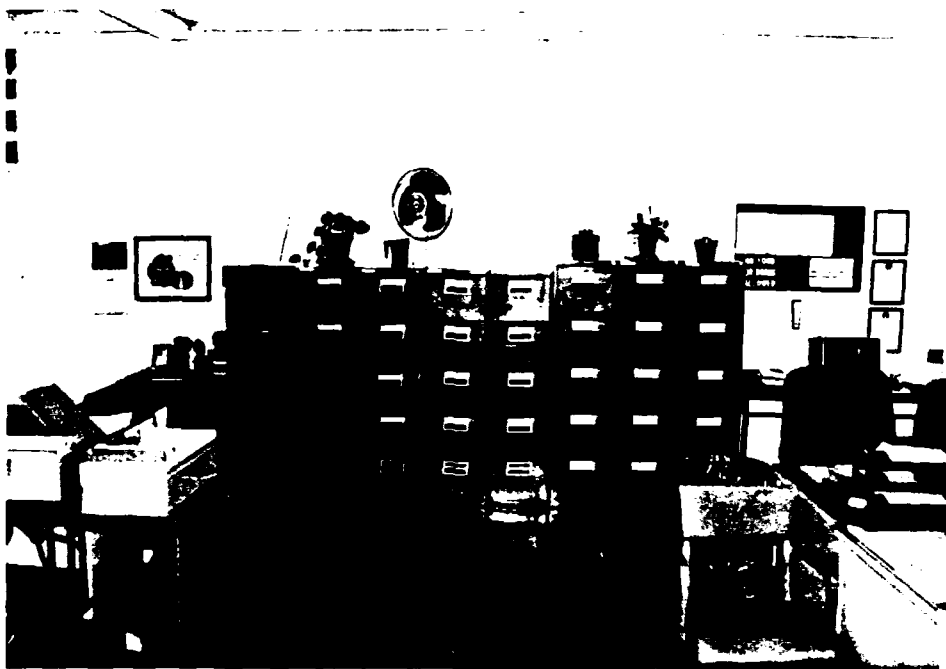
Stained floors were observed in several second-story west wing offices. These stains suggest that file cabinets or other furniture had been in place for a prolonged period. In particular, stains were observed adjacent to the east wall of Room 219 where occupants reported that, in February 1987, the cabinets along this wall had been moved to the west wall (Figure 41). Eight five-drawer file cabinets are now aligned along the west wall and centered about its width (Figure 42).

example, in Room 219, there are eight five-drawer file cabinets along the west wall of the room. Until February 1987, these file cabinets had been located along the east wall of the room, next to the storage closet. Directly below the east wall of Room 219, in Rooms 114 and 115, there is a crack across the ceiling parallel to the direction of the floor joists. It is believed that overloading due to the weight of the file cabinets along the east wall of Room 219 is in part responsible for the ceiling crack in Rooms 114 and 115. A similar problem does not appear with the file cabinets along the west wall of Room 219 because there is a 2 in. by 4 in. load bearing partition wall directly under this wall which provides considerable support for this area.

Figure 42. Filing cabinets along west wall of Room 219.

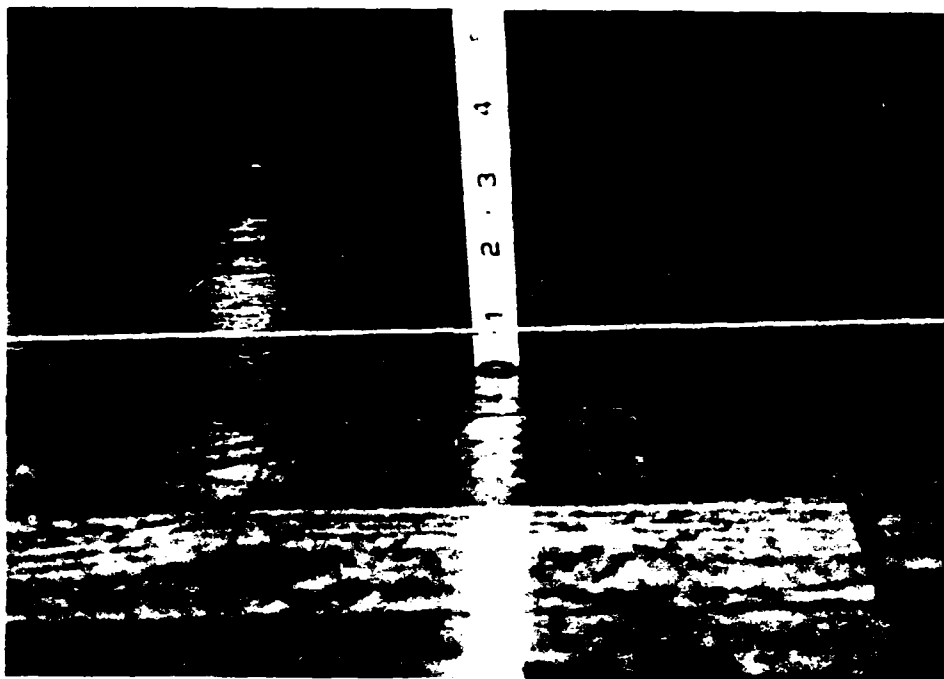
In Rooms 209 and 210, there are two major humps in the floor that coincide with the load bearing walls of the women's restroom on the south side of the first floor. The maximum deflection between the two humps is about 5/8 in. The exact cause for such a large deflection is unknown. Perhaps this area of the room was heavily overloaded with file cabinets or file drawers in the past. If so, the floor joists would transfer a major portion of the load to the header beam over the 11 ft wide first-floor window. If the overload had remained in place for an extended period, creep may have occurred in both the header beam and the floor joists which would have resulted in permanent deflection when the load was removed.

Figure 43. Deflection of floor in Room 210 between women's restroom walls below.

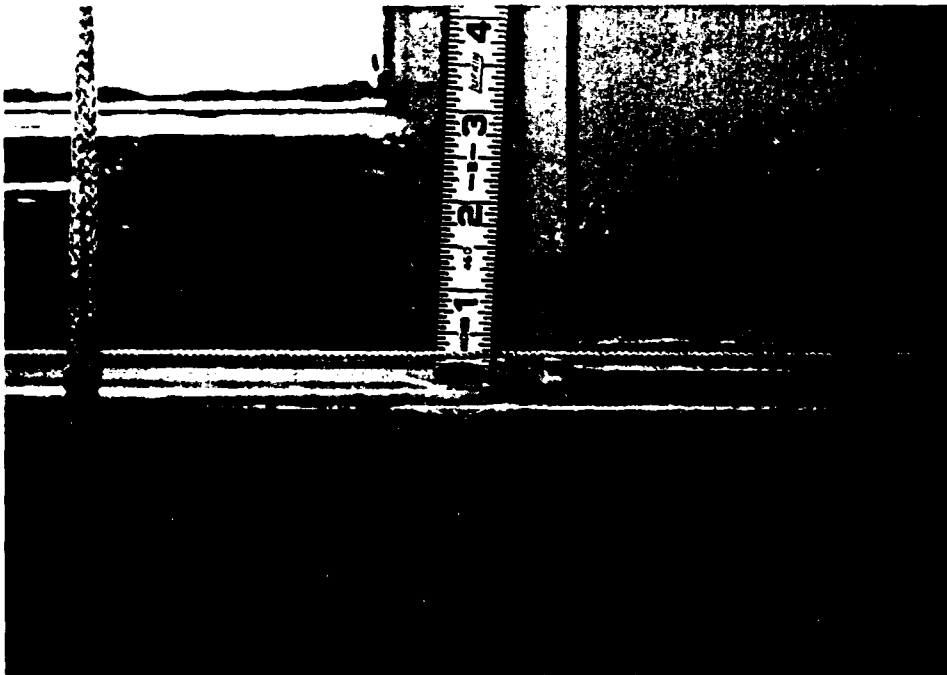
ii. Rooms 212 and 213, deflections were measured at the top and bottom of the three-section window units in the southeast corner of the room. Deflections of about 0.25 in. were observed at the top and bottom of the window trim and sill (Figure 45).

The original drawings indicate that the header beam above the second-story three-section window units consist of three 2 in. by 10 in. members with a span of about 11 ft 3 in. The header beams carry the roof loads. The structural analysis of the header beam revealed that the current dead loads will produce a deflection of nearly 0.30 in. which corresponds reasonably well with the 0.25-in. deflection observed at the top and bottom of the southeast window in Rooms 212 and 213. Moreover, when ponding was considered in the structural analysis, the combined dead and live load stresses in the header beam exceeded the allowable stress by about 52 percent.

The added dead load from the second roof system, ponding, and creep are thought to be the reasons for the sagging observed at the second-story three-section window units.

Figure 45. Deflection of window sill in Room 212.

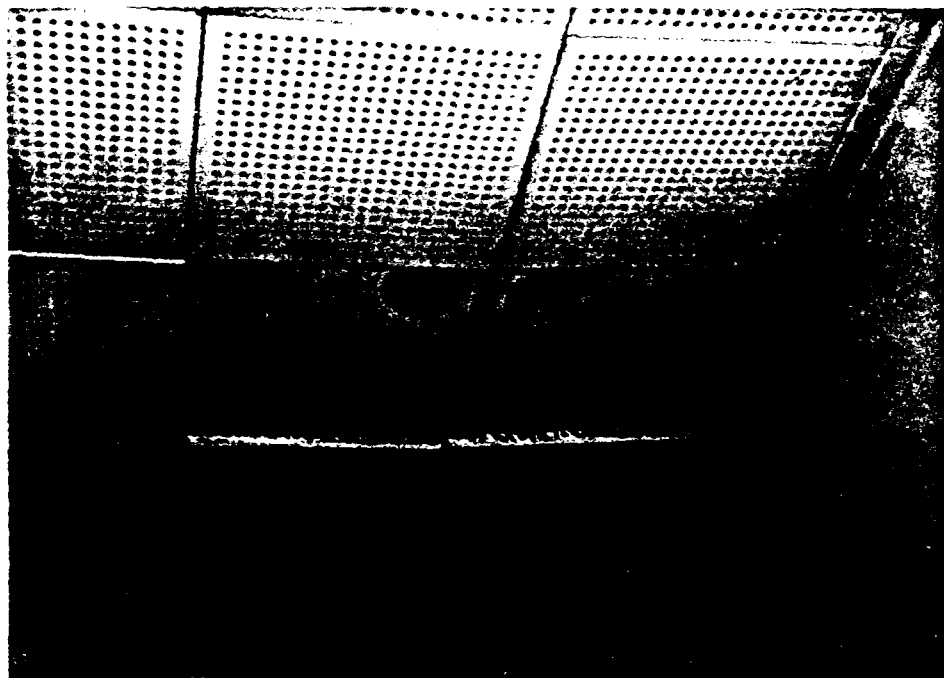
On the first floor, evidence of heavy second-floor loading was observed in specific areas. Deflection of the ceiling tiles in Room 104 indicates that a significant crack in the plasterboard extends from the south side of the room to the north approximately 1 ft east of the partition wall. Several ceiling tiles had fallen recently, exposing the crack (Figure 46). Room occupants stated that when the stamping machine directly above in Room 210 is in use, the ceilings of Rooms 104 and 105 experience significant vibrations. Overload and vibration due to the stamping machine appear to have caused this crack.

Figure 46. Ceiling crack in Room 104.

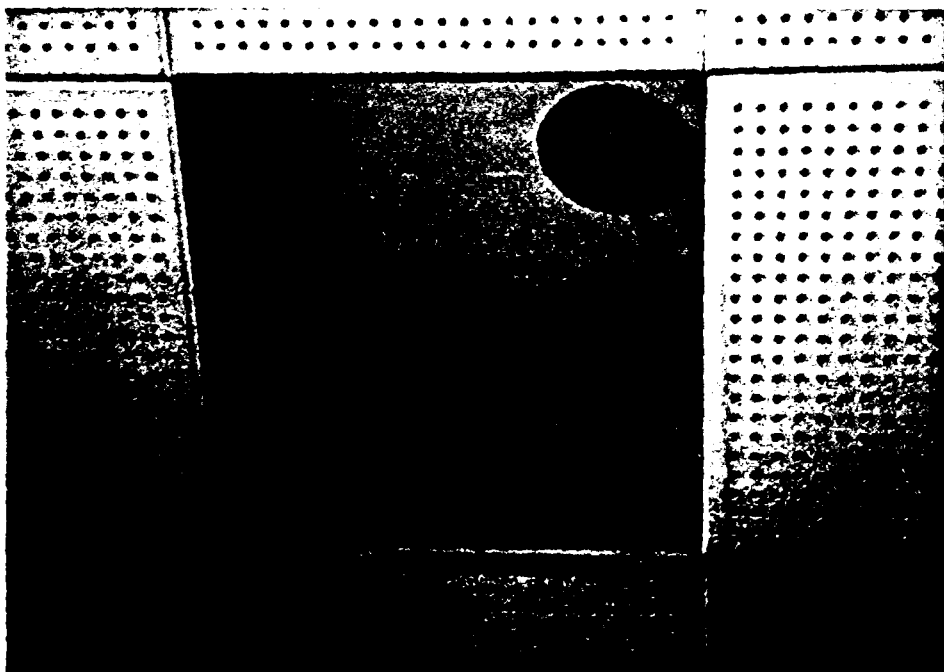
No crack in the ceiling plaster was observed in the hall but another crack extended from the south side of Room 114 to the north. This crack is located under the east wall of Room 219 above. Here, ceiling tiles are also deflecting and separating from the plasterboard (Figure 47). When a few tiles were removed from one area to investigate the structural condition, several tiles fell in other areas along the length of the crack. It appears that the file cabinets that had been located above in Room 219 prior to February had overloaded the floor and caused the crack.

Figure 47. Ceiling crack in Room 114.

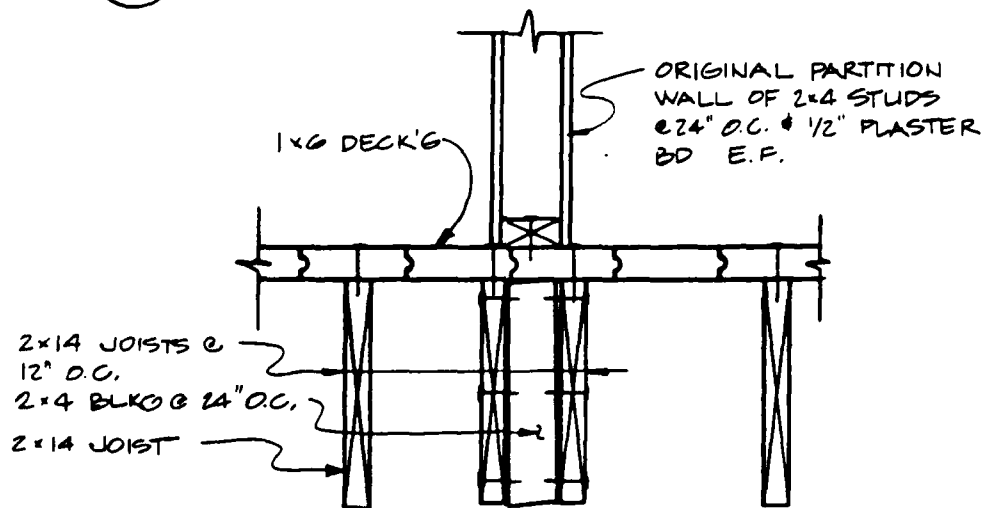
A PARTITION WALL @ RM. 114 DETAIL

The structural detail for support of the original partition wall on the east end of Room 219 also was observed from Room 114. As stated in the specifications, a joist has been installed under the partition and blocking is provided at 24 in. on-center between the typical floor joist and the added joist. Here, the blocking is not snug between the

typical floor joist and the added joist. Gaps of 1/8 in. on one side and 1/16 in. on the other side are evident at the top of the blocking. At the bottom of the blocking, there are gaps of 3/16 in. and 1/16 in. on the two sides. The blocking has dropped about 3/8 in. below the joists. Figures 48 (detail A) and 49 show this condition.

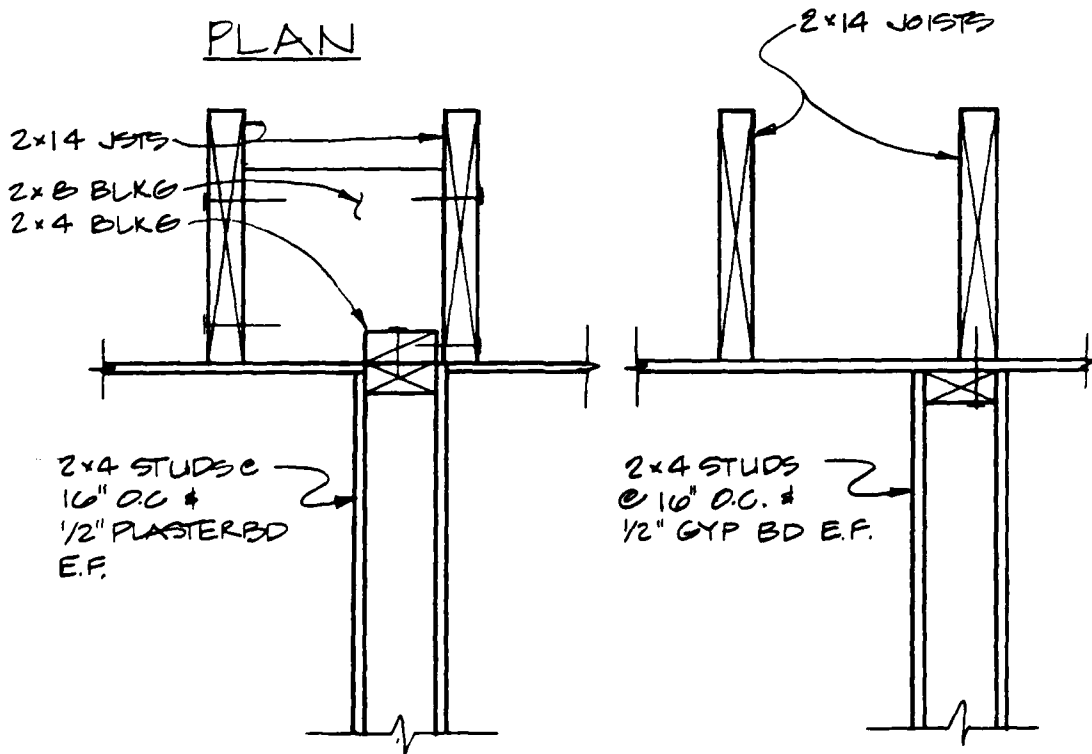
Connections at the top of both new and original partition walls were also investigated. In Figure 50, detail A shows this condition for the original walls and detail B shows it for new partition walls.
