USAFOEHL REPORT

CONTAMINATION OF THE EXTERIOR OF A C-130E AIRCRAFT USED FOR AERIAL SPRAY, 907 TAG, RICKENBACKER ANGB OH

THOMAS H. LILLIE, Major, USAF, BSC

September 1988

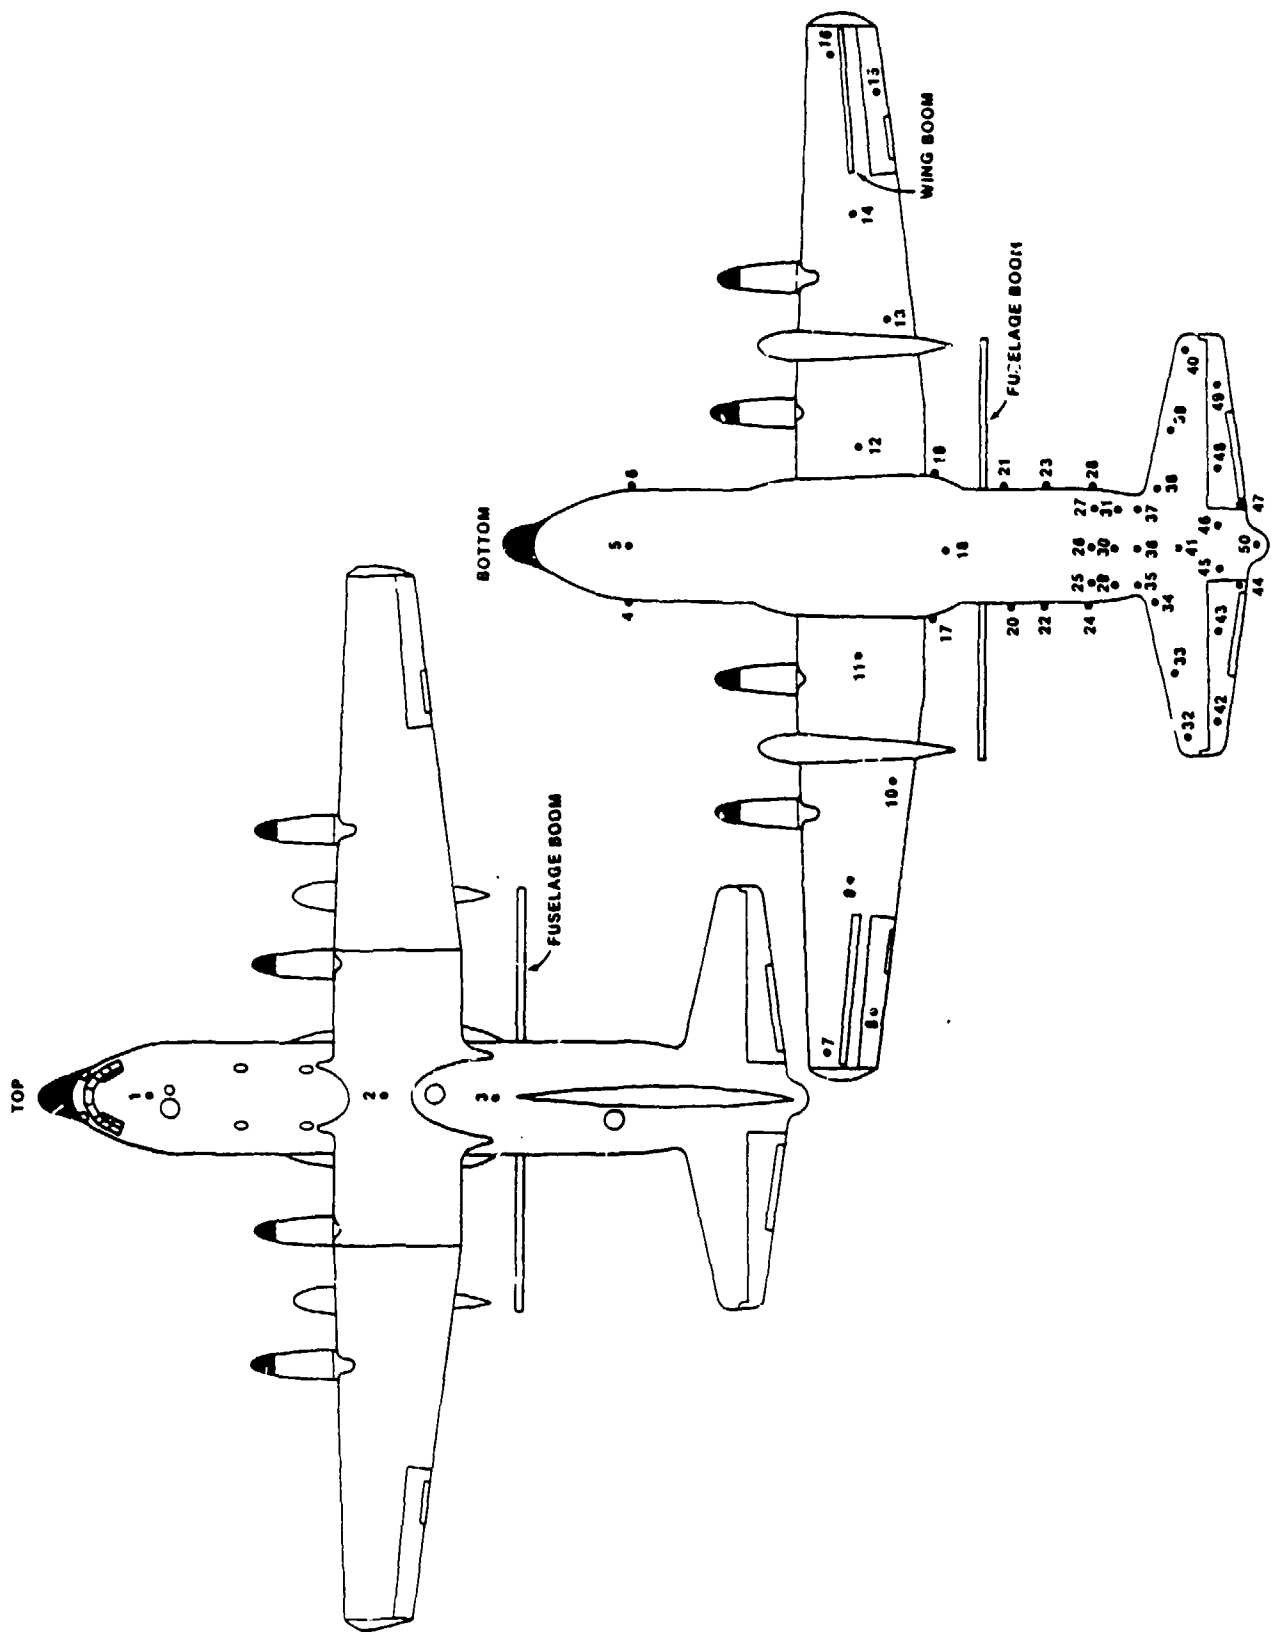
Figure 1. Location of monitoring cards on exterior of C-130E aircraft during evaluation of Modular Aerial Spray System.

All paper index cards were negative after the preliminary flight test. However, background contamination occurred at locations 10, 11, 12, and 13 (Fig 1) when oil sensitive cards were used. The oil came from the aircraft engines, but it did not interfere with the evaluation because the drops were large and thus distinguishable from spray droplets. Also, negative results at the same locations during definitive tests when paper index cards were used to detect red dye, applied through the wing booms, indicates that material from the spray system did not contaminate the underside of the wings near the engines.

Light contamination of the aileron (cards 8 and 15, Fig 1) occurred when wing booms were used to apply soybean oil and water. The same locations were negative when Dibrom and Malathion were applied at lower rates with smaller droplets, however, one card (3, Fig 1) on top of the aircraft near the tail received light contamination during the third flight involving Malathion (Table 1). The aircraft most likely flew through a cloud of spray which was kept suspended by a temperature inversion. All other cards were negative on the horizontal stabilizer (Fig 2B), cargo door, wings, and fuselage when the wings booms were used. An additional piece of oil sensitive card taped to the back of a nozzle was positive after Dibrom application. The chemical moved up a low pressure area on the back of the nozzle, but did not contaminate the wing above the spray boom. This does not pose a problem because nozzles must be replaced for various other reasons after prolonged use.

B. Only one oil sensitive card was positive on the C-130 after applications of Dibrom and Malathion. The card (3, Fig 1) was on top of the aircraft where the tail joins the fuselage. This occurred when Malathion was applied during a temperature inversion; the plane most likely flew through the spray after application.

A. The spray booms and area of the wings above and behind the booms (particularly the aileron) should be washed with soap, water, and a scrub brush within 24 hours after each flight involving application of corrosive material.

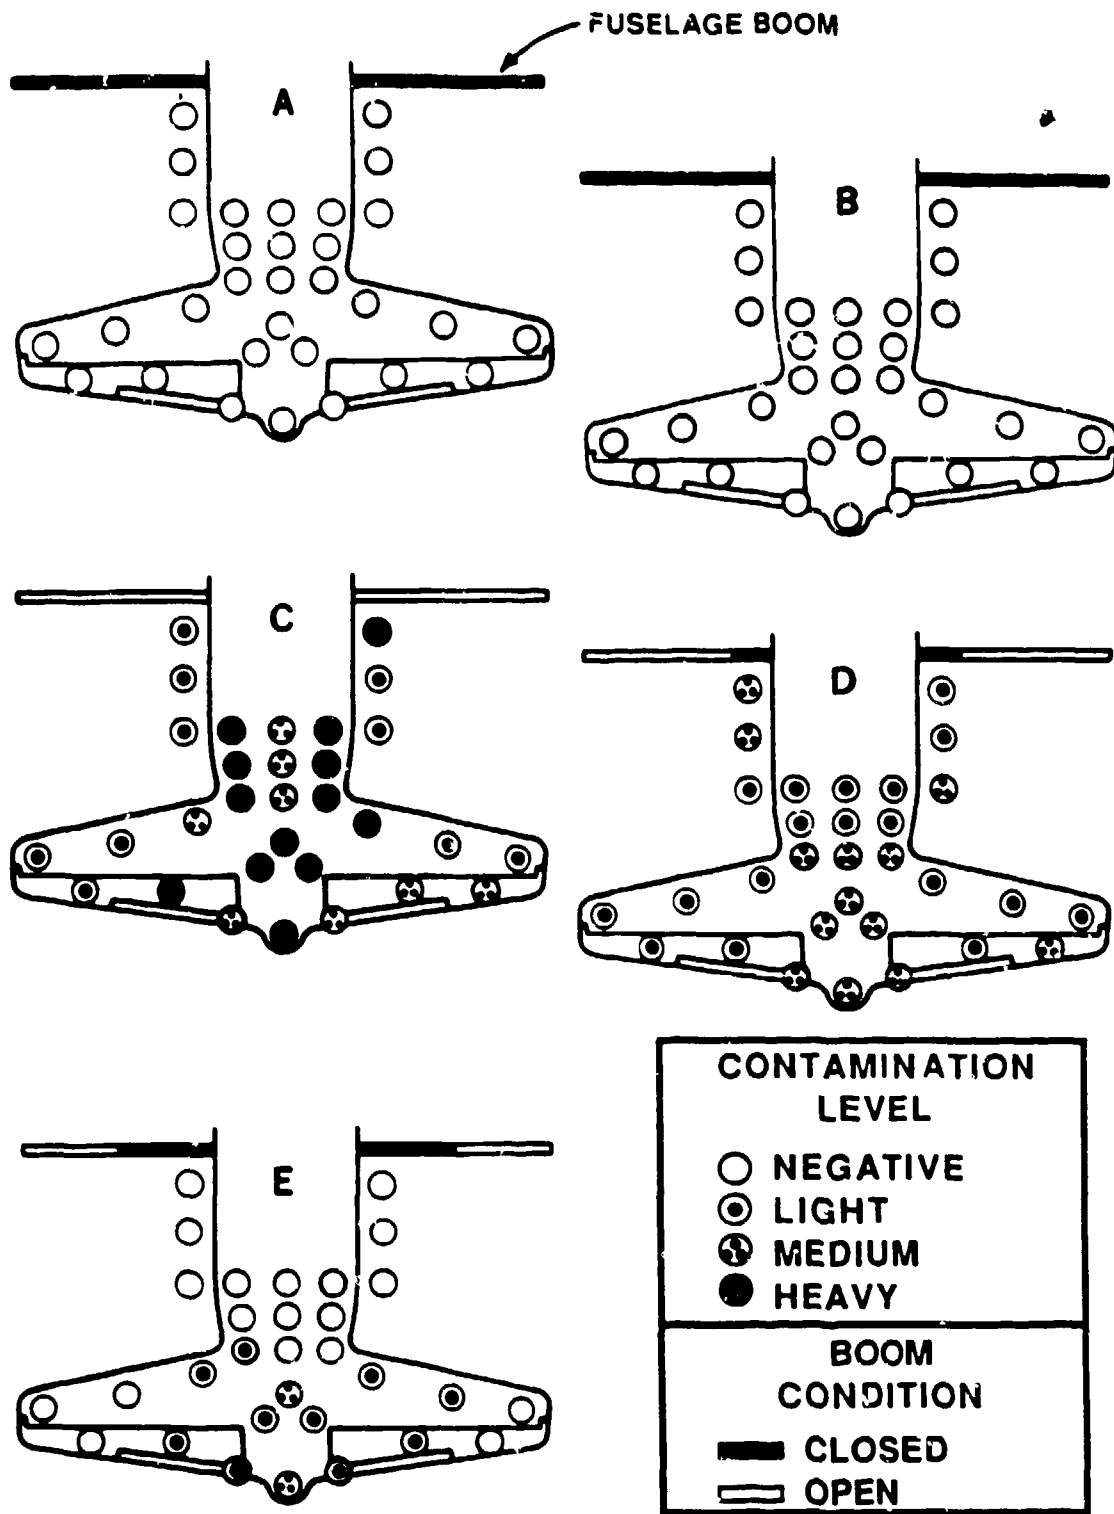
The cargo door and horizontal stabilizer (Fig 2C) were heavily contaminated with red dye when the fuselage booms were used. Deposition of material during flight was not apparent when viewed from the ground or video films taken by a chase plane, but cards near the outer edges of the cargo door and rear fuselage were saturated with red dye. Contamination was so heavy that red dye could easily be seen on the aircraft. Some of the dye flowed up the rear of the fuselage and onto the top of the horizontal stabilizer. Spray nozzles closest to the fuselage were the most likely source of the material because the amount of contamination decreased after 10 nozzles were closed on each boom (Fig 2D) and a further decrease in contamination was observed when 24 nozzles were closed on each boom (Fig 2E).

Application of corrosive material such as Dibrom(5) through the fuselage booms could affect the structural integrity of the aircraft. Decontamination will be difficult if not impossible if such materials penetrate the infrastructure through seams around the cargo door. Contamination can be reduced by closing nozzles near the fuselage, but the spray deposition pattern may be affected and more flights may be required to obtain the necessary application rate.

Figure 2. Contamination of the rear of a C-130E aircraft after: A. Spray system not used; B. Wing booms used; C. Fuselage booms used with 114 nozzles opened; D. Fuselage booms used with 94 nozzles opened; E. Fuselage booms used with 66 nozzles opened (view of underside of aircraft).

E. The underside of the horizontal stabilizer and cargo door, and the side of the fuselage were heavily contaminated with red dye when all nozzles were opened on the fuselage booms (Fig 2). The amount of red dye deposited on each card decreased when nozzles closest to the fuselage were closed; however, spray deposition may have been affected. A compromise must be made if fuselage booms are used. Aircraft contamination can be reduced by closing nozzles, but additional flying may be needed to obtain complete coverage with spray material.

Removal of residue of most chemicals from the aircraft can be accomplished by washing surfaces with soap, water, and a scrub brush. This should be done around the wing booms, particularly the aileron, and behind the fuselage booms, particularly the cargo door and underside of the horizontal stabilizer. Maintenance personnel should wear coveralls, gloves, and a face shield to avoid contact with toxic chemicals when performing the task. The USEPA does not consider the washwater a hazardous waste under the Resource Conservation and Recovery Act; therefore, collection and disposal procedures are not required(3) unless the state where aerial spray is being performed has more stringent requirements.

B. The fuselage booms should not be used to apply corrosive materials because the underside of the cargo door and horizontal stabilizer will be contaminated.

C. The underside of the cargo door and horizontal stabilizer should be washed with soap, water, and a scrub brush after any type of pesticide is applied through the fuselage booms.

D. Contamination of the underside of the cargo door and horizontal stabilizer can be significantly reduced by closing nozzles closest to the fuselage whenever the fuselage booms are used.
