TECHNICAL REPORT CERC-88-16

# SIDE-SCAN SONAR APPLICATIONS FOR EVALUATING COASTAL STRUCTURES

James E. Clausner, Joan Pope

November 1988

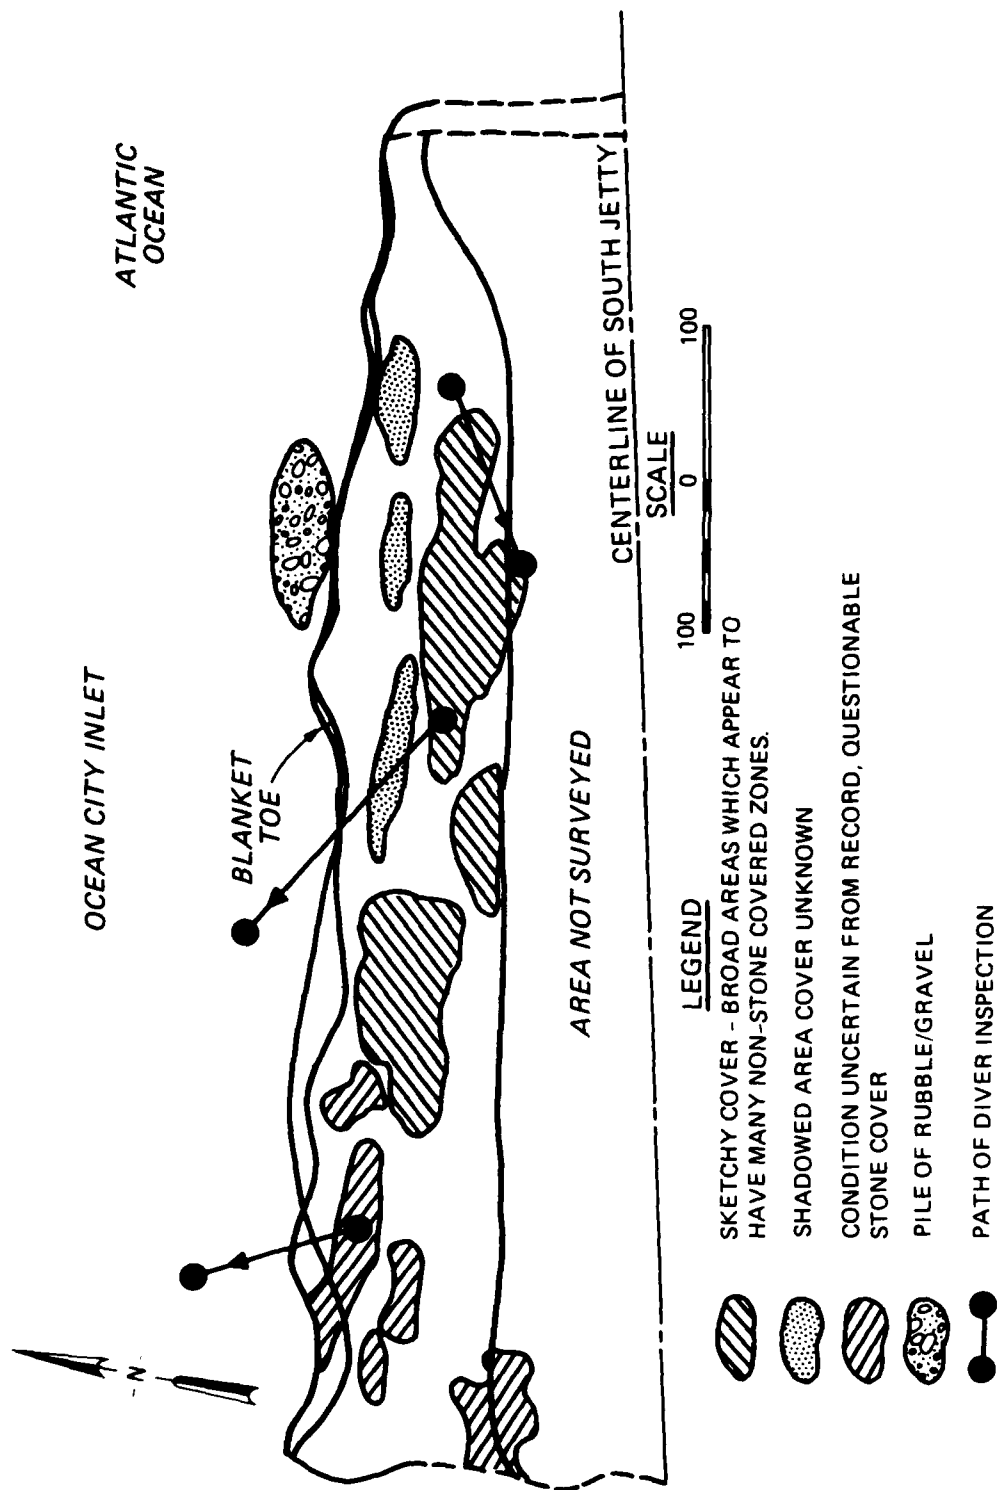
Figure 17. Map of stone blanket coverage produced from composite of several individual side-scan sonar records

then composited to create a map showing cover over the specified stone blanket area (Figure 17). Divers verified the results shown on the side-scan sonar images by traversing along the three tracklines shown in the figure. Some of the areas identified as sketchy cover were determined to be areas with adequate stone cover but where drifting sand had covered the stone.
