TECHNICAL REPORT REMR-CO-3

CASE HISTORIES OF CORPS BREAKWATER  
AND JETTY STRUCTURES

Report 6

NORTH PACIFIC DIVISION

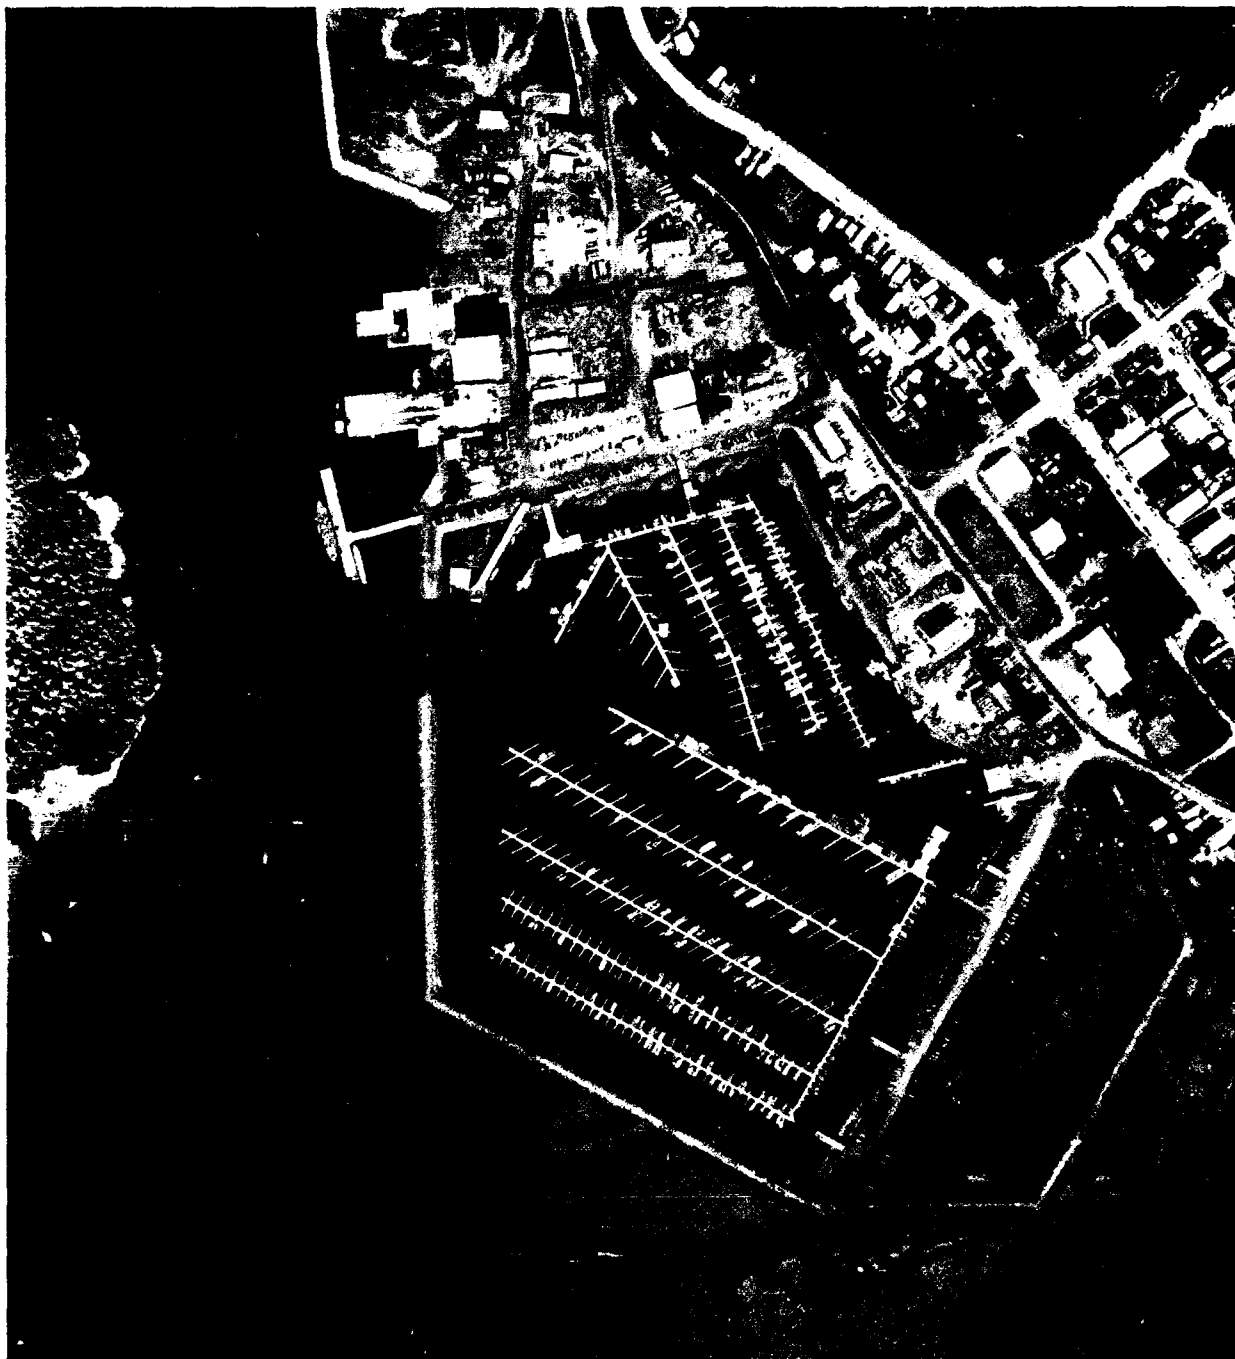
Figure 6. Aerial photograph of Cordova Harbor, Alaska, 1984

| <u>Date(s)</u> | <u>Construction and Rehabilitation History</u> |
|---|---|
| 1985 | The harbor is illustrated in Figure 5, and an aerial photograph of the harbor is presented in Figure 6. The breakwaters appear in good condition at this time. |

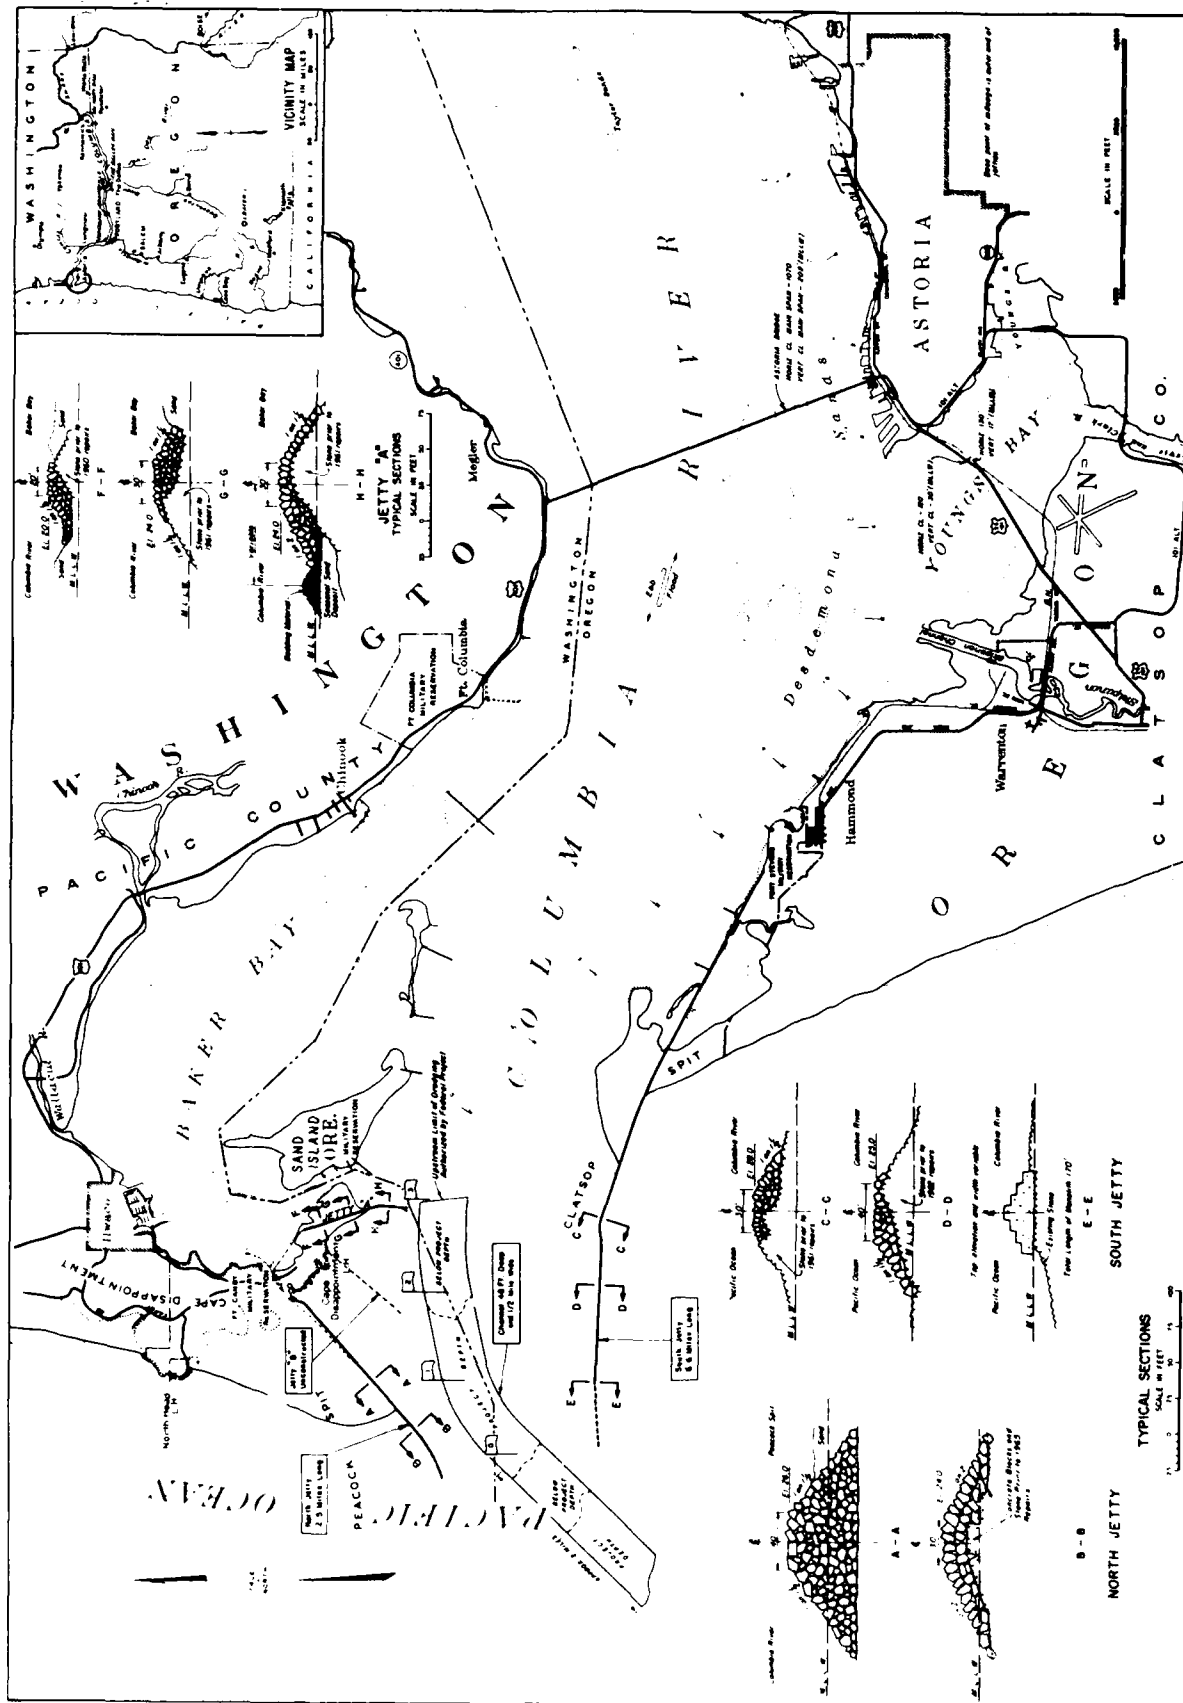
Figure 53. Site layout of Columbia River at Mouth, Oregon and Washington (revised 1979)

| Date(s) | Construction and Rehabilitation History |
|---|---|
| 1985 | The harbor and cross sections of the jetties are illustrated in Figure 53. The north jetty and training jetty "A" have scour problems at the heads. The south jetty is in need of repair. |

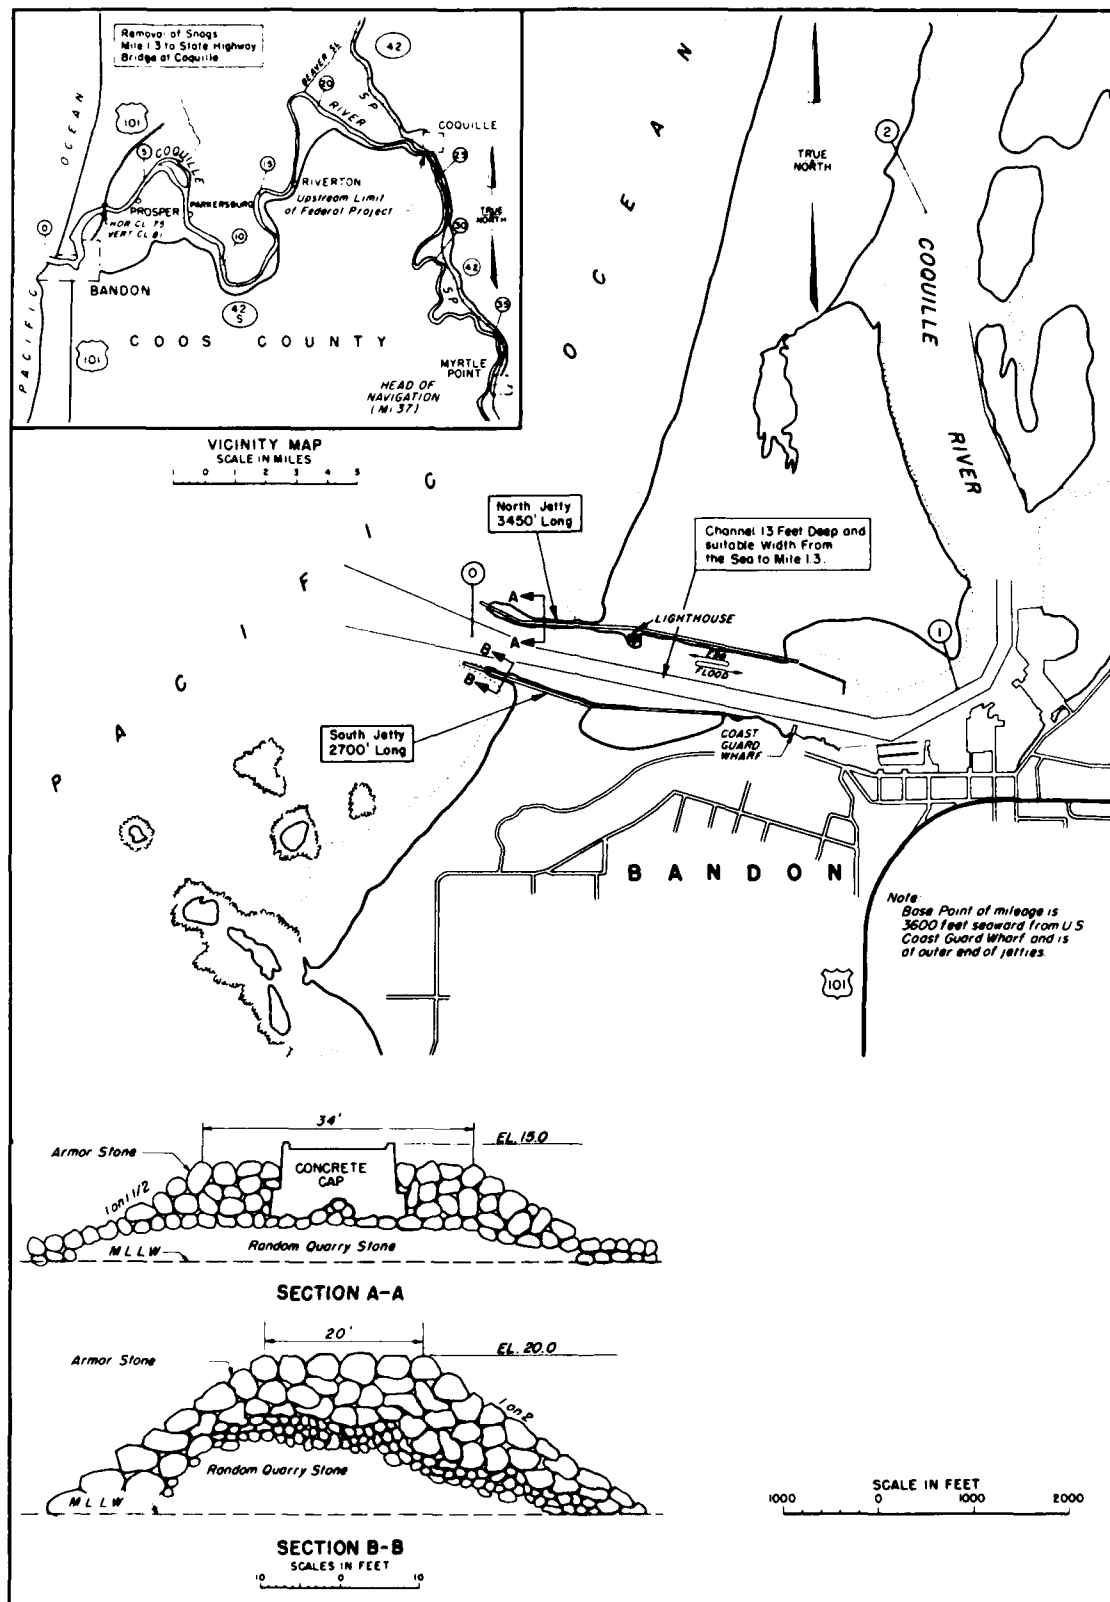
Figure 55. Site layout of Coquille River, Oregon (revised 1981)

| Date(s) | Construction and Rehabilitation History |
|---|---|
| 1985 | The harbor and cross sections of the jetties are illustrated in Figure 55. The head of the north jetty is in need of repair, but it is still functional. The south jetty is in good condition. |

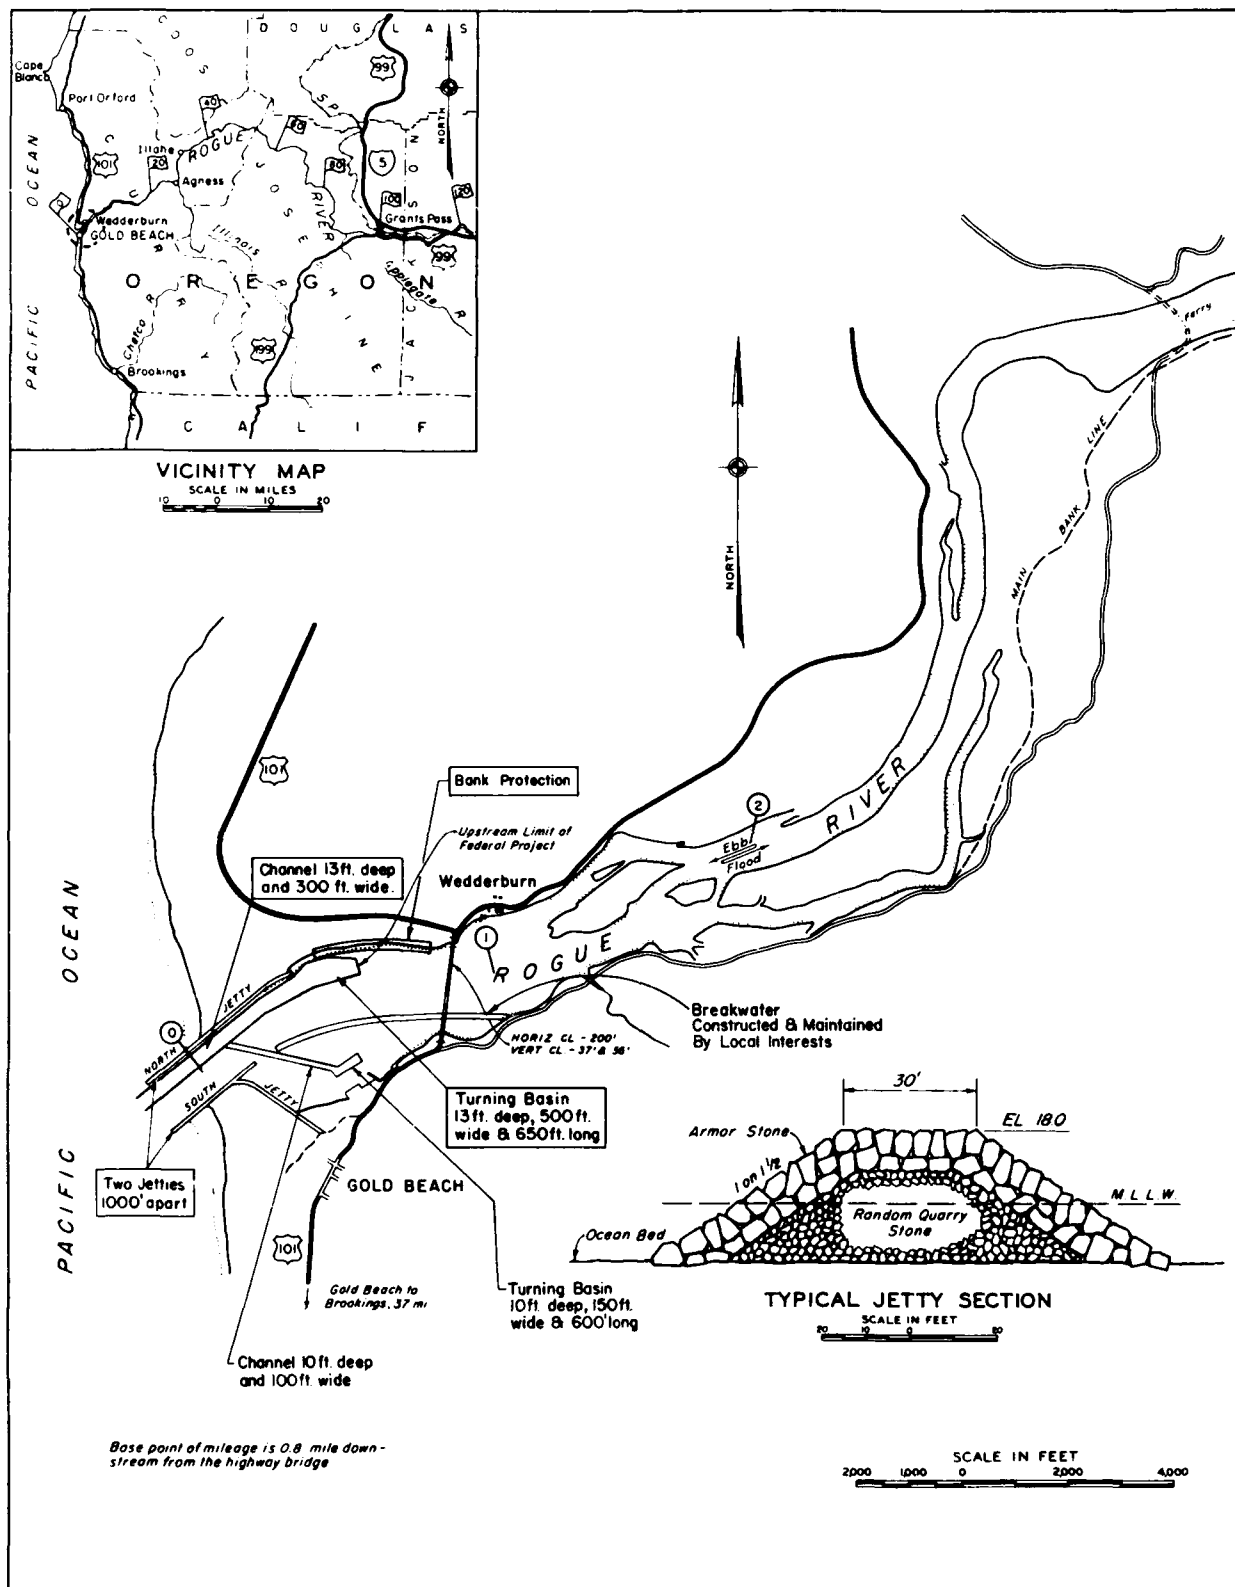
Figure 59. Site layout at Rogue River, Oregon (revised 1977)

| <u>Date(s)</u> | <u>Construction and Rehabilitation History</u> |
|---|---|
| 1985 | The harbor and cross section of the jetties are illustrated in Figure 59. There is some localized damage on the jetties. |

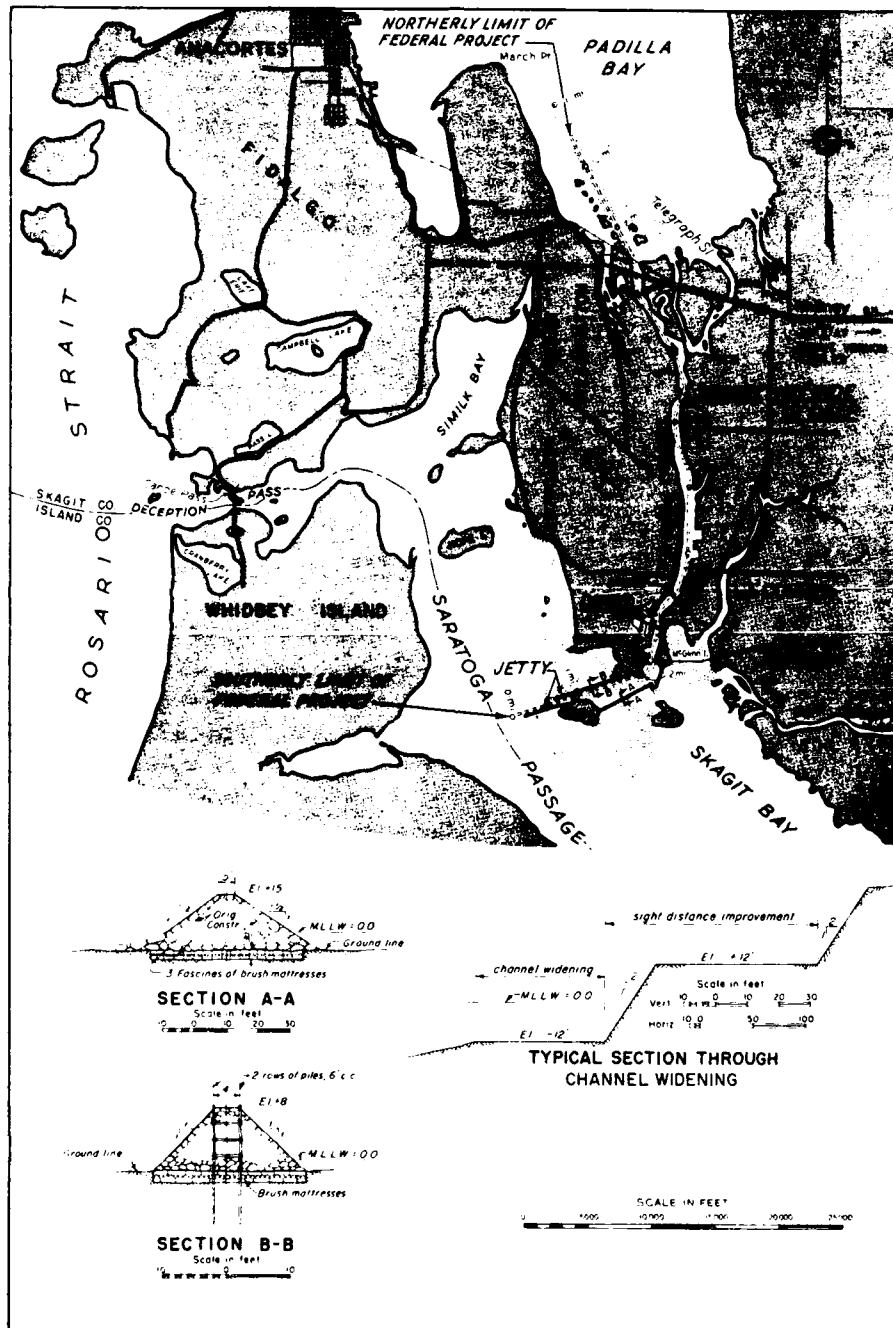
Figure 79. Site layout of Swinomish Channel, Washington (revised 1979)

| Date(s) | Construction and Rehabilitation History |
|---|---|
| 1985 | The jetty layout and cross sections of the jetties are illustrated in Figure 79. The north jetty shows obvious deterioration, and the south jetty and Goat-McGlinn Island jetty appear in good condition. |
