TECHNICAL REPORT REMR-CO-2

PROTOTYPE EXPERIENCE WITH THE USE
OF DISSIMILAR ARMOR FOR REPAIR AND
REHABILITATION OF RUBBLE-MOUND
COASTAL STRUCTURES

Robert D. Carver

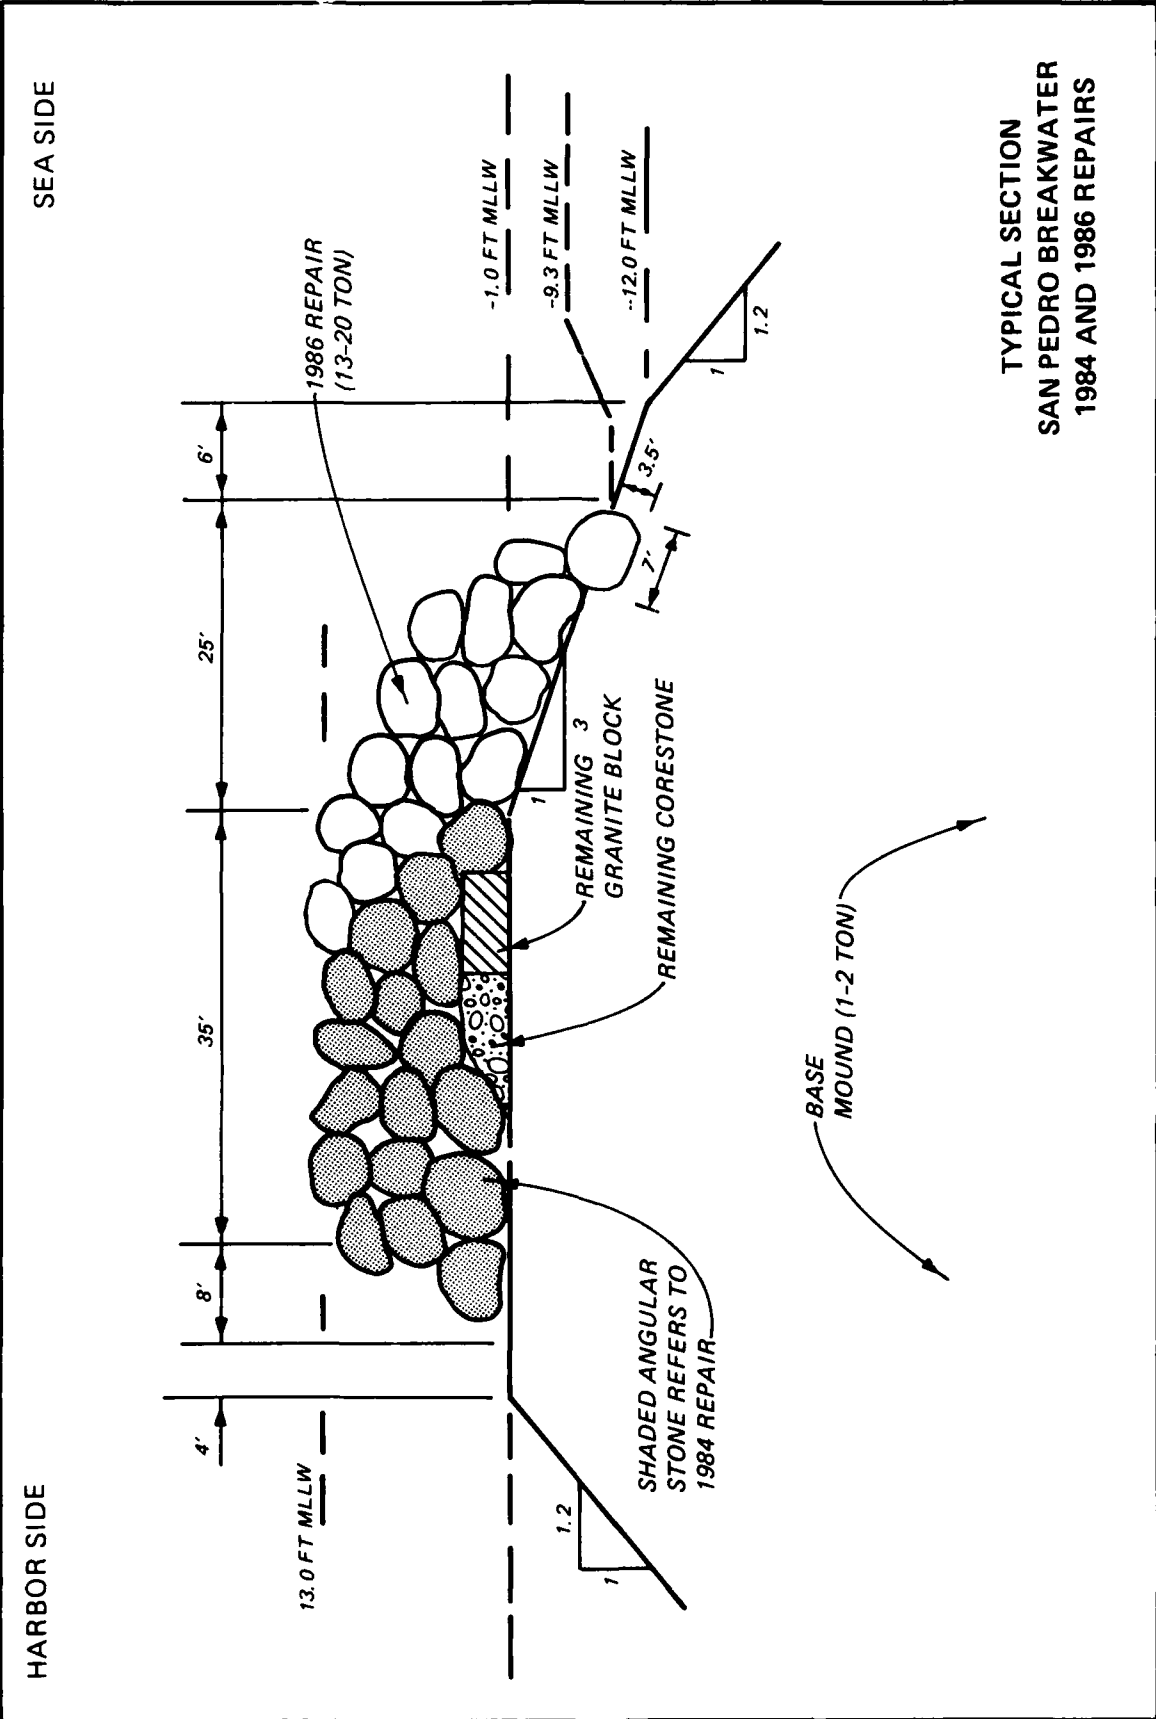
TYPICAL SECTION
 SAN PEDRO BREAKWATER
 1984 AND 1986 REPAIRS

12. San Pedro Breakwater, Los Angeles, California, is one of three separate breakwaters that provides protection for the Ports of Los Angeles and Long Beach (Plate 13). Construction of the 11,150-ft breakwater was initiated in 1899 and completed in 1912 (Plate 14). In 1917 the 392-ft *S.S. Governor* collided with the ocean side of the structure, displacing both substructure and superstructure stone along a 50-ft section. Repairs to the structure, completed in 1918, consisted of 1,000 tons of salvage stone and 200 tons of new stone. In 1941 wave-induced damage that occurred in 1939 was repaired. Although little information is available, it appears that the damage consisted of displaced dimension stones from the superstructure, and the repair work consisted of returning the dimension stones to their original positions. A storm on 21 March 1983 caused damage to the breakwater, including breaches of the superstructure at six locations as well as displacement of numerous dimension stones. The largest breach was 400 ft long, while the others varied from 20 to 80 ft. Based on results of model tests (Carver 1984), a molded concrete block repair section and a stone rubble-mound repair section that are more stable than the dimension stone section of the existing superstructure were developed. The stone rubble-mound repair option was chosen (first use of dissimilar armor on the breakwater); however, due to temporal constraints, the emergency repair section used in the large breach was considered temporary and differed significantly from the section developed in the model study. In 1984 about 12,000 tons of 7- to 20-ton capstone were placed in the major breach, and the smaller breaches were repaired using 1,600 tons of 7- to 20-ton capstone. Spot damage at numerous other locations was repaired by retrieving and replacing displaced dimension stone. Plans are being formulated to strengthen the major breach repair with additional 13- to 20-ton capstone, as shown in

Plate 15 (Baumgartner, Carver, Davidson, and Herrington 1986). Table 9 summarizes the construction and rehabilitation history of the breakwater.
