TECHNICAL REPORT REMR-CO-3

CASE HISTORIES OF CORPS BREAKWATER  
AND JETTY STRUCTURES

Report 7  
NEW ENGLAND DIVISION

January 1989

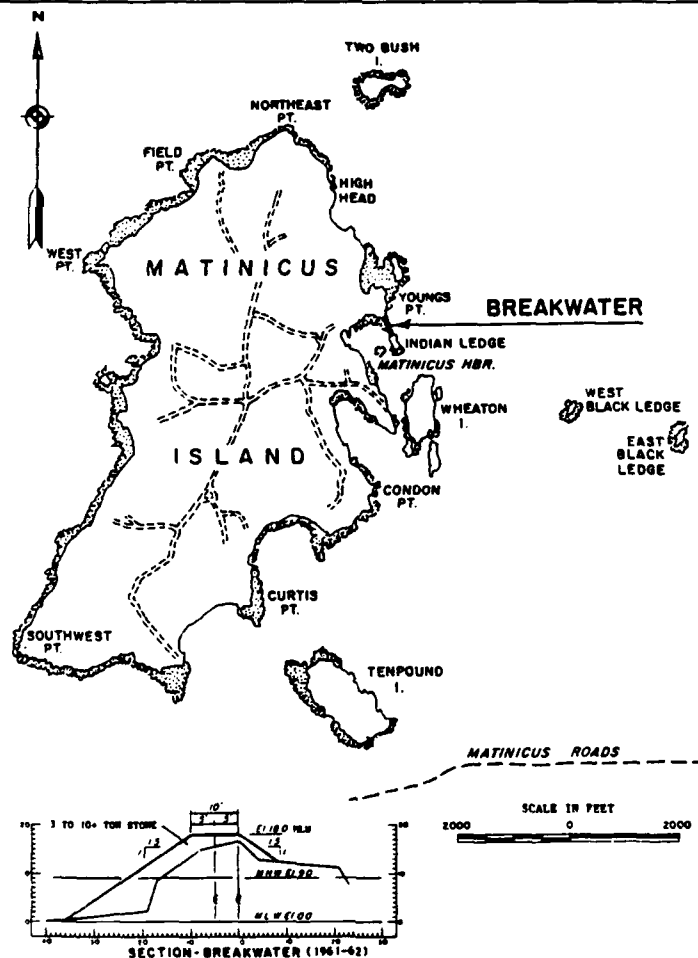
Figure 6. Location map of breakwater at  
 Matinicus Harbor, Maine

| Date(s) | Construction and Rehabilitation History |
|---|---|
| 1967-<br>1977 | Inspections indicated the breakwater was in good condition with some displacement of cover stone on its seaward face. |

| Date(s) | Construction and Rehabilitation History |
|---|---|
| 1961-<br>1962 | The breakwater was rehabilitated using 5,930 tons of stone at a cost of \$103,000. The repair geometry (Figure 6, inset) had 1V:1.5H side slopes, a 10-ft top width, and a +18 ft mlw crown elevation. Seventy-five percent of the stone by weight was a minimum of 10 tons, and the remainder was a minimum of 3 tons. The cover stones weighed a minimum of 10 tons. |

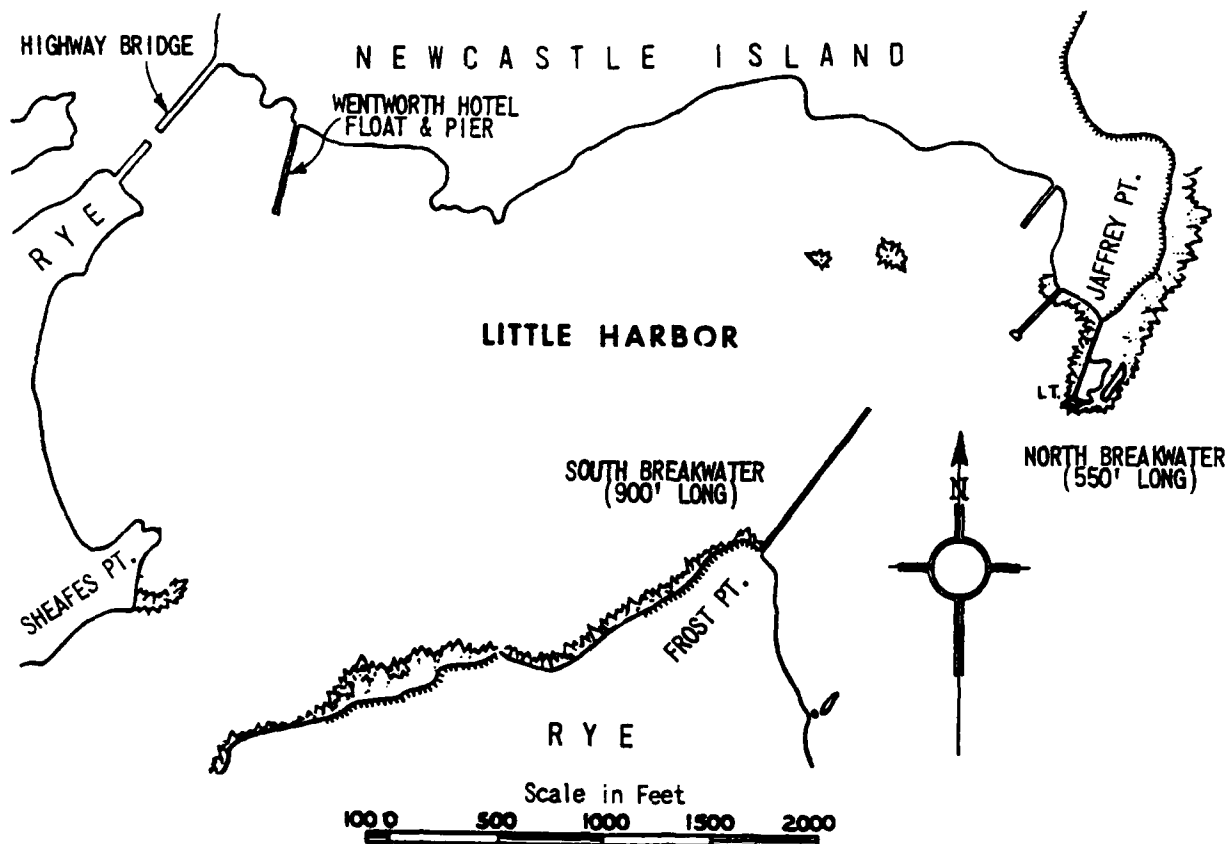
TYPICAL SECTION-NORTH BREAKWATER (1975)

| <u>Date(s)</u> | <u>Construction and Rehabilitation History</u> |
|---|---|
| 1983 | An inspection showed that the north jetty had a few small areas of displaced stone, and the south jetty had substantial damage which was subsequently repaired along the seawardmost 150 ft. |

| <u>Date(s)</u> | <u>Construction and Rehabilitation History</u> |
|---|---|
| 1975 | Seaward sections of the north and south jetties, 350 and 850 ft long, respectively, were repaired using 4 to 7-ton stone. The design cross section (Figure 16, inset) had a +12 ft mlw crown elevation, a 12- or 14-ft top width, and 1V:1.5H side slopes. The side slope on the seaward facing quadrant of the breakwater heads was 1V:2H. The cost for placing 7,800 tons of stone was \$159,500. |
