AEFA Project No. 88-06

ARTIFICIAL AND NATURAL ICING TESTS OF THE EH-60A QUICK FIX HELICOPTER

Final Report

AVIATION ENGINEERING FLIGHT ACTIVITY
Edwards Air Force Base, California 93523-5000

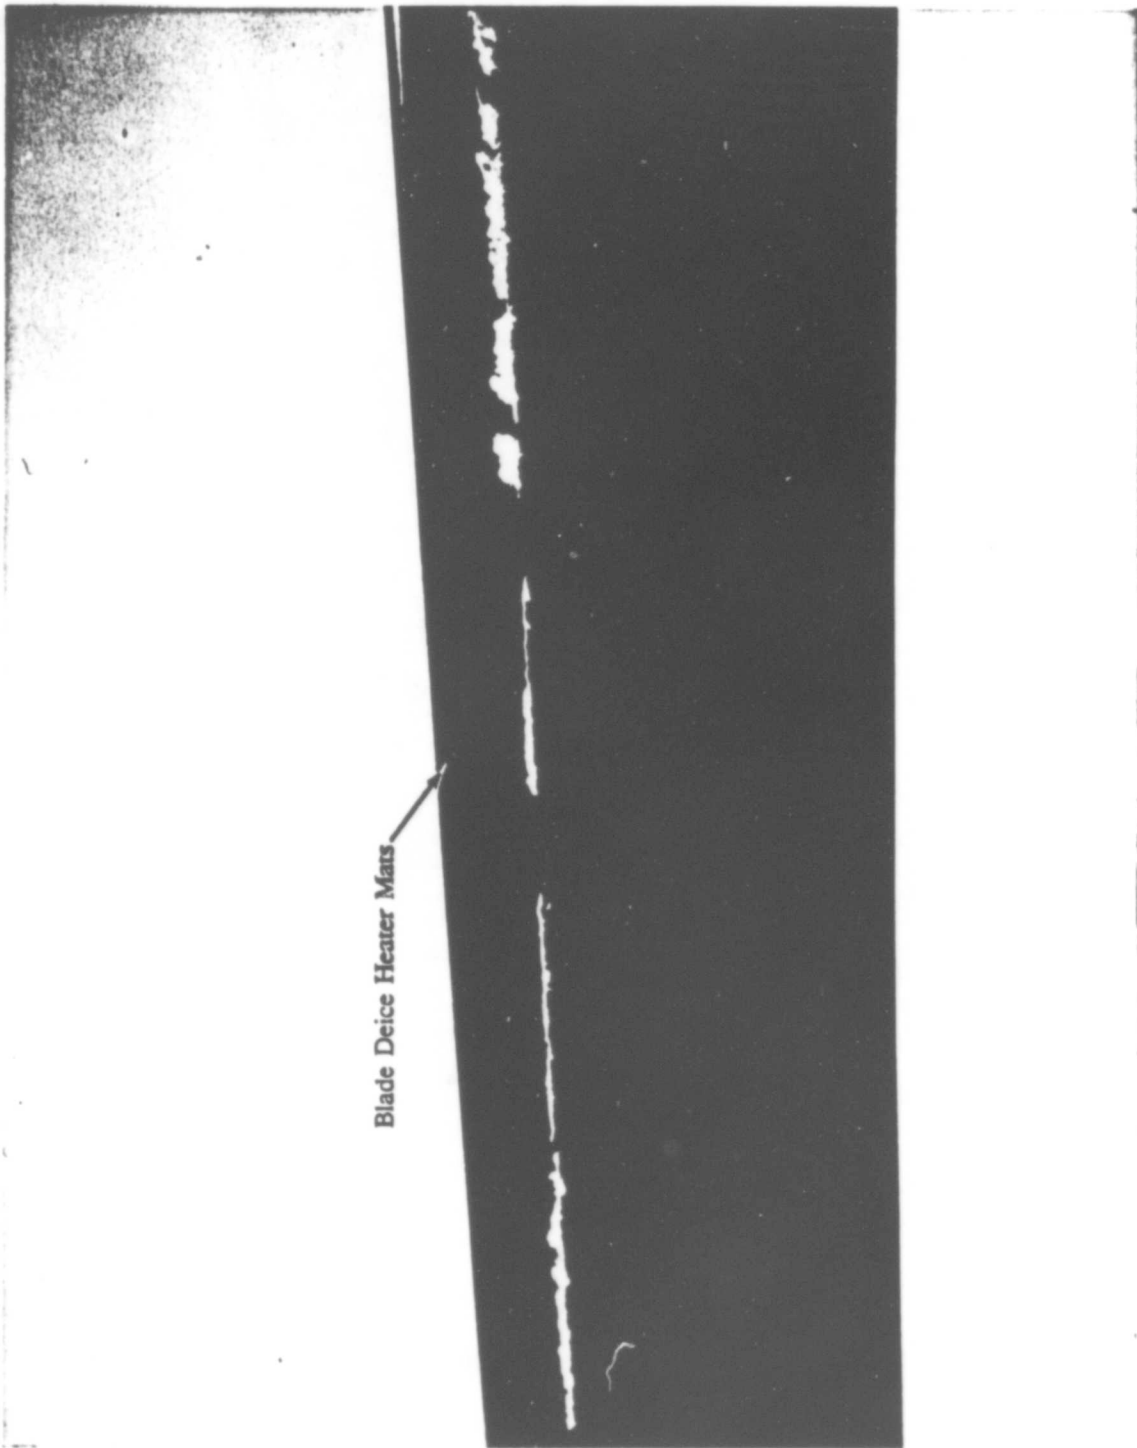
11. The ice accretion and operational characteristics of the main rotor were evaluated throughout these tests. During a natural icing flight at -13.0°C and LWC of 0.55 gm/m^3 , an increase of 27% indicated torque was observed. The cloud was entered with a 55% indicated torque and was flown collective fixed. After approximately fifteen minutes an indicated torque of 72% was attained. Following a blade deice cycle, the indicated torque dropped to 67% and began cycling between 68% to 72% correlating with the blade deice cycles. At twenty minutes the cloud was exited to visual meteorological conditions. One minute after exiting the cloud, the indicated torque returned to 58%. Post flight inspection revealed one inch fingers of ice protruding forward from the trailing edge of

Figure H-1. Main Rotor Blade Ice Accumulation
Natural Icing - .55 gm/m³ LWC, -13°C OAT, 21 min

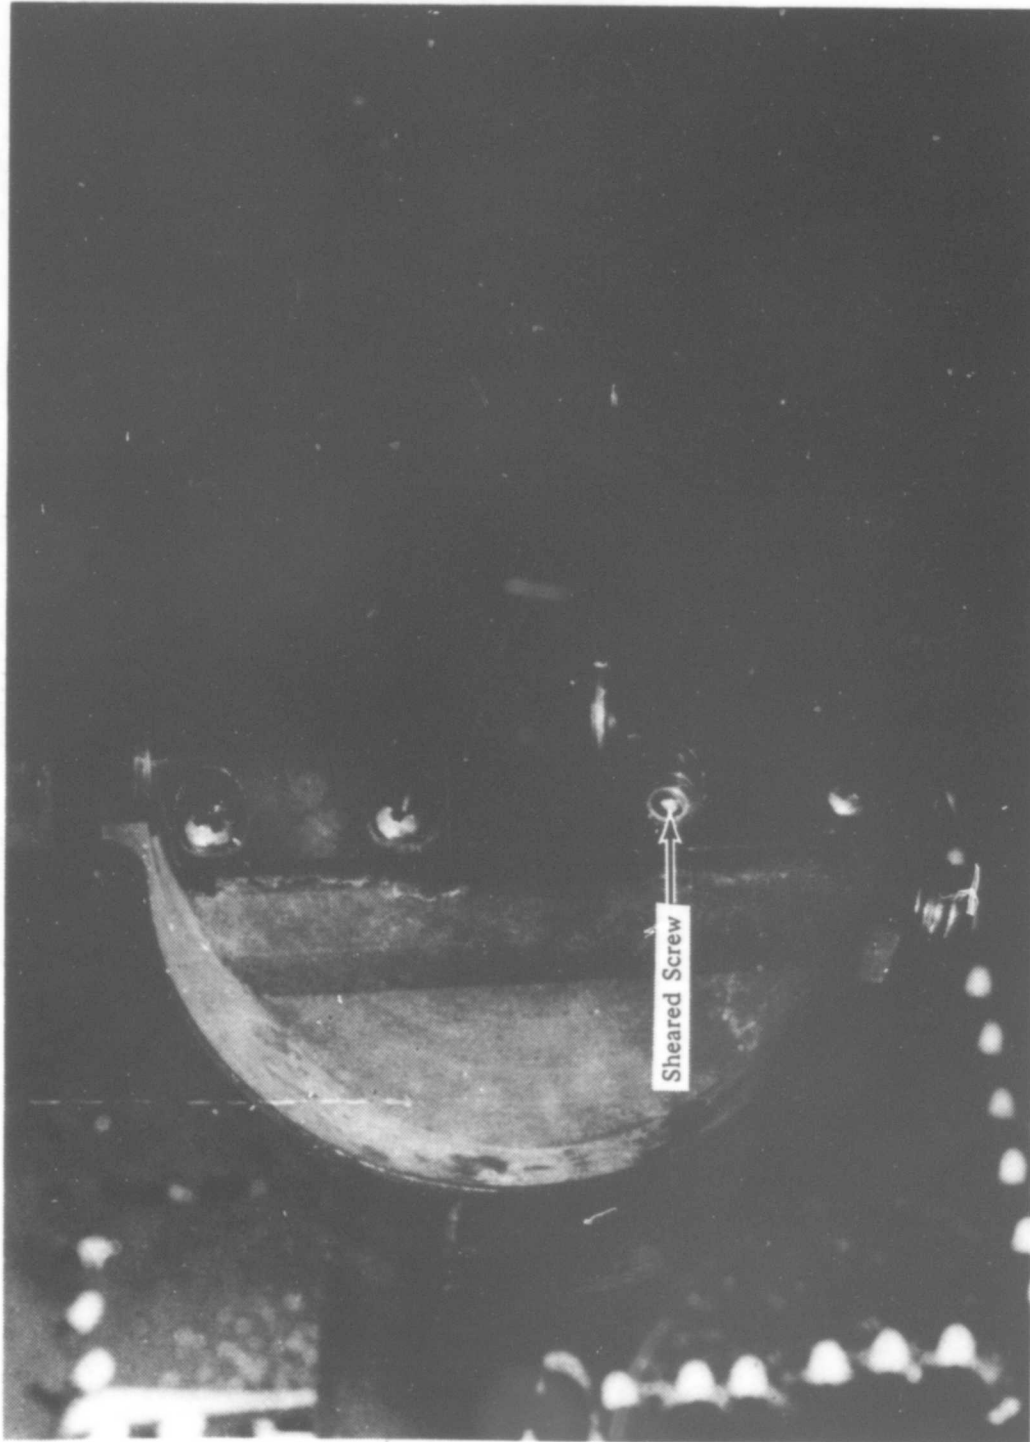
Figure H-5. Sheared Dipole Retaining Screw
Artificial Icing - .52 gm/m³ LWC, -15°C OAT, 44 min

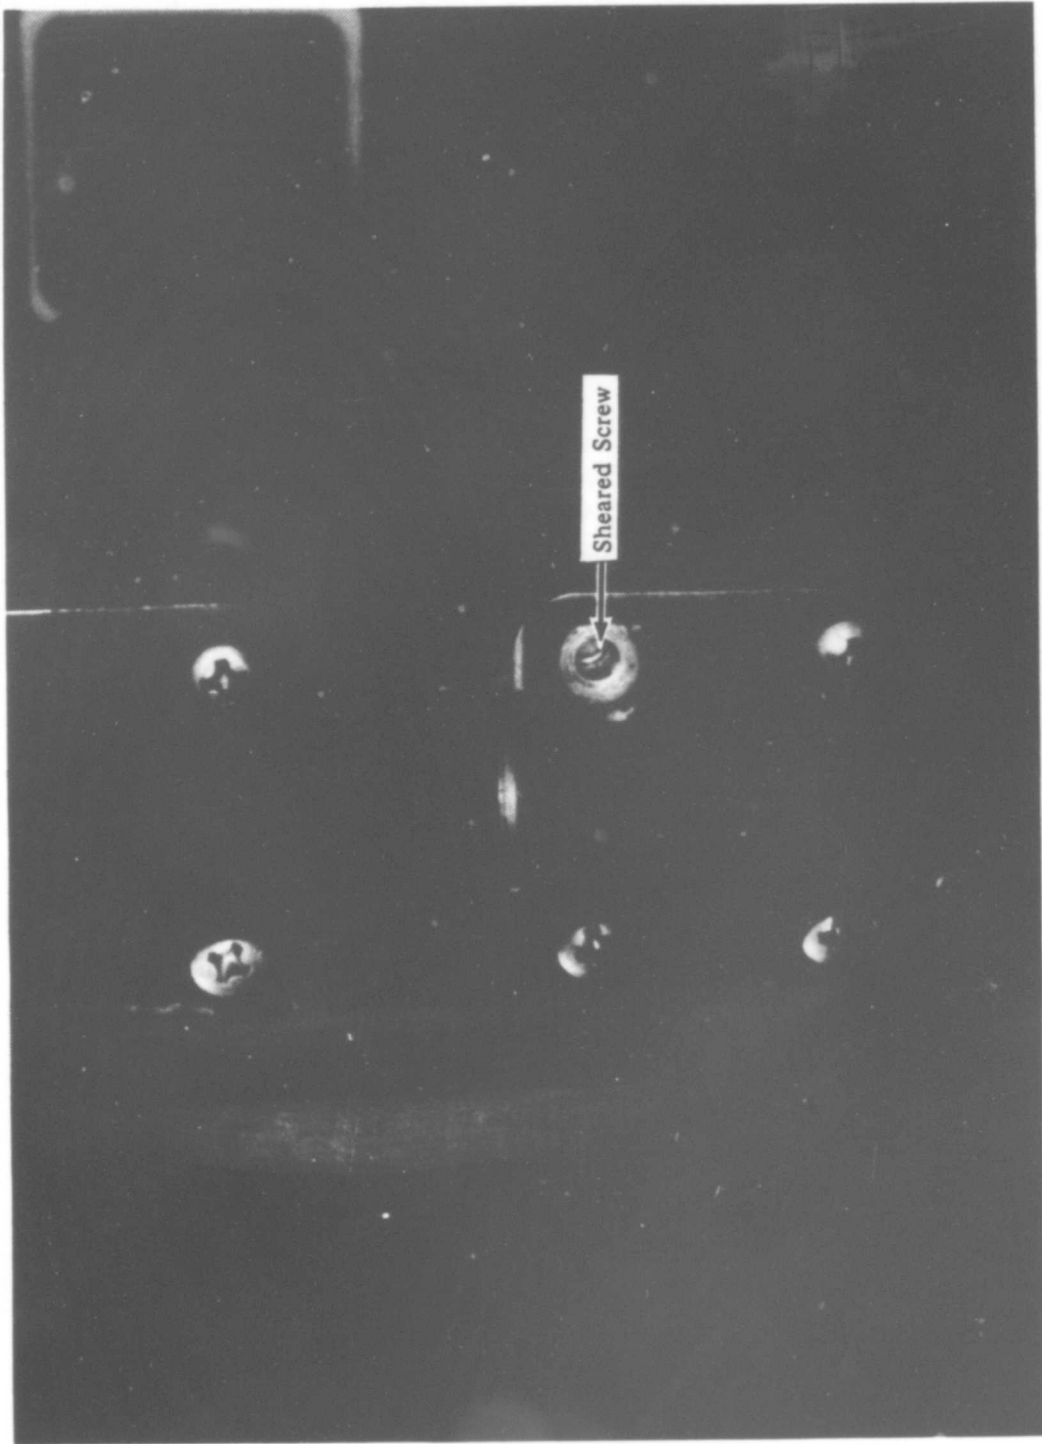
Figure H-6. Sheared Dipole Retaining Screw
Natural Icing - .20 gm/m³ LWC, -9.3°C OAT, 21 min

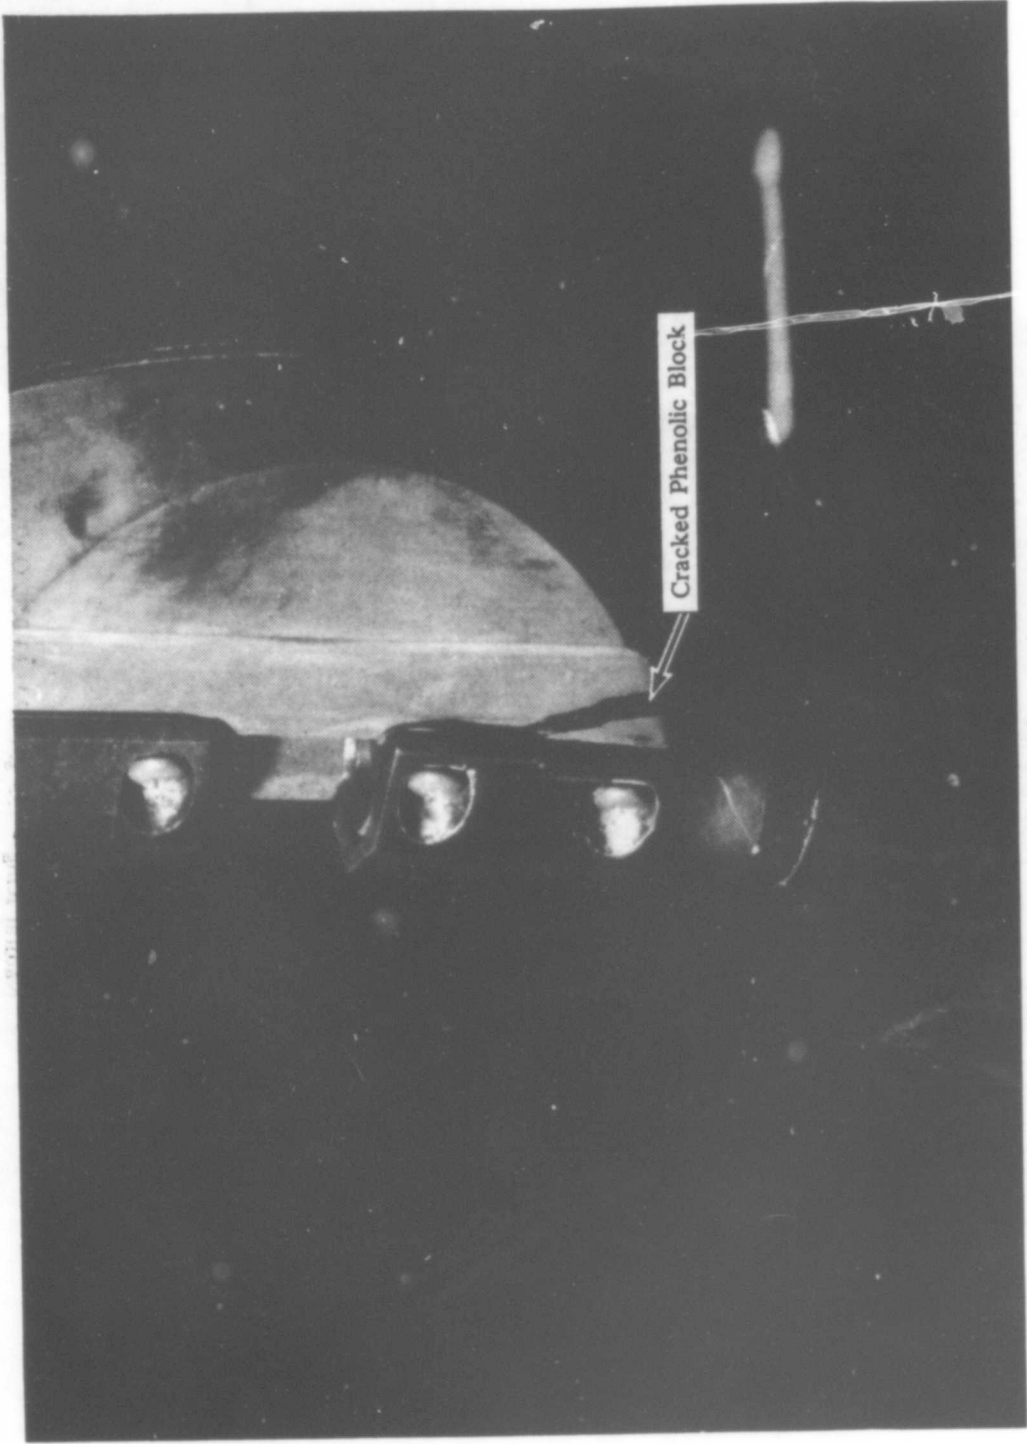
Figure H-8 #2 Dipole Antenna Cracked Phenolic Block
Natural Icing - .55 gm/m³ LWC, -13.0°C OAT, 21 min

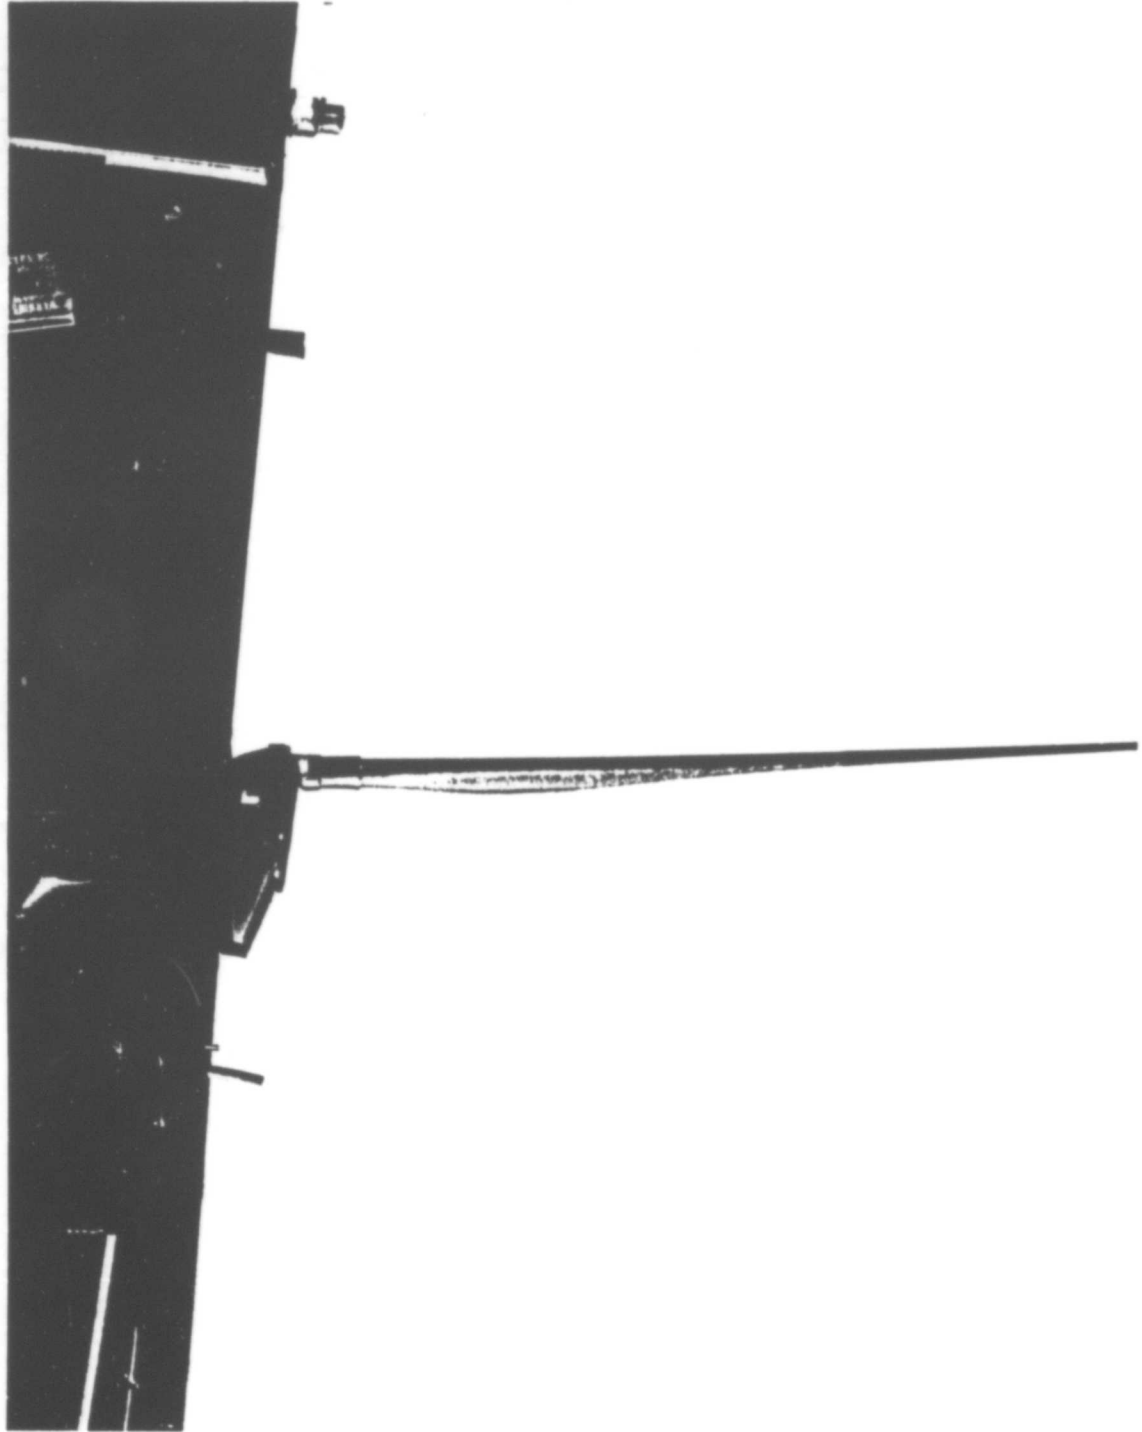
Figure H-10. ECM Antenna: Artificial Icing
Artificial Icing - .95 gm/m³ LWC, -5.1°C OAT, 57 min

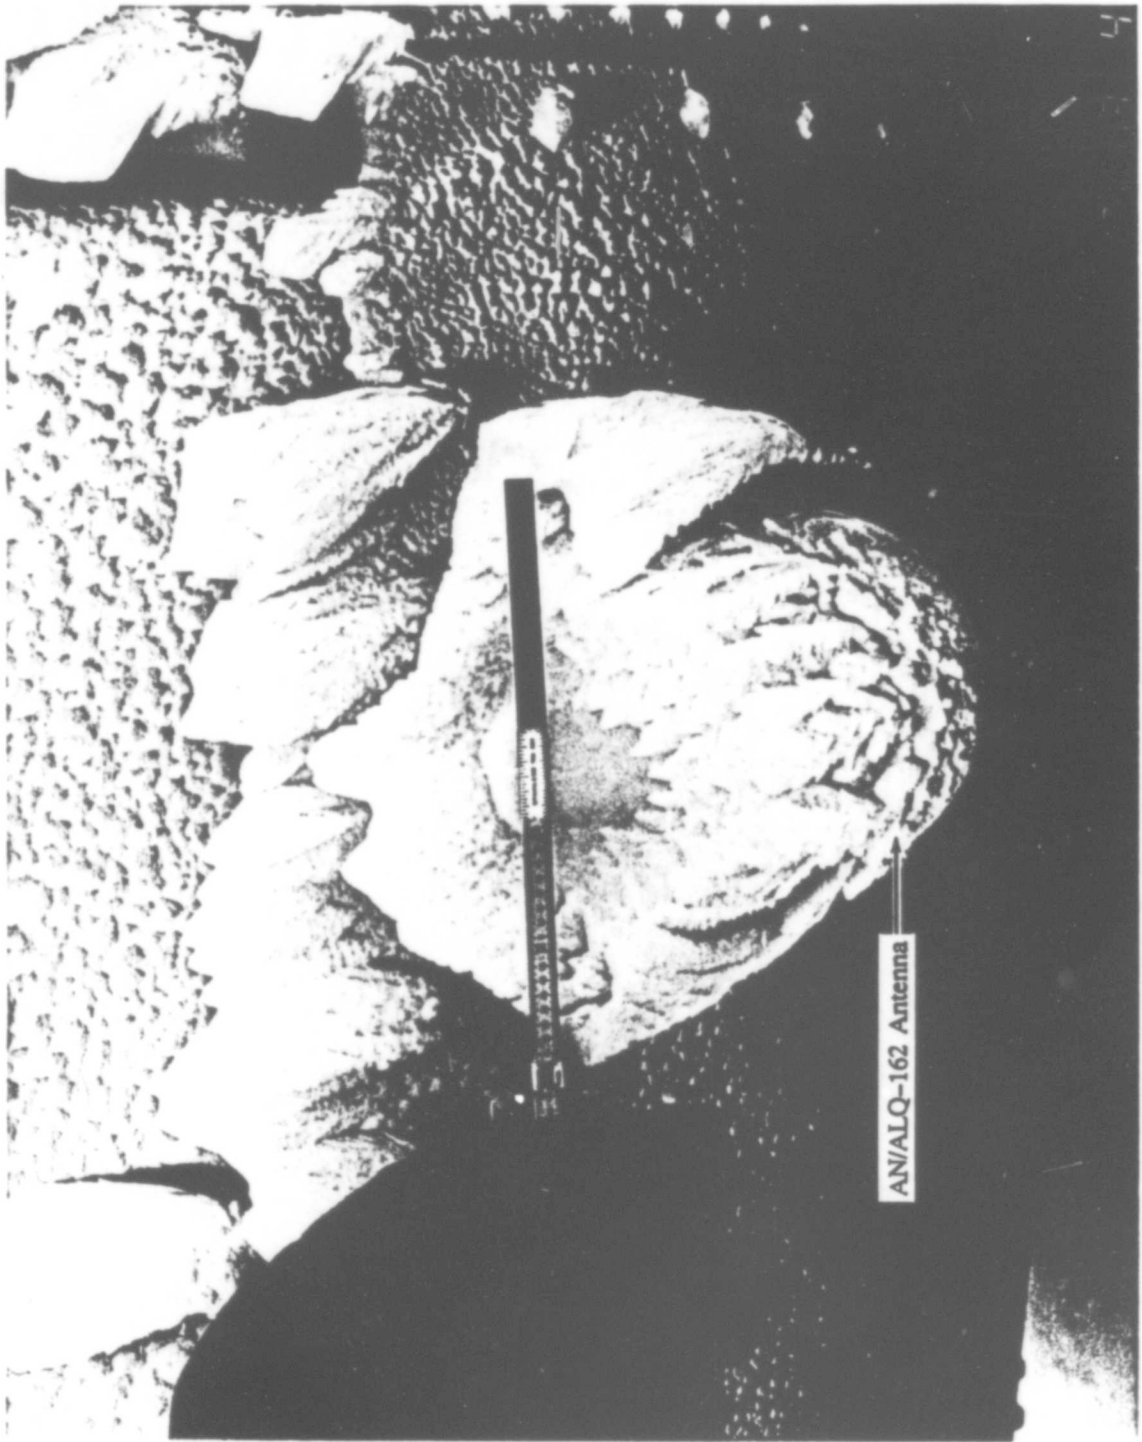
Figure H-12. AN/ALQ-162 Antenna Accumulation (Front View)
Artificial Icing - .52 gm/m³ LWC, -15.0°C OAT, 60 min

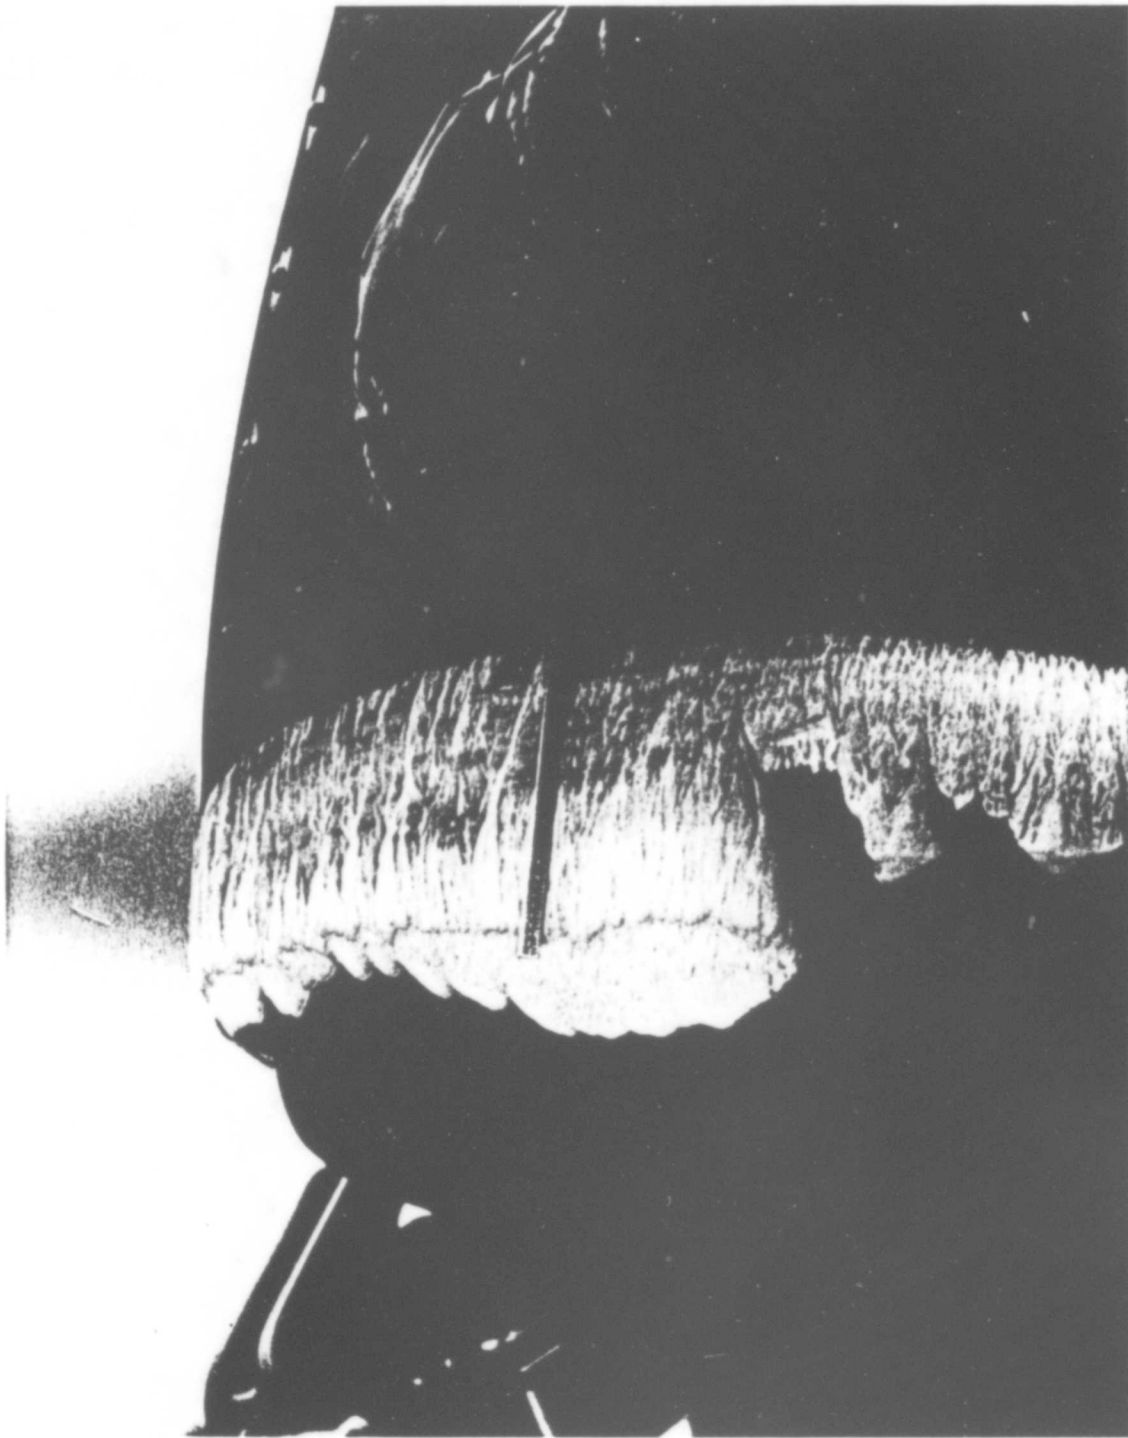
Figure H-14. HIRSS Engine Cooling Air Inlet Fairing
Artificial Icing - .52 gm/m³ LWC, -15.0°C OAT, 60 min

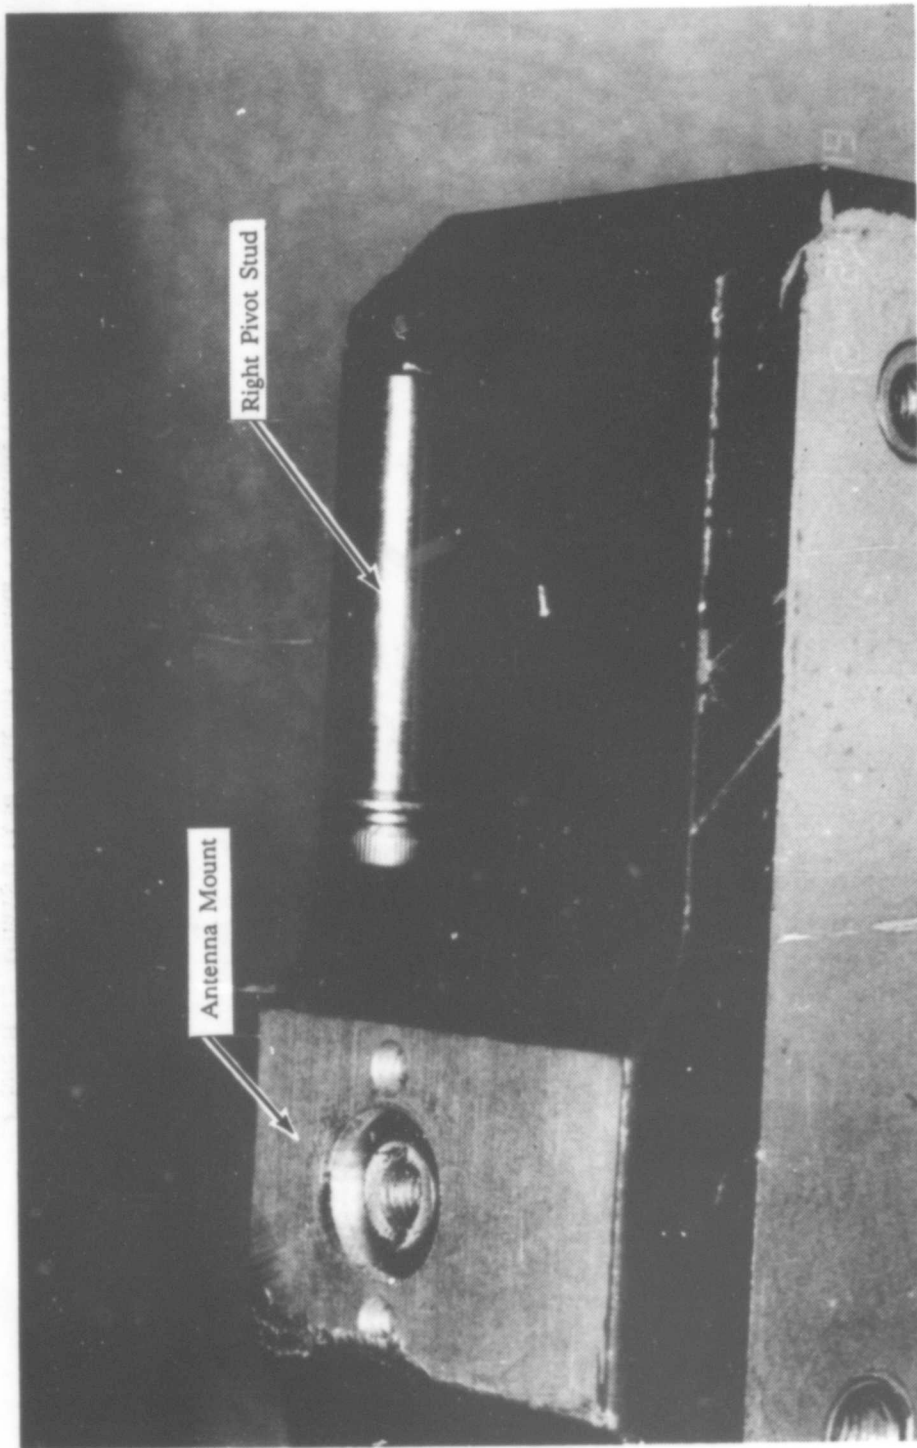
Figure H-21. ECM Antenna Mount and Sheared Pivot Stud
Natural Icing - .20 gm/m³ LWC, -9.3°C OAT, 92 min

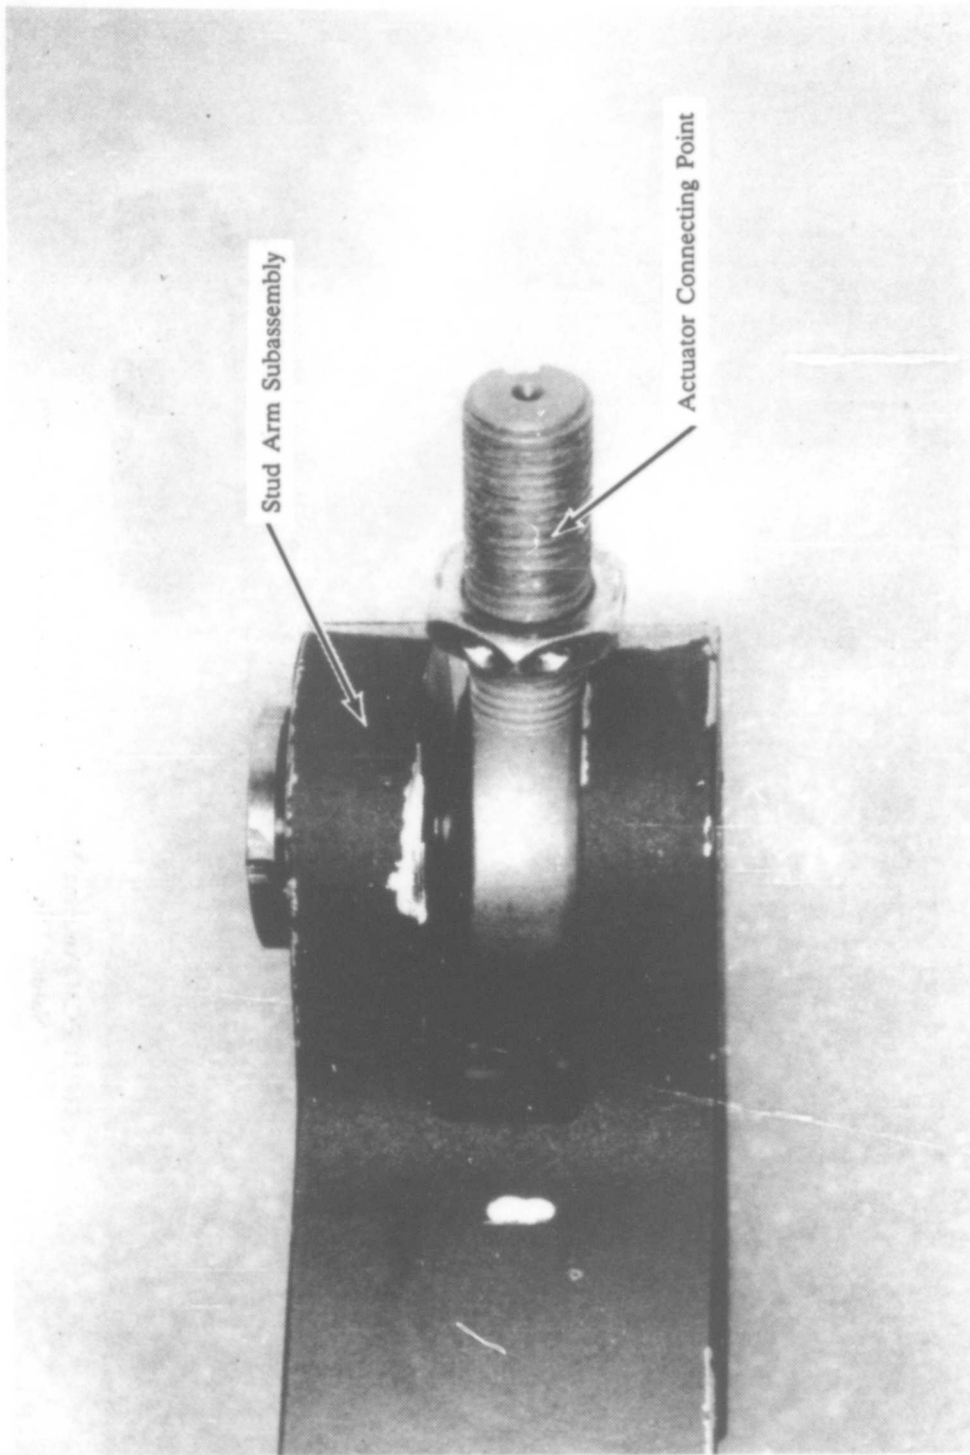
Figure H-22. Damaged ECM Antenna Actuator Connecting Point
Natural Icing - .20 gm/m³ LWC, -9.3°C OAT, 92 min
