DISC-E-95GP-0301

REPORT OF FINDINGS: ENGINEERING PRACTICES STUDY ON FAILURE ANALYSIS OF NSN 5340-00-136-9872 GROOVED COUPLING CLAMP

Bohdan Hasiuk  
Defense Industrial Supply Center  
DISC-ECM  
700 Robbins Avenue  
Philadelphia, PA 19111-5096

3 October 1988

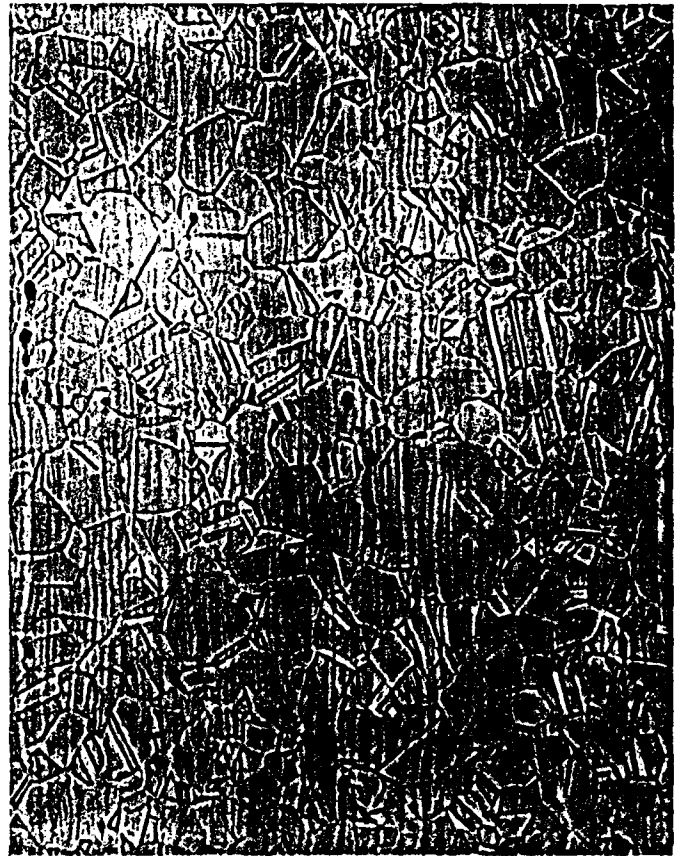
Figure 1C - 500X. Same as figure 1B, only higher magnification. Note the spherical shape of the non-metallic inclusions (probably cross-sections of the stringers from figures 1 and 1A).

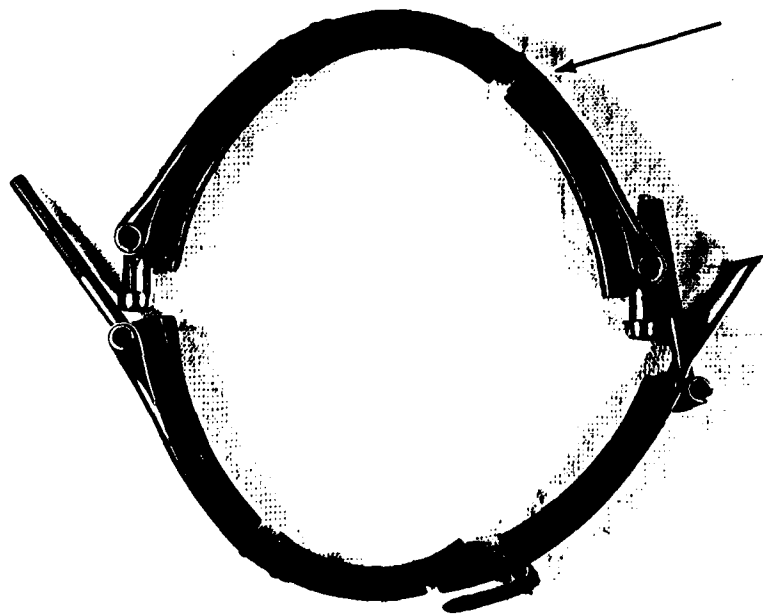
Figure 2A - 0.4X. The as-received V-Band coupling clamp. The arrow indicates the rivet area of the clamp where a crack was found. The area of the crack is shown in more detail in figure 2B.

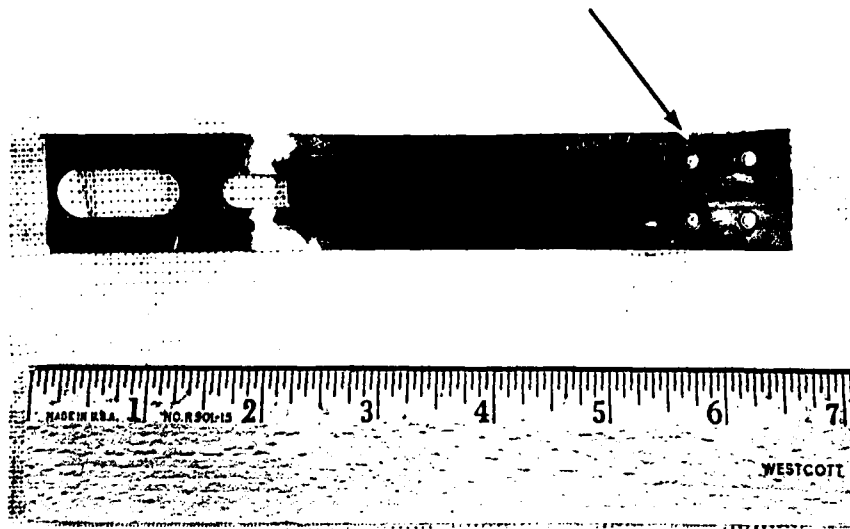
A section of the clamp containing the crack was cut out and is shown in figure 2B (with the arrow pointing to the crack). The area containing the crack is shown in more detail in figures 2C through 2E. Examining figures 2C through 2E, the following generalizations can be made:

Figure 2B - 0.63X. Inside surface of the clamp showing the four rivet holes. The arrow points to a crack in the close proximity to one of the rivet holes. The area indicated by the arrow is shown in more detail in figure 2C.

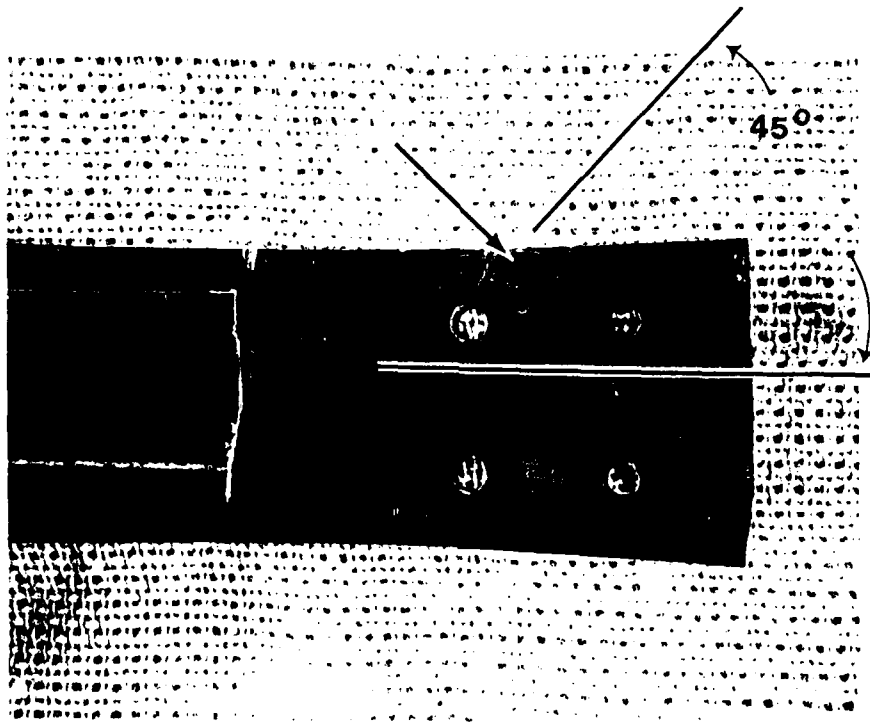
1. The main crack lies at about 45 degrees to the longitudinal (circumferential) direction of the clamp. This is important from the view point of the resolution of forces (stresses) acting on the clamp.

Figure 2C - 1.5X. A more detailed view of the inside surface of the clamp from figure 2B. The arrow points to a crack, which is plainly visible. Note that the crack is at approximately 45° to the circumferential direction (of the clamp). This area is shown in more detail in figure 2D.

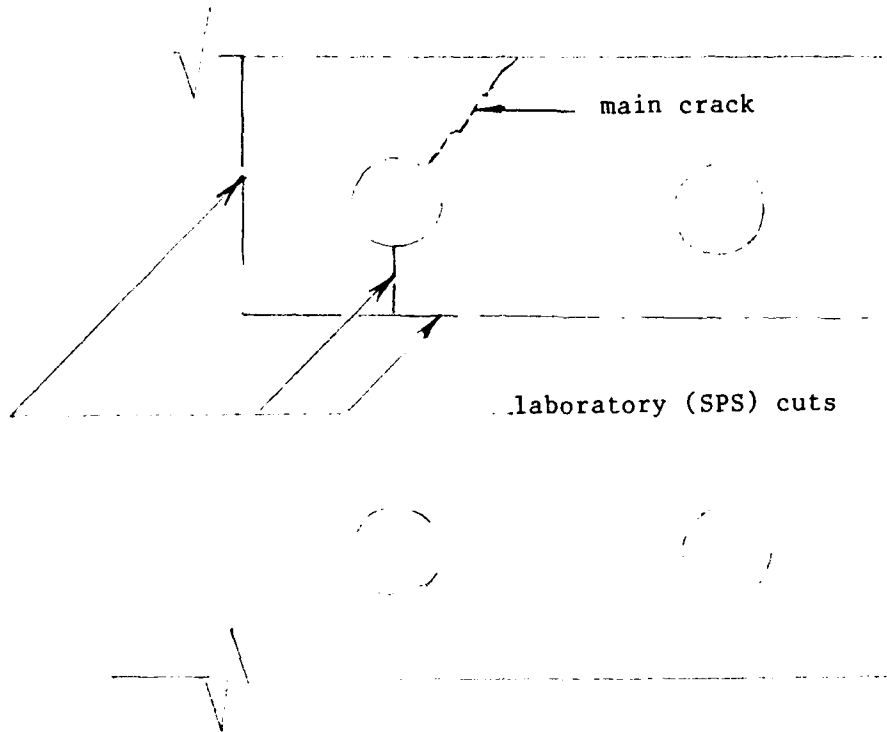
Figure 3-3.25X. A sketch of the inside surface of the clamp segment from figures 2B and 2C containing the crack. A part of this clamp segment was cut out and the crack was opened and is shown in figures 3A and 3B.

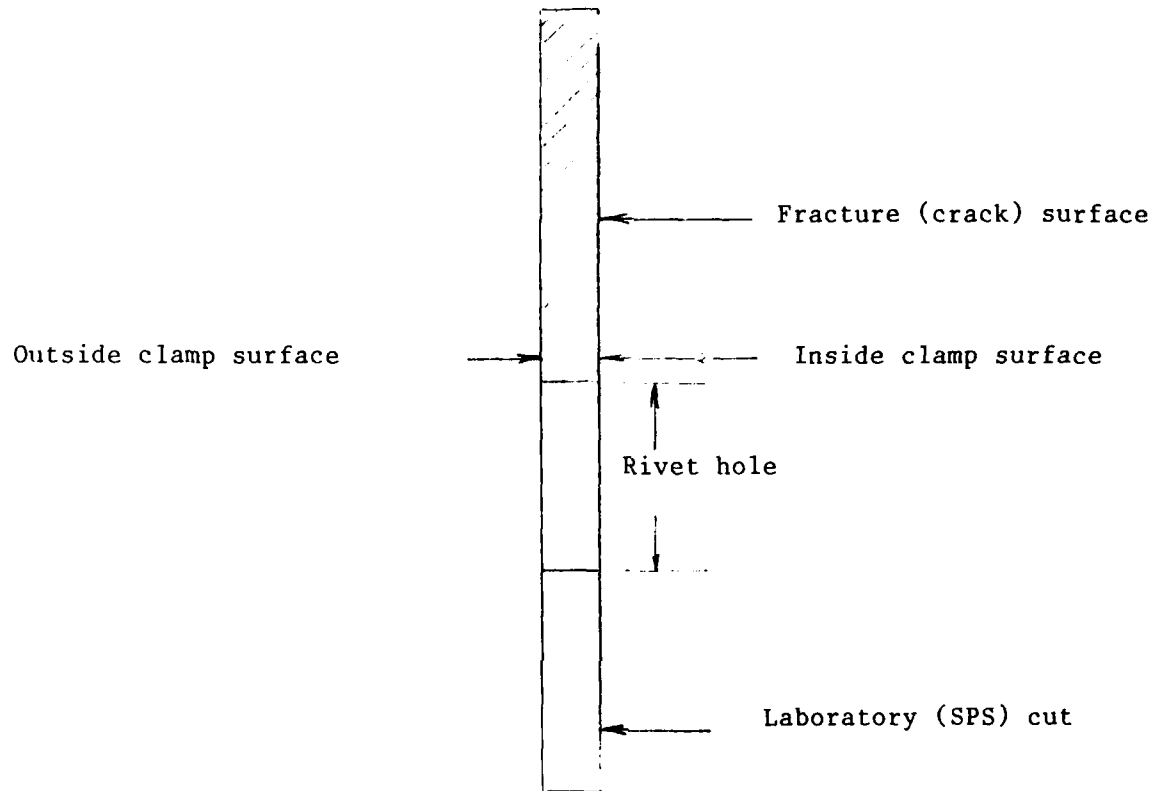
Figure 3A-9.75X - A sketch, from figure 3, of the opened main crack and its relation to the clamp segment. A more detailed sketch of the crack surface is shown in figure 3B.

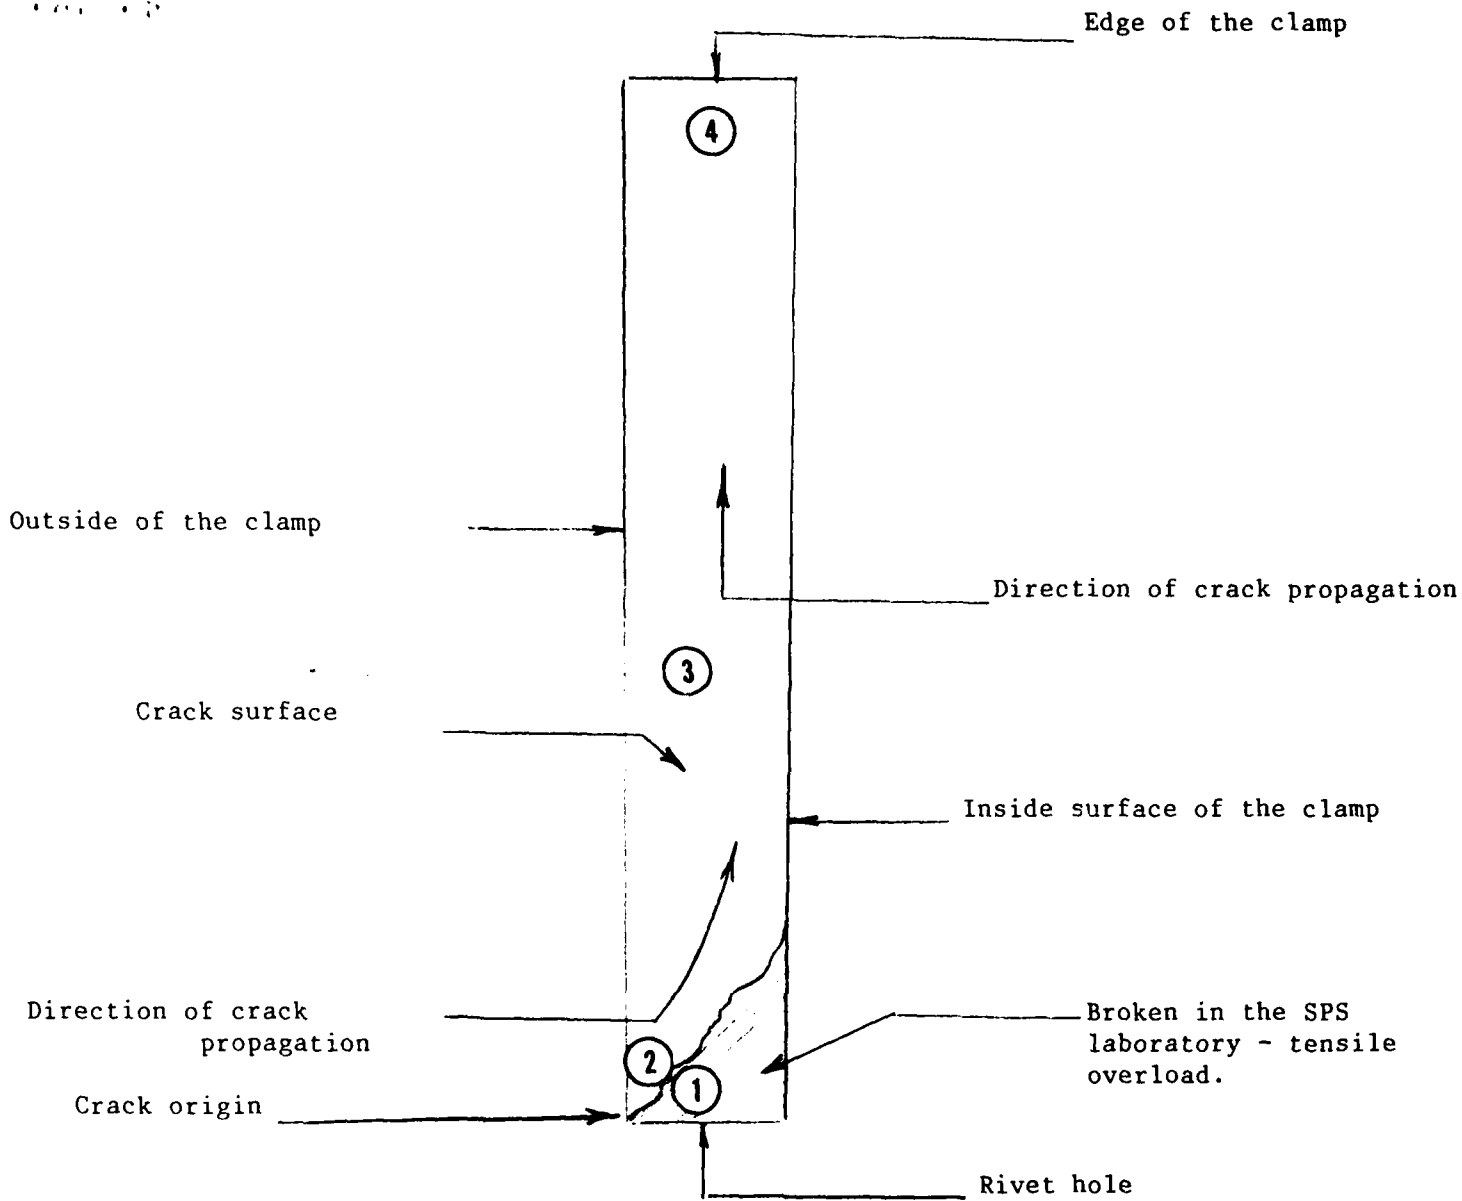
1. The crack originated on the outside surface of the clamp at the rivet hole (underneath the rivet).
2. The crack originated in an intergranular stress-corrosion mode.
3. As the crack progressed the intergranular mode began to change to intergranular/transgranular mode with a slight corrosion fatigue component. The change in failure mode resulted from a change in crack propagation (i.e., the crack began to accelerate due to the reduction of load carrying area and the resultant increase in stress). The load carrying area (cross-section of the clamp) was continuously reduced not only because of the continuing propagation of the main crack but also because new cracks were forming.

Figure 3B-20X. A sketch of the crack surface from figure 3A. The surface of this crack was examined by the Scanning Electron microscope (SEM) and was analyzed by Energy Dispersive Spectroscopy (EDS) and the representative areas (labeled 1 through 4 in this sketch) were photographed and the results are shown in figures 4 through 5A.

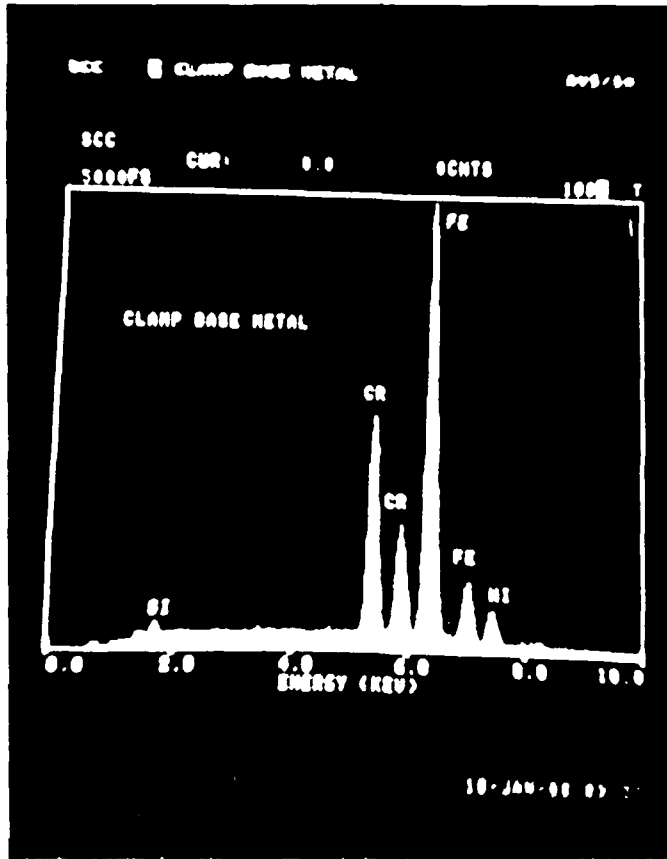
Examining figure 4 it becomes obvious that we are looking at austenitic stainless steel (very strong primary and secondary iron lines as well as significant chromium, nickel and silicon lines). However, when we look at figure 4A, which represents the EDS analysis of the crack surface, we see an extremely strong chloride line and very significant sulfide, potassium and sodium lines. This represents quite a "zoo" of corrodents with the most powerful corrodent, namely chloride, in extremely high concentrations.

Figure 4. Energy Dispersive Spectroscopy (EDS) of the clean (broken in the laboratory) surface showing the basic chemistry of the clamp material (AMS 5595, iron-chromium-nickel alloy).

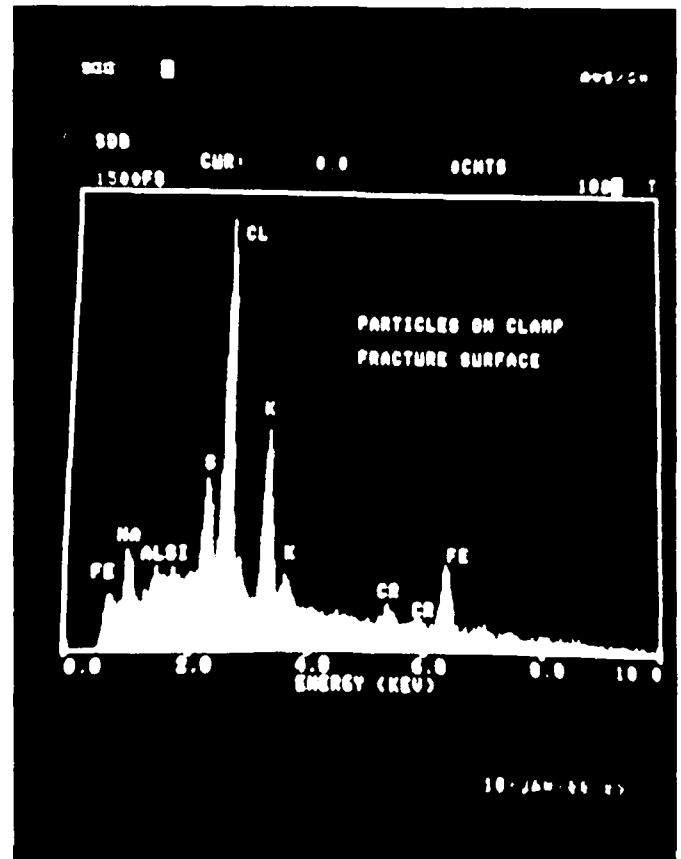
Since the crack originated under the rivet head (crevice attack) and large concentration of sulfur (polythionic acid) and chlorides were found (figure 4A) - all the corrosion conditions for stress corrosion cracking were present.

Figure 4A. Energy Dispersive Spectroscopy (EDS) of the particles found on the surface of the opened crack ("A" crack of figures 2D and 2E). Note the relatively high concentrations of chlorides and sulfides.

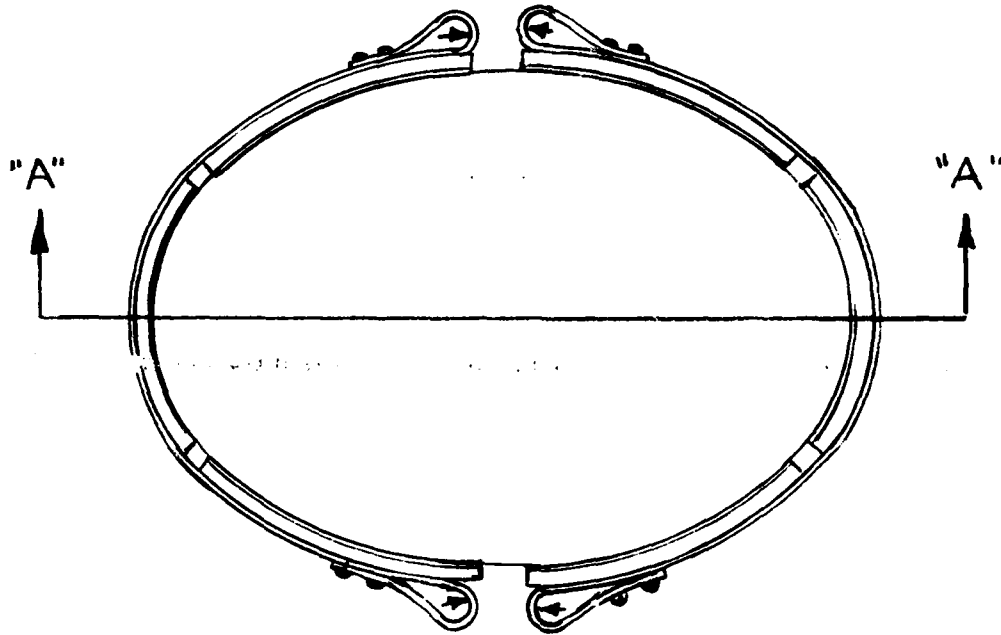
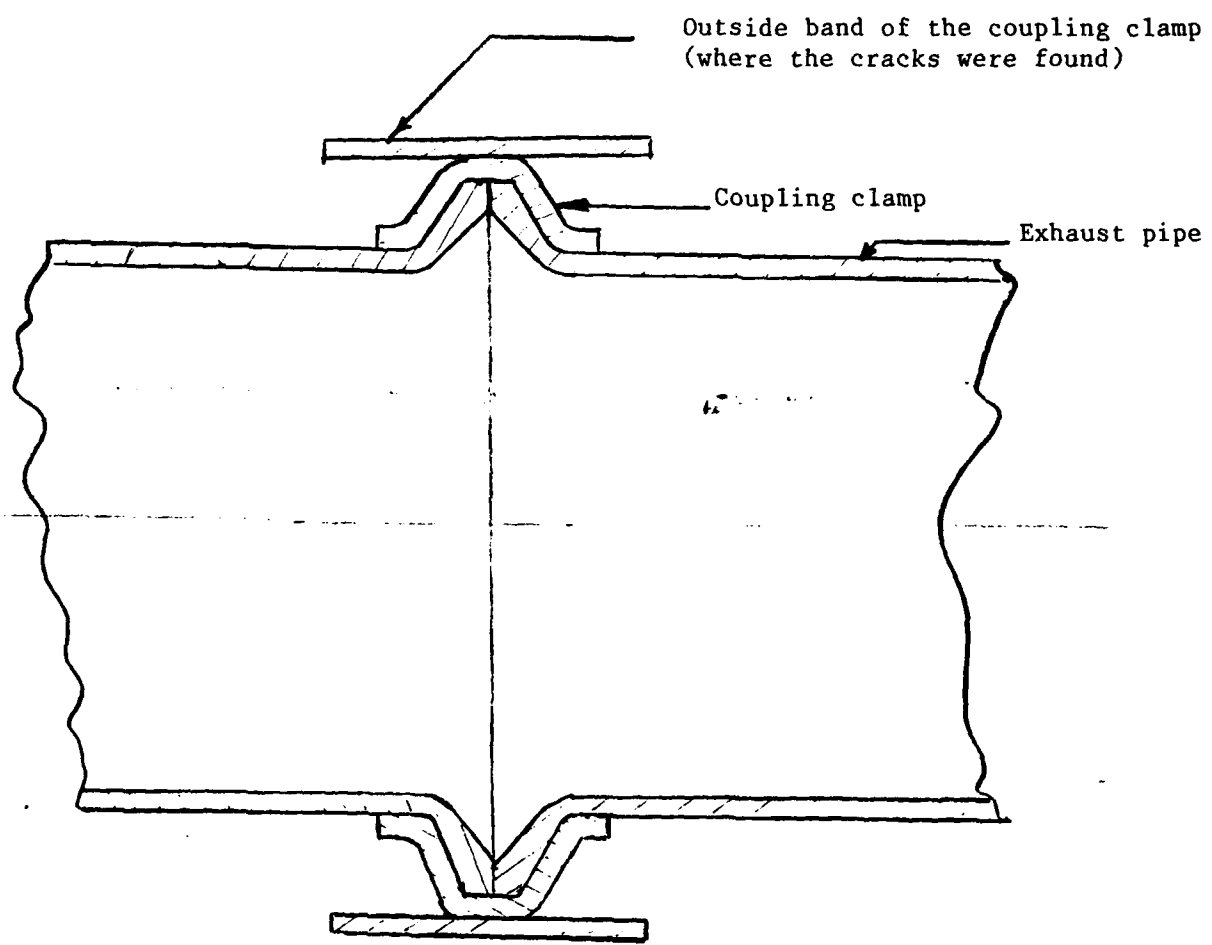
Taking the geometry of the cross-section of the entire clamp under consideration, the metal temperature of the exhaust pipe of the OH-58 helicopter would have to be considerably above 1000 F to cause the temperature of the outside clamp surface to reach 1000 F. This is graphically portrayed in figure 8.

After contacting Boeing-Vertol (4) and Bell Helicopter (5) (the manufacturer of OH-58 helicopter) - we were informed that the outside temperature of the exhaust pipe never exceeded 1000 F and reached 1000 F only on rare occasions. From the heat transfer considerations this would put the temperature of the outside surface of the clamp at about 600 to 700 degrees F maximum. We must conclude, therefore, that the sensitization of the clamp material occurred during heat treatment! Furthermore, on our own initiative we asked the SPS to do a titanium/columbian analysis. Titanium and/or columbium is sometimes added to austenitic stainless steel for stabilization purposes (so that titanium and/or columbium will "tie up" the carbon and thus preclude it (carbon) from combining with chromium). SPS laboratory did, in fact, find 0.45% titanium in the band material, thus proving that NUCO (or the maker of the band material) was either aware of sensitization problem or was unsure of its ability to control carbon, or both (6).
