11. TITLE (Include Security Classification) FABRICATION AND FEASIBILITY TESTING OF THE COMPOSITE ROADWHEEL FOR THE LVT-7 AMPHIBIAN VEHICLE			
12. PERSONAL AUTHOR(S)			
13a. TYPE OF REPORT FINAL	13b. TIME COVERED FROM 8/85 TO 1/88	14. DATE OF REPORT (Year, Month, Day) 1988 January 8	15. PAGE COUNT 39

PHASE I
FABRICATION AND FEASIBILITY TESTING
OF THE COMPOSITE ROADWHEEL FOR THE
LVT-7 AMPHIBIAN VEHICLE

Prepared under Contract No. N00167-85-C-0126
for David Taylor Naval Ship R & D Center
Bethesda, Maryland 20084

COMPOSITEK ENGINEERING CORPORATION
1095 Columbia Street
Brea, California 92621

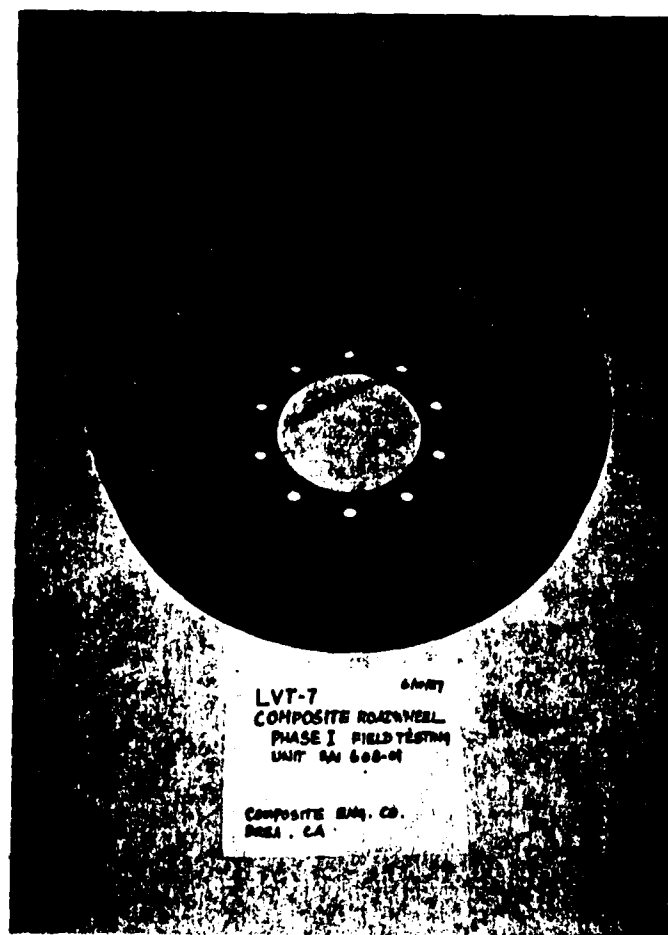
Figure 37. S/N 608-01 after Field Testing

1. S/N 608-01 - Figures 37 and 38

This composite roadwheel operated 25.6 hours and approximately 330 miles. The failure analysis indicated poor bonding resulted in the loss of the stiffening ring during vehicle operation. Since vehicle operations continued after stiffening ring bond failure, extensive delamination and damage occurred in the hub, rim and wear plate areas.

A short term solution would be to add mechanical locking pins acting as a shear restraint for the two pieces, and use of film adhesive to bond the components together. This approach would add a slight amount of weight to the roadwheel, however, an increase in manufacturing cost would result due to the additional machining operations. Tooling modification would be minimal.

A long term solution for this problem would be a re-design of the winding mandrel to allow winding of the stiffening ring and composite insert as a one piece structure. This would require a new collapsible mandrel and a modification to the existing manufacturing process. Although tooling cost increased for design and fabrication of the new winding mandrel, the potential cost savings per unit may be close to 50 percent due to a decrease in the machining and fabrication effort.

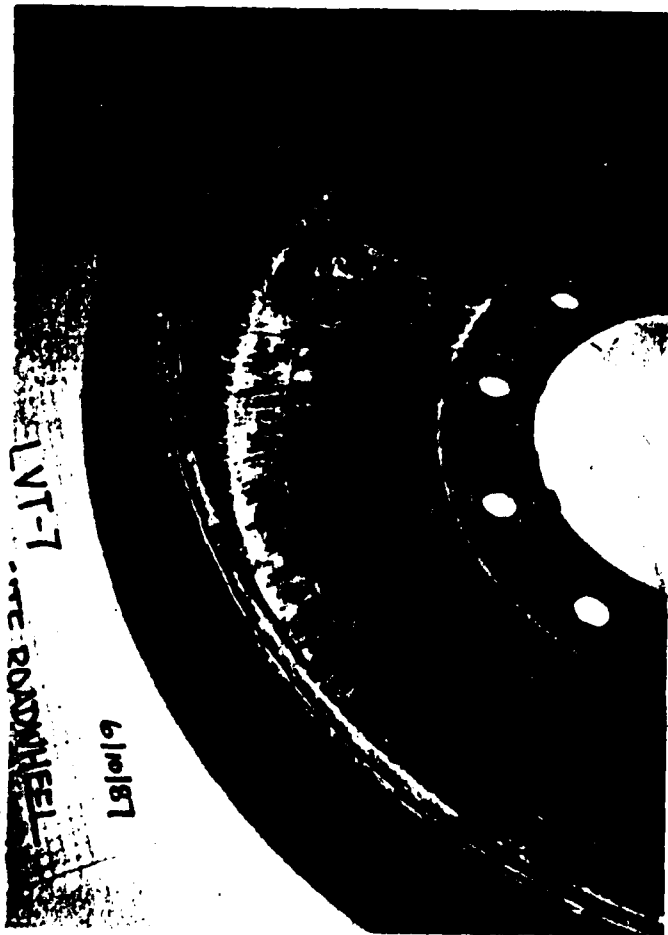
Figure 38. S/N 608-01 after Field Testing -
Rim Delamination

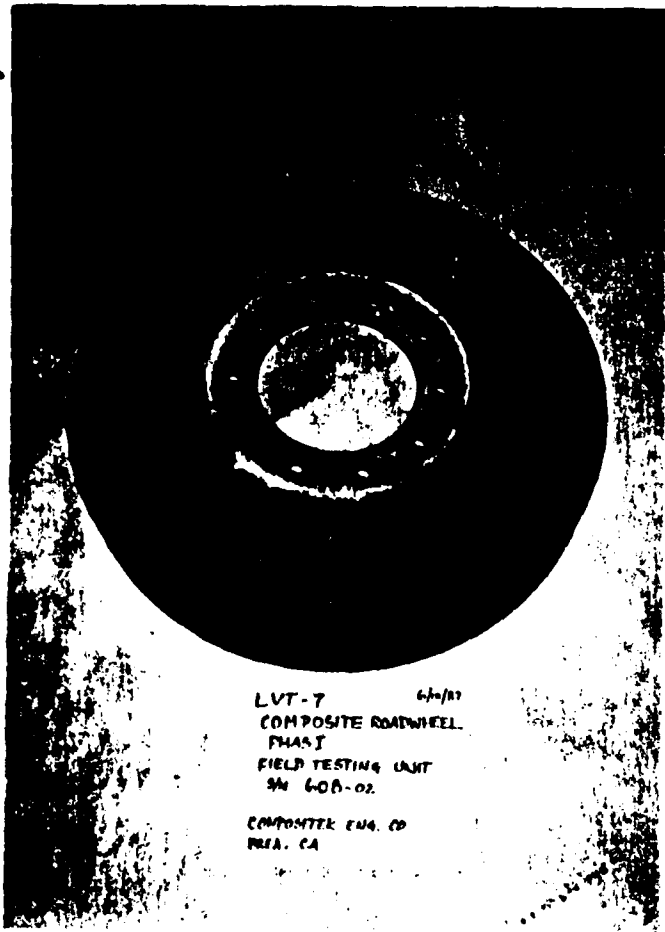
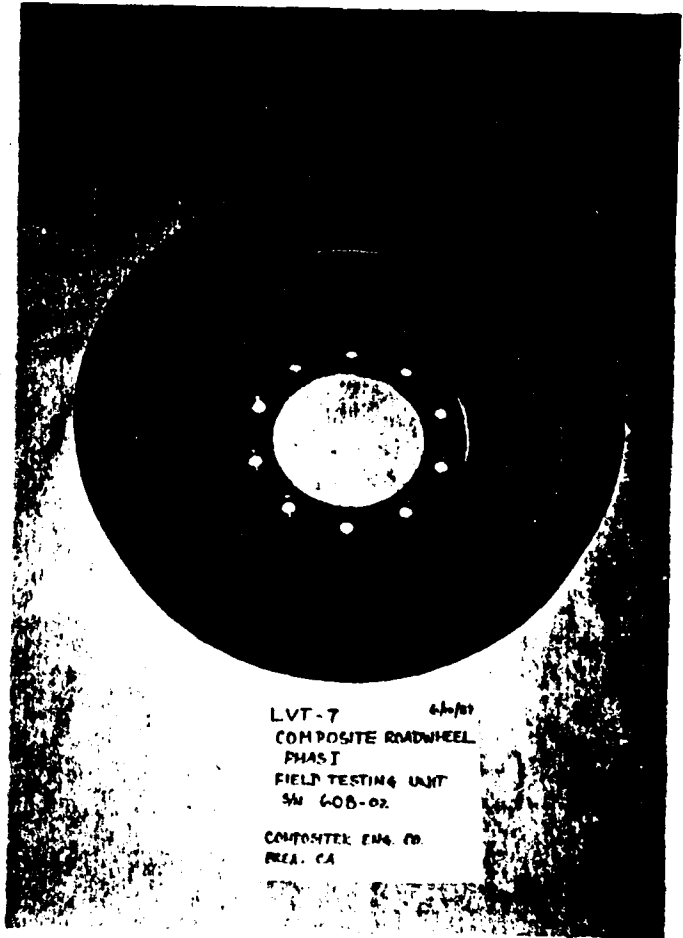
2. S/N 608-02 - Figures 39 and 40

This composite roadwheel did not show significant structural damage during the 25.6 hours of operation. However, partial debonding occurred between the urethane tire and the fiberglass insert. This wheel currently remains operable.

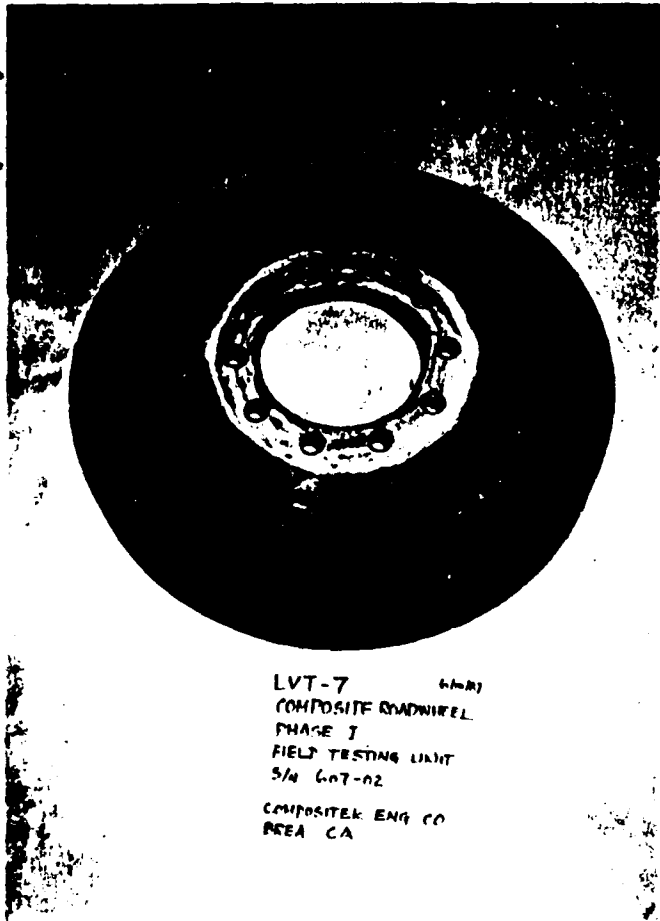
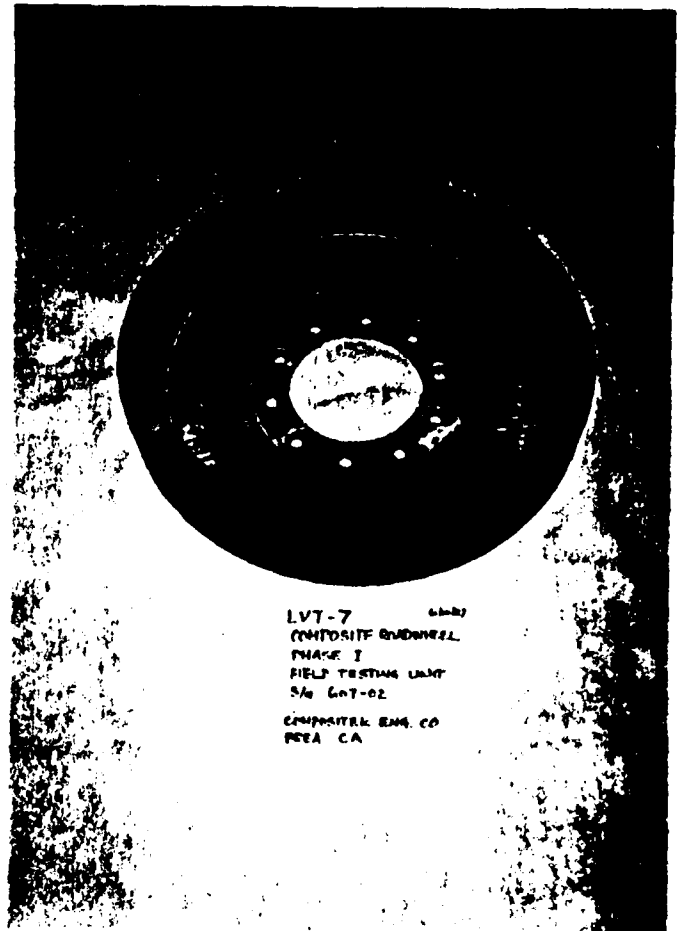
4. S/N 607-02 - Figures 43, 44 and 45

The failure mode of this wheel was similar to roadwheel S/N 608-01. The composite roadwheel lost the stiffening ring during operation and, subsequently, resulting in delamination at the hub area.

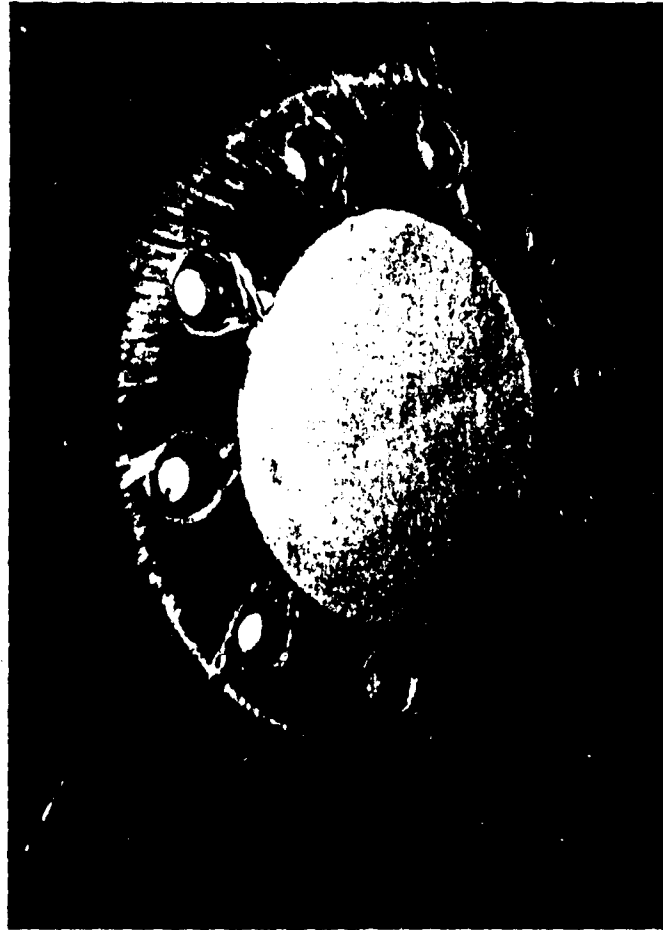
Cracking and delamination was observed around the machined outside surface of the hub area and the mounting holes. This delamination and cracking was caused by excessive roadwheel deflections after loss of the graphite stiffening ring. It has been learned from the Marine Corps Composite Sprocket Carrier Program that continuous fibers from the hub to the free edge of the rim could extend the fatigue life approximately 3 to 4 times. It is our recommendation to modify the hub section thickness configuration in order to allow for continuous fibers.

Figure 45. S/N 607-02 after Field Testing -
Delamination at Hub Section.
