# CHEMICAL AND SURFACE CHARACTERIZATION OF TOW MISSILE CASES

SIN-SHONG LIN and WAI K. CHIN  
MATERIALS SCIENCE BRANCH

December 1988

US ARMY  
LABORATORY COMMAND  
MATERIALS TECHNOLOGY LABORATORY

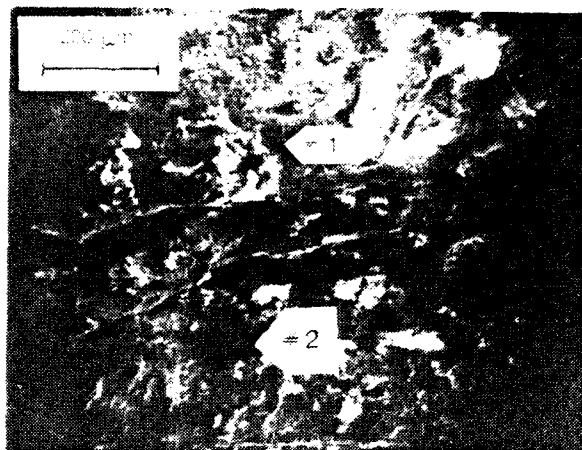
Figure 8. SEM of fracture surface #O-7e from Oahu failure.

**#O-7e:** The surface is found to have several strain fracture cracks running parallel to the cross section. The surface appearance is rusty brown with numerous fractures and cracked lines and edges. Some portions are rugged and others smooth, as shown in Figure 8. Composition analyses were made on four locations as indicated in the figure. The elemental constituents of these spots are very similar except for varying small concentrations of K and Cl.

(a) Strain cracks in fracture surface

(b) Detailed morphology of strain cracks. Spot numbers refer to EDXA chemical constituents

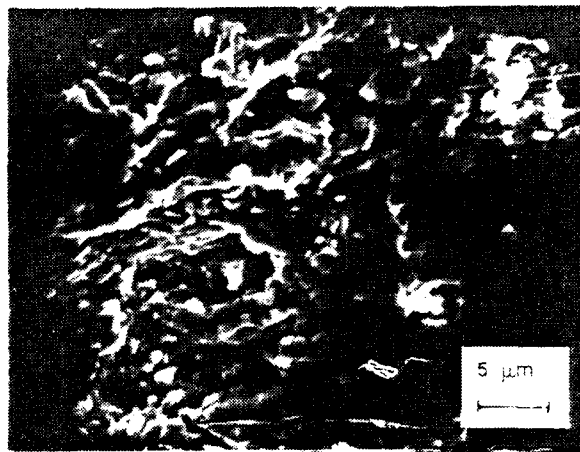
Figure 9. SEM of fracture surface #O-13e from Oahu failure.

**#O-13e:** This unique fracture surface (Figure 9) consists of many spots appearing as dark circular areas in the SEM photos (brown/black spots in OM photos, Figure 6). Presumably, these spots are preferentially oxidized portions of steel components. EDXA analyses indicate that they are mainly composed of maraging steel components with varying amounts of minor elements Al, Cr, and Ca. No Cl is detected.

(a) Fracture surface

(b) Magnified view of spot #4 on the top of crack edge

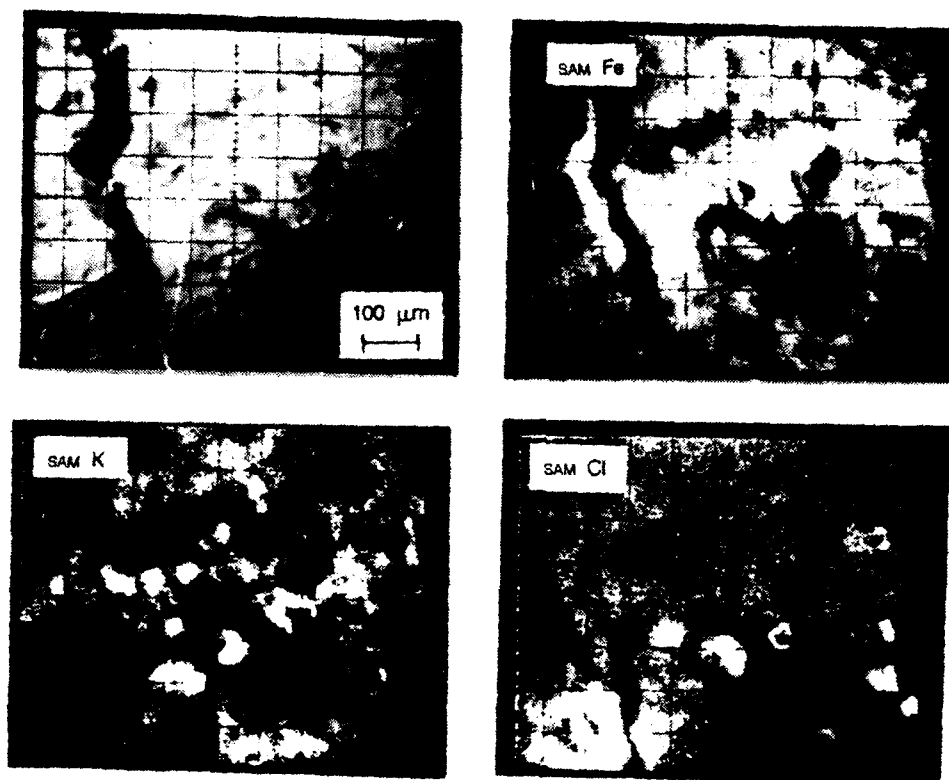
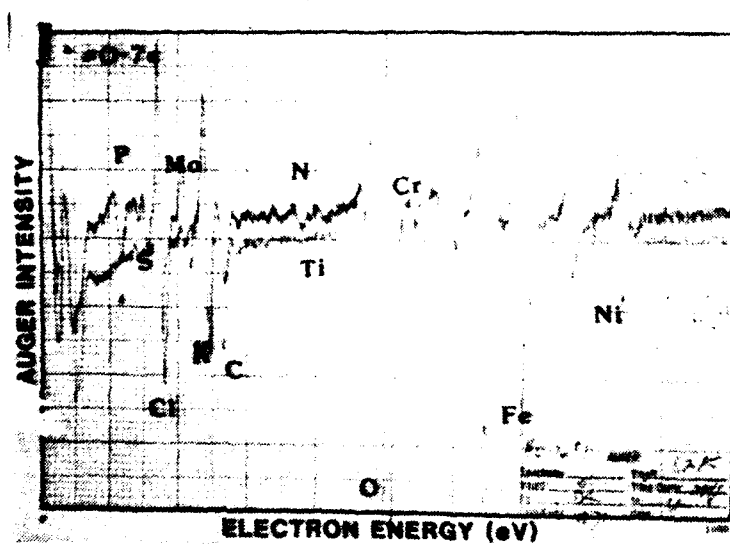
Figure 14. SAM images and AES spectra of fracture surface #O-70.

#O-7e: The SAM imaging is obtained on the region containing a strain crack. As expected, the surface is highly oxidized and contaminated. Several concentrated Cl sites are observed as illustrated in Figure 14. The SAM imaging and analyses also revealed a widespread concentration of K. These K and Cl sites are widely scattered and they could only be derived from the surface contamination by the missile propellant. Two AES spectra illustrate the magnitude of Cl on two different locations.

(a) SAM images: reference, iron, potassium (K) and chlorine.  
The K and Cl are widely scattered

(b) Auger spectra with/without chemical element Cl. The X and Y locations of analyses are indicated

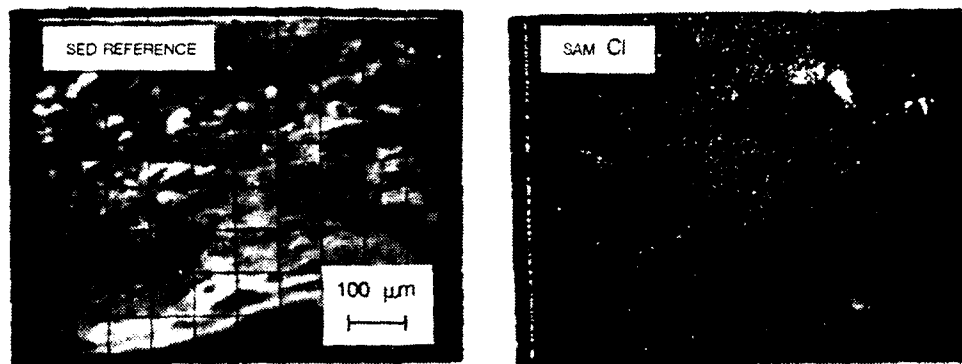
Figure 15. SAM images of fracture surface #O-13e reference and chlorine images. The Cl rich area is not near the inner wall, but is situated at a half wall thickness

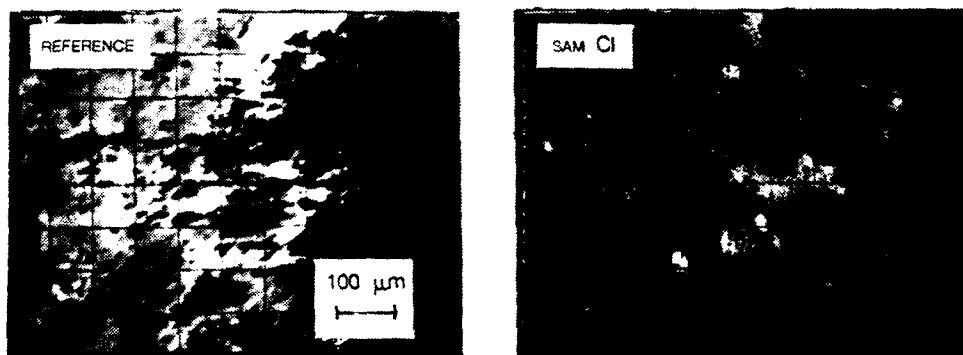
Figure 16. SAM images and AES spectra of fracture surface #Y-24e.

#Y-24e: This sample obtained from Yakima failure exhibits several Cl concentrations on the fracture surface. Most of the Cl is aggregated near the inner wall as shown in Figure 16. The AES spectra clearly confirm the presence of Cl.

(a) Reference image and SAM chlorine near inner wall

(b) Auger spectra taken at three locations: center, two Cl rich spots
