EGG-HWP-8128  
August 1988

**Idaho  
National  
Engineering  
Laboratory**

FINAL REPORT

DISMANTLEMENT OF BUILDING 666 AND INDUSTRIAL  
WASTEWATER TREATMENT PLANT NO. 4

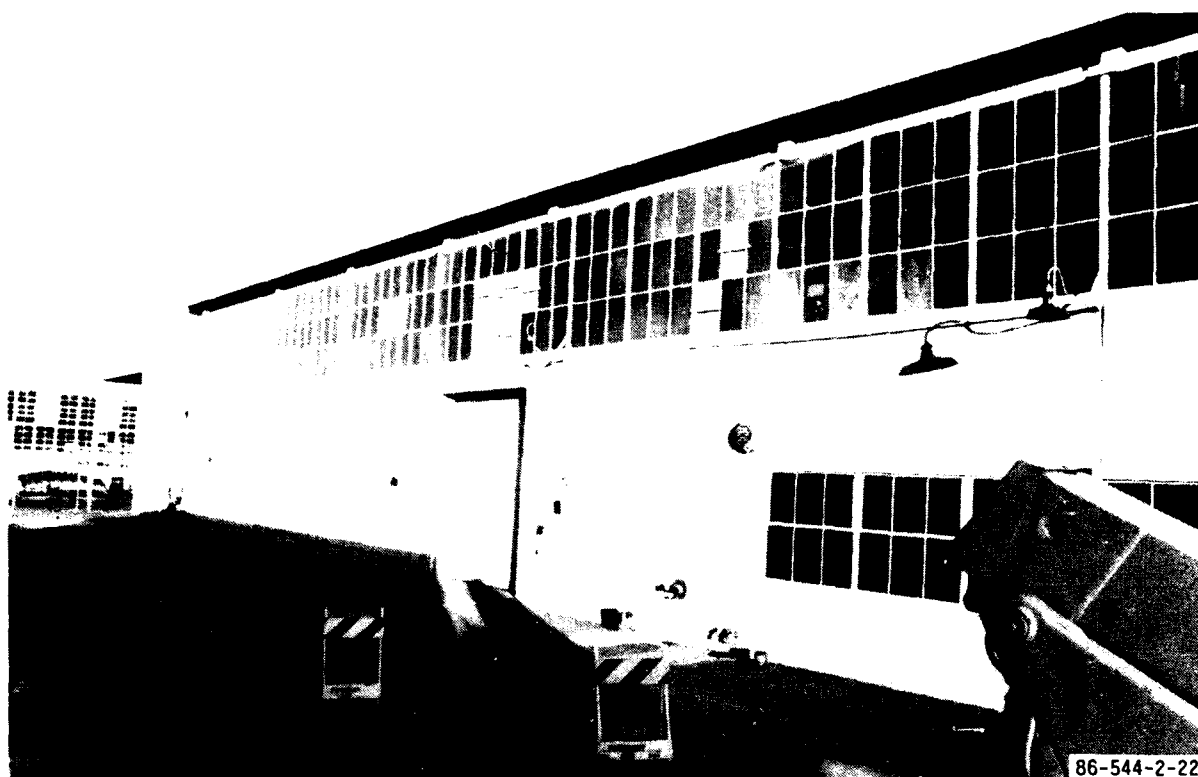
Building 666 had broken windows, open windows, open doors, and louvers in the three HVAC towers which, if not closed, would have allowed airborne contamination to leave the building once work began inside the building. All these openings were closed before activities started inside the building (see Figures 23 and 24).

Figure 23. South side of Building 666 showing boarded-up broken windows, closed windows, and closed doors.

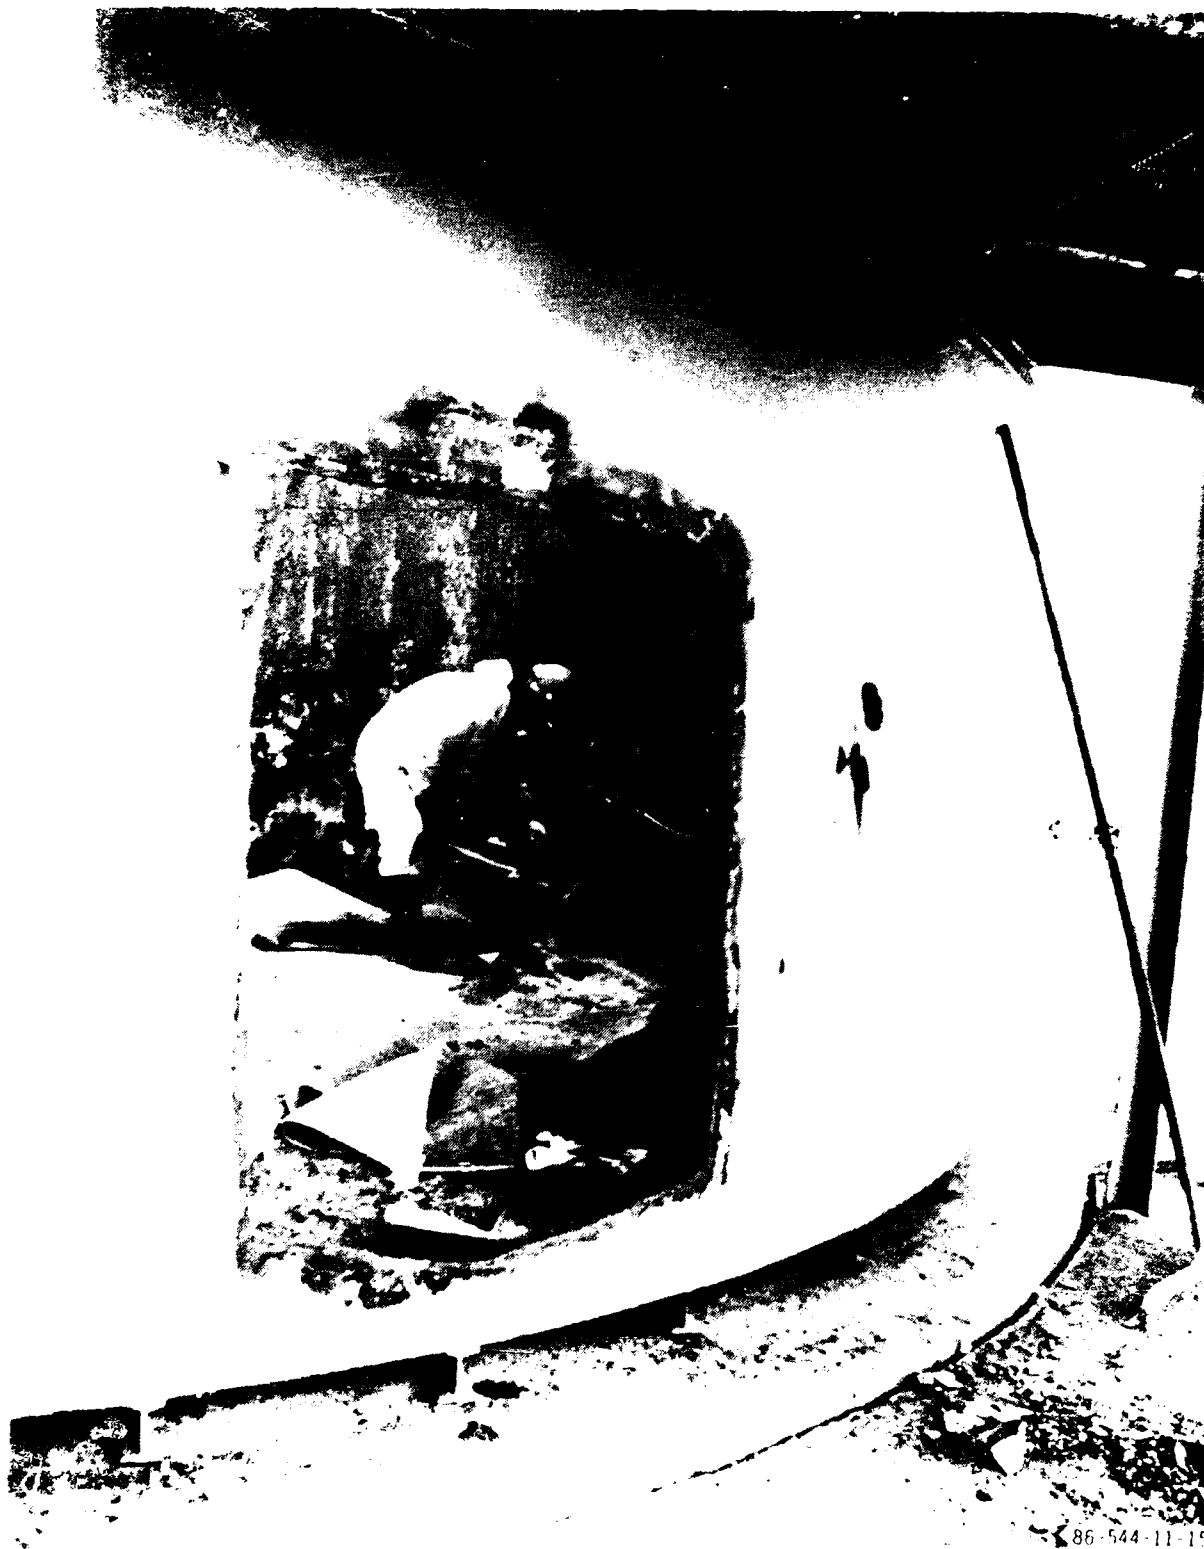
Several of the tanks contained sludge. The open-topped tanks contained dry sludge because the previously accumulated rainwater had evaporated. Tank number 525, the coagulator tank, contained approximately 120,000 lb of dry sludge. Six ion-exchanger tanks contained resin. The tanks containing sludge were accessed by torch cutting a hole near the bottom in the side of the tank. Each tank was then entered, the sludge removed, and the tank interior cleaned and vacuumed (Figure 63). In the case of Tanks 526 and 527, the rubber lining was also removed (Figure 64).

Figure 64. Interior liner being removed from Tank 526.
