TECHNICAL REPORT REMR-CO-3

CASE HISTORIES OF CORPS BREAKWATER  
AND JETTY STRUCTURES

Report 5

NORTH ATLANTIC DIVISION

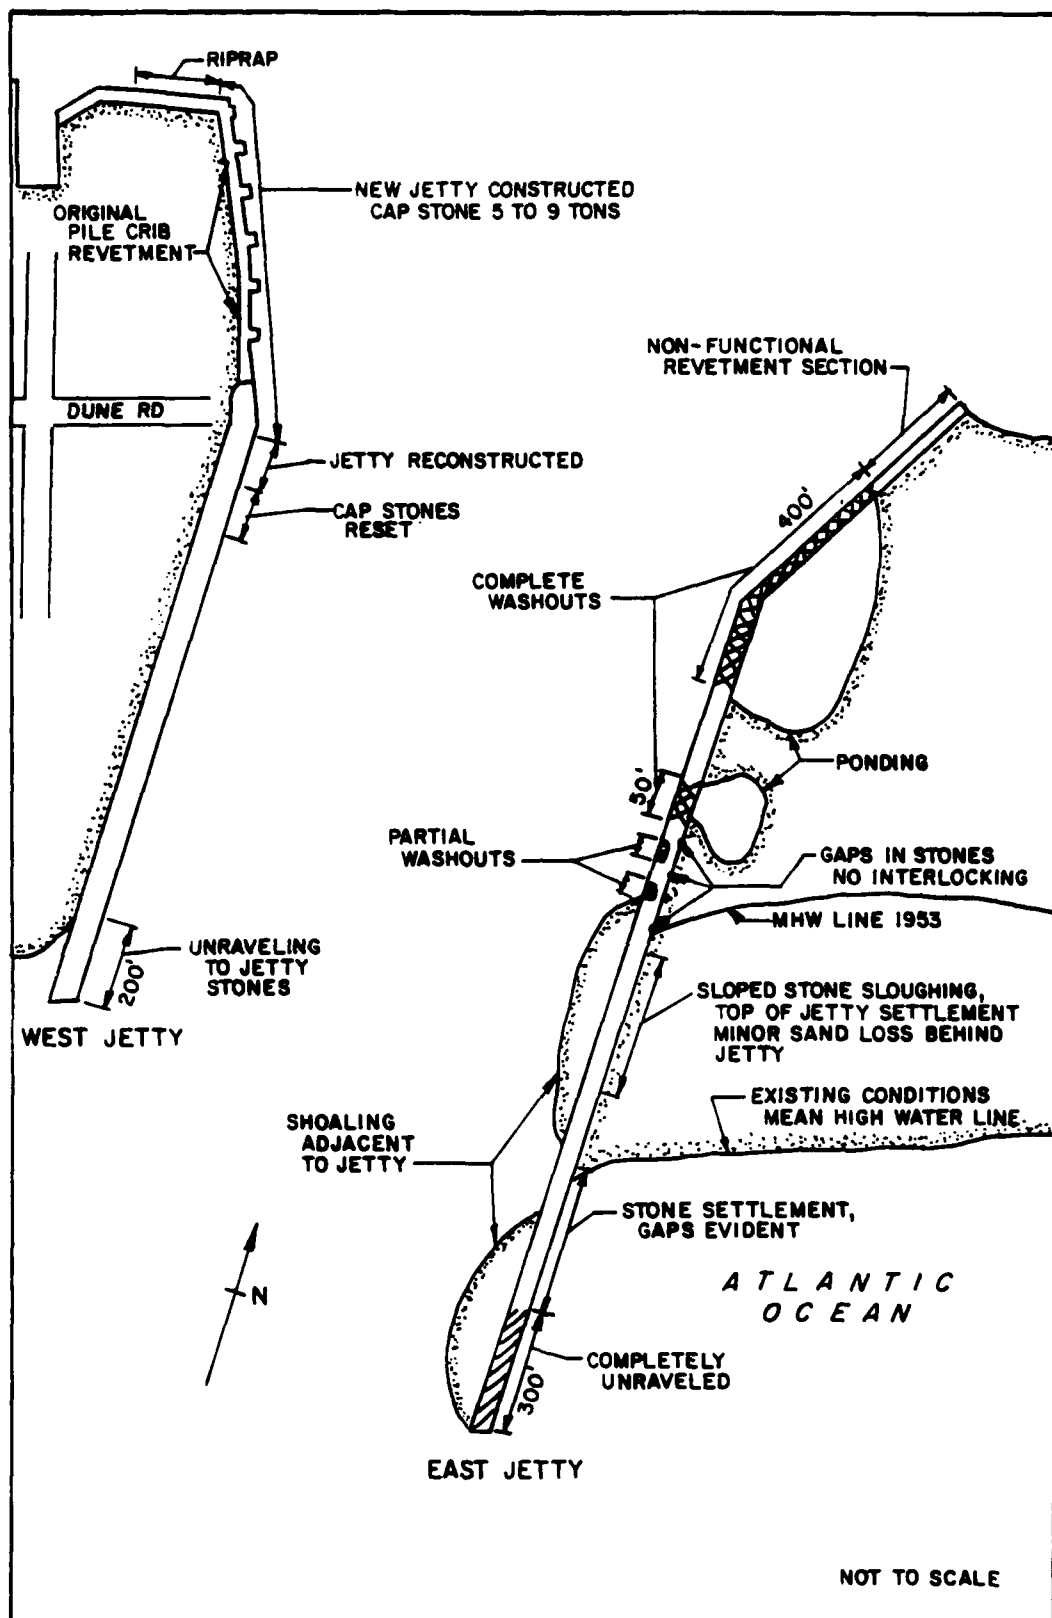
Figure 18. 1982 reconstruction of west jetty and 1985 existing conditions of east jetty, Shinnecock Inlet

| <u>Date(s)</u> | <u>Construction and Rehabilitation History</u> |
|---|---|
| 1982 | The west jetty was reconstructed by resetting cap stones to original design geometry over 170 ft. A 1,470-ft-long pile crib revetment on the north end of the west jetty was replaced by a rubble-mound jetty. (Figure 18). |
| 1985 | A survey revealed that the reconstructed portion of the west jetty was in good condition. The seaward 200 ft of the west jetty had unraveled and capstones were scattered. The west jetty head had not maintained design configuration. Stones on the inlet side of the east jetty had sloughed in some sections, but stones on the beach side had retained their original position. Two areas on the northern end were completely deteriorated. Erosion of sand caused undermining of the east jetty with continual loss of sand undermining it further. |

| Date(s) | Construction and Rehabilitation History |
|---|---|
| 1985<br>(Cont.) | There were areas of partial washouts of stone, settlement, and non-interlocking capstones. The seaward 300 ft was completely unraveled, with all stones scattered (Figure 18). It was determined that the jetties had served their function of inlet stabilization and they were not leaking significant amounts of sand. |

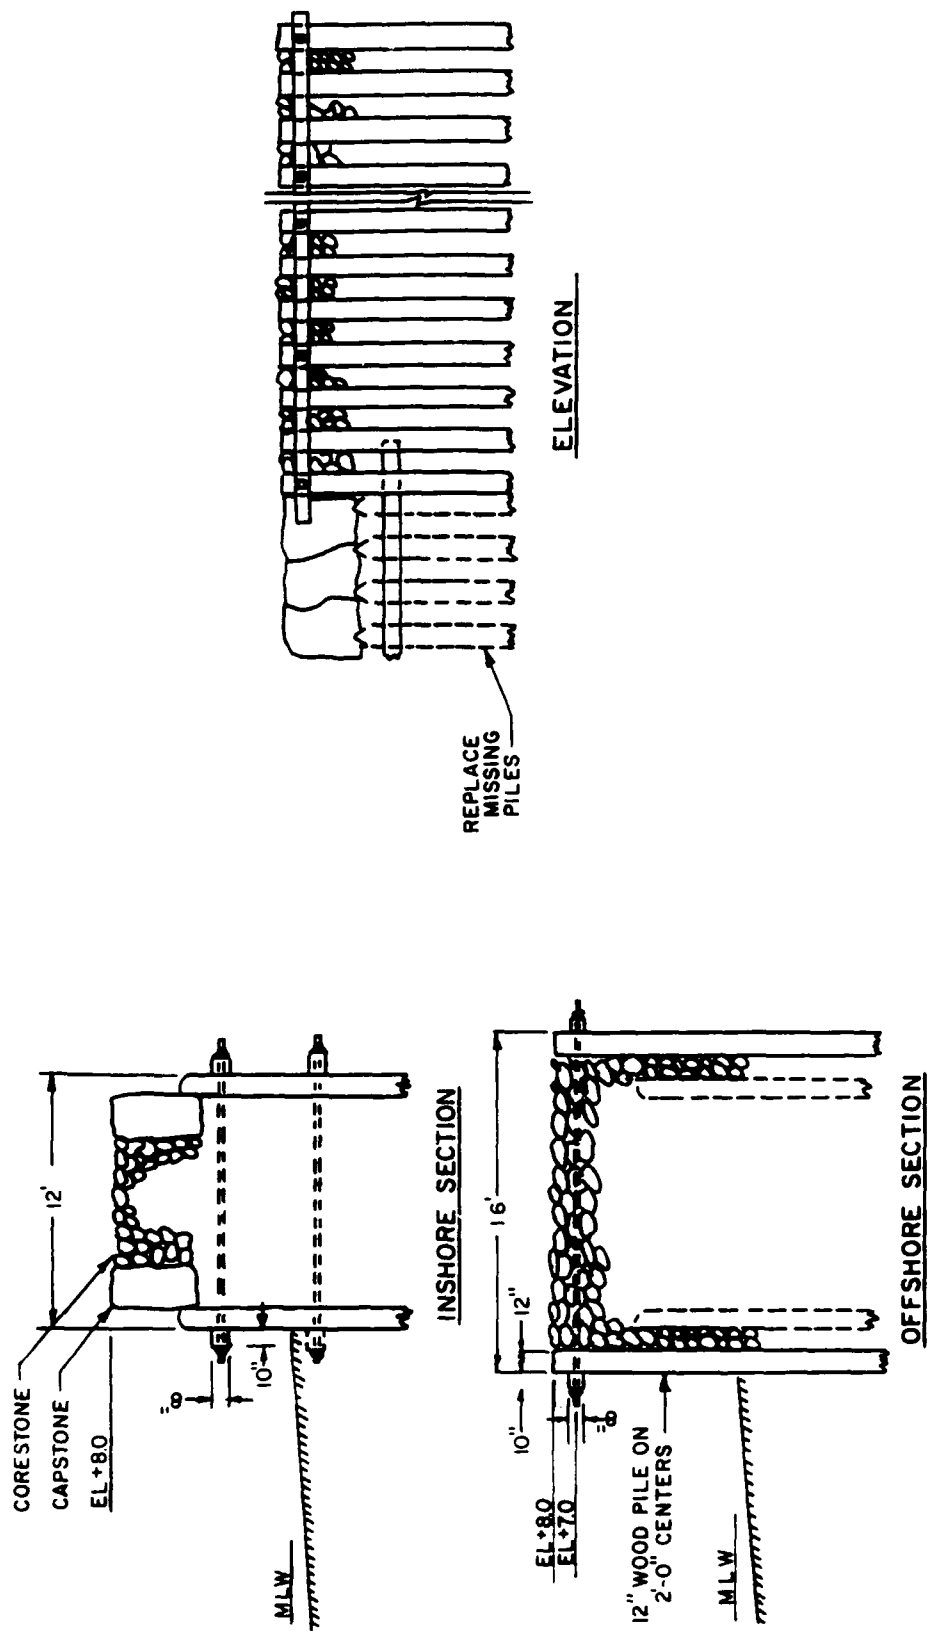
Figure 29. Rehabilitation of Mantua Creek jetties, 1963

| <u>Date(s)</u> | <u>Construction and Rehabilitation History</u> |
|---|---|
| 1962 | An investigation of the jetties revealed the jetties had settled an average of 2.0 ft. Approximately 100 ft of the offshore end of the east jetty had deteriorated, with most of the pilings gone, and stone had fallen out to below the waterline. Most of the walings had deteriorated and were missing. Piles were missing at intermediate locations along the jetties, but there was no significant loss of stone at those locations. Piles that remained were in good condition. |

| <u>Date(s)</u> | <u>Construction and Rehabilitation History</u> |
|---|---|
| 1963 | The jetties were rehabilitated at a cost of \$136,895. A new row of piles was placed over approximately 100 ft at the offshore ends. Piles were placed 7.5 ft on either side of the center line of the jetties. Corestone was dumped between the piles to an elevation of +8.0 ft mlw (Figure 29). Missing piles were replaced, and new wales were provided along the remainder of the jetties. One row of capstone was placed on the inner sides of both cribs on top of the existing stone to +8.0 ft mlw. Core stone was filled between the capstones in the center of the jetties to +8.0 ft mlw (Figure 29). Crown width was 16.0 ft at the offshore ends and 12.0 ft on the remainder of the jetty. Design wave height was 4.2 ft. |
