HISTORIC STANDING STRUCTURE  
INVESTIGATION OF THE SOURIS RIVER  
BASIN PROJECT RURAL IMPROVEMENTS

HISTORICAL RESEARCH ASSOCIATES

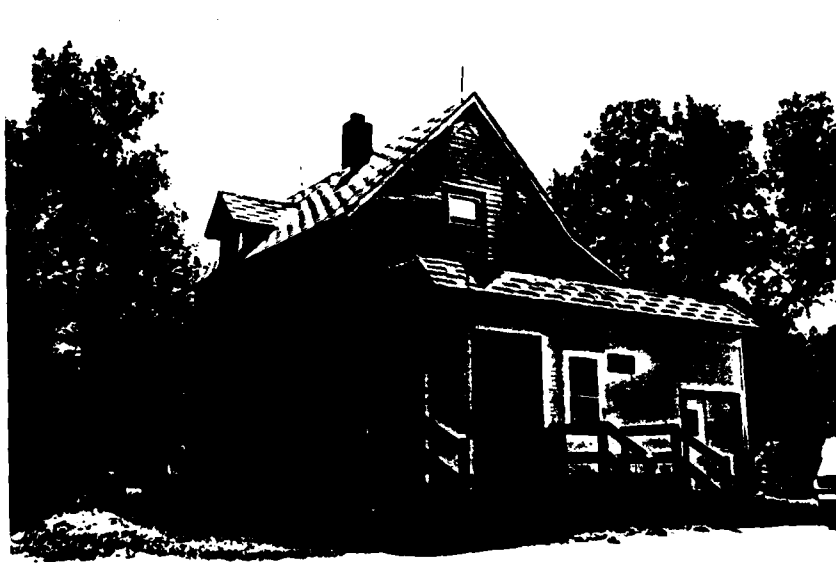
Feature 6 is a two story, gable-roofed, wood frame residence built, according to the present owners, in 1906 or 1907 (Figure 5). The building has a shed-roofed, frame addition on the west elevation and a flat-roofed, frame, enclosed porch addition on the north elevation. There is a small, gable-roofed dormer on the second floor of the east elevation of the main feature and a recently added redwood deck on the first floor of the east elevation. The feature rests on a cut sandstone foundation. The siding material is 1x4 clapboard on the original structure and the shed-roofed addition, and is wood paneling on the north-facing, flat-roofed addition. There is one one-over-one (1/1) double-hung window with an aluminum storm on the second floor of the north elevation, and two two-lite Anderson windows and two single-entry doors on the porch addition on the north elevation. There is a three-lite fixed-pane window on the west elevation of the porch addition, a one-lite Anderson window and a 2/2 double-hung window on the west elevation of the original structure, and

Figure 5. Looking southeast at Feature 6 of 32MH31 (HRA 81).

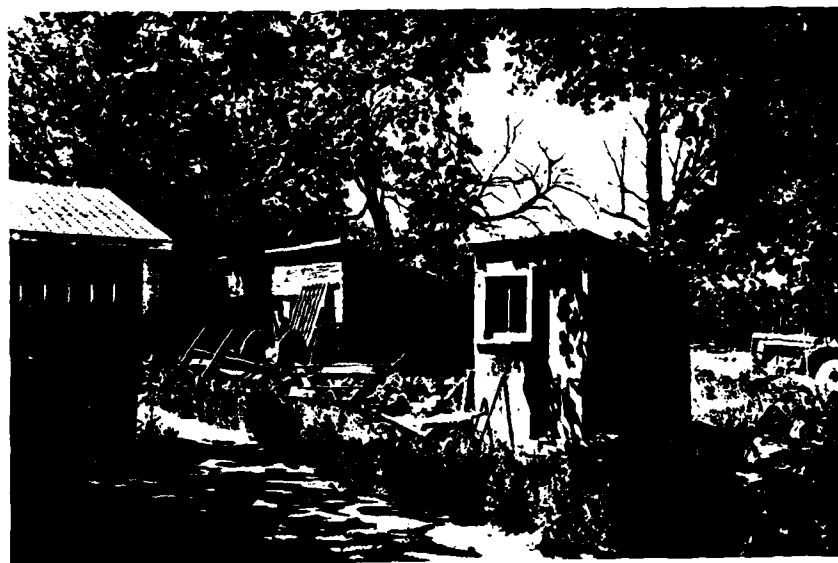
Feature 8 is a one story, frame, shed-roofed, storage building (Figure 6). The siding and roofing material consists of plywood panels. The building does not have a foundation. There is a single-entry door and one two-lite fixed-pane window on the south elevation. The building is in good condition and, although the owners did not know when it was built, it was probably constructed in the late 1930s. The feature is not architecturally significant.

Feature 9 is a one story, shed-roofed, frame, chicken coop that rests on the ground (see Figure 6). The roofing material is wood shingles and the siding is 1x4 tongue and groove. There are a single-entry door, three window openings without glass, and one two-lite fixed-pane window on the south elevation of the feature. The chicken coop is in fair condition and probably was built in the 1930s. The feature is not architecturally significant.

Figure 6. Looking northwest at Feature 8 (far right) and Feature 9 (rear center) of 32MH31 (HRA 81). A portion of Feature 10 is visible in the left of the photo.

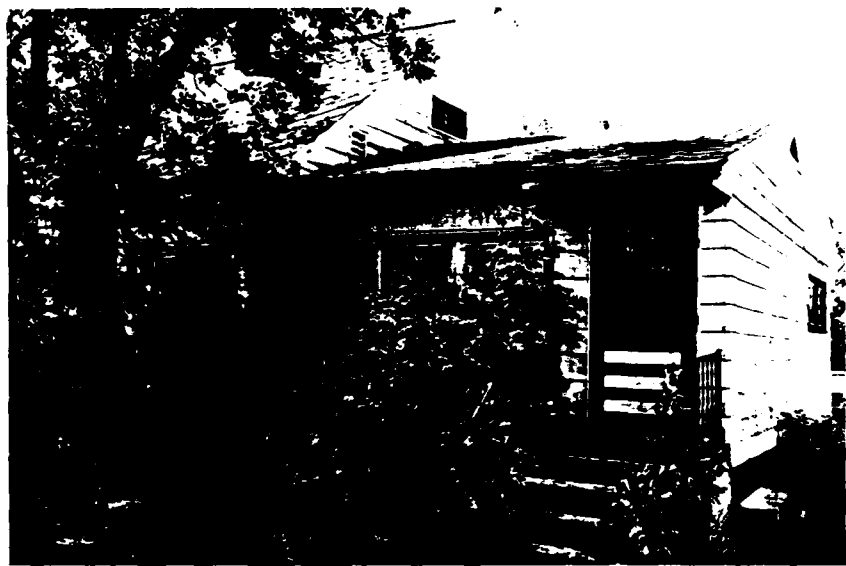
Feature 9 is a one story, wood frame, gable-roofed dwelling with a saltbox-roofed addition on the north elevation, and a gable-roofed addition on the west elevation (Figure 15). The roof is composed of asphalt shingles, and the siding is 1x10 clapboard. An exterior chimney abuts a porch on the north elevation, and an interior chimney is located near the center of the structure. The foundation is a combination of concrete and concrete block. There are a single-entry door, two 4/4 double-

Figure 15. Looking southeast to the northwest end of Feature 9 of 32MH33 (HRA 195-199).

hung windows, and two 6/6 double-hung windows on the north elevation of the main part of the house; and a single-entry door and two one-lite fixed-pane windows on the north elevation of the west addition. The east elevation of the house has three 6/6 double-hung windows, and the south elevation has five 6/6 double-hung windows. The house was built since 1945 and is in good condition. The feature is less than fifty years old and does not maintain historic association.

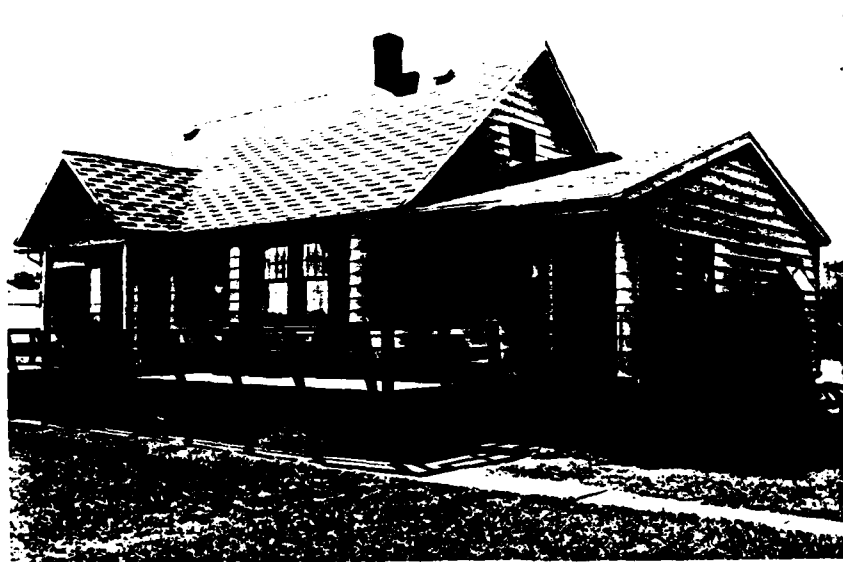
Feature 10 is a one and one-half story, wood frame, gable-roofed dwelling (Figure 16). There is a gable-roofed addition on the north elevation. The main house stands on a concrete foundation, while the addition has a concrete block foundation. The roof is composed of asphalt shingles and the house is sided with aluminum siding. On the north elevation of the house are two single-entry doors, three 6/1 double-hung windows, one 1/1 double-hung window on the main portion, and a single-entry door on the west addition. A deck runs the length of the north elevation. On the west elevation are two one-lite Anderson windows. The south elevation has three 6/1 double-hung windows and one 1/1 double-hung window on the main portion, and a one-lite Anderson window on the addition. The east elevation has two 1/1 double-hung windows. The house was built since 1945 and is

Figure 16. Looking southeast at Feature 10 of 32MH33 (HRA 195-199).

in good condition. The feature is less than fifty years old and does not maintain historic association.

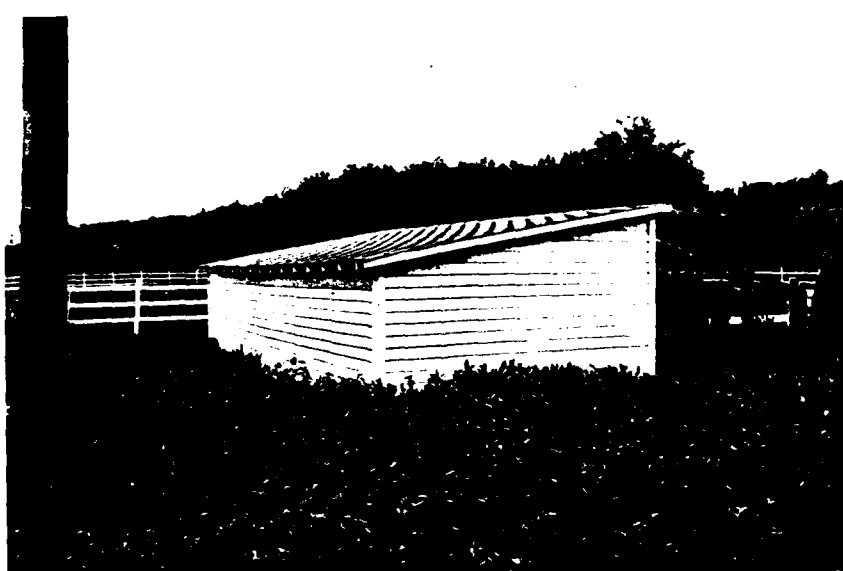
Feature 8 is a one story, wood frame, shed-roofed, chicken house (Figure 29). The structure has an asphalt shingle roof, 1x4 tongue and groove siding, and no visible foundation. There are single-entry doors on the east and south, and six window openings covered with chicken wire along the south elevation. The chicken house probably dates from around 1930-1945 and is in good condition. The feature is not architecturally significant.

Figure 29. Looking southeast at Feature 8 of 32MH36 (HRA 320).

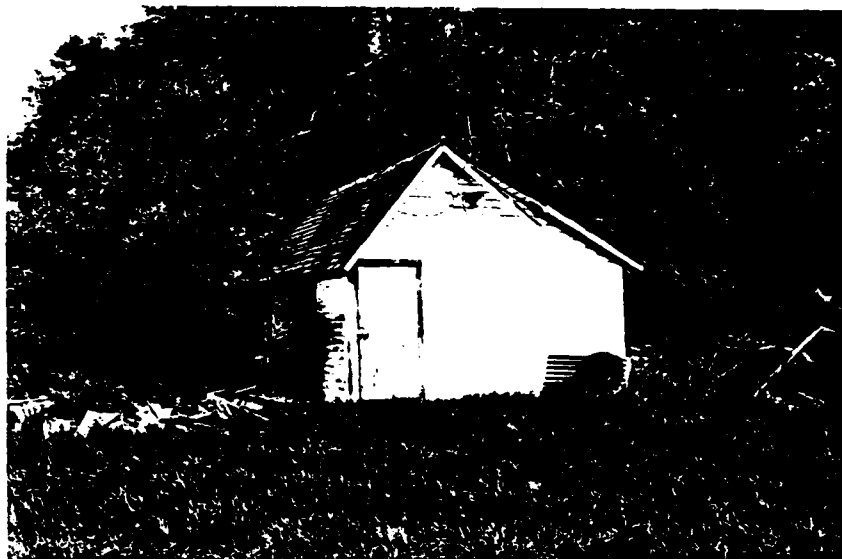
Feature 8 is a one story, wood frame, storage building with a saltbox roof (Figure 38). It is roofed with wood shingles and sided with 1x4 clapboard. The building rests on a concrete foundation. There is a single-entry door on the east elevation and four six-lite fixed-pane windows on the south elevation. The storage building probably was built after 1945. It is now used partially for coal storage and is in good condition. The feature

Figure 38. Looking west at Feature 8 of 32MH43 (HRA 430).

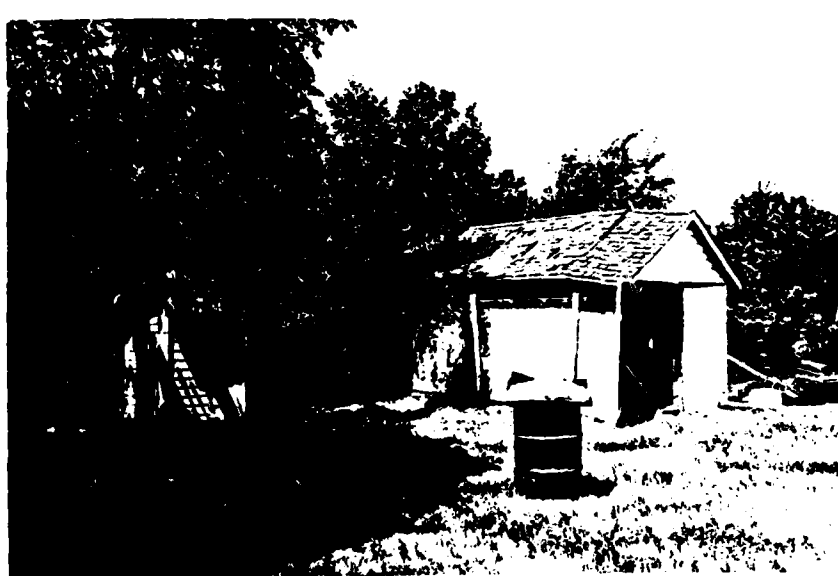
Feature 3 is a one story garage with a gable roof (see Figure 42). It was built in 1935. Probably once used as a buggy shed, the western three-quarters of the feature is the original portion, and the eastern one-quarter is an addition, which is separating from the original. The roofing material is wood shingles and the exterior siding is comprised of tongue and groove. The foundation is concrete. There is a single vehicle entry with two hinged doors on the east elevation. The feature

Figure 42. Looking northwest at Feature 2 (left) and Feature 3 (right) of 32MH34 (HRA 451).

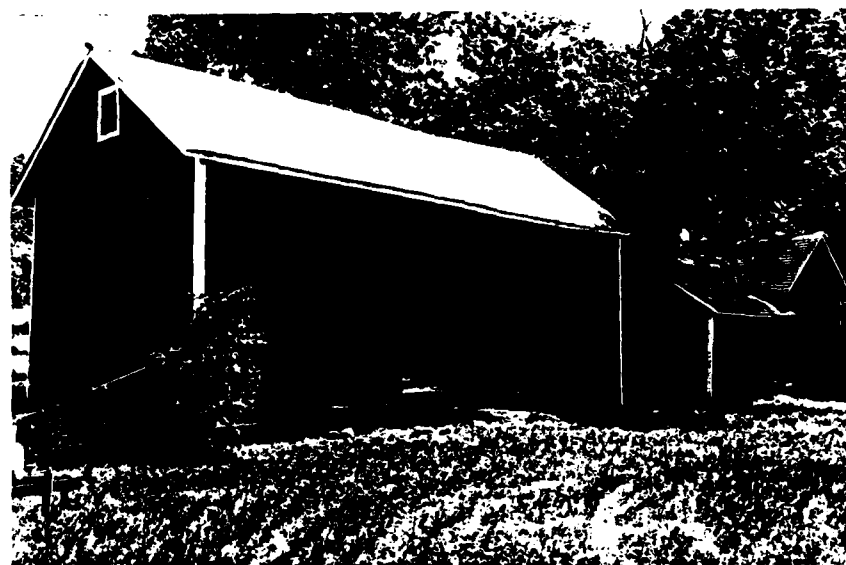
Feature 8 is a one story storage building with a gable roof (see Figure 44). The feature appears to be two buildings joined together. The roofing material is wood shingles. The exterior siding is comprised of tongue and groove. The feature rests on a rock foundation. On the west elevation is a boarded up window opening and two single-entry doors. The feature is in fair

Figure 44. Looking east at Feature 7 (left) and Feature 8 (right) of 32MH34 (HRA 451).

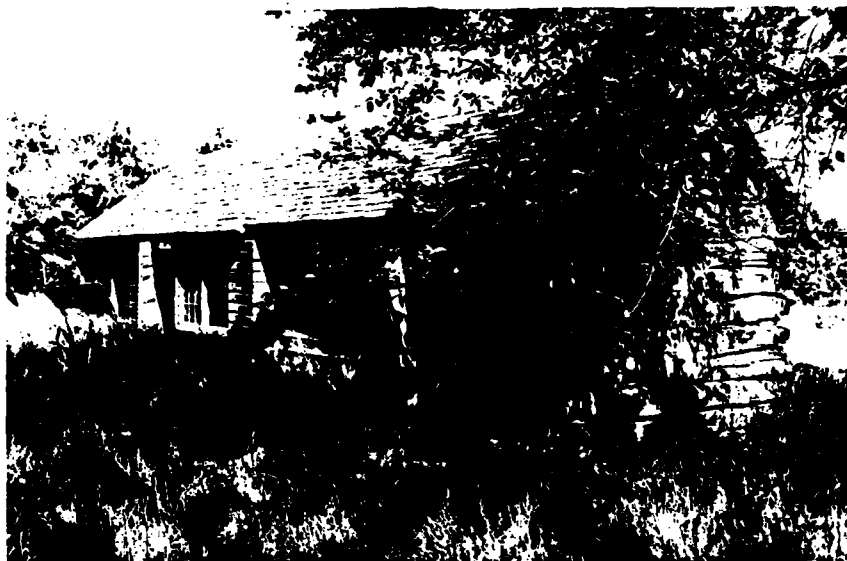
Feature 9 is composed of two single story gable-roofed buildings joined together and converted to a chicken coop (Figure 48). The east half of the feature is made of dovetail-notched logs and is covered with a combination of 1x4 tongue and groove

Figure 48. Looking northwest at Feature 9 of 32MH42 (HRA 452).

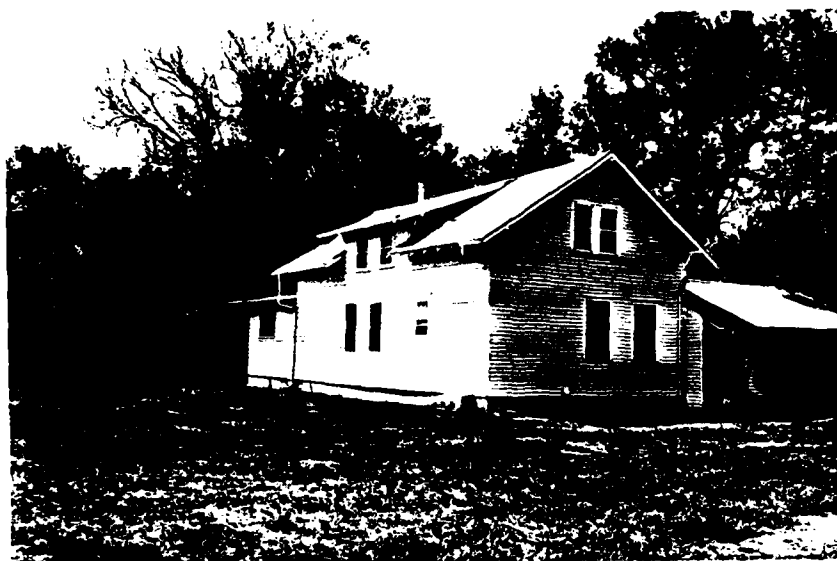
Feature 11 is a two story, frame, house with a gable roof (Figure 54). The house has asphalt shingle roofing, 1x4 clapboard siding, and rests on a concrete foundation. There are two story gable-roofed additions on both the north and south elevations, a one story gable-roofed addition on the south elevation, and a one story gable-roofed garage adjoining the northwest elevation. The east elevation has five 6/6 double-hung windows with wood frame screens and a one-lite fixed-pane window on the one story addition. The north elevation has four 6/6 double-hung windows on the house and two four-lite fixed-pane windows on the garage. There are three 6/6 double-hung windows, one six-lite fixed-pane window, and two single-entry doors on the west elevation. The south elevation has two four-lite fixed-pane windows in the garage, two 6/6 double-hung windows on the second floor, and a picture window on the ground floor with a one-lite Anderson window on either side. The feature was moved onto the site in 1946. The two story additions and the garage were built

Figure 54. Looking southwest at Feature 11 of 32MH35 (HRA 454).

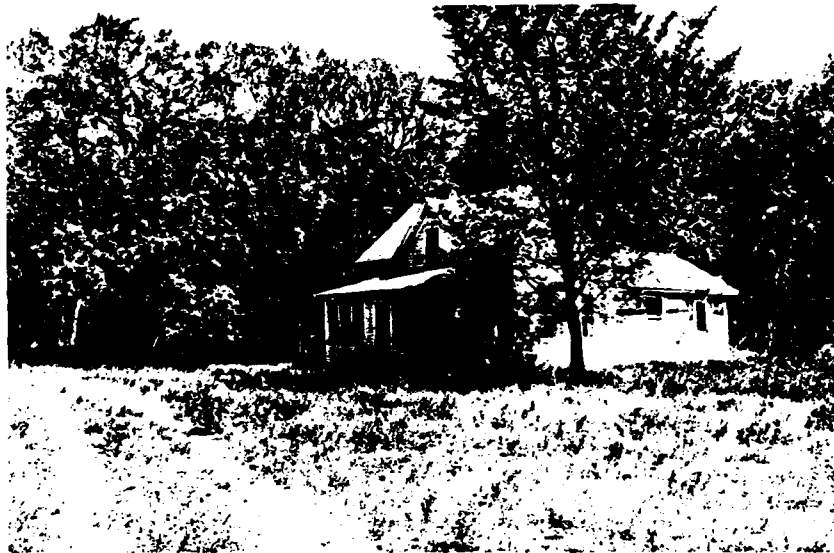
Feature 11 is a two story, wood frame, gable-roofed dwelling on a concrete foundation (Figure 58). There is an original, rectangular portion with a north/south orientation, and additions are located on the east and west elevations. The south elevation of the original portion has a 1/1 double-hung window in the second floor gable and two 1/1 double-hung windows on the ground floor. The north elevation has a 1/1 double-hung window in the second floor gable, one off-centered 1/1 double-hung window on the ground floor, and an exterior brick chimney opposite it. On the west elevation is a one 1/1 double-hung gabled window in the upper floor. There is a one story, shed-roofed addition on the west elevation, with a single-entry door and three 1/1 double-

Figure 58. Looking north at Feature 11 of 32MH40 (HRA 475).

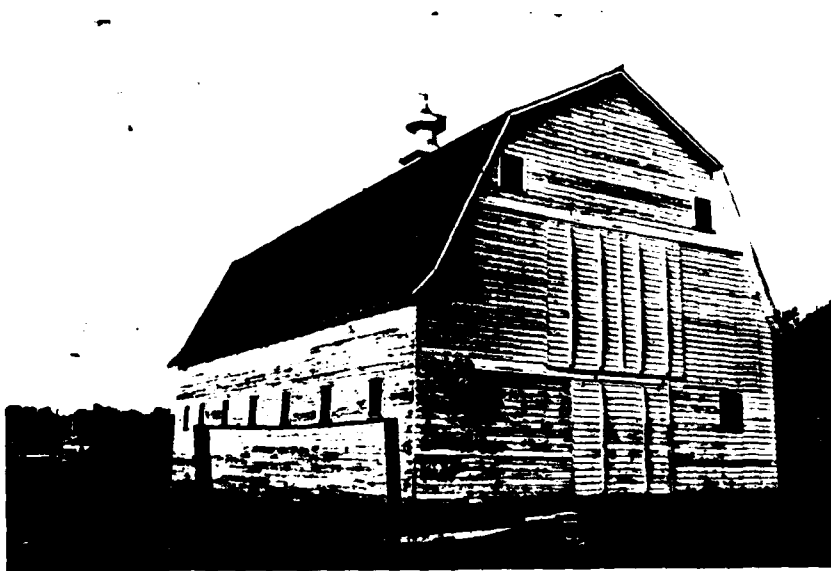
Feature 7 is a three story, frame, barn with a gambrel roof (Figure 62). The roofing material is wood shingles. There is a metal vent at the center of the roof. The exterior siding is 1x4 clapboard. The foundation is concrete. On the north elevation are two four-lite fixed-pane windows. On the first floor of the

Figure 62. Looking southwest at Feature 7 of 32MH39 (HRA 485).

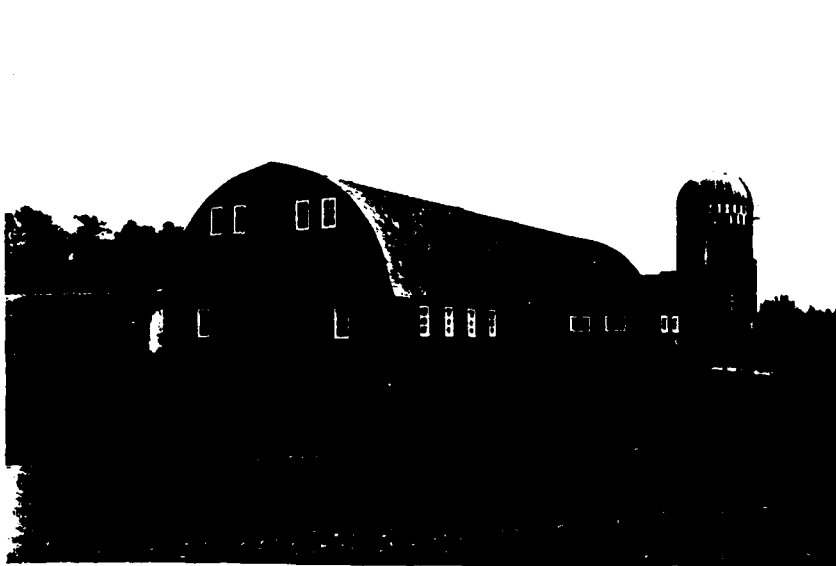
Feature 5 is a three story, concrete block, silo with a dome roof (see Figure 69). It was constructed in 1957. The roofing material is corrugated metal. There are cable bands at one- to two-foot intervals. The grain loading doors are located on the third level on the north elevation. The doors for unloading are located on the first level on the north elevation. The feature is in good condition. The feature is less than fifty years old and does not maintain historic association.

Figure 69. Looking southeast at Feature 1 (center), Feature 4 (right), and Feature 5 (right rear) of 32MH41 (HRA 580).

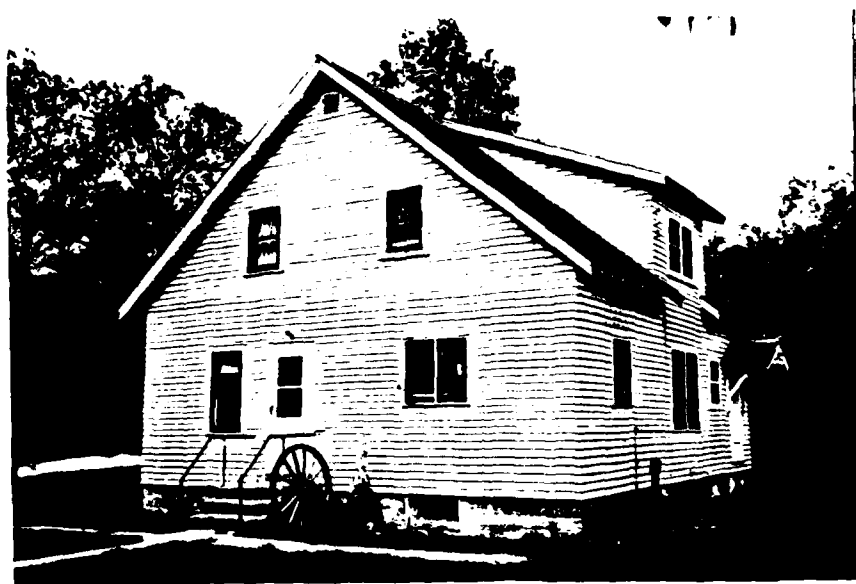
Feature 7 is a two story, wood frame, residence with a gable roof (Figure 71). It was built in 1949. The roofing material is wood shingles. There are two dormers -- one on the west elevation and one on the east elevation. A chimney is located in the center of the roof. The exterior siding is 1x4 clapboard. The foundation is concrete. The feature includes a three-step, concrete porch on the south elevation, and a basement. Also located on the south elevation of the feature are two 3/1 double-hung windows on the upper level and a twelve-lite fixed-pane window, a 1/1 double-hung window, and a single-entry door on the lower level. There are two 1/1 double-hung windows and one 3/1

Figure 71. Looking northwest at Feature 7 of 32MH41 (HRA 580).

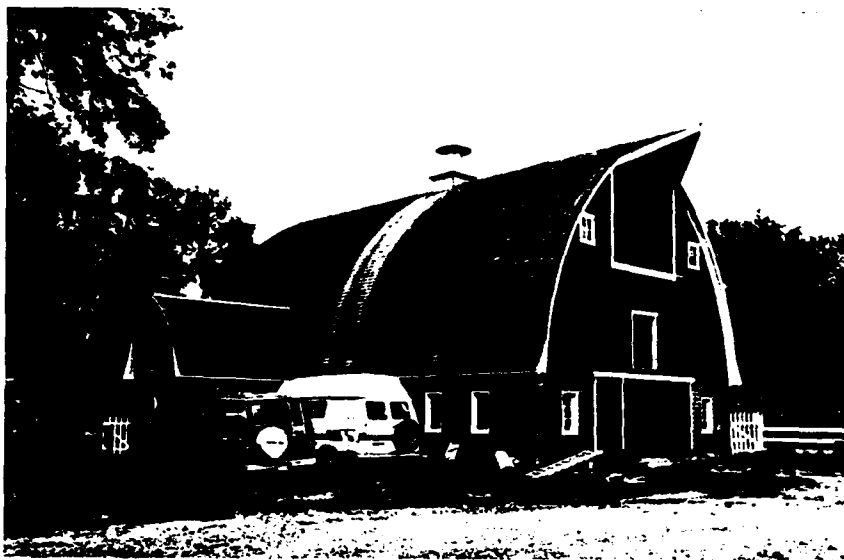
Feature 5 is a two and one-half story, gothic-roofed, frame barn on a concrete pad (Figure 80). The north elevation has three four-lite fixed windows in the upper floor, one hay loading door on the second floor, and a wide vehicle access opening with sliding wooden doors. The west elevation has one single-lite fixed window and one six-lite fixed window on the northwest end. There is a six-lite window with a 3/4 wooden door above it on the addition to the west elevation. There are a door and a six-lite window on the south elevation of the addition. There are five six-lite fixed-pane windows on the ground floor of the west elevation of the main structure. The south elevation has a large opening with a hinged door in the hay mow. There are two four-lite fixed-pane windows on either side of this door. There is one hay loading door on the second floor. There are two six-lite fixed-pane windows on the first level. There is also a wide vehicle access opening with sliding wooden doors. The east elevation has seven six-lite fixed-pane windows and one single-entry door. The walls of the barn are constructed of ceramic tile bricks on the first floor with horizontal tongue and groove milled lumber on the second and third floor of the north and

Figure 80. Looking northeast at Feature 5 of 32WD55 (HRA 1130).

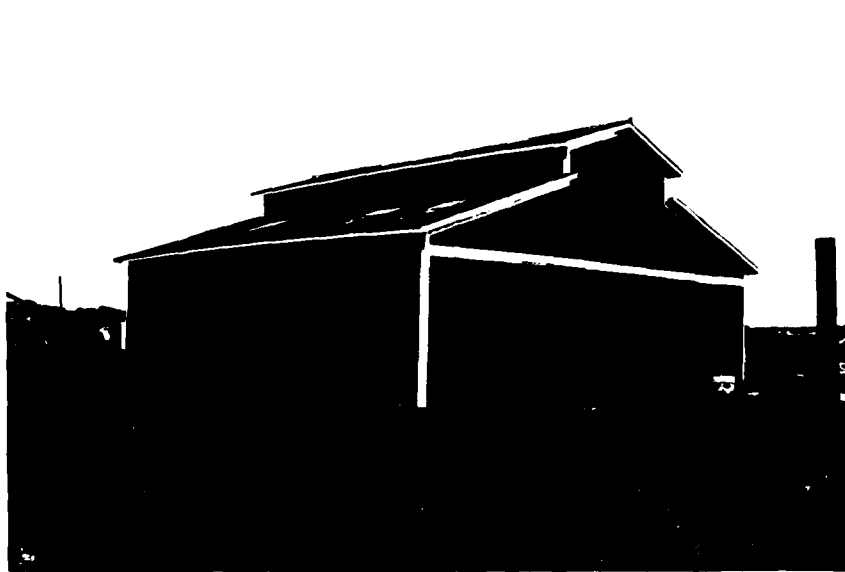
Feature 6 is a one and one-half story, gable-roofed granary measuring 8.25x9 meters, with 1x4 shiplap siding (Figure 81). There are full-length, shed-roofed additions on both the north and south elevations. There are sliding doors on both the northwest and southeast ends. There is a grain door on the lower south elevation and two grain doors on the lower north elevation. The foundation consists of a long concrete pad through the center of the structure and the north and south grain storage areas are supported by long concrete beams. The roofing material is wood shingles. The feature was moved onto the site and therefore lacks integrity of association.

Figure 81. Looking southeast at Feature 6 of 32WD55 (HRA 1130).
