TECHNICAL REPORT REMR-CS-21

IN SITU REPAIR OF DETERIORATED CONCRETE  
IN HYDRAULIC STRUCTURES:  
A FIELD STUDY

Final Report

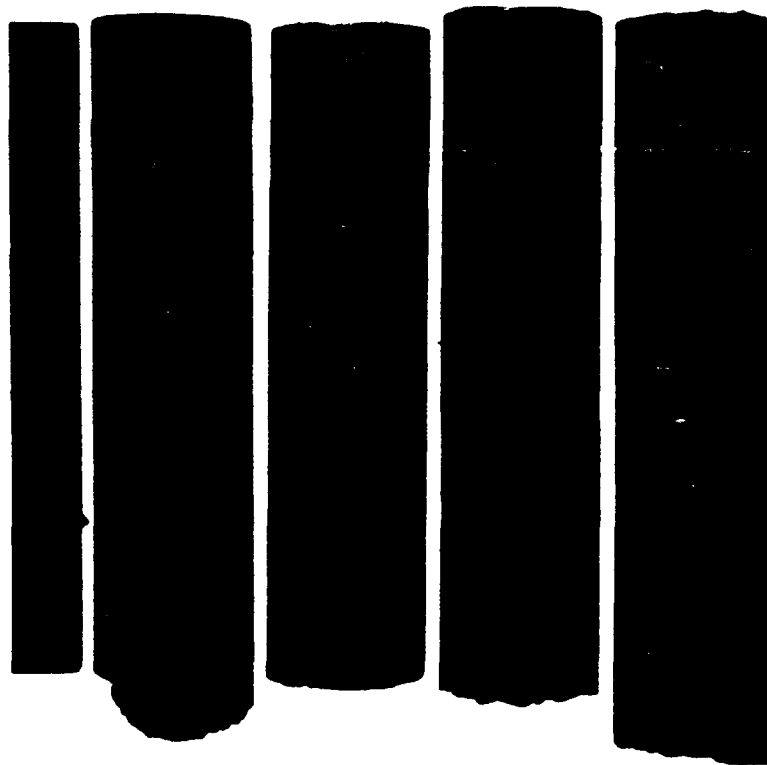
32. Visual examination of the 3-in.-diam cores removed from the wall after repair showed that the crack extended a minimum of 12 in. into the wall (Figure 7). Crack thickness varied up to 0.04 in. The cracks appeared to contain 80- and 100-percent epoxy.

33. Results of splitting tensile strength tests varied between 591 and 805 psi and averaged 693 psi, compared to an average of 659 psi for the uncracked controls.

Figure 7. Cores removed from concrete retaining wall after repair

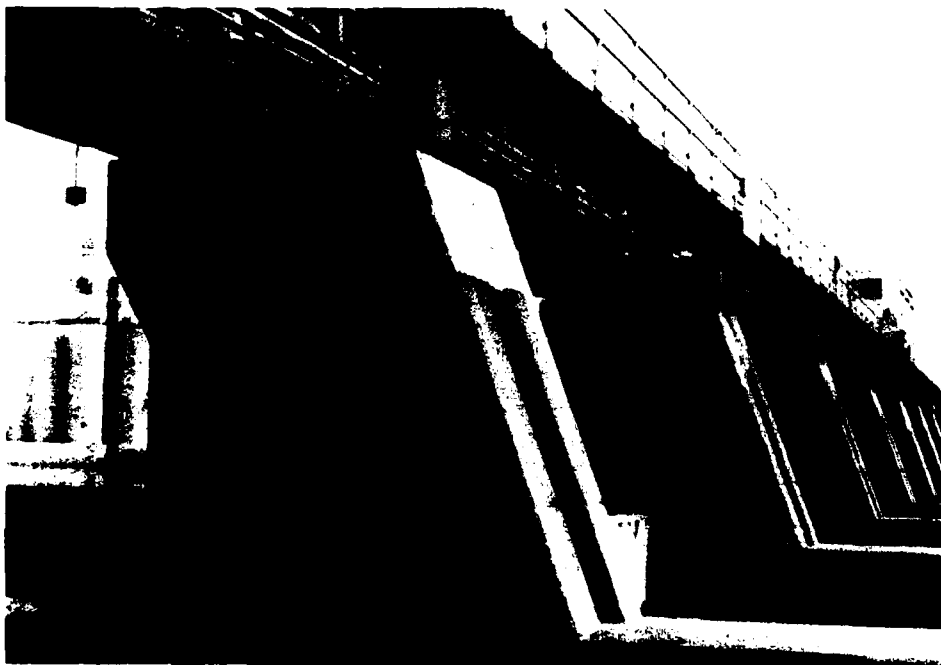
Figure 8. Pier No. 27 (in foreground)

36. Damage to the pier stems is most significant in the top 11 ft, the area from el 490 to the top of the pier at el 501.\* The damage is attributed to stresses developed by a lack of slip between the service bridge sole plates and the anchored bearing seats in the tops of the stems. Water allowed to pond because of the recessed bearing seats gains access to the pier stem interior through cracks caused by the anchor forces and accelerates deterioration of the concrete. Cracking in this area of the pier stems has been observed since 1939.

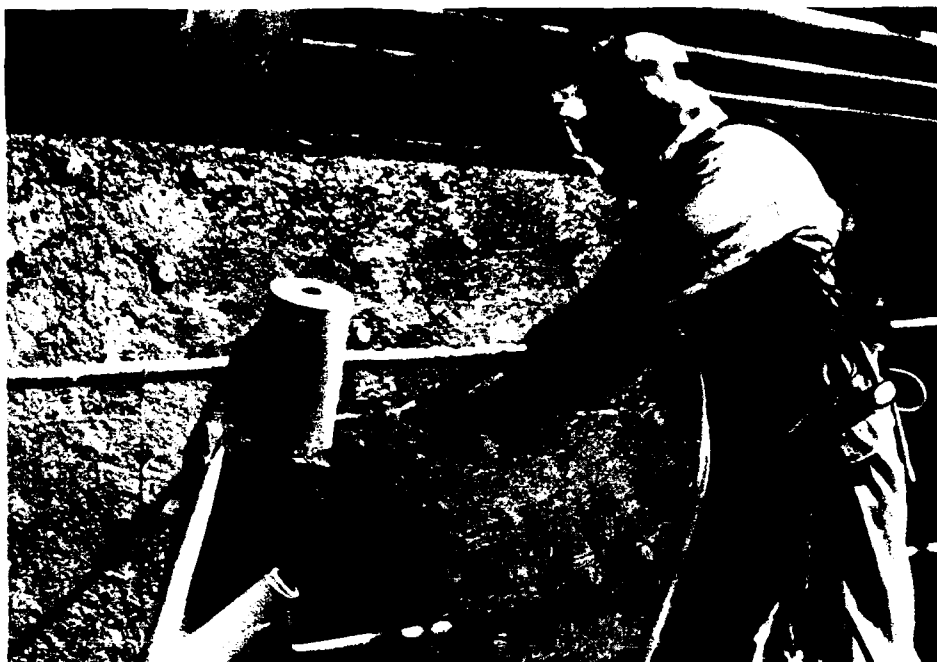
Figure 22. Injection of downstream face of pier stem

56. Injection of the pier stem began on the downstream face along the major crack that extended from the top of the pier stem down to the archway ceiling (Figures 22 and 23). Injection was started at the second port from the top of the crack: within 2 to 3 min epoxy appeared in the ports located directly above and below. These ports were plugged, and injection of resin into the starting port was continued until epoxy was observed coming out of ports farther along the crack. The starting port was plugged and the operation moved to another port along the crack. Injection proceeded downward along the length of the crack until all connecting cracks were filled, as evidenced by the pumping of epoxy out of the injection ports. All unconnected cracks remaining in the section were then injected. The operation then was moved to the next section.

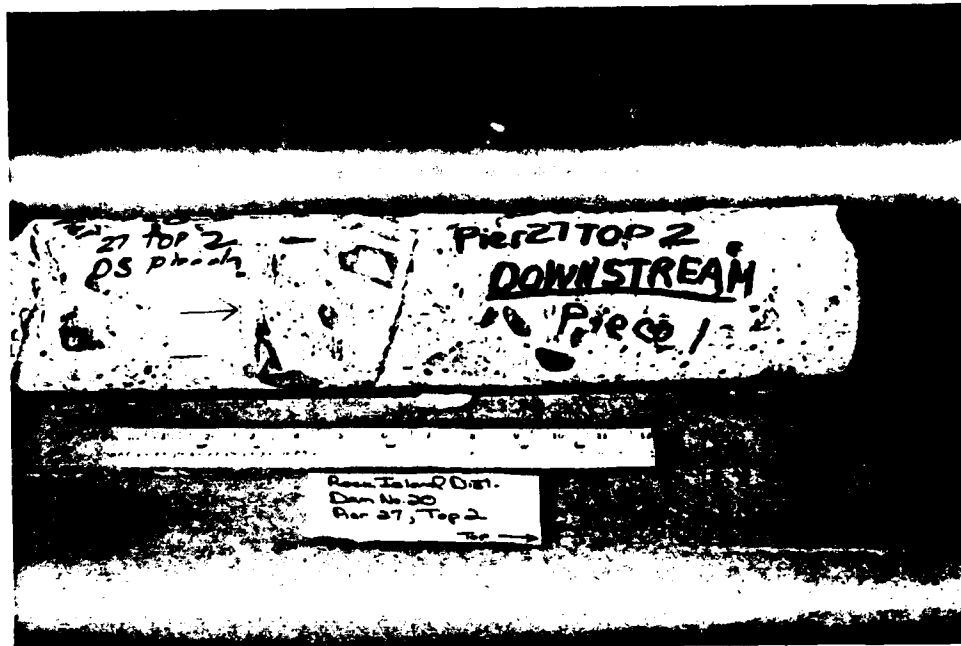
Figure No. 1

Side view of 4 in. dia. epoxy impregnated concrete core. Arrow denotes highly fractured deleterious chert coarse aggregate particle transected by well developed open fracture.

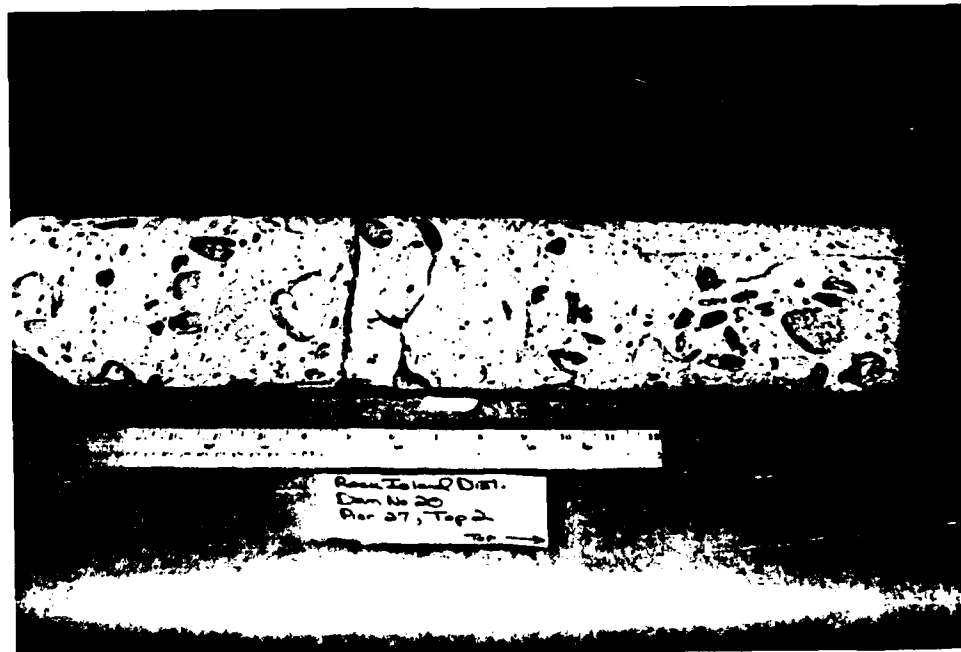
Figure No. 2

Same concrete core as in Figure 1, viewing opposite side. Note the two open fractures midway in the core at 0.88 ft. and 1.0 ft. below top of concrete.

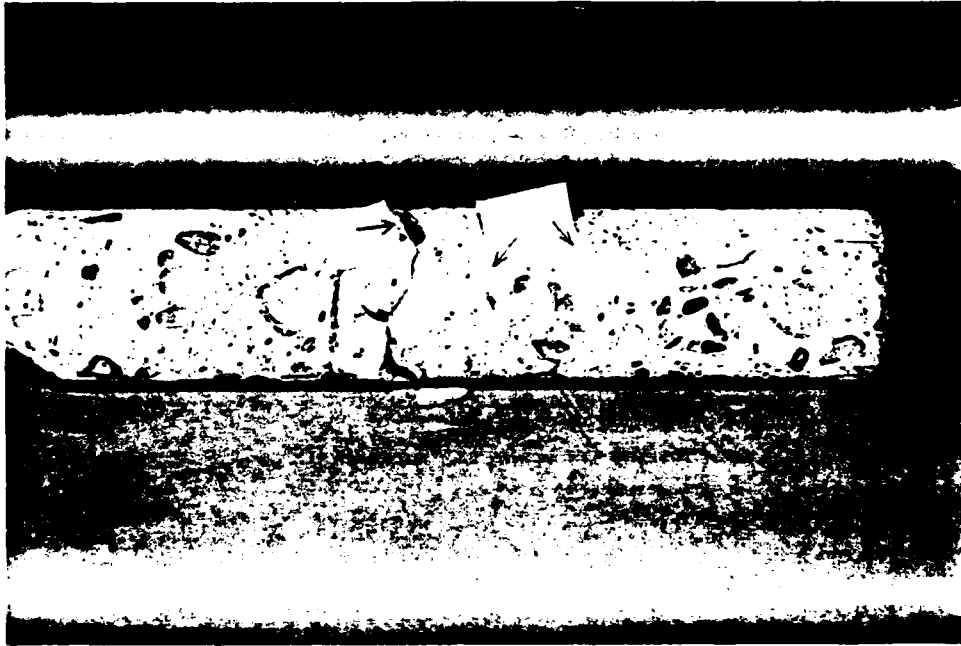
Figure No. 3

Same view as in Figure 2, arrows denote highly fractured freeze - thaw susceptible clay ironstone and chert coarse aggregate particles.

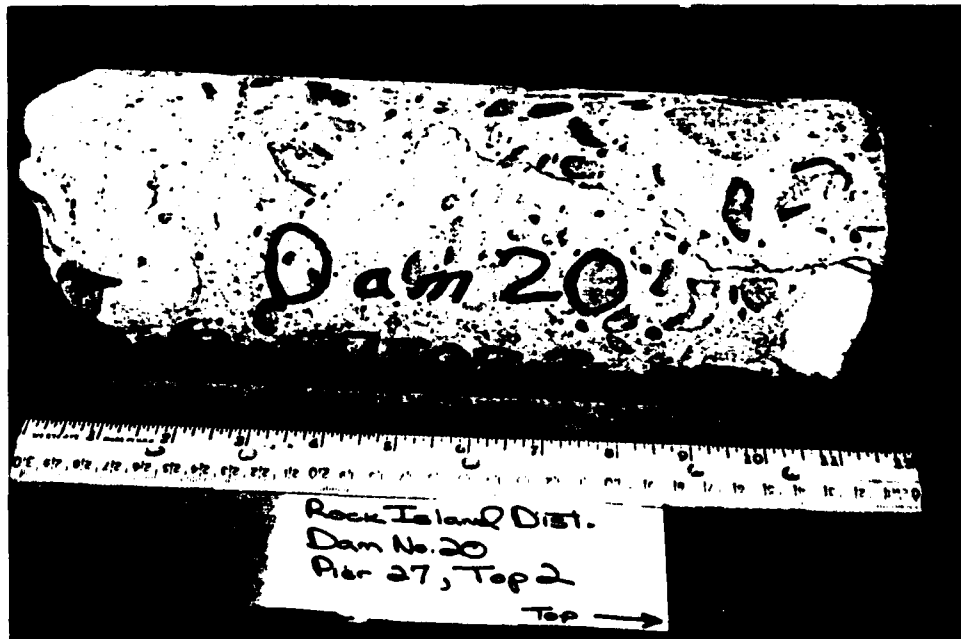
Figure No. 4

Same view as in Figure No. 1, close-up view of upper portion of epoxy injected concrete. Note prominent epoxy injected fracture oriented subparallel to the core axis.

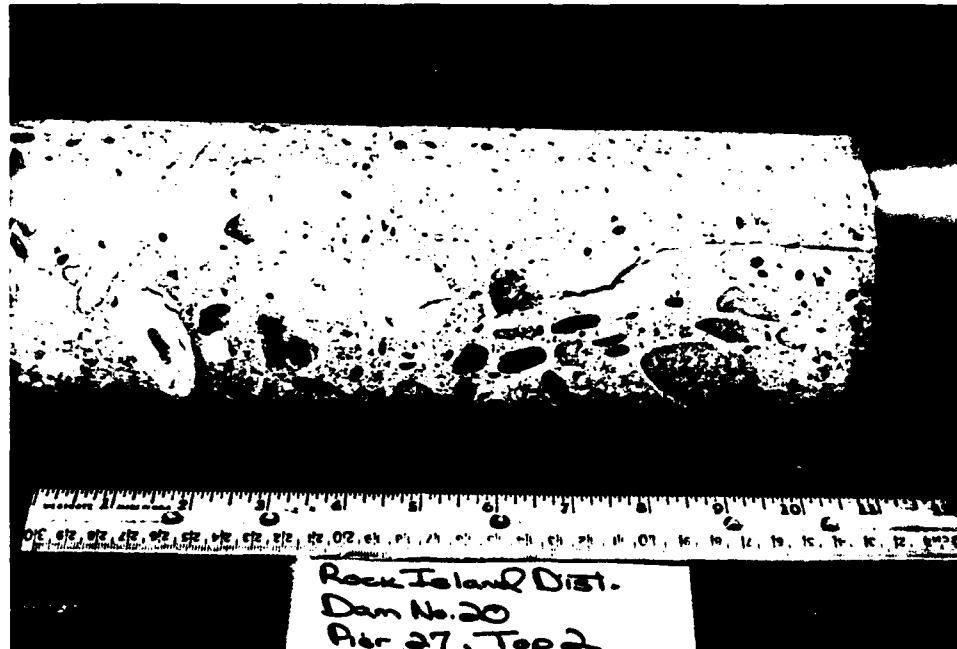
Figure No. 5

Magnified view of upper portion of concrete core shown in Figure 3. Note the light gray white chert coarse aggregate that have been highly fractured by freeze - thaw action.

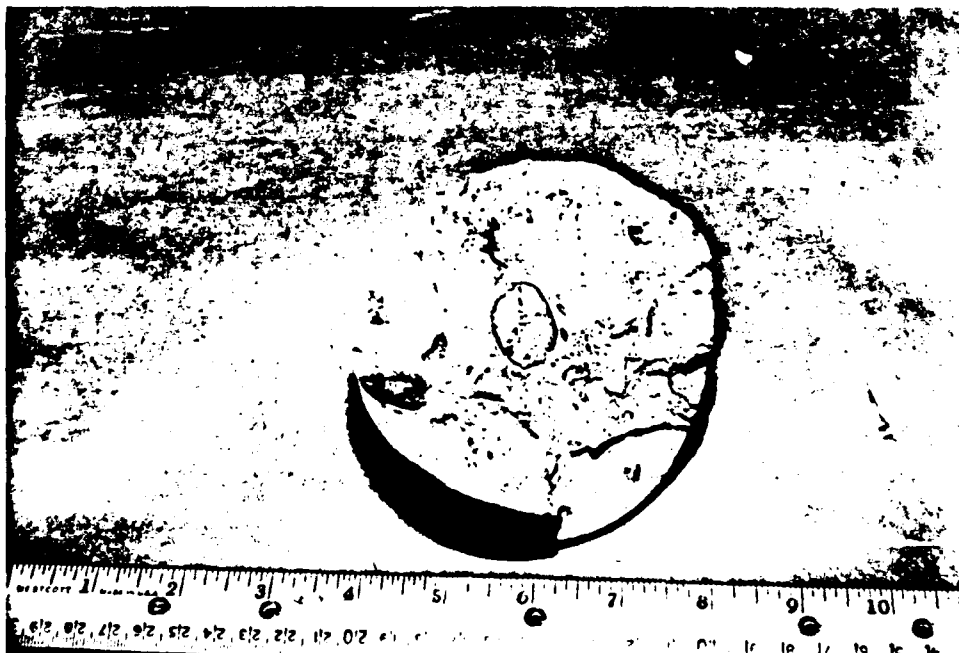
Figure No. 8

View of lower fracture surface located 0.88 ft. below top of core. Note alkali - silica reaction rims in deleterious coarse aggregate particles and white silica gel precipitate coating fracture surfaces.

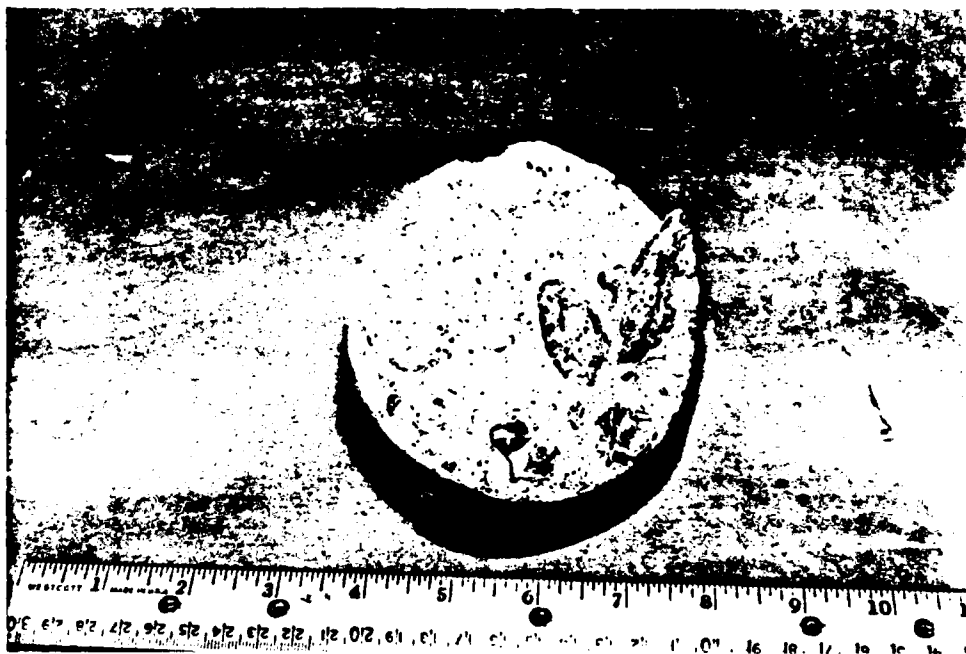
Figure No. 9

View of upper fracture surface located 1.0 ft. below top of concrete. Note white silica - gel soaking concrete paste surrounding alkali - silica reactive coarse aggregate.
