✓  
DOT/FAA/CT-88/27

# Electro-Impulse De-Icing Research (Fatigue and Electromagnetic Interference Tests)

March 1989

Final Report

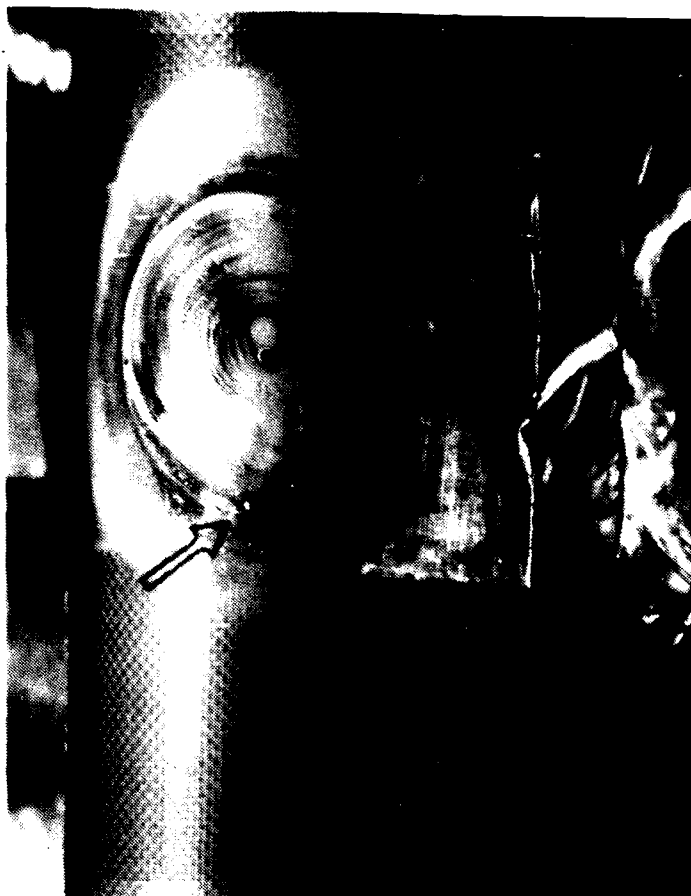
The coils had been made by Cessna with techniques developed at WSU. In the initial inspection, it was found that in one of the bays of each model, one of the coils had a connecting pin that was poorly covered by insulation, as shown in Figure 2-2. This was corrected by grinding the pin and covering it with fiberglass and epoxy. This would likely have caused a short across the 0.1 inch gap between the coil and doubler. The short could be dangerous to personnel as well as seriously reducing the de-icing capability of the unit.

Figure 2-2  
Coil Mounted on Semi-Cylindrical Beam. Poorly  
Insulated Pin is on Left Side of Coil.

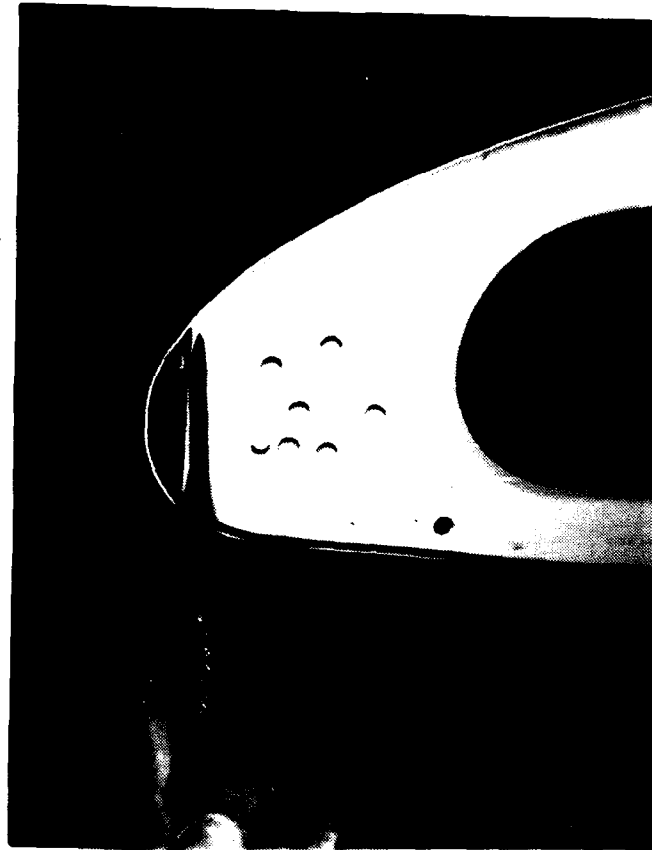
Similarly, the end closure rib which was rather casually inserted, showed the danger of ignoring fatigue considerations. The rivet holes misalignment and failure to bond the rib led to hairline cracking. The main conclusion is that fatigue is a solvable problem, but the EIDI system can cause fatigue breakage when stress concentration points are permitted in the design.

Figure 2-11  
Hairline Crack on End Rib  
of 0.040 Inch Skin Model

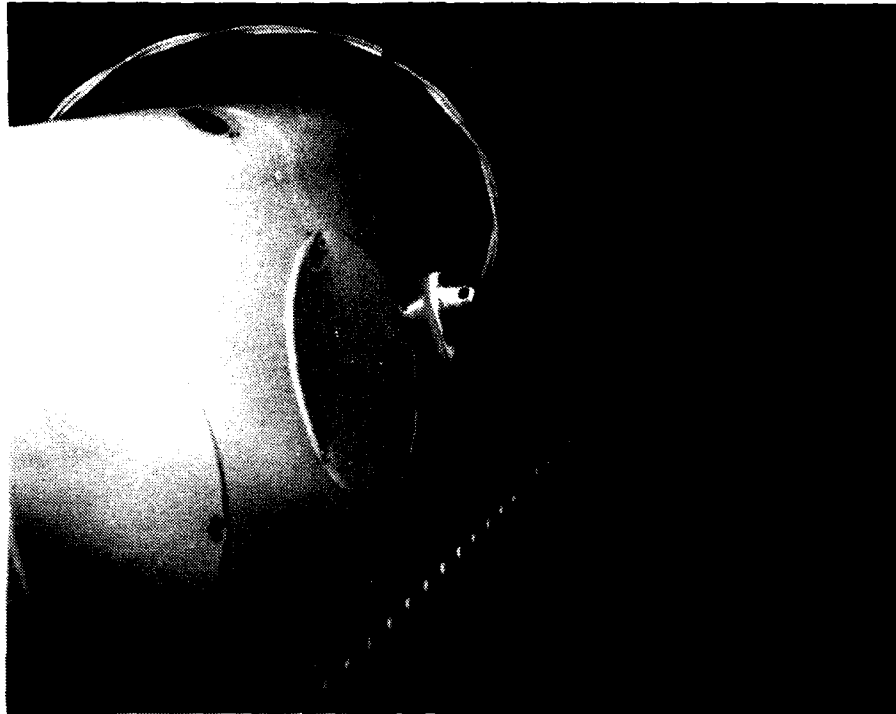
Figure 3-13  
Third Test Setup Power Wire Unshielded
