MISCELLANEOUS PAPER HL-89-4

SCOUR PROTECTION FOR MORGANTOWN DAM MONONGAHELA RIVER, WEST VIRGINIA

Hydraulic Model Investigation

August 1989

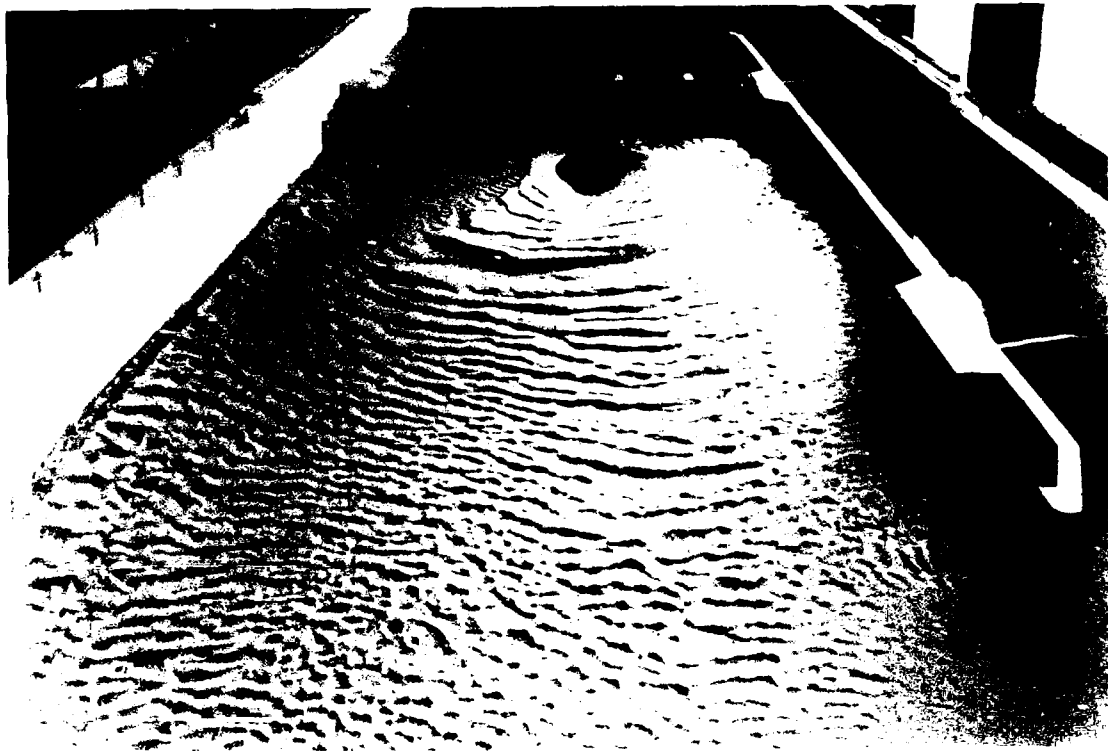
All tests were conducted using gate 3, which was one of the center-bays of the model, unless stated otherwise. After completion of the test, the model was drained slowly and results indicated that the type 1 riprap plan had failed. Another test was conducted with normal upper pool and tailwater, and a 6-ft gate opening, for a duration of 5 hr. The results shown in Photo 1 indicate riprap was displaced throughout the entire blanket and this was considered failure since displacement occurred so quickly. Flow conditions for normal operating conditions with 6- and 8-ft gate openings are shown in Photos 2 and 3, respectively. Supercritical flow exits the existing basin and plunges through the tailwater severely attacking the area below the basin and creating undesirable flow conditions for these gate settings and tailwaters.

Photo 1. Type 1 riprap protection plan, scour after 5 hr of operation:
normal pool el 814, normal tailwater el 803.6, gate opening 6 ft

10. The type 1 riprap plan was replaced with the type 2 riprap plan shown in Plate 3. This plan consisted of 4- to 5-ft-diameter stones placed in the same manner as the type 1 riprap plan. The type 2 riprap plan was tested for 5 hr (prototype) with normal operating conditions for a 6-ft gate opening. The plan remained stable and results from this test are shown in Photo 4. The weight of the 4- to 5-ft-diameter stones was sufficient to resist displacement with this flow condition. A test was then conducted with normal upper pool, a 6-ft gate opening and gradually lowering the tailwater in an attempt to reach the minimum tailwater elevation. The type 2 riprap plan failed when the tailwater elevation reached 797.8, 0.8 ft higher than the minimum, as shown in Photo 5. This procedure was repeated for a 3-ft gate opening and the riprap again failed when the tailwater reached el 797.8. The type 2 riprap plan was then tested to determine if it would remain stable for 5 hr of operation with normal upper pool and tailwater (799.7) and a 3-ft gate opening. The riprap was unstable for these conditions and had the previous tests with 6- and 8-ft gate openings been conducted for 5 hr, failure probably would have occurred for tailwater elevations higher than 797.8.

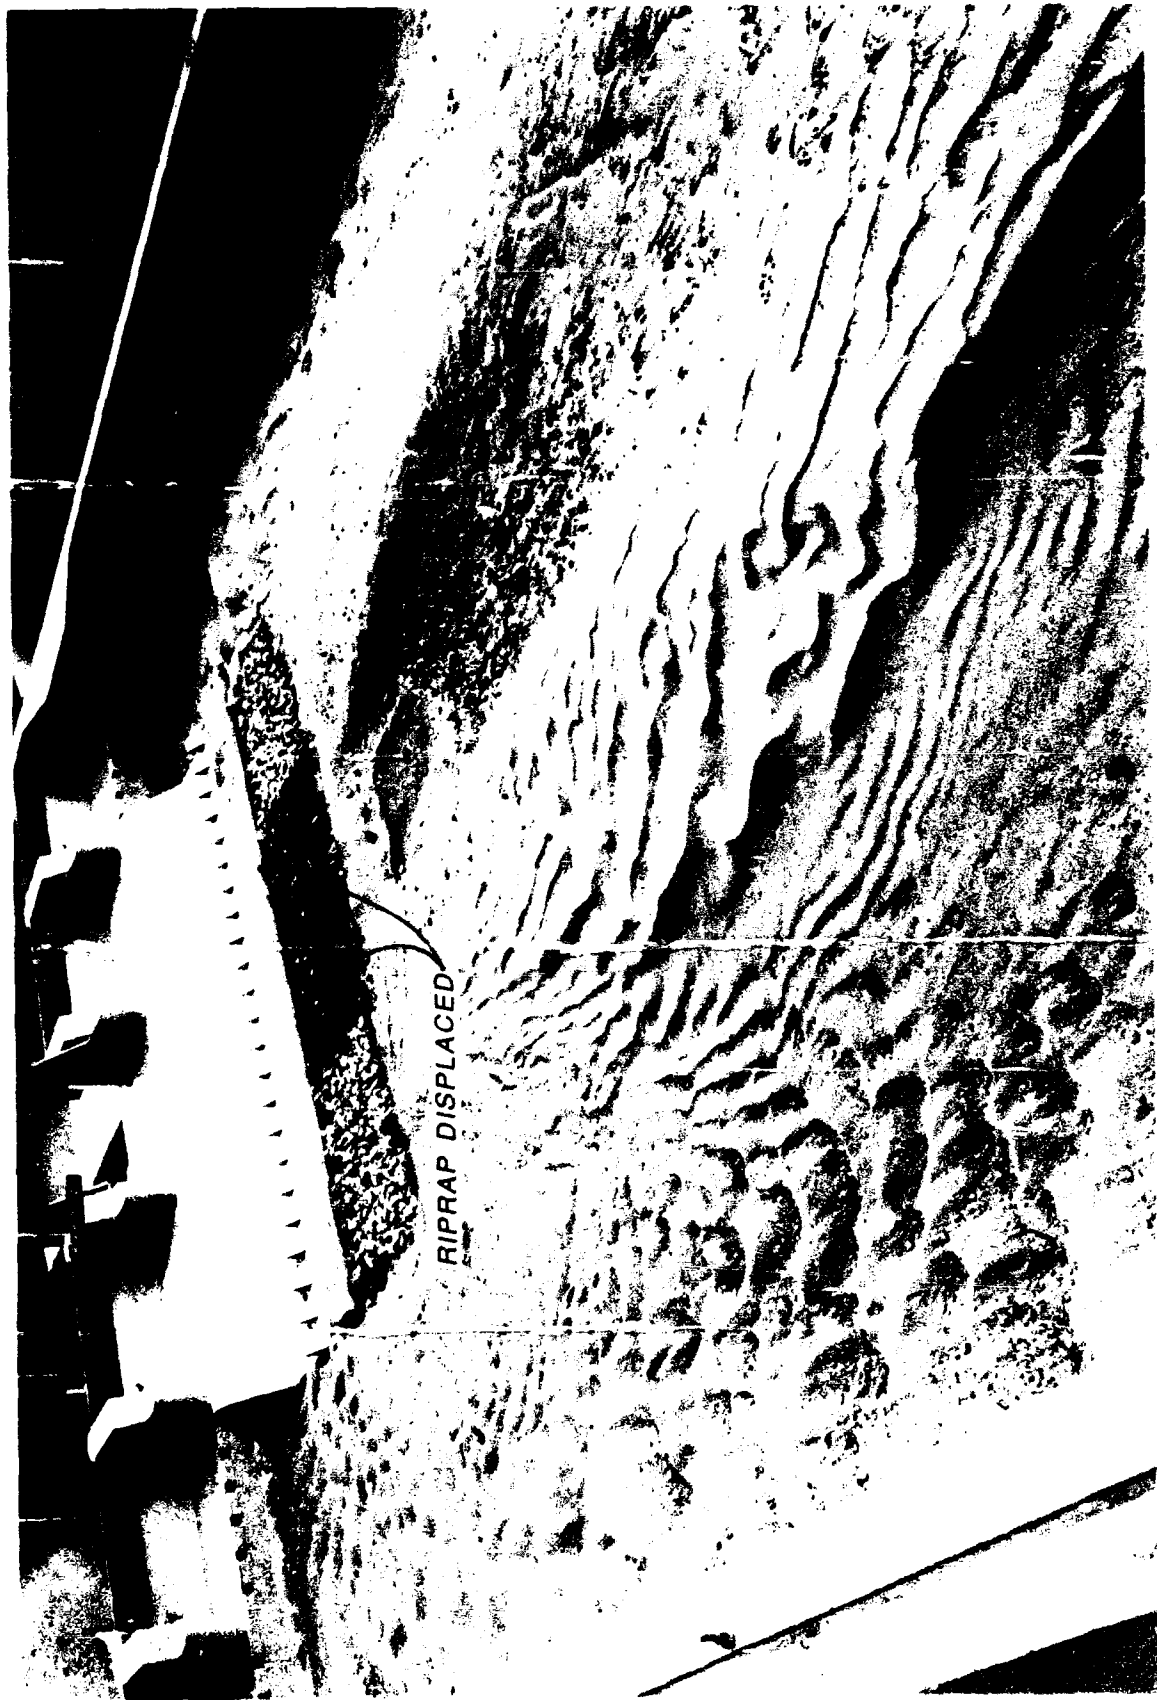
Photo 11. Riprap failure downstream of type 9 scour protection plan after 5 hr of operation with normal upper pool, gate 3 open full and minimum tailwater

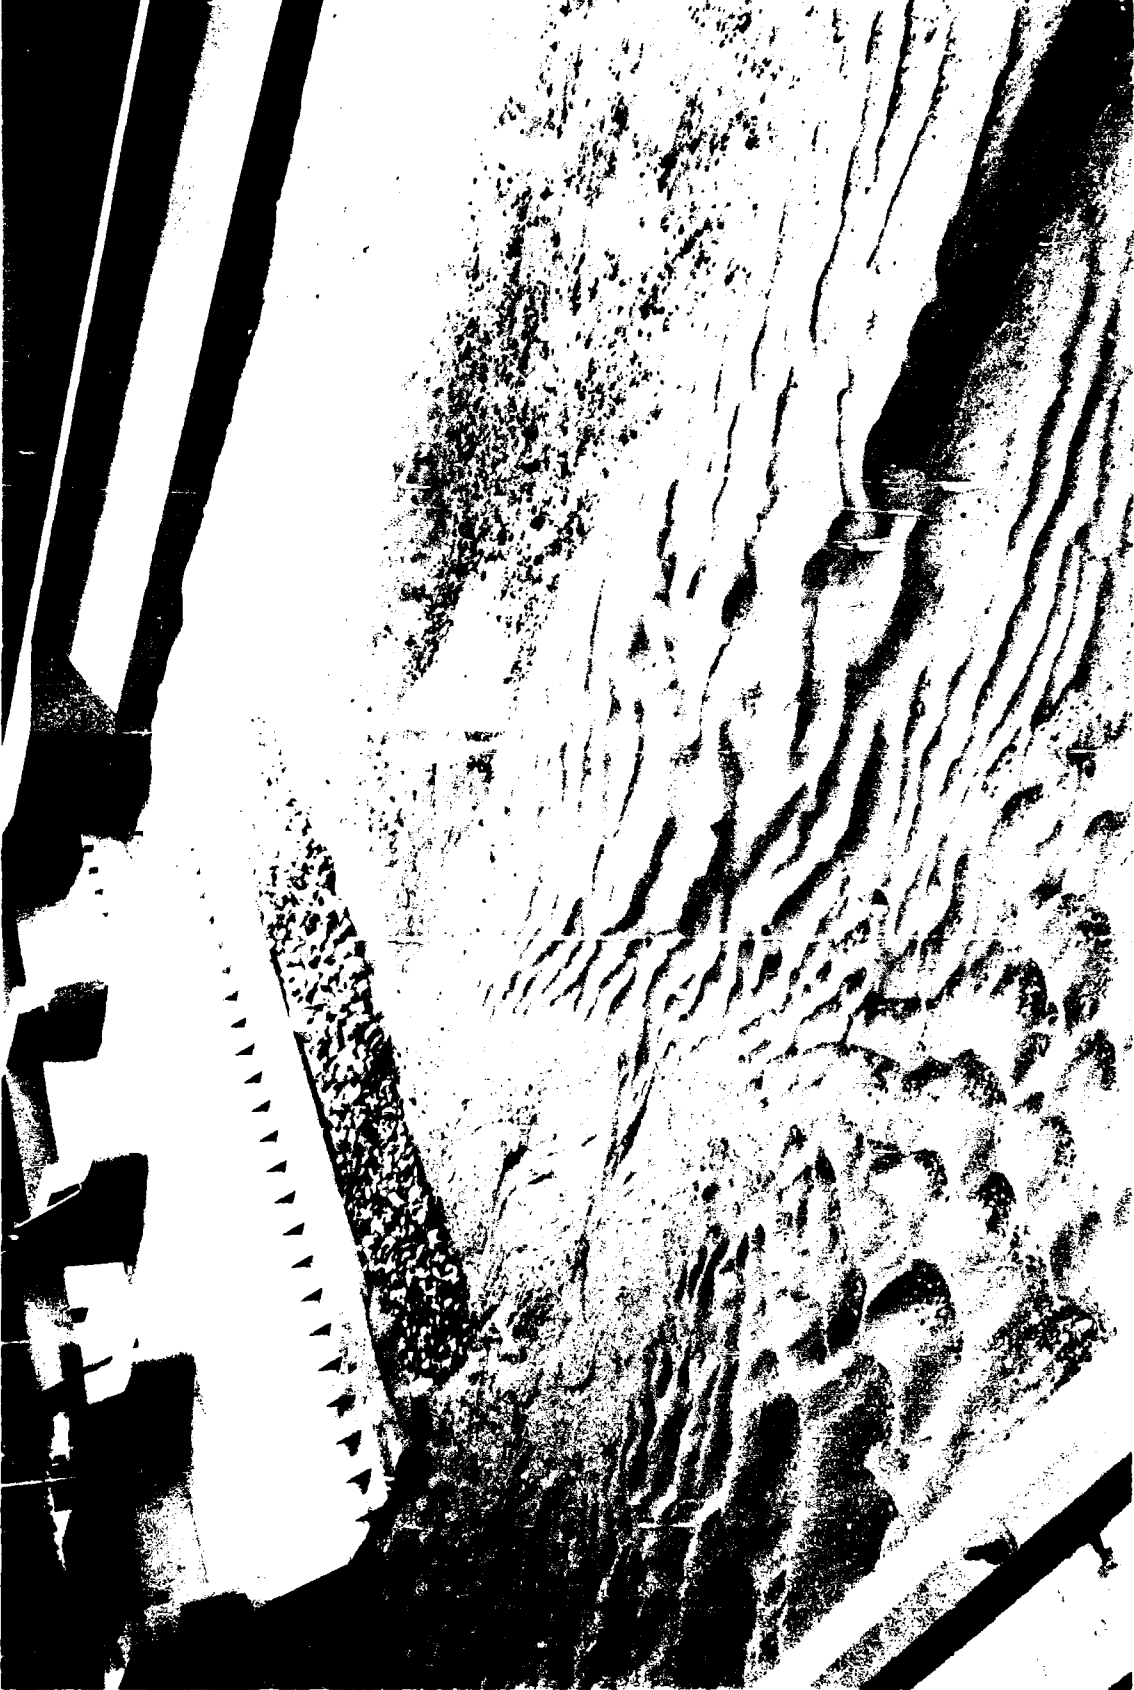
19. The 54-in.-thick blanket of graded riprap was replaced with 4- to 5-ft-diameter stones to form the type 10 scour protection plan shown in Plate 10. The stones in this plan remained stable during 5 hr of operation with gate 3 open full and minimum tailwater. Results from this test are shown in Photo 12.

Photo 12. Type 10 scour protection plan after 5 hr of operation with normal upper pool, gate 3 open full and minimum tailwater

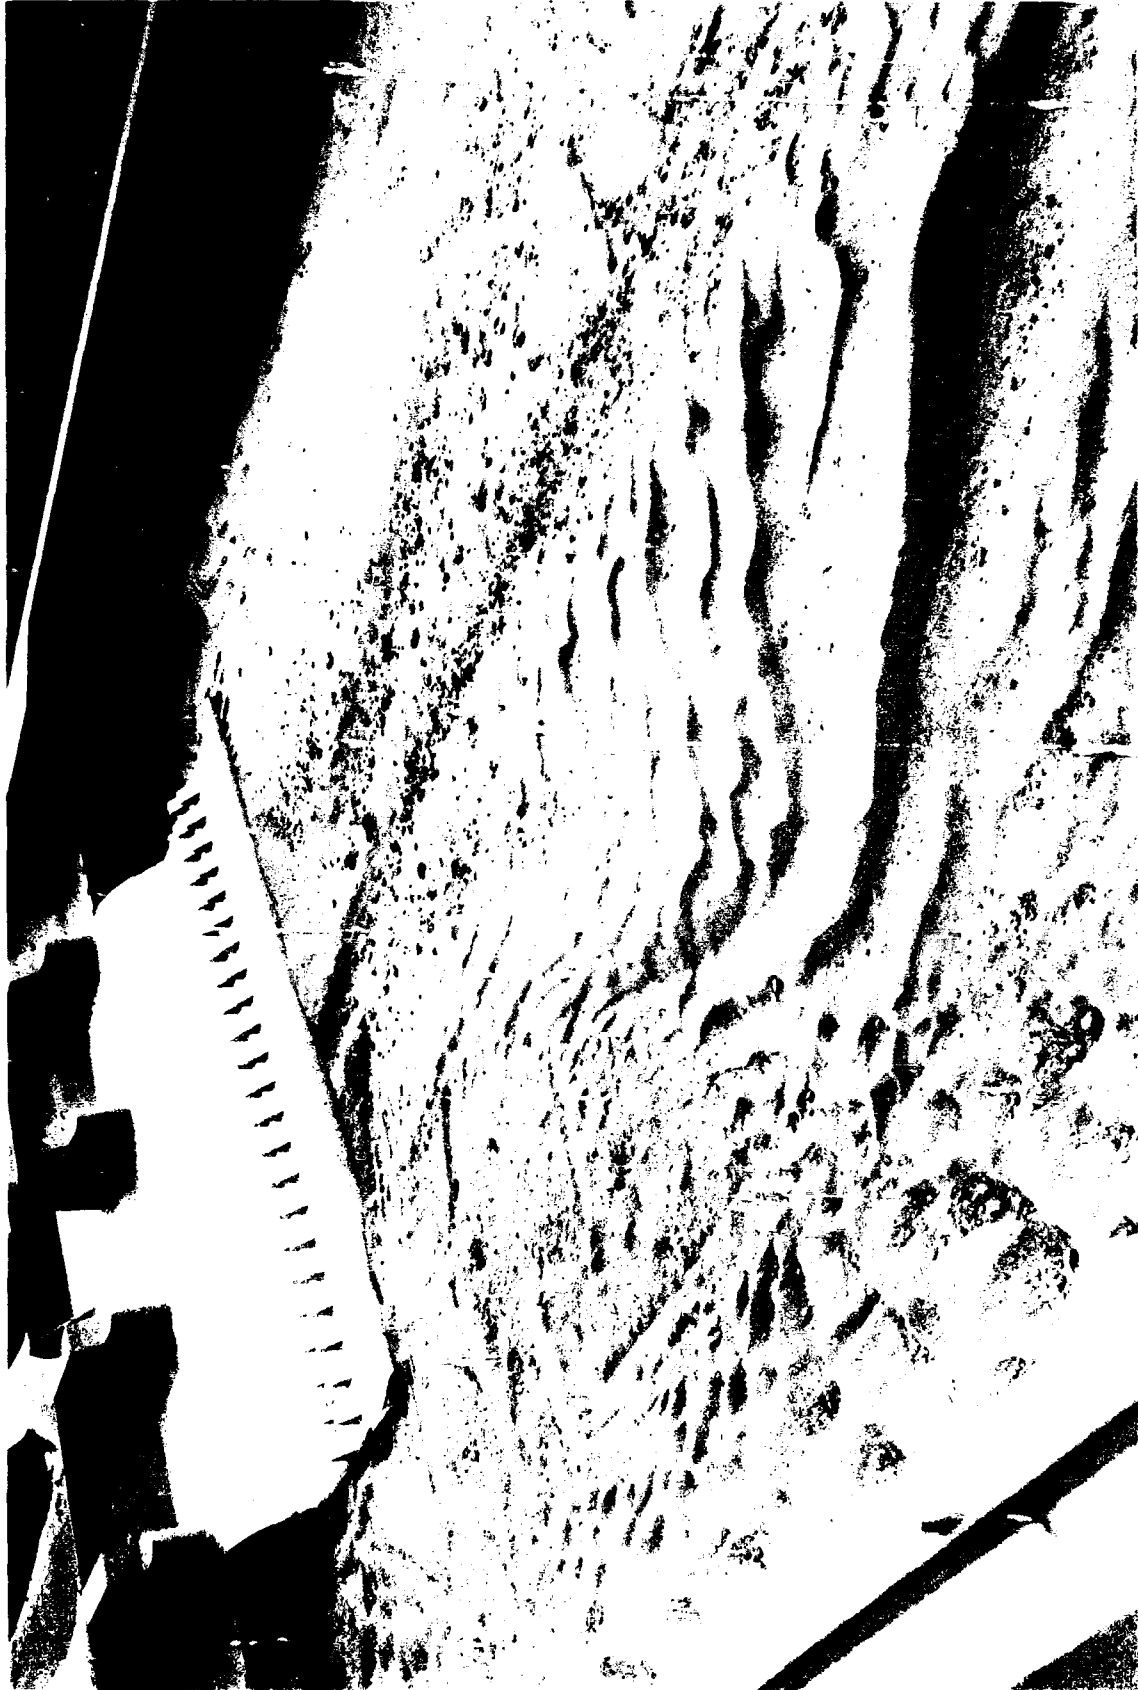
Photo 13. Scour downstream of type 11 scour protection plan after 5 hr of operation with normal upper pool, gate 3 open full and minimum tailwater

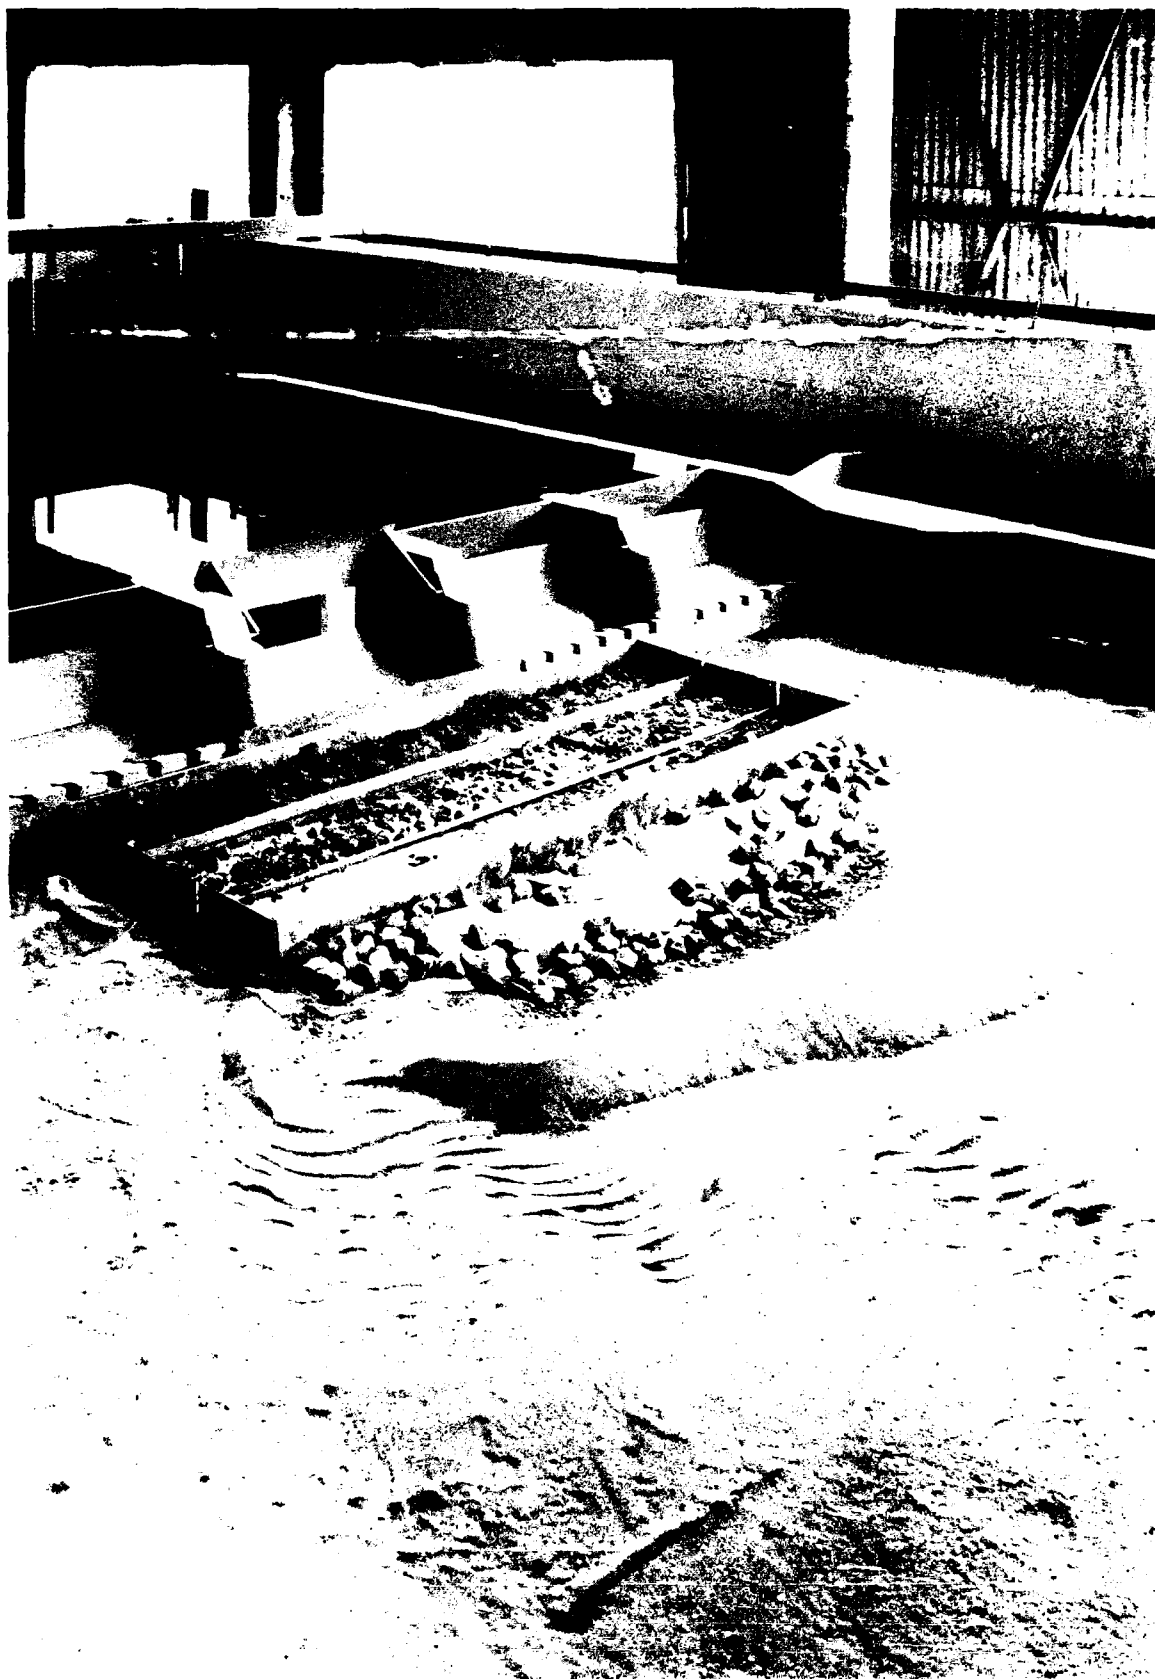
Photo 25. Scour downstream of type 20 scour protection plan after 5 hr of operation; normal upper pool, minimum tailwater, gate 3 open full

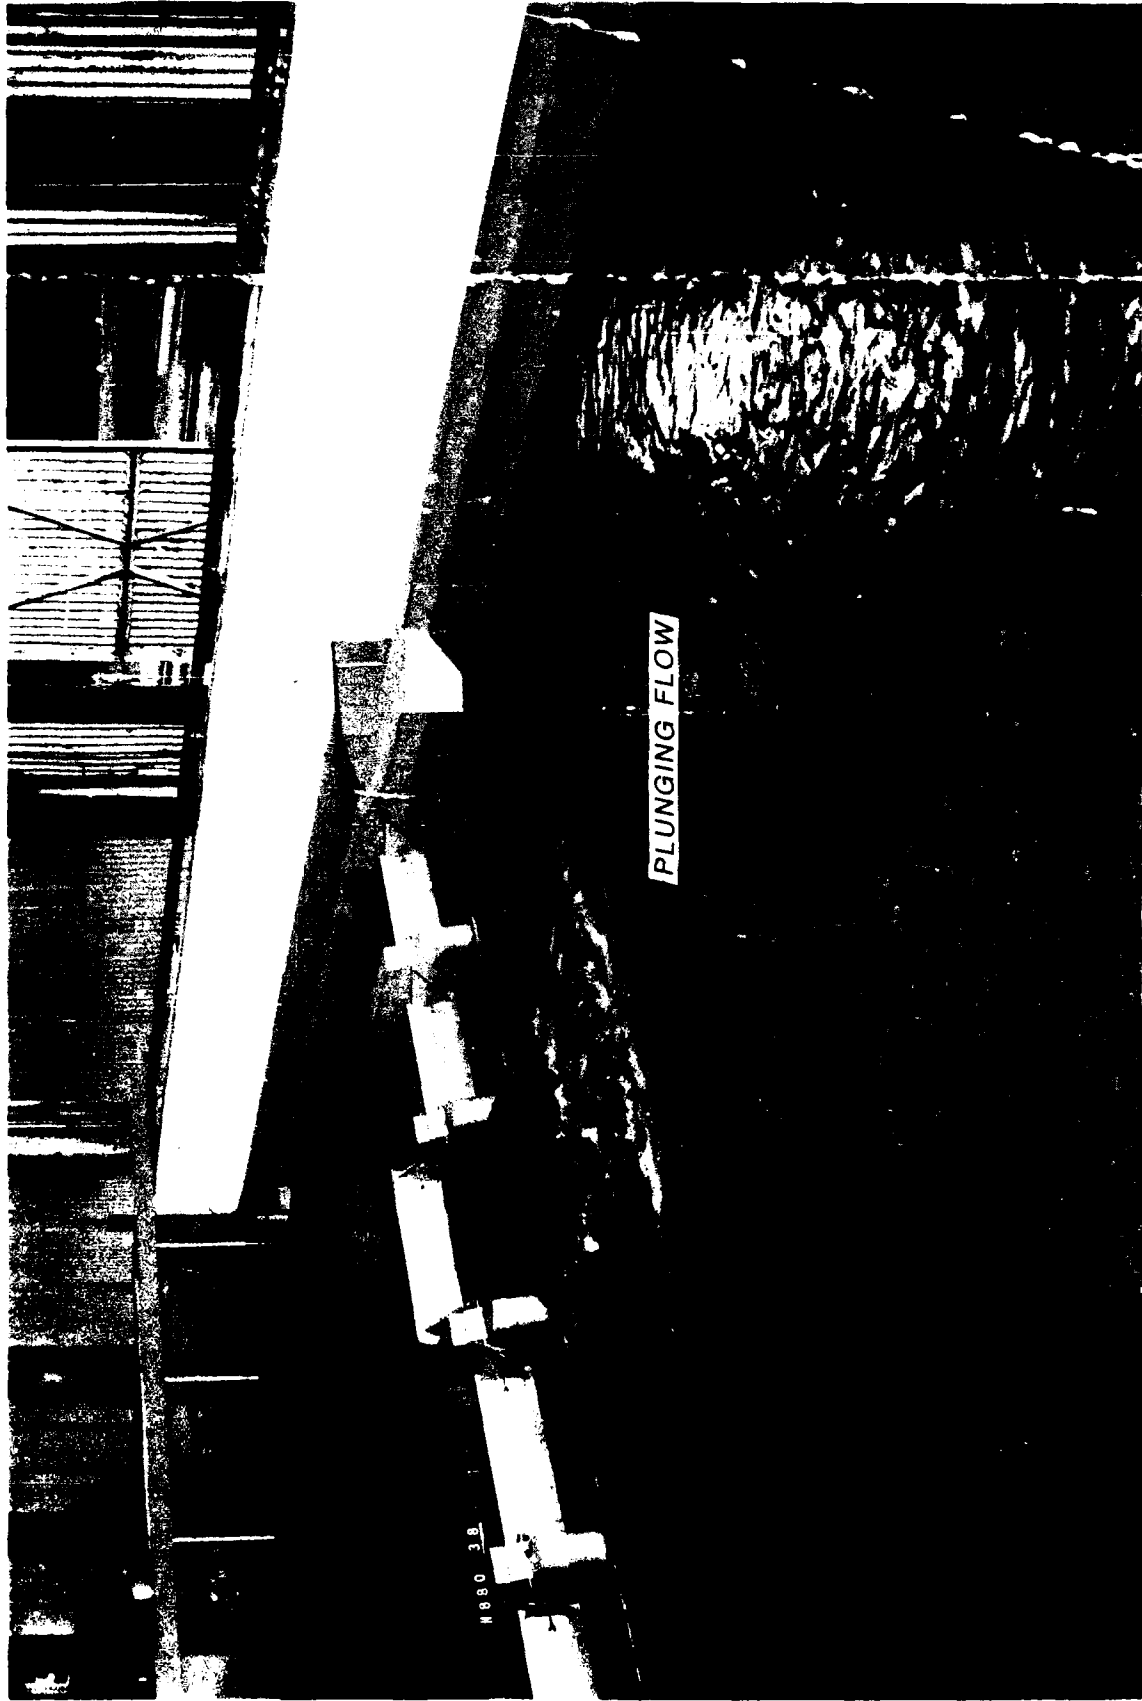
displaced by the flow plunging over the downstream wall of the last barge as shown in Photo 26. The downstream wall of the third barge was lowered to 6 ft, type 21 scour protection plan shown in Plate 21. Stones 4 to 5 ft in diameter were placed horizontally for a distance of 25 ft downstream from the barges. Flow conditions were improved because the flow no longer plunged over the wall of the last barge, Photo 27, but considerable turbulence and high velocity flow caused the stones downstream from the barges to be displaced.

Photo 26. Flow conditions with type 20 scour protection plan, normal upper pool el 814, minimum tailwater el 797, gate 3 open full

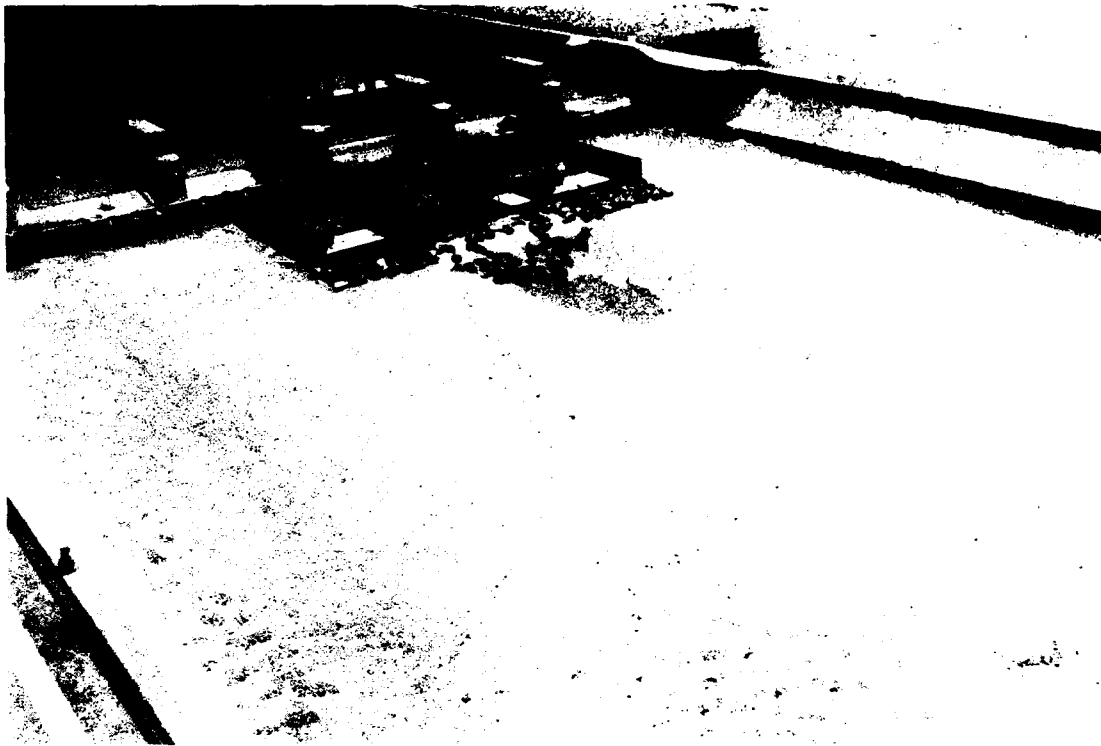
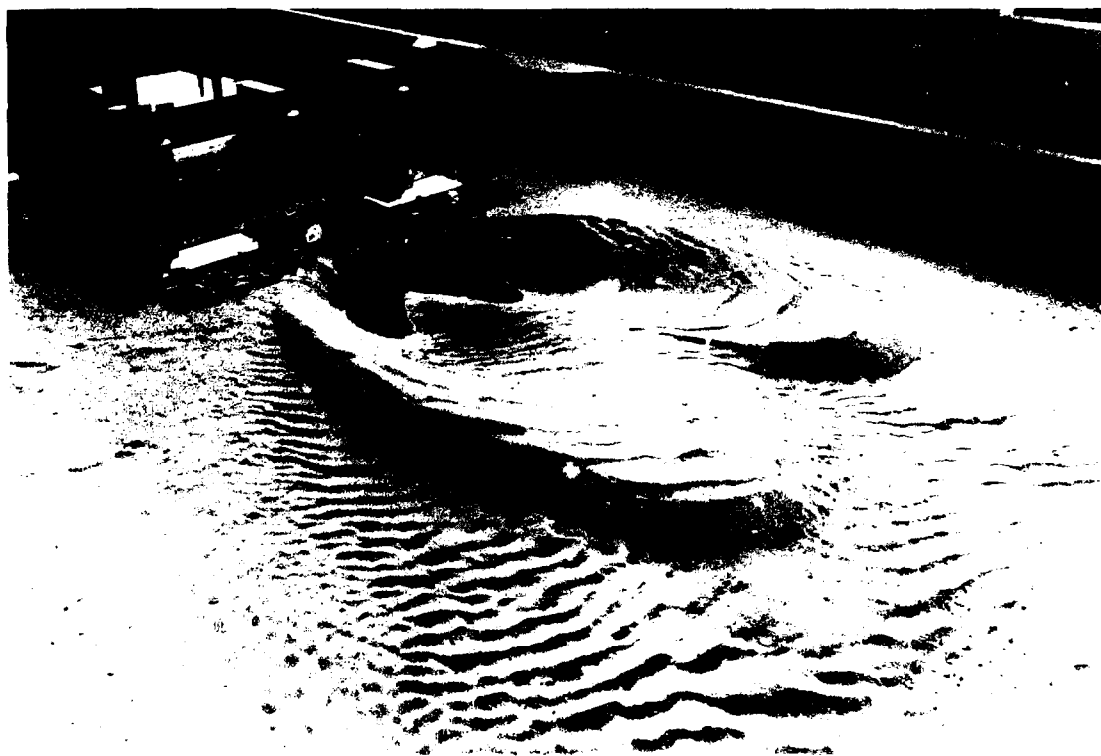
31. The walls between the first and second barges were lowered to 9 ft with the remaining walls 6 ft high to form the type 24 scour protection plan shown in Plate 24. A test was conducted for 5 hr with gate 3 opened 6 ft, normal upper pool and minimum tailwater and scour in the exit channel after completion of the test is shown in Photo 33a. The stones failed due to displacement by the flow conditions shown in Photo 34a. Results from another test conducted with the normal tailwater of 803.6 are shown in Photo 33b and indicate the stones failed again. Flow conditions during the test are shown in Photo 34b.

Photo 33. Scour downstream of type 24 scour protection plan after 5 hr of operation; normal upper pool el 814, gate 3 open 6 ft
