# NONCONVENTIONAL ROOF SYSTEMS FOR IN-HOUSE INSTALLATION AT AIR FORCE BASES

W.B. ROSE  
D.M. BAILEY

CONSTRUCTION ENGINEERING RESEARCH LABORATORY  
PO BOX 4005  
CHAMPAIGN, ILLINOIS 61824-4005

JULY 1989

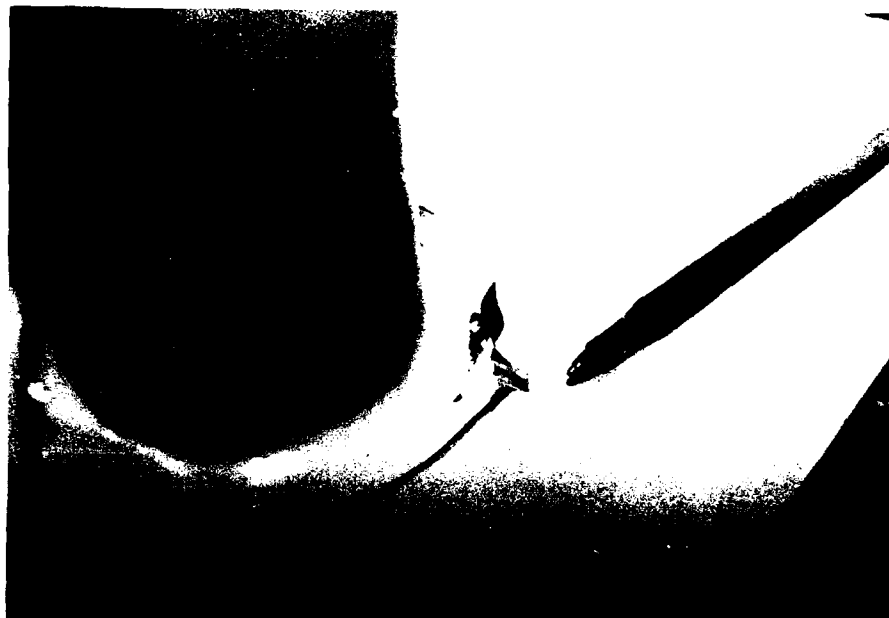
Figure 9. Poor weld due to local overheating of flange at the bottom of the pipe stem.

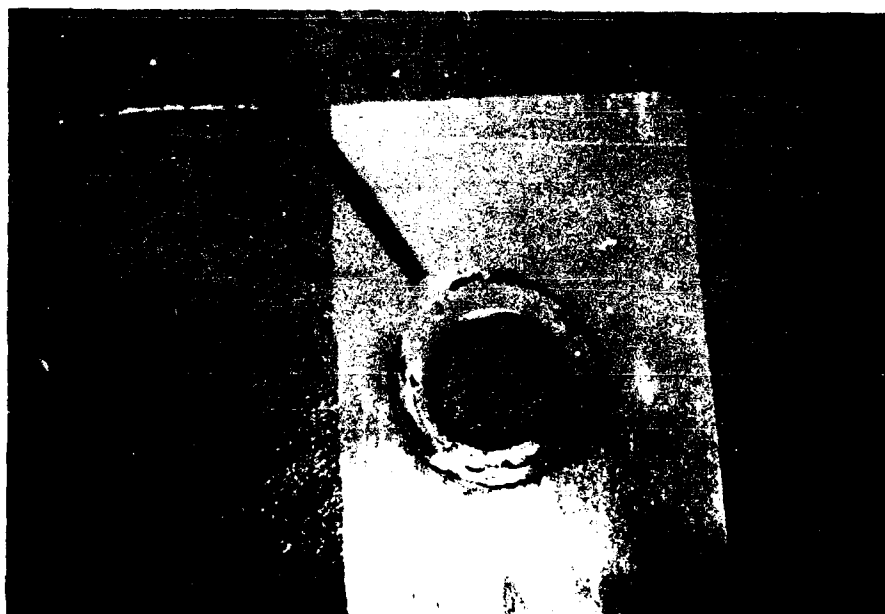
Figure 10. Poor weld in test pipe stem due to uneven application of heat at the flange.

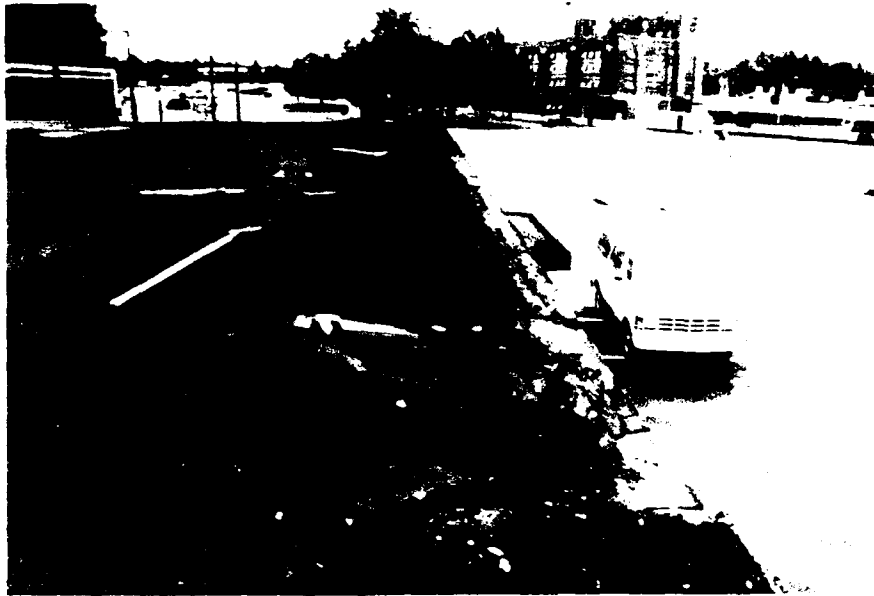
effort required to replace rotted edge nailers (Figure 57), and wet insulation on about 20 percent of the roof surface (Figure 58) was unexpected and disrupted the schedule. As in the other installations, the time necessary for proper preparation seemed very long.

Figure 57. Rotted wood edge nailers are removed and replaced.

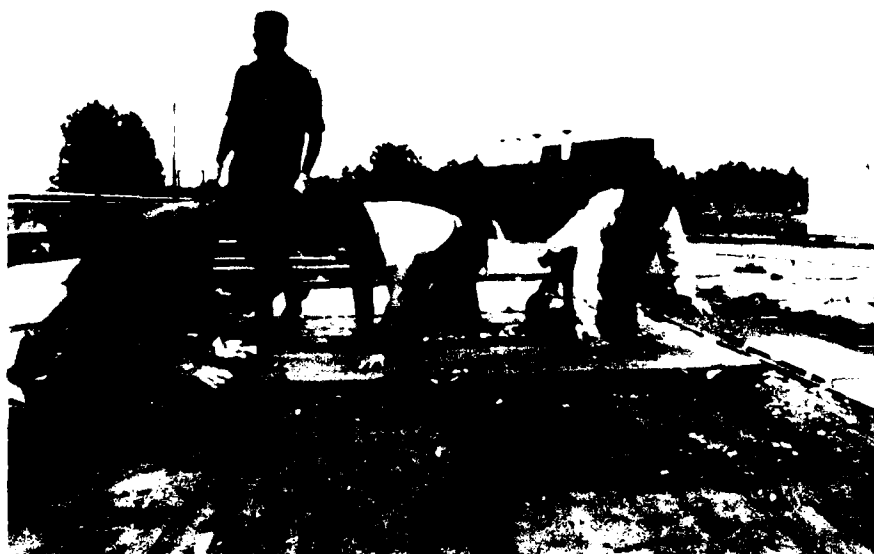
Figure 58. Wet insulation is removed and replaced.
