REPAIR, EVALUATION, MAINTENANCE, AND  
REHABILITATION RESEARCH PROGRAM

TECHNICAL REPORT REMR-CS-22

MONOLITH JOINT REPAIRS: CASE HISTORIES

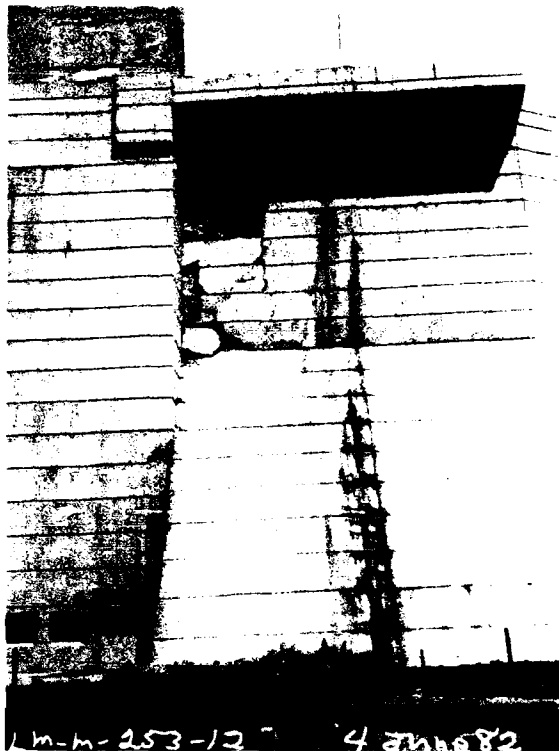
10. Periodic Inspection Reports No. 4 (USAED, Walla Walla, 1973) and No. 5 (USAED, Walla Walla, 1975), documented the continued deterioration of the concrete adjacent to these joints. The deterioration extended from el 420\* to 460 on monolith 26 and el 480 to 537 on monolith 28. The cause of the deterioration (Figure 3) was described in Periodic Inspection Report No. 5 (USAED, Walla Walla, 1975) as follows:

Damage is caused by relative movements of adjacent monoliths from hydraulic loading during lockages. These movements are much more significant during the cold winter months when the concrete has contracted and there is less friction along the monolith joint. When the locks are emptied the upstream monoliths 25 and 26 move inward relative to the larger downstream monoliths 27 and 28, thereby causing a tearing action along the joint surface. This action spalls the concrete through repeated shearing and continued crack propagations.

Figure 5. Monolith joint deterioration, 4 June 1982, Lower Monumental Lock and Dam

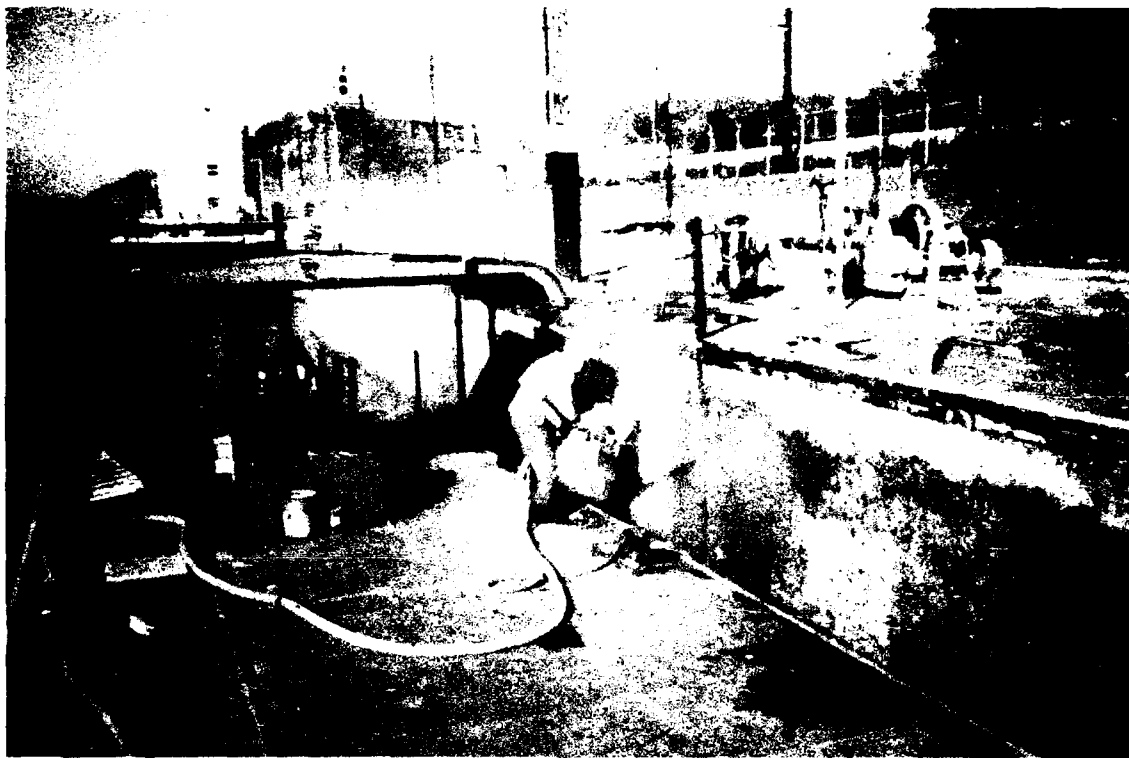
Figure 32. Fibercrete test section, November 1980, Emsworth Locks

32. After 3 months the test section exhibited impact failures, abrasion erosion, and delamination. One explanation for the poor performance was that the prepackaged mixture used for the demonstration contained only 60 lb/cu yd of fibers. For the actual repair 200 lb/cu yd of fibers would have been specified.

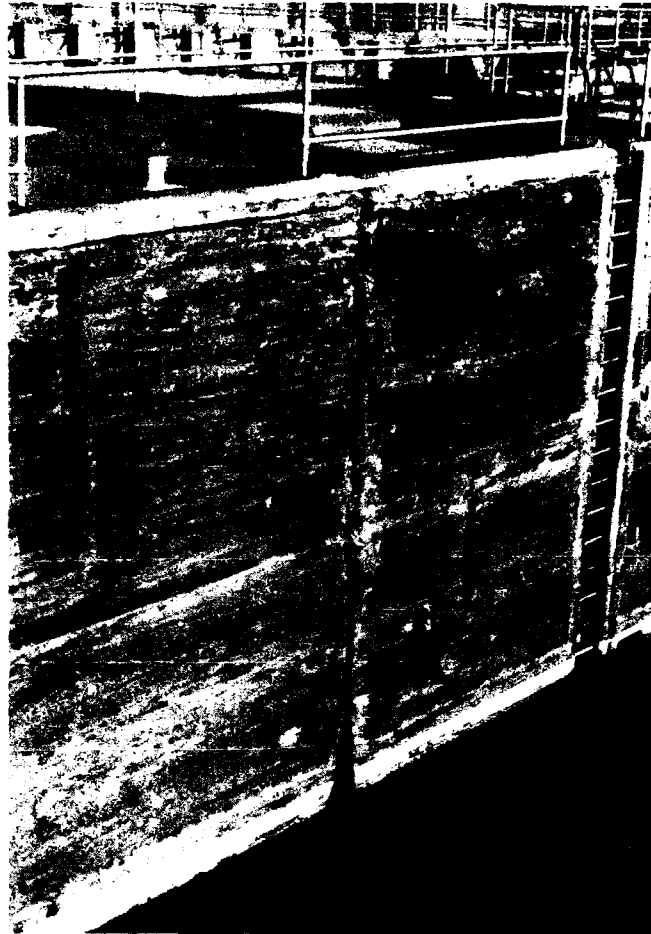
Figure 41. Typical monolith joint deterioration, Lock and Dam No. 2

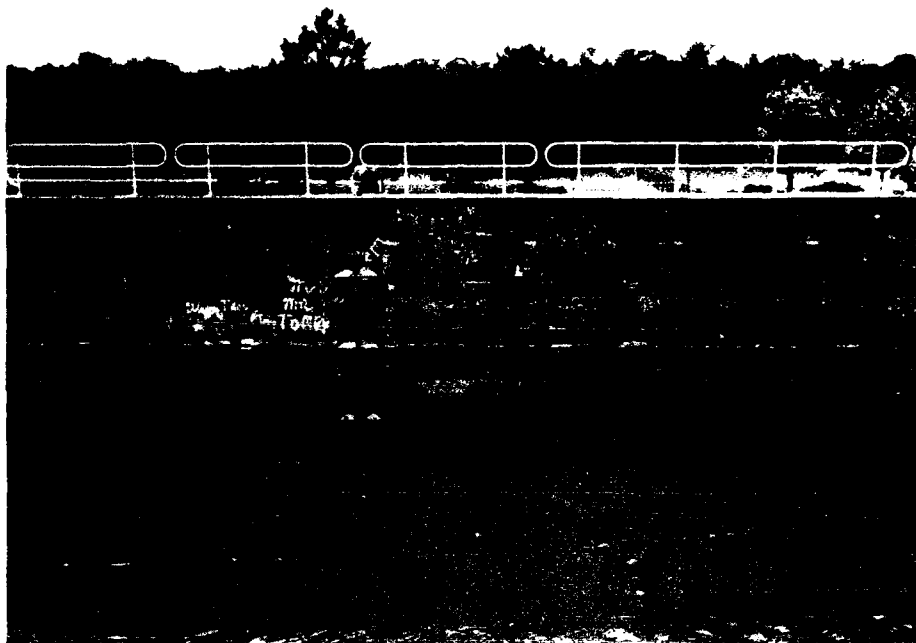
Figure 52. Typical examples of joint deterioration,  
Algiers Lock
