MISCELLANEOUS PAPER GL-89-19

# CONDITION SURVEY REPORT ROBINS AIR FORCE BASE, GEORGIA

September 1989

Final Report

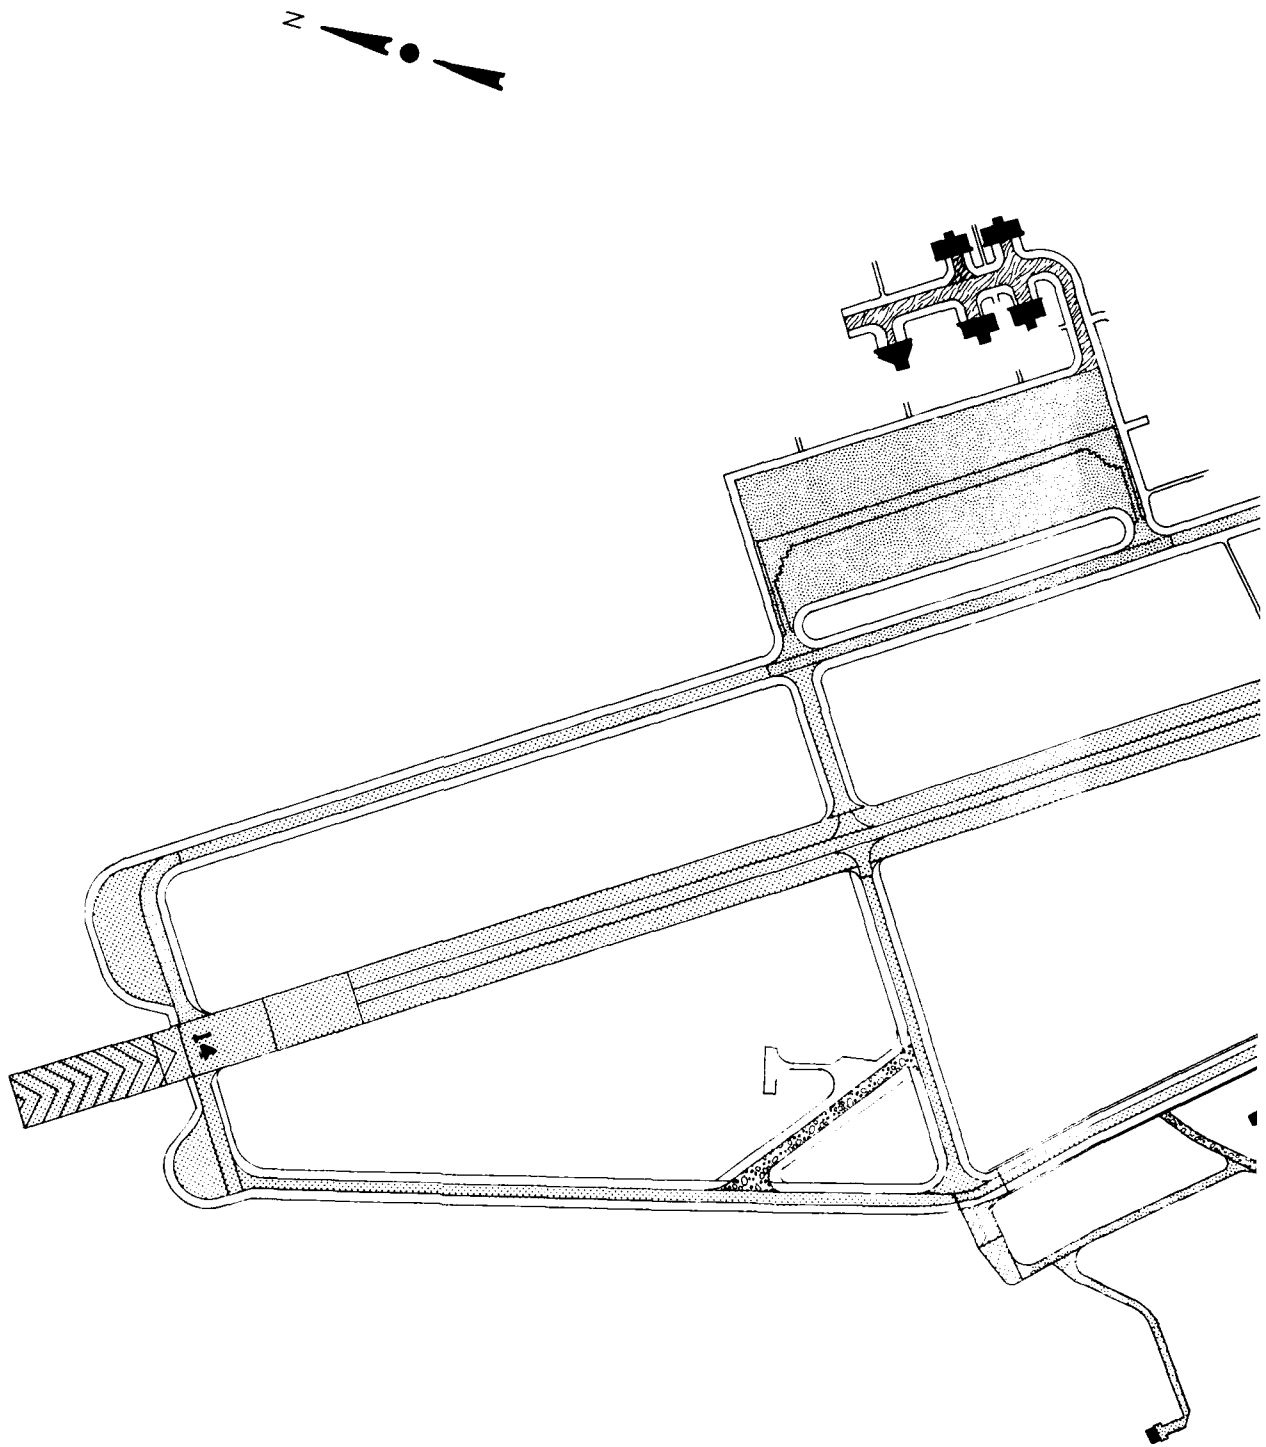
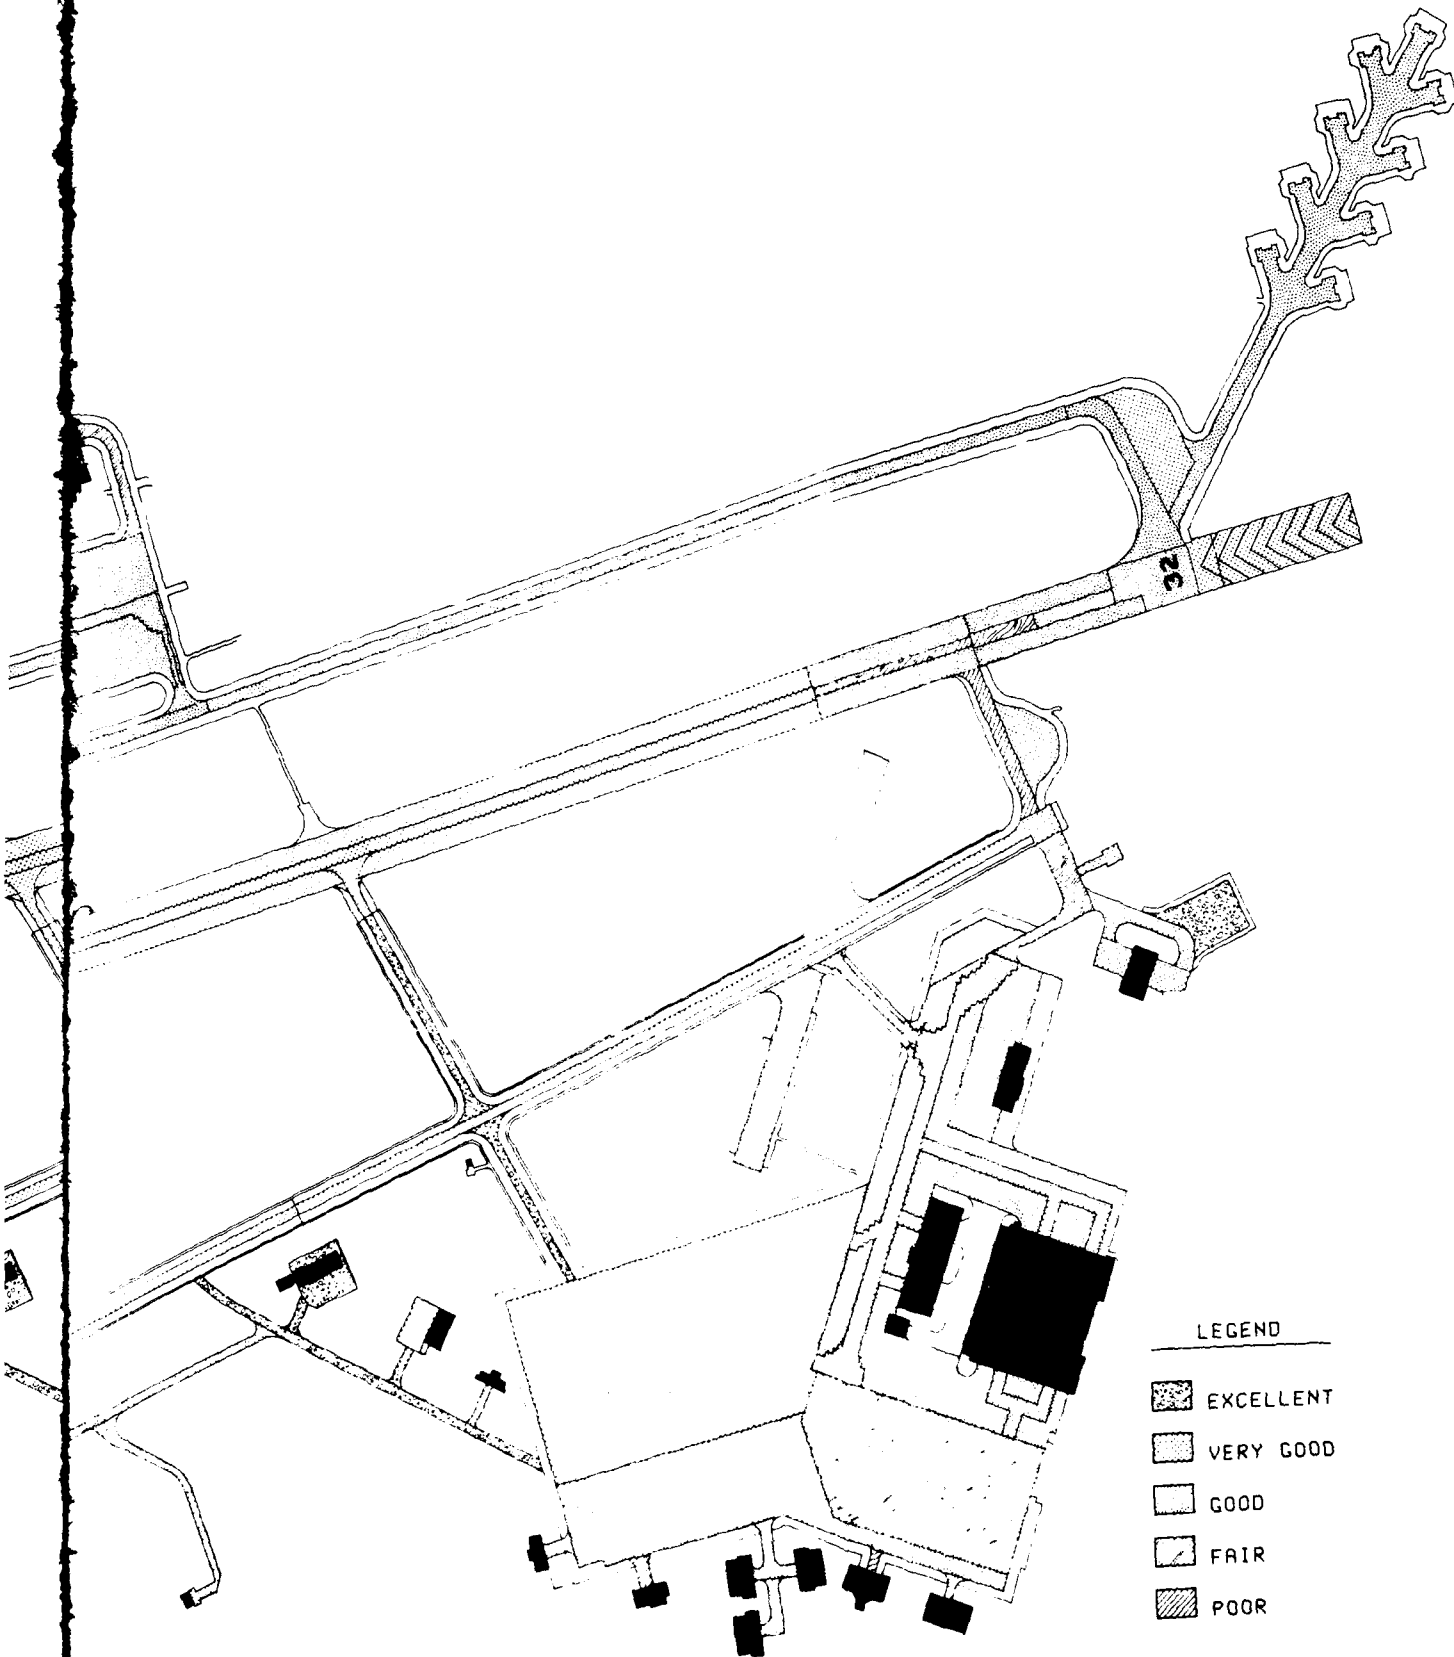
Figure 54. Pavement conditior

12. The majorities of the pavement features at Robins AFB are rated from fair to excellent condition with some features rated poor. Figure 54 illustrates the condition ratings of the features at Robins AFB, and the PCI of each feature is included in Table 1. Table 2 describes the more prominent distresses observed in each feature. Photos 1 through 26 show various distresses that were observed on the airfield pavements. Table 3 compares the 1979 PCI with the current PCI.

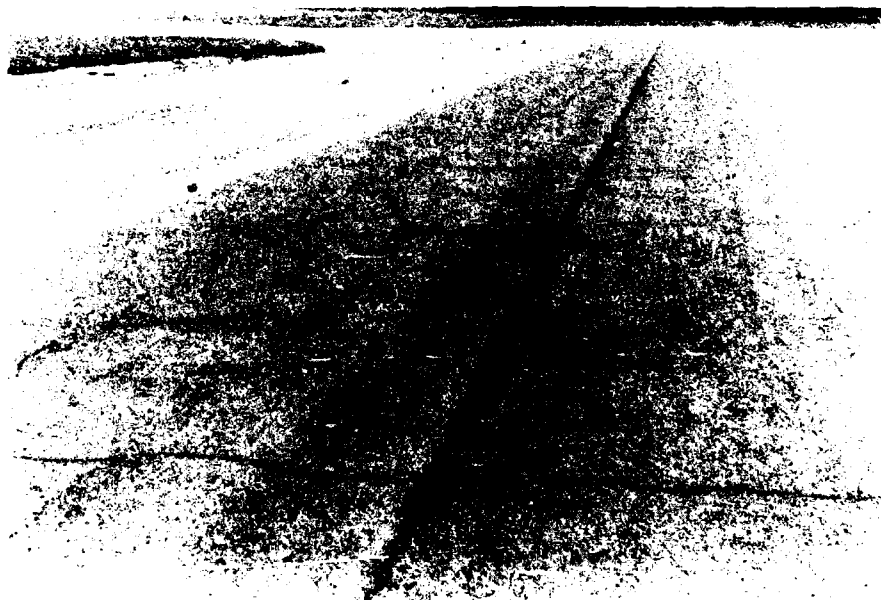
Photo 12. Low severity reflective and block cracking,  
typical of Taxiways 1 and 3 (T2A1, T2A2, T3A, and T4A)
