**Enhanced Preliminary  
Assessment Report:**

**Bedford Army Housing Units  
Bedford, Massachusetts**

September 1989

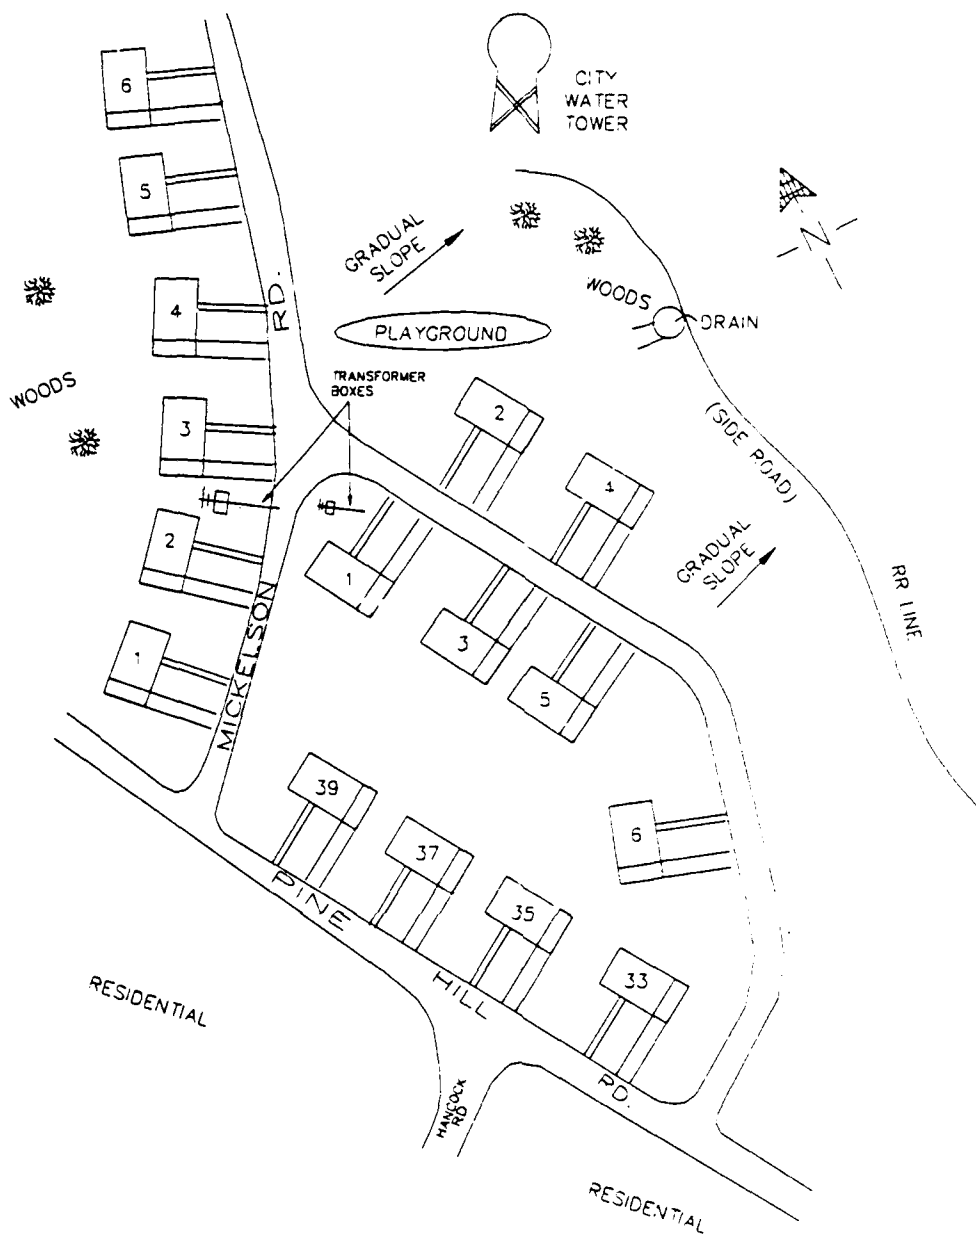
**FIGURE 3 Site Plan Map of Bedford Army Housing Units**

Figure 3 presents the site plan of the housing property.
