Final Report  
for the Period  
September 1984  
to July 1989

# Pulsed Plasma Mission Endurance Test

Authors:  
R.J. Cassidy

Rocket Research Company  
Olin Defense Systems Group  
11411 Willows Road NE  
Redmond WA 98073-9709

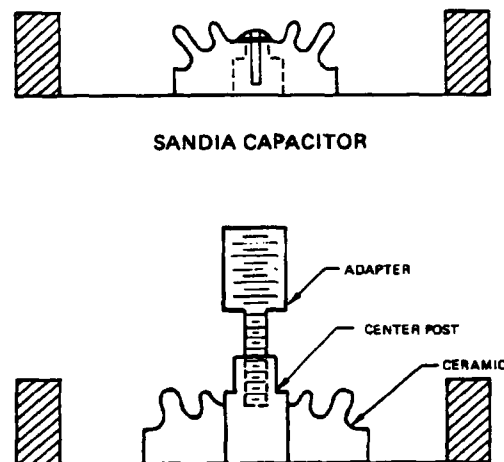
Fig. 28. Sandia Capacitor Centerpost Adapter

The center post adapters changed the geometry of the electrode, as shown in Figure 28. This geometry change, among other things, allowed a direct line-of-sight view across the insulator to the anode. The adapter designs also presented a sharp right angle corner to the anode surface, which could have served to intensify the voltage gradient between the electrodes. It is suspected that this change caused the arcing. Only a complete insulation of the capacitor tops inside the anode ring was sufficient to stop the arcing. The final design incorporated a modified center post adapter which made better face contact with the stripline than the previous ones, and a completely insulated anode face to remove any possibility of arcing.
