St. Marys River  
Shoreline Erosion and Shore Structure Damage  
1980 Closed Navigation Season

February 1981

Corps of Engineers  
U.S. Army Cold Regions Research and Engineering Laboratory  
Hanover, New Hampshire 03755

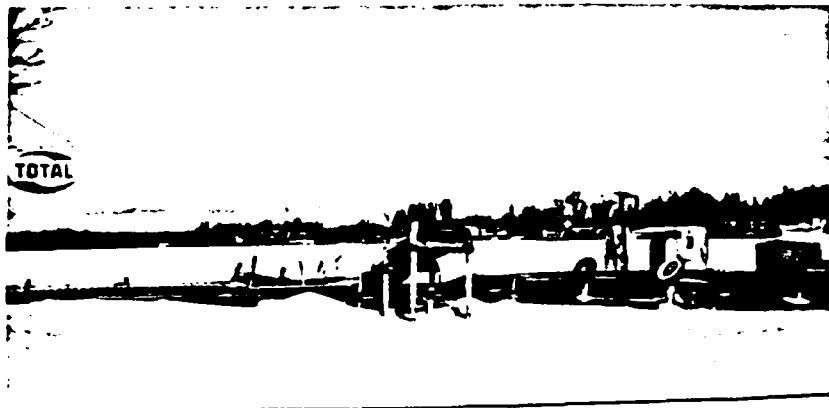
During last year's closed navigation season these cracks were not evident. Figure 52 shows conditions several weeks after the close of navigation. No active cracks were evident. The uplifted docks shown in Figure

Figure 52. Little Neebish Resort at beginning of closed navigation season.

52 were in that condition at the close of navigation and no further change was observed during the closed period. Figure 53 taken on 30 March again shows the uplifted finger pier with no further perceptible damage.

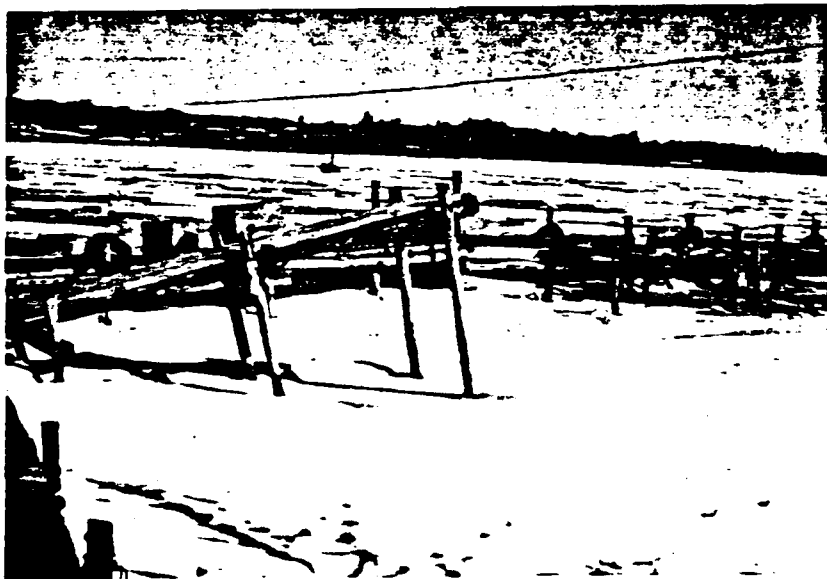
Figure 53. Little Neebish Resort with navigation reopened.

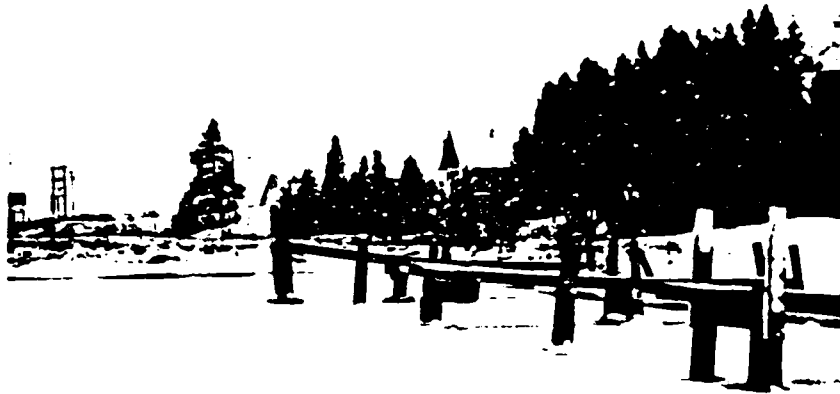
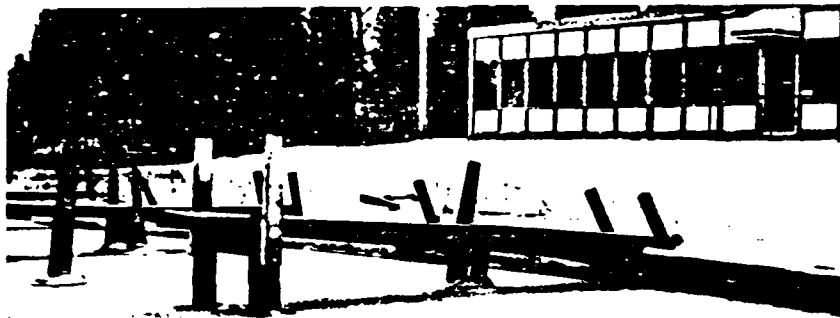
Detour. Figures 56 and 57 show the condition of a series of small docks near the mainland Drummond Island Ferry dock on 25 January 1980. Some uplift is apparent, but as shown in Figures 58 and 59 taken on 15

Figure 56. Small docks at Detour after close of navigation.

Figure 57. Small dock at Detour after close of navigation.
