Bank Conditions and Recession Along the U.S. Shorelines
of the St. Marys, St. Clair, Detroit and St. Lawrence Rivers:
Ancillary Data

Lawrence W. Gatto
Earth Sciences Branch

February 1982

Prepared for the
U.S. Army Engineer District, Detroit

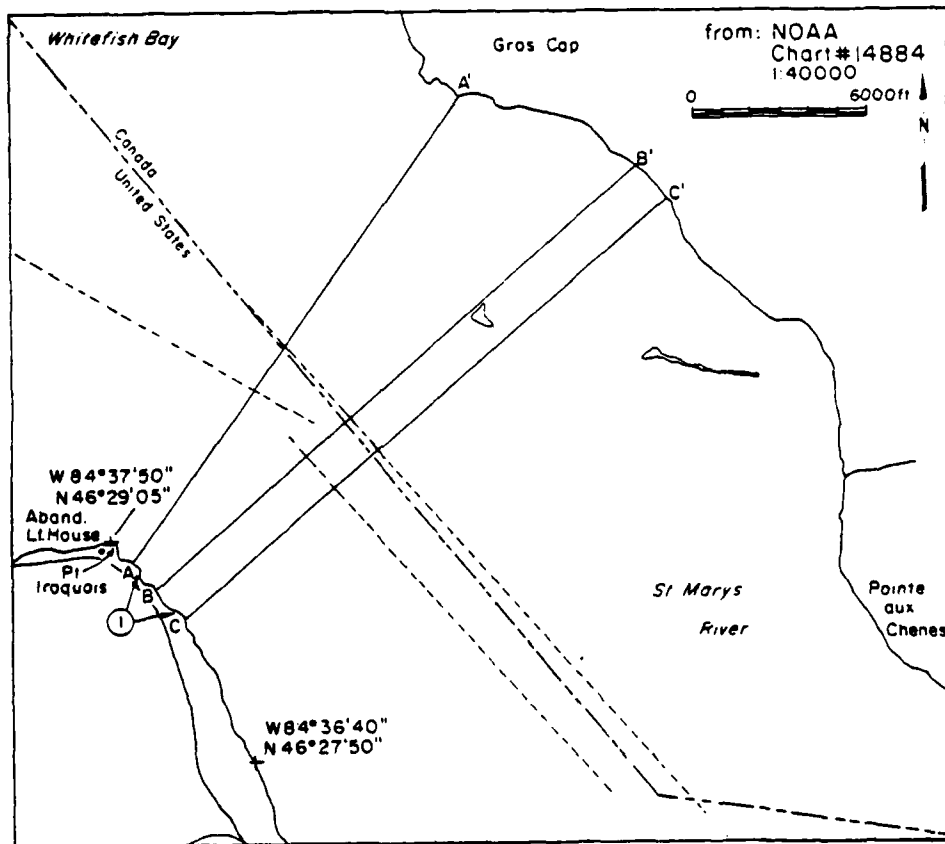
Figure D13. Generalized river cross-sections, site 1, St. Marys River.

X (Fig. D 3 and D13)	Steep		Cobbles and gravel with sand pebbles		Type <input checked="" type="checkbox"/> No <input type="checkbox"/>
LANDUSE	Sparse	Residential	Dense	Sparse	Commercial	Recreational
	<input checked="" type="checkbox"/> Medium <input type="checkbox"/> Dense	Medium <input checked="" type="checkbox"/> Dense	<input type="checkbox"/> Sparse <input type="checkbox"/> Medium <input type="checkbox"/> Dense			
UPSTREAM CONDITIONS	Protective Structures	Slope	Vegetated Bluff	Slope	Nearshore Conditions	Remarks
	B.H. RR Cab Other	Becomes gradual	X	Similar	Bluff height decreases	
DOWNSTREAM CONDITIONS	Protective Structures	Slope	Vegetated Bluff	Slope	Nearshore Conditions	Remarks
	B.H. RR Cab Other	Becomes gradual	X	Similar	Bluff height decreases	
Photo No.	None

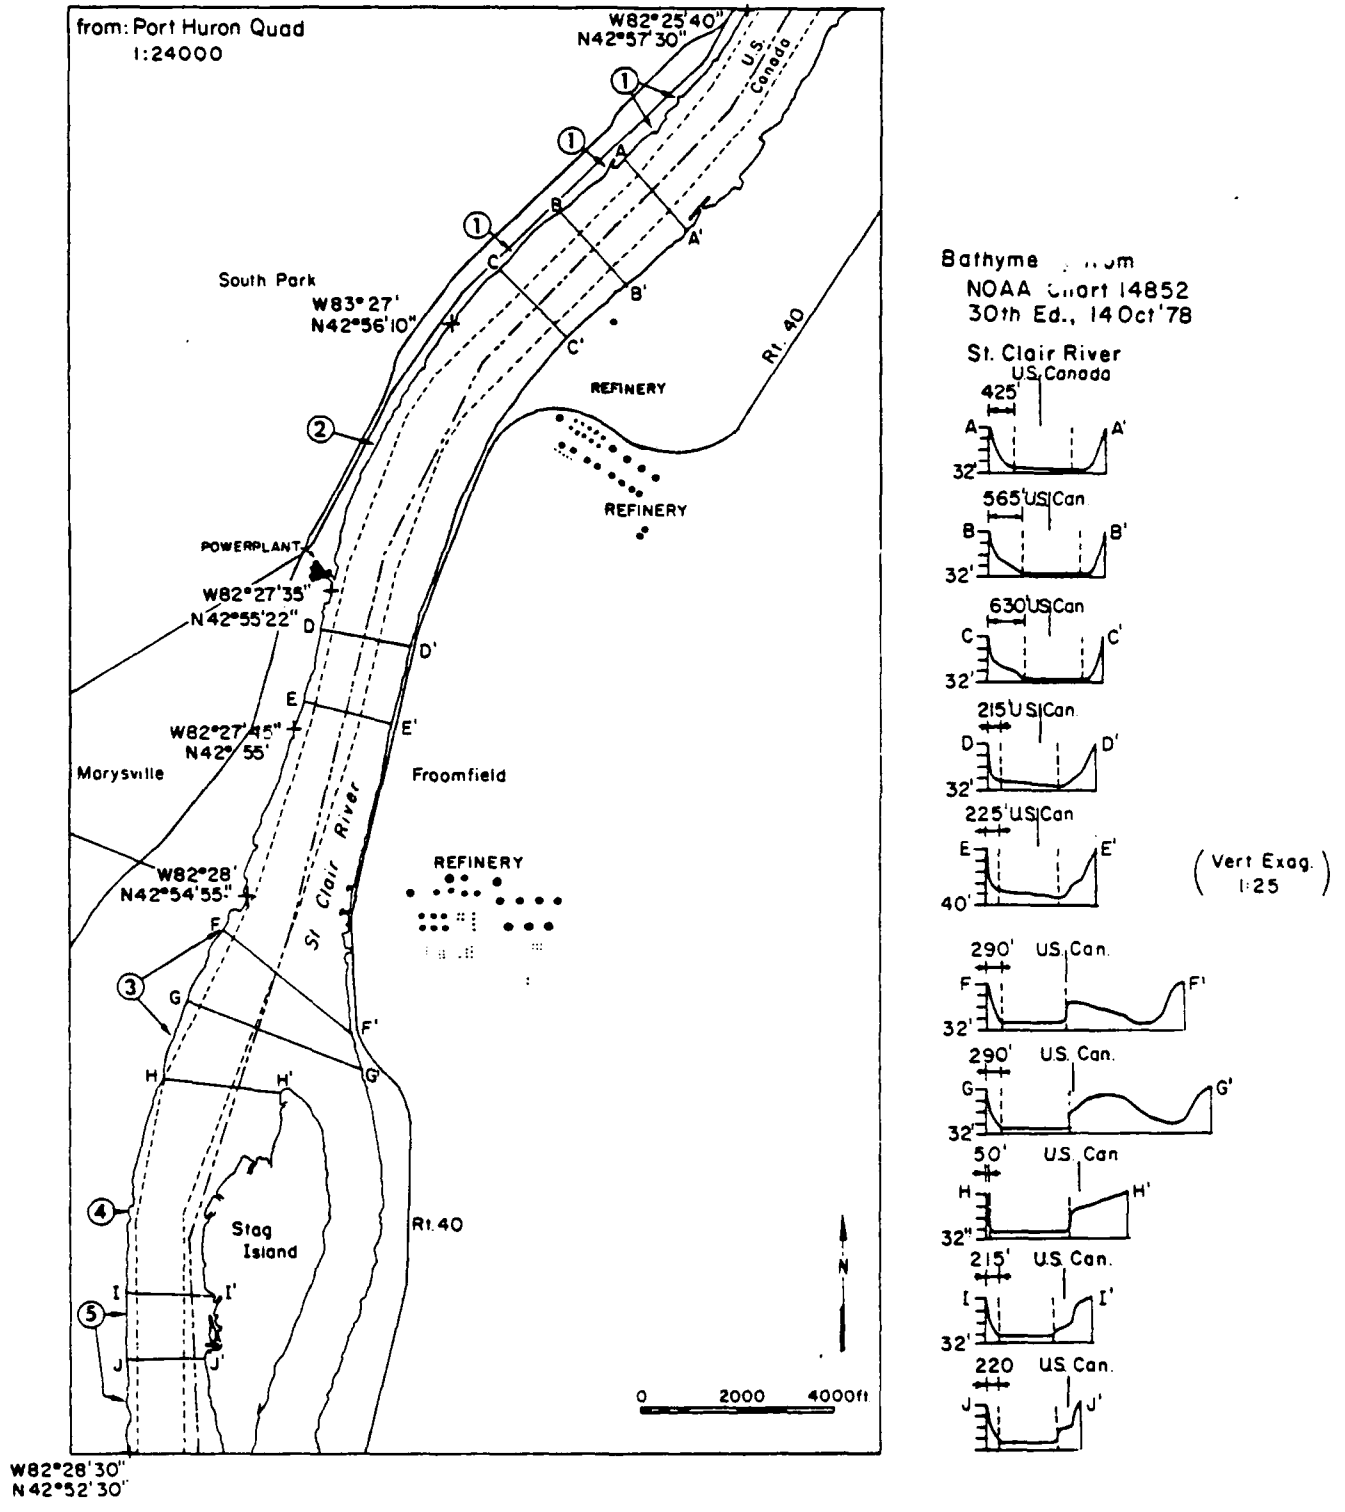
Figure D42. Generalized river cross-sections, sites 1 to 5, St. Clair River.

NEARSHORE CONDITIONS		(Fig. D42)		λ		Ripples		Agricultural		Recreational	
NEARSHORE CONDITIONS		Residential		Sparse	Medium	Dense		Sparse	Medium	Dense	
NEARSHORE CONDITIONS		Protective Structures		B.H.	RR	Gab	Other	Slope		Nearshore Conditions	
NEARSHORE CONDITIONS		X		Vegetated Bluff		Slope		Similar		Remarks	
DOWNSTREAM CONDITIONS		Protective Structures		B.H.	RR	Gab	Other	Slope		Nearshore Conditions	
DOWNSTREAM CONDITIONS		X		Vegetated Bluff		Slope		Similar		Remarks	
DOWNSTREAM CONDITIONS				Remarks		Borders a road

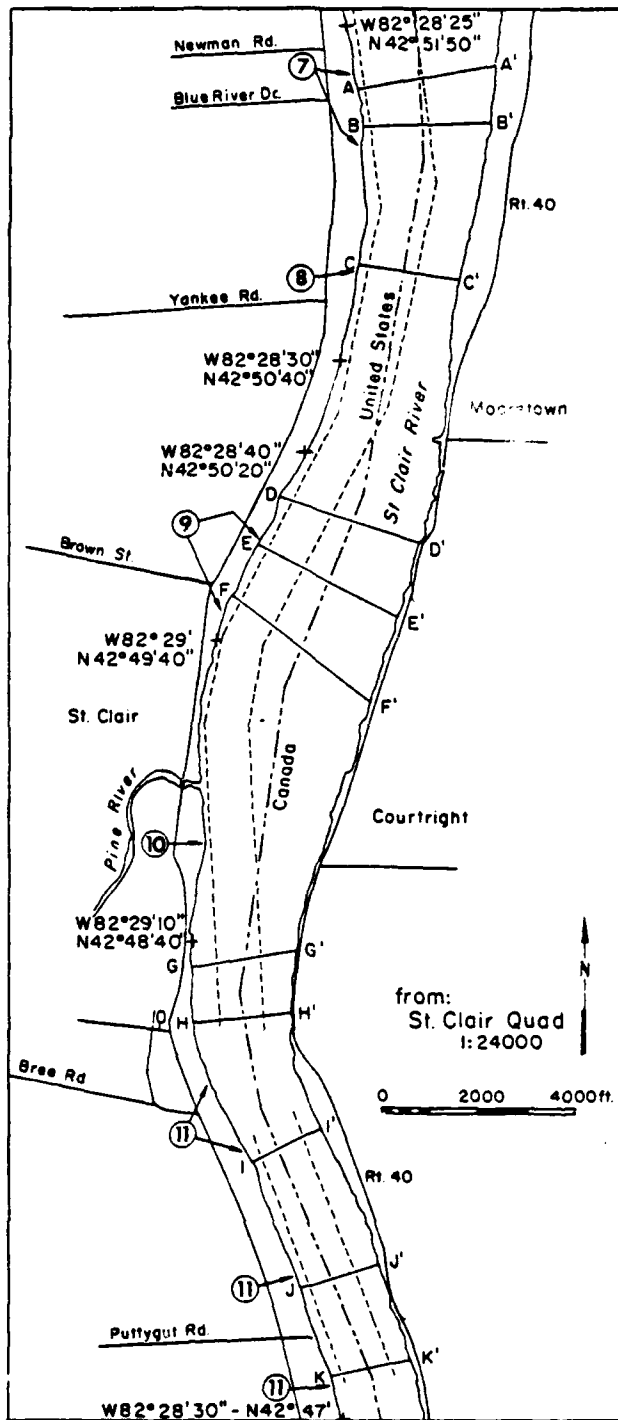
Figure D43. Generalized river cross-sections, sites 6 to 11, St. Clair River.

SOIL	<input checked="" type="checkbox"/> Artificial (fill) <input checked="" type="checkbox"/> Natural	Texture Sandy clay	Color Tan	Structures No; looks massive	Remarks		
NEARSHORE CONDITIONS	Bathymetry Shelf Steep Shelf/Drop off (Fig. D43) X	Texture Clayey sand with scattered cobbles	Bedforms No <input checked="" type="checkbox"/> Yes <input type="checkbox"/>	Vegetation Type Density	Remarks		
LANDUSE	Sparse <input checked="" type="checkbox"/> Medium <input type="checkbox"/> Dense <input type="checkbox"/> Residential	Sparse <input type="checkbox"/> Medium <input type="checkbox"/> Dense <input type="checkbox"/> Commercial	Agricultural	Recreational	None	X	Vacant lot
UPSTREAM CONDITIONS	Protective Structures B.H. RR Gab Other X	Vegetated Bluff	Slope	Nearshore Conditions Similar	Remarks Poured concrete over bank at scattered locations		
DOWNSTREAM CONDITIONS	Protective Structures B.H. RR Gab Other X	Vegetated Bluff	Slope	Nearshore Conditions Similar	Remarks

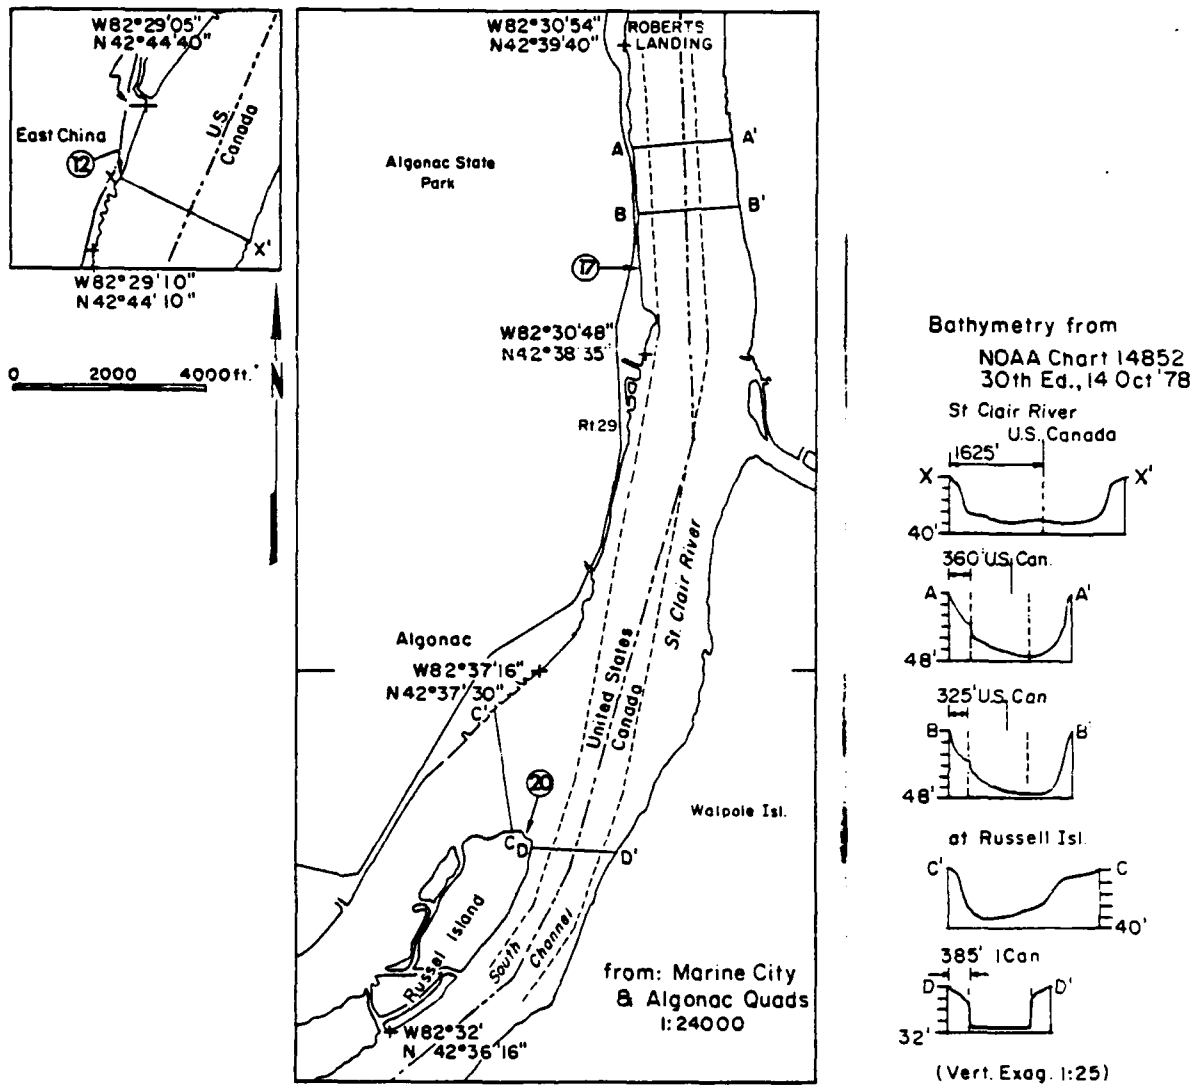
Figure D44. Generalized river cross-sections, sites 13 to 20, St. Clair River.

NEARSHORE CONDITIONS		Bathymetry Shelf Steep (Fig. D44) X		Texture		Bedforms		Vegetation Type		Remarks	
		X		Sand		None observable		Density <input checked="" type="checkbox"/> No <input type="checkbox"/>

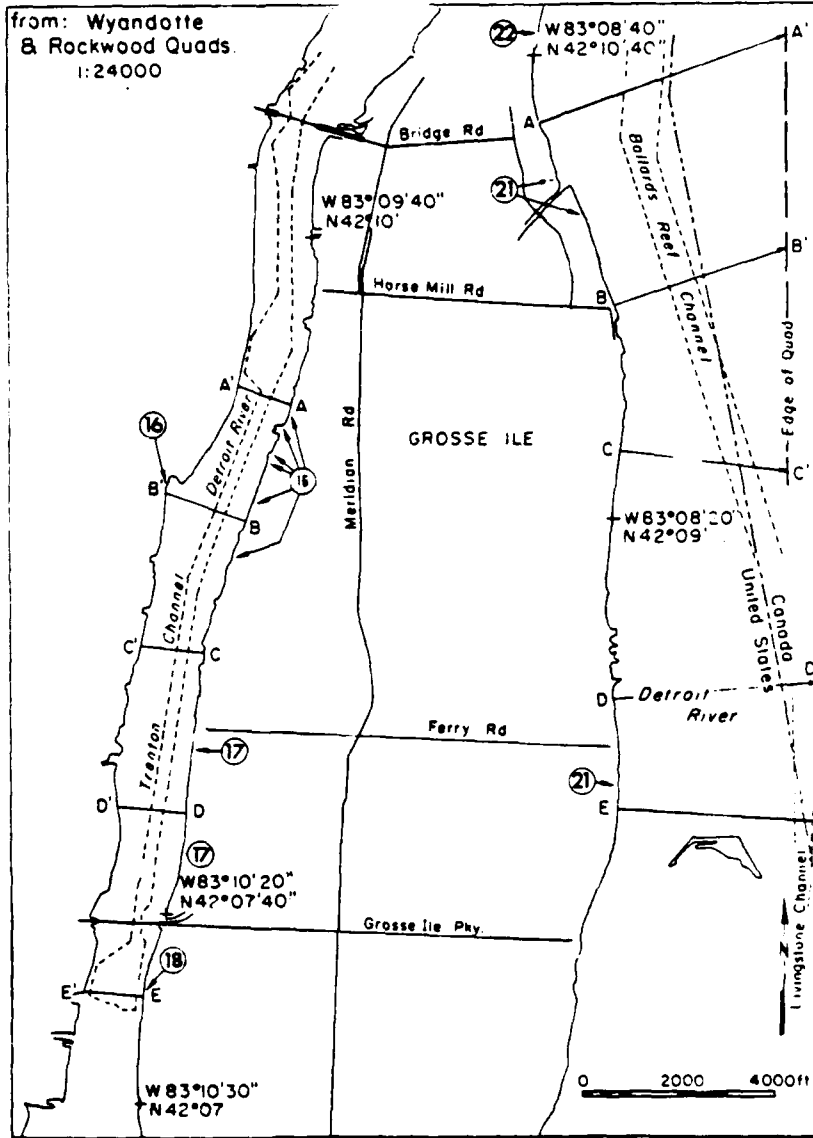
Figure D59. Generalized river cross-sections, sites 16, 17, 18, 21, 22 and 23, Detroit River.

<input checked="" type="checkbox"/> Natural		Sandy and Gravelly clay	Tan	Weak layering	
	Mathometry		Texture	Bedforms	Vegetation	Remarks
	Shelf	Steep	Sand gravel	Not observable	Type	Density
	(Fig. D59)	X				
	Residential		Commercial		Agricultural	
	Sparse <input checked="" type="checkbox"/>	Medium <input checked="" type="checkbox"/>	Dense <input checked="" type="checkbox"/>	Sparse <input checked="" type="checkbox"/>	Medium <input checked="" type="checkbox"/>	Dense <input type="checkbox"/>
	Protective Structures		Vegetated Bluff		Nearshore Conditions	
	B.H. <input checked="" type="checkbox"/>	RR <input checked="" type="checkbox"/>	Cab <input checked="" type="checkbox"/>	Other <input checked="" type="checkbox"/>	Slope	
	UPSTREAM CONDITIONS		Vegetated Bluff		Nearshore Conditions	
	B.H. <input checked="" type="checkbox"/>	RR <input checked="" type="checkbox"/>	Cab <input checked="" type="checkbox"/>	Other <input checked="" type="checkbox"/>	Slope
