AEFA Project No. 87-25-1

EVALUATION OF THE IMPROVED OV-1D ANTI-ICING SYSTEM PHASE II

April 1989
Final Report

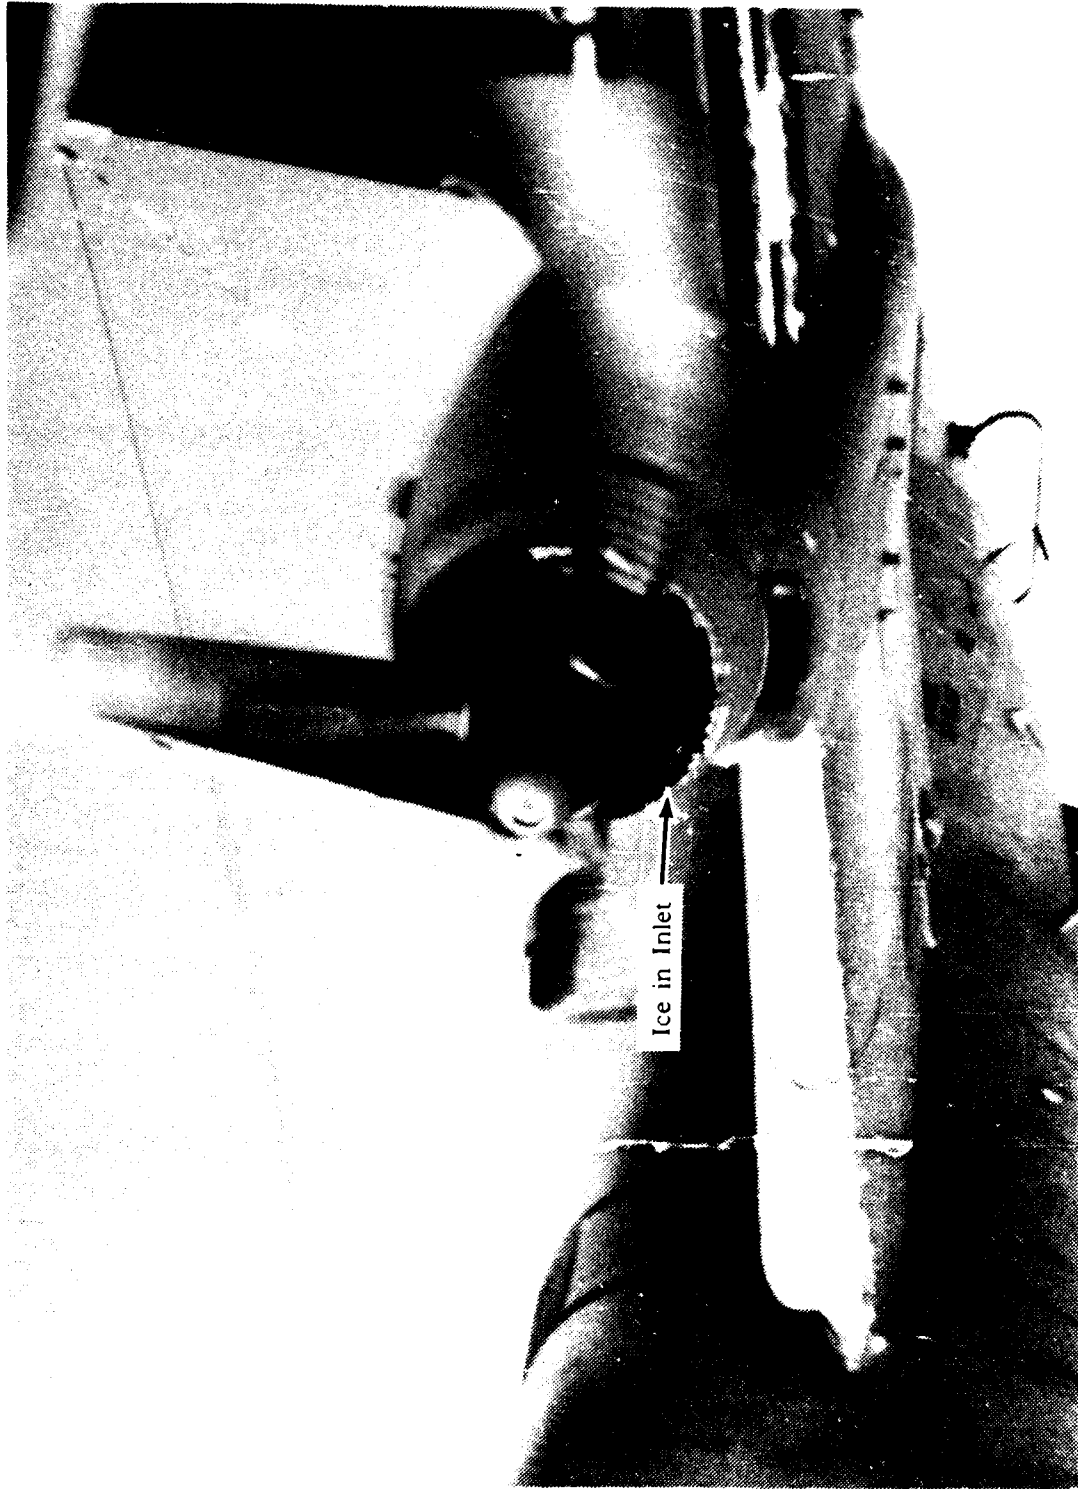
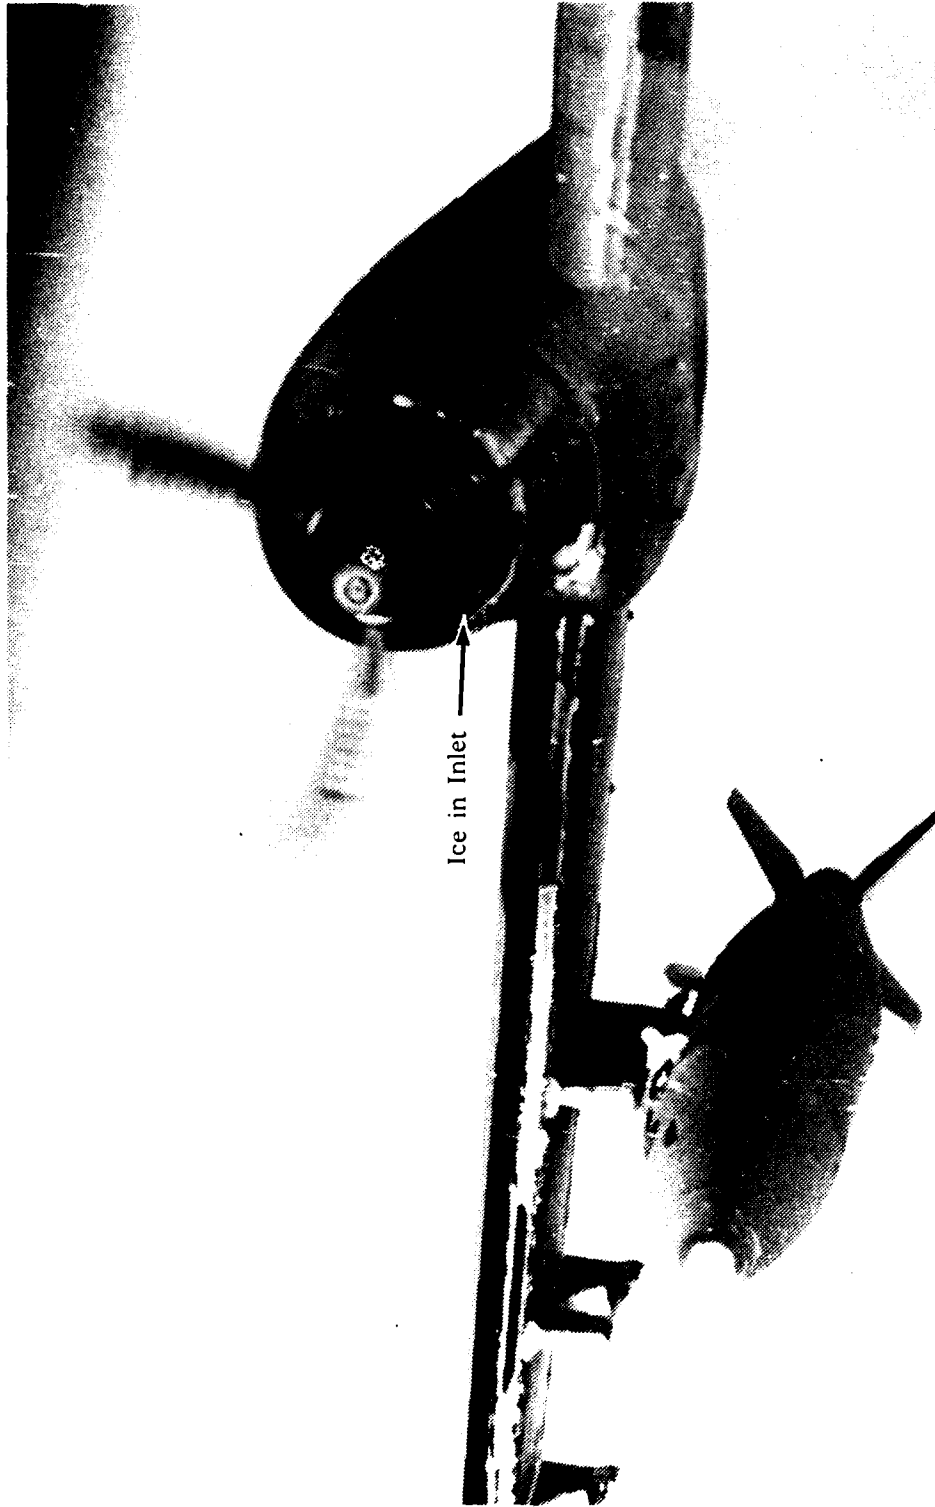
7. The ice accretion characteristics of the engine inlet at temperatures colder than -15 degrees C were reported as a deficiency during AEFA Project No. 87-25. The actual temperature at which ice starts to accrete in the inlet was determined during this test to be -11 degrees C (figs. D-1 and D-2). The failure of the anti-icing system to keep the engine inlet clear at temperatures colder than -10 degrees C is a deficiency. The engine inlet anti-ice system should be redesigned to allow safe operation in icing conditions at temperatures colder than -10 degrees C. The OV-1 with the improved anti-icing system should be cleared into icing conditions up to and including moderate with ambient temperatures no colder than -10°C.

*b. The failure of the anti-icing system to keep the engine inlet clear at temperatures colder than -10 degrees C (para 7).

Figure D-1. Ice in Inlet: LWC = 0.6 gm/m³, Time in Cloud = 0.5 hr, OAT = -11°C

Figure D-2. Ice in Inlet: LWC = 0.6 gm/m³, Time in Cloud = 0.5 hr, OAT = -11°C

29. Correct the deficiencies listed in paragraphs 27a through 27c prior to release of the aircraft for flight in icing conditions at temperature colder than -10°C.
30. Correct the deficiencies listed in paragraphs 27d and 27e prior to release of the aircraft for flight in icing conditions at any temperature.
31. Correct the deficiencies listed in paragraphs 27f and 27g prior to release of the aircraft for operational mission or for flight in instrument meteorological conditions.
32. Correct the shortcomings listed in paragraph 28 as soon as practicable.
33. The following **WARNING** should be placed in the operator's manual.

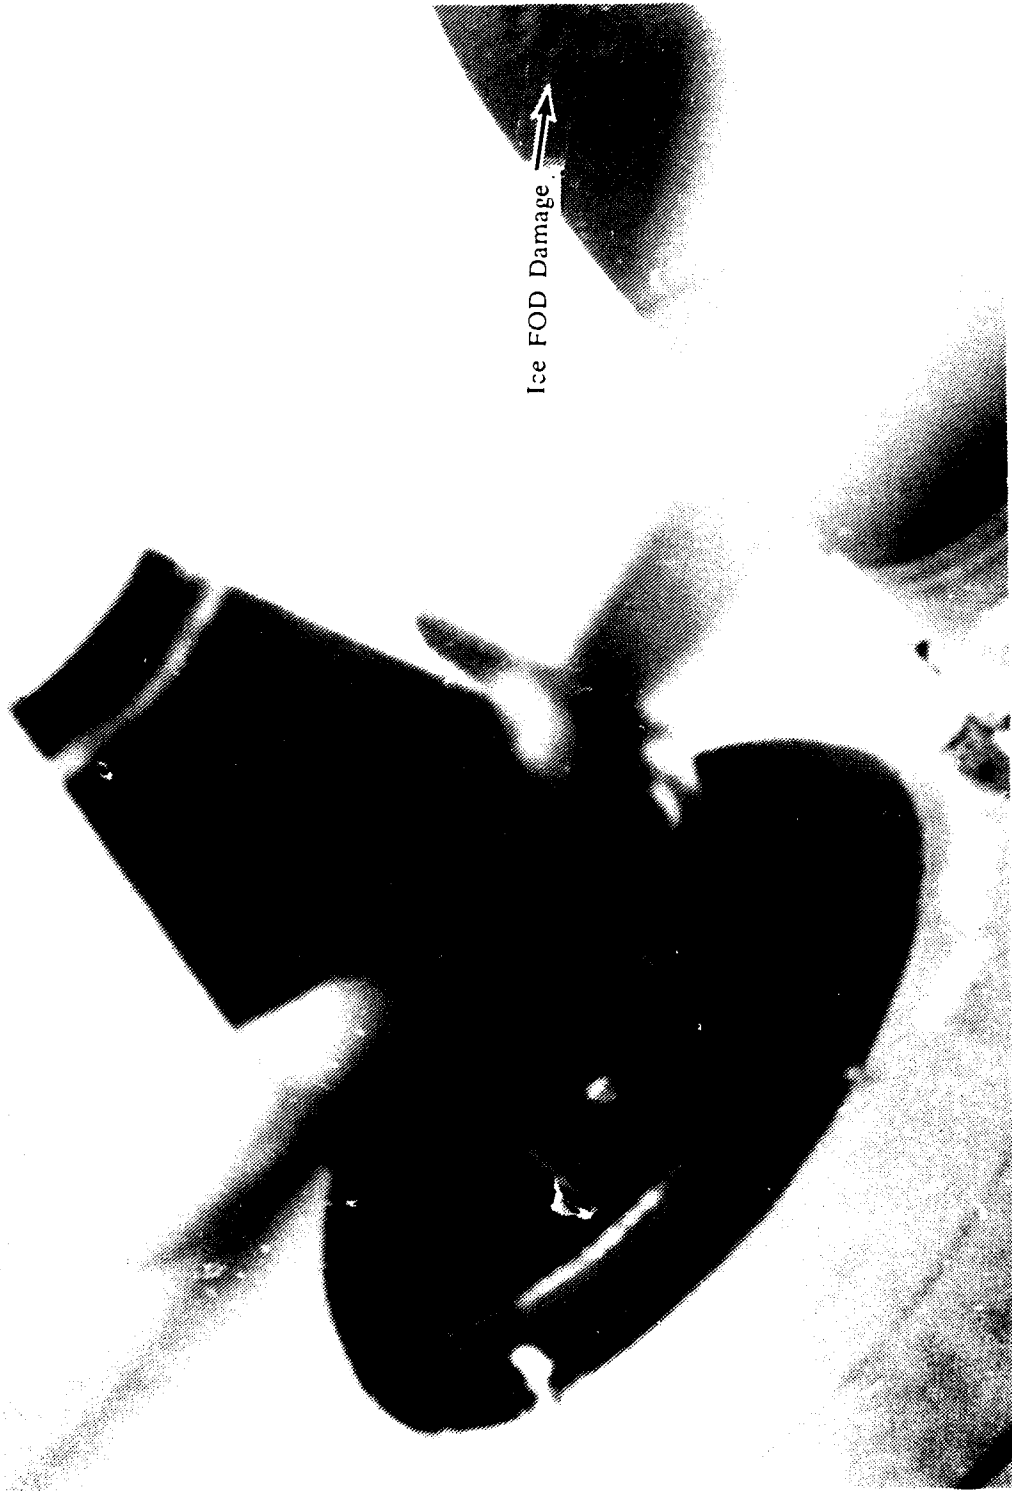
15. Propeller and wing ice sheds occurred during deice cycles in all of the icing conditions tested. Ice departing the blades and or wings frequently hit the fuselage, empennage or fuel drop tanks. Figures D-3, D-4, and D-9 shows fuselage damage resulting from propeller ice sheds. Dents as large as 3/8 inch deep and 4 inches in diameter were observed during AEFA Project 87-25. The propeller shedding characteristics are a shortcoming because of the resulting fuselage, empennage and drop-tank damage.

Figure D-4. Ice Damage to Left Drop Tank from Propeller

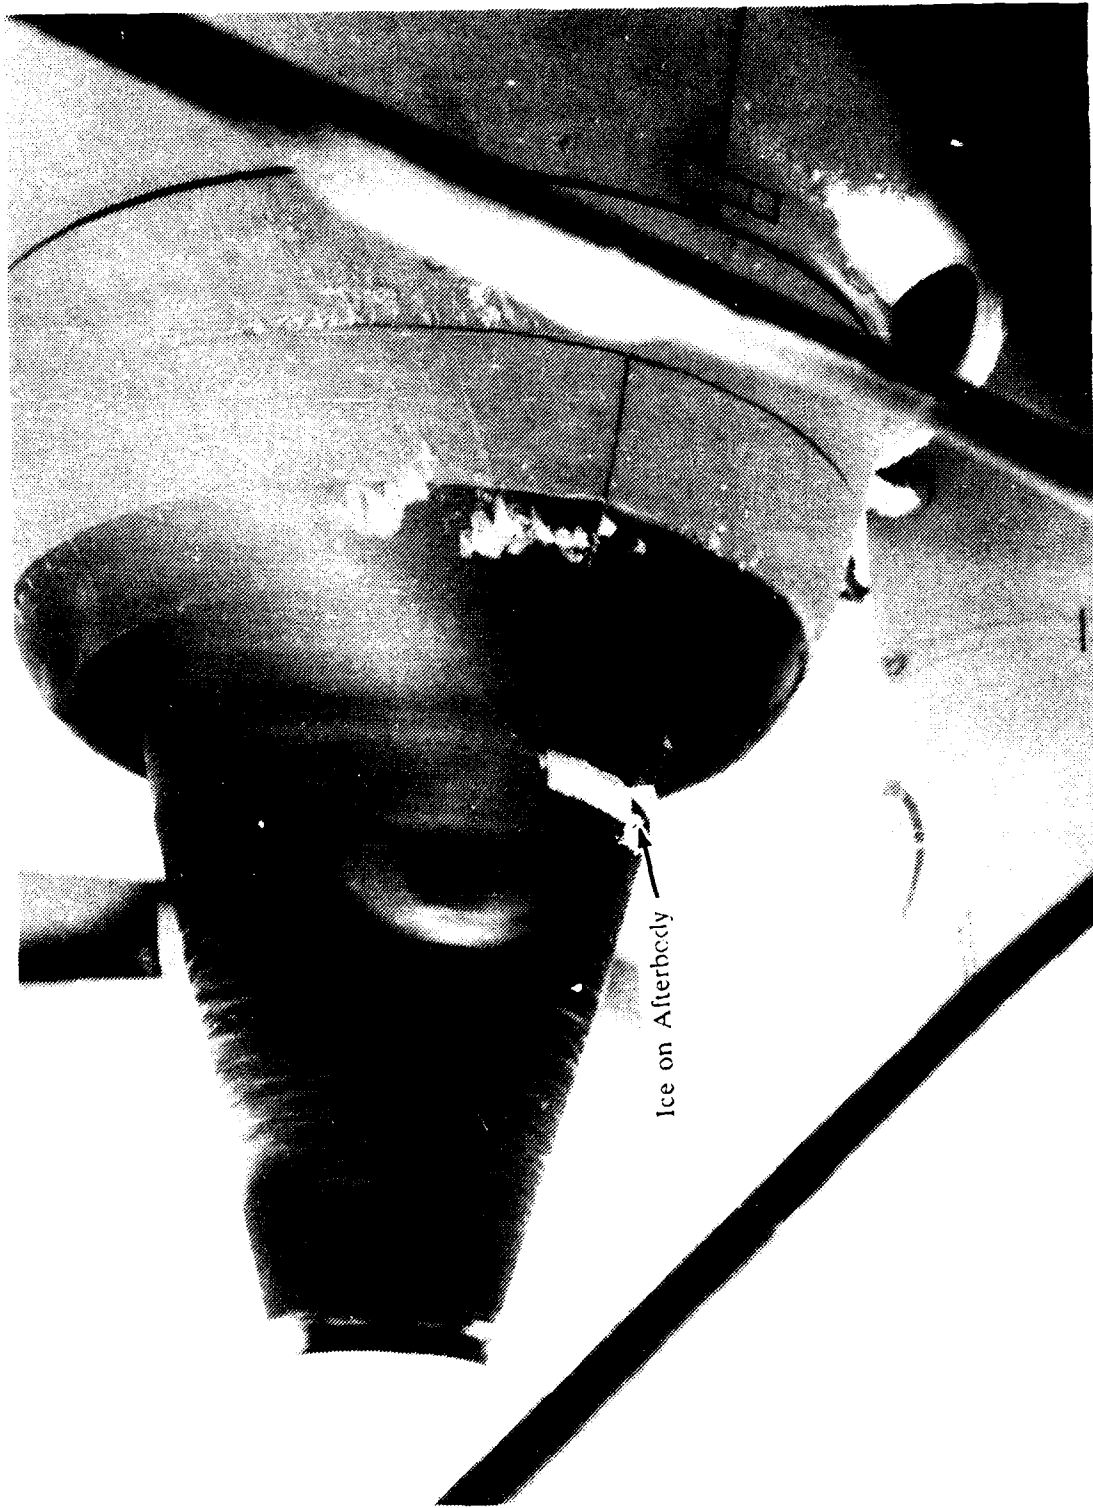
10. Splinter shaped ice accreted on the spinner afterbody on the bottom portion from the 4 to 8 o'clock positions from the leading edge of the afterbody to approximately 6 inches aft (fig. D-6). During icing encounters, ice accreted at the leading edge of the afterbody and grew forward until it was dislodged by vibration or air pressure, or impacted by the rotating propeller blade shank. When a section of the accreted ice broke off, it was ingested into the inlet and, therefore, is a potential ingestion hazard to the engine, although there was no engine damage noted. At temperatures colder than -10 degrees C the splinter shaped ice accretions grew to approximately two inches by three-fourths inch in thickness prior to shedding. The ice accretion and shedding characteristics of the propeller spinner afterbody which may result in ice foreign object damage (FOD) to the engine in light and moderate icing conditions at temperatures colder than -10 degrees C are a deficiency.

*c. The ice accretion and shedding characteristics of the propeller spinner afterbody which may result in ice FOD to the engine in light and moderate icing conditions at temperatures colder than -10 degrees C (para 10).

Figure D-6. Propeller Spinner Afterbody: LWC = 0.6 gm/m³, Time in Cloud = 0.8 hr, OAT = -8.0°C

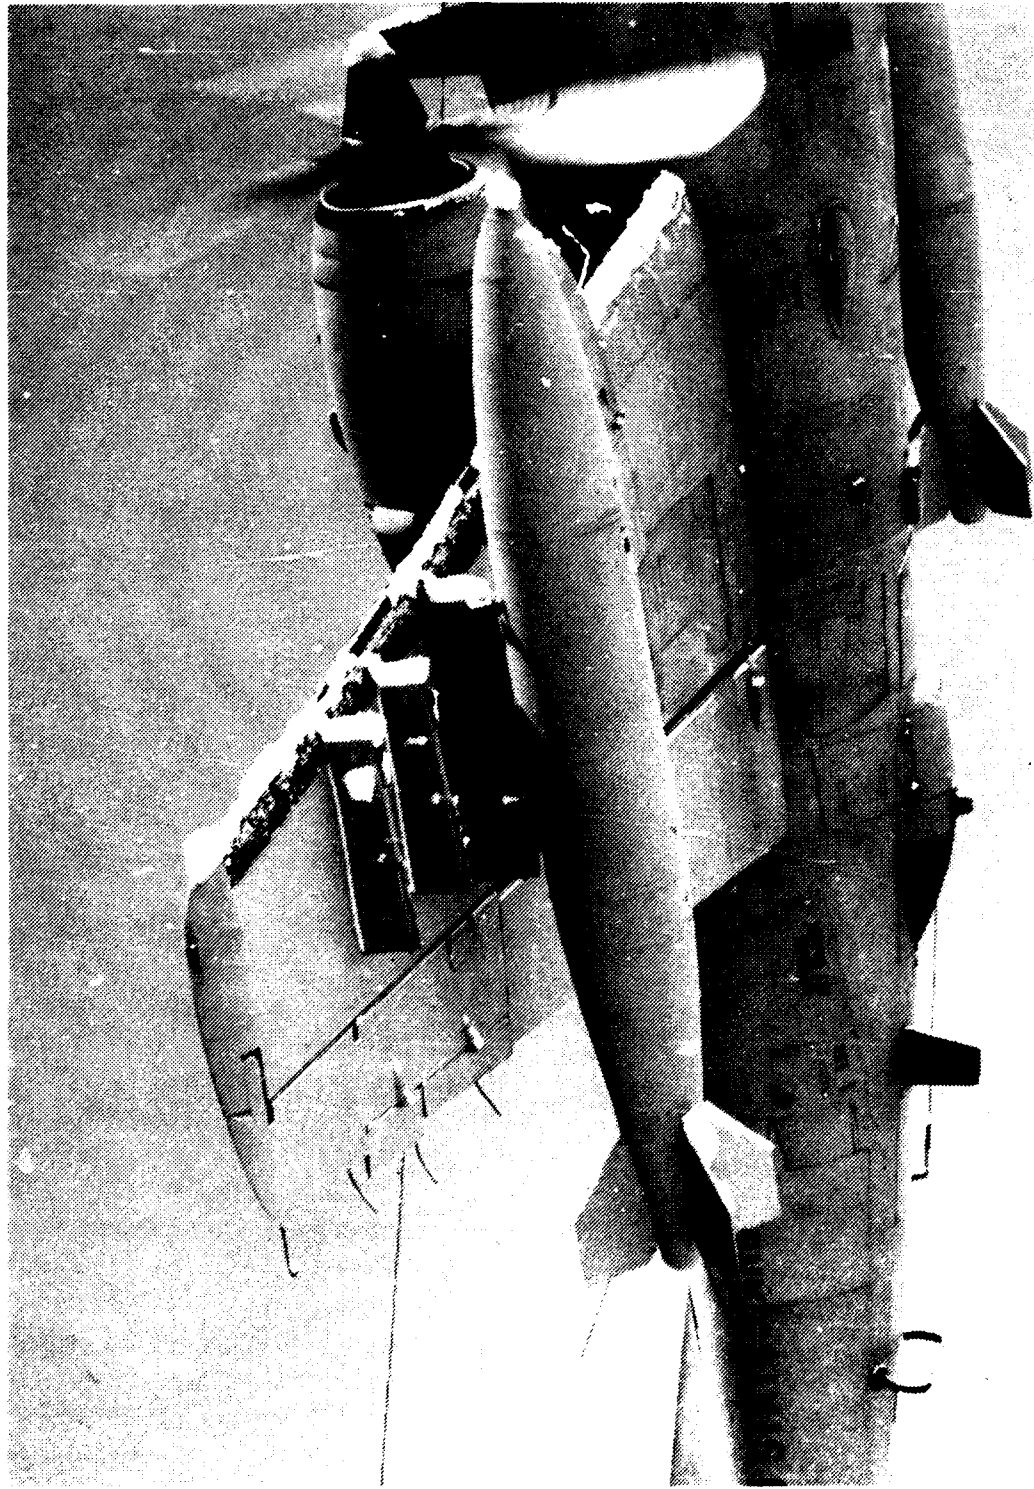
Figure D-7. Wing/Vertical/Horizontal Stabilizer Leading Edge Ice Accretions: $LWC = 0.17 \text{ gm/m}^3$,
Time in Cloud = 1.0 hr, $OAT = -12^\circ\text{C}$

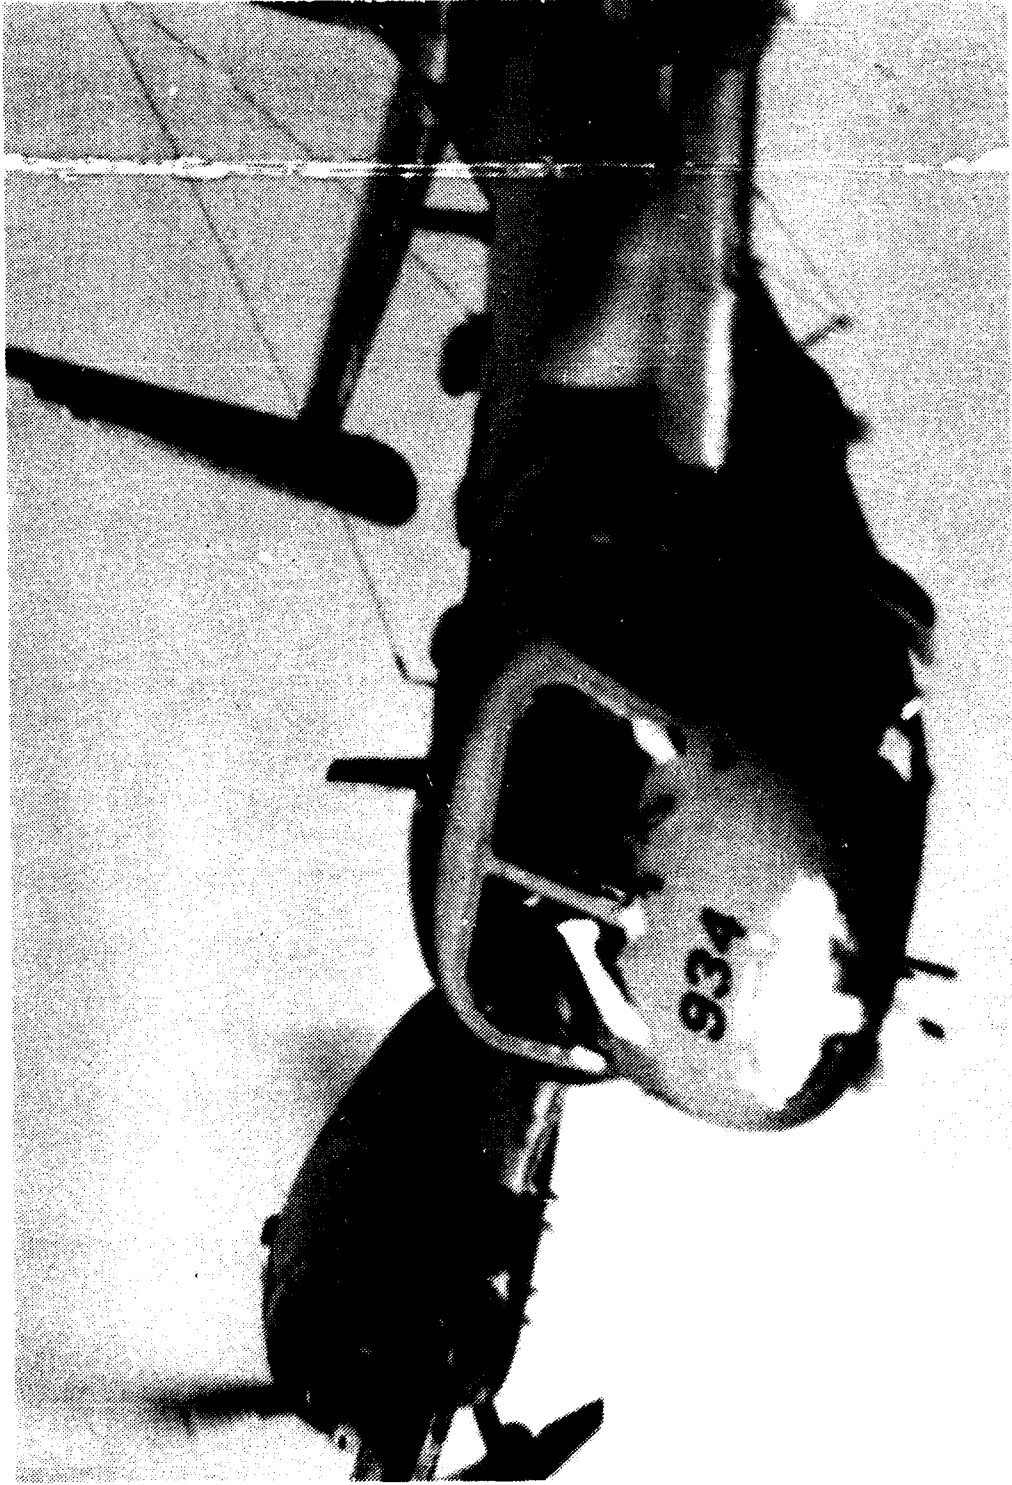
16. During AEFA Project No. 87-25 and during this evaluation there was propeller damage caused by ice departing from the windshield wipers and going through the propellers. Windshield wiper ice accumulation is shown in figure D-10. The ice accretion and shedding characteristics of the windshield wipers are a shortcoming due to the damage caused to the propellers.

b. The ice accretion and shedding characteristics of the windshield wipers due to the damage caused to the propellers (para 16).

Figure D-10. Windshield/Vertical Stabilizer Ice: LWC = 0.6 gm/m³, Time in Cloud = 0.9 hr,
OAT = -8.0°C

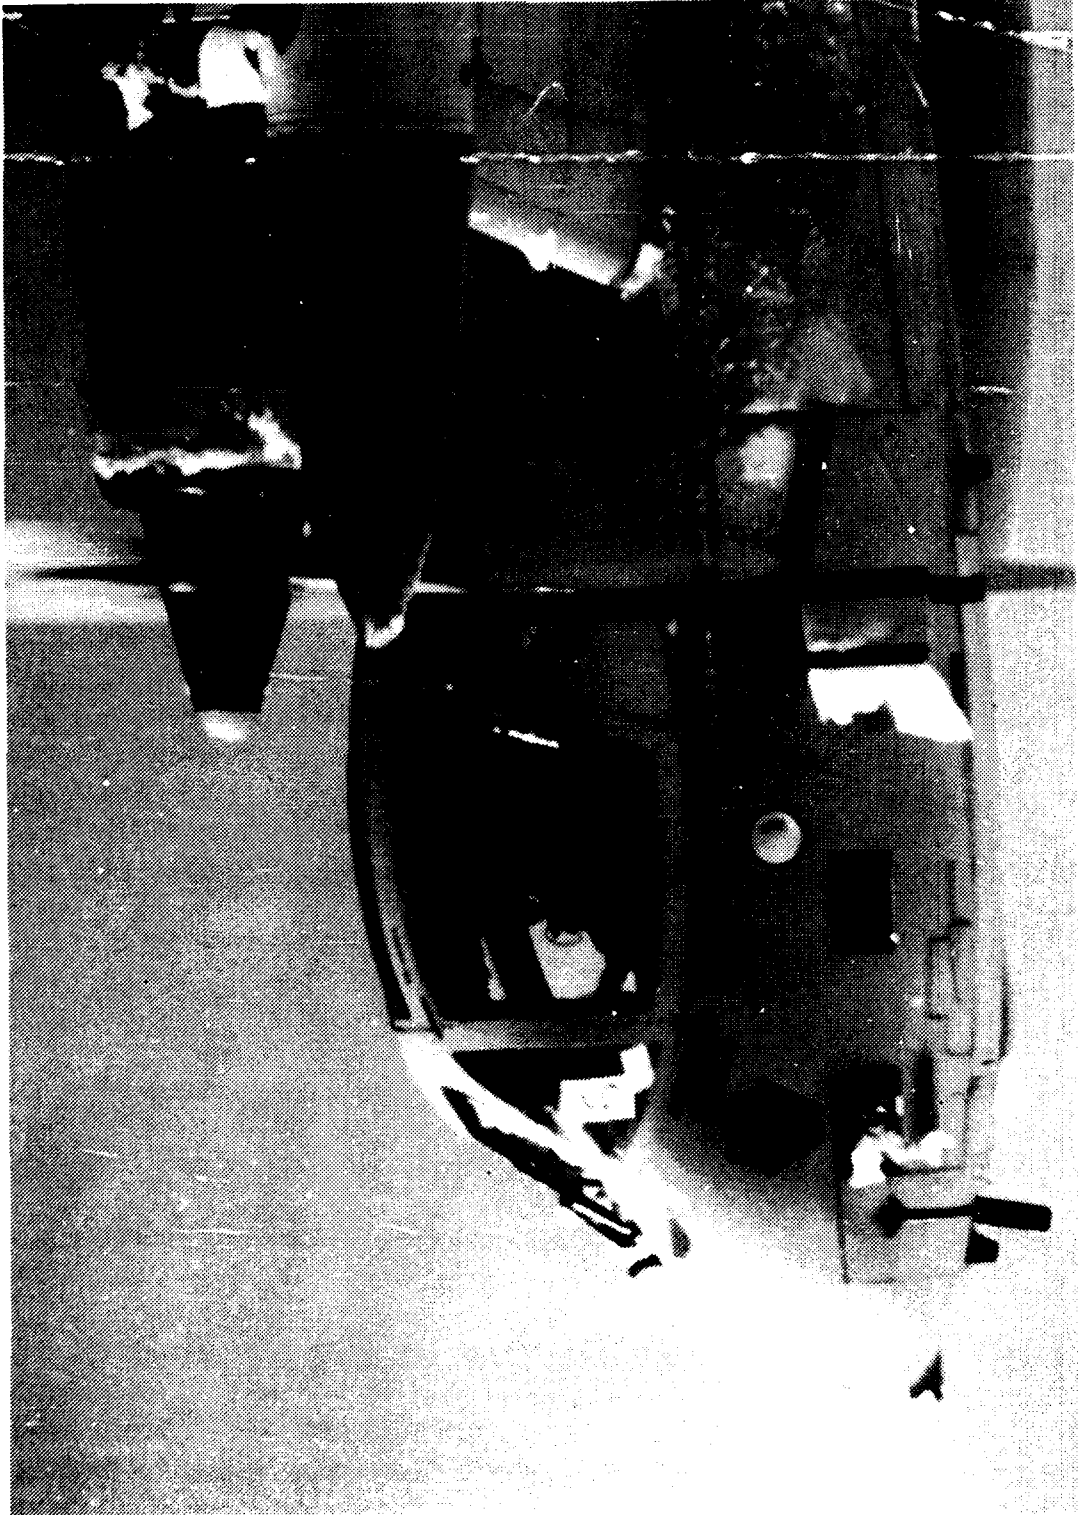
23. During this evaluation in light and moderate icing conditions, ice accretion started on the vertical base of the pitot tube and built forward and up around the pitot tube (figs. D-11 and D-12), never touching the horizontal portion of the pitot tube itself. Airspeed indications were disrupted (the airspeed reading was from 50 to 90 KIAS), after the ice accreted to within one-half inch of the leading edge of the pitot tube opening. The pitot heating element was checked in accordance with maintenance procedures and was verified to be working as required. The aircraft manufacturer has also verified that the pitot heating element was producing specification heat output. The ice accretion characteristics of the pitot tube which result in erroneous airspeed indications are a deficiency.

Figure D-11. Ice on Pitot Tube: LWC = 0.6 g/m³, Time in Cloud = 0.9 hr, OAT = -8.0°C

Figure D-12. Ice on Pitot Tube: LWC = 0.6 g/m³, Time in Cloud = 0.9 hr, OAT = -8.0°C
