| 4. Title and Subtitle<br><br>Examination of Blistering of Fiberglass Reinforced Laminates | | 5. Report Date<br>June 26, 1987 | |
| 12. Sponsoring Agency Name and Address<br><br>U. S. Coast Guard<br>Department of Transportation<br>Washington, D.C. 20593-0001 | | 13. Type of Report and Period Covered<br><br>Final Report 1986-1987 | |

EXAMINATION OF BLISTERING OF  
FIBERGLASS REINFORCED LAMINATES

June 26, 1987

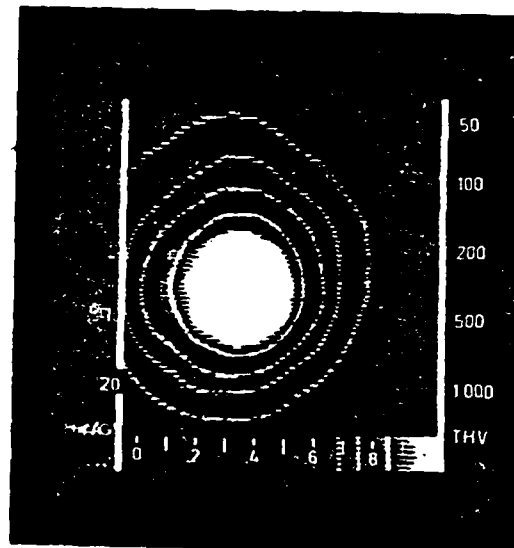
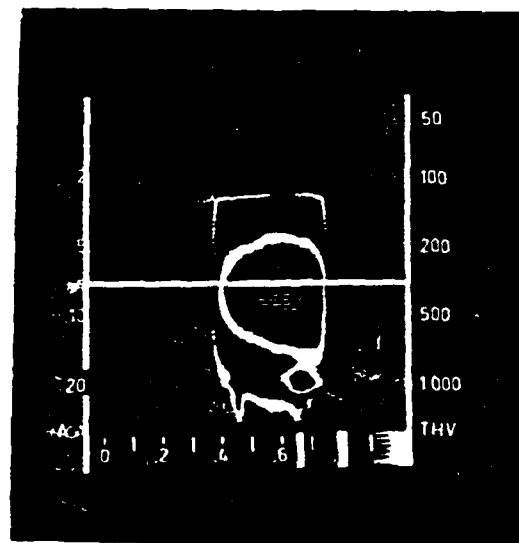
FIGURE 2. PANEL DEFECTS AS DETERMINED BY INFRARED CAMERA
