AEFA Project No. 88-06-1

## NATURAL ICING RE-EVALUATION OF THE EH-60A QUICK FIX HELICOPTER

May 1989

Final Report

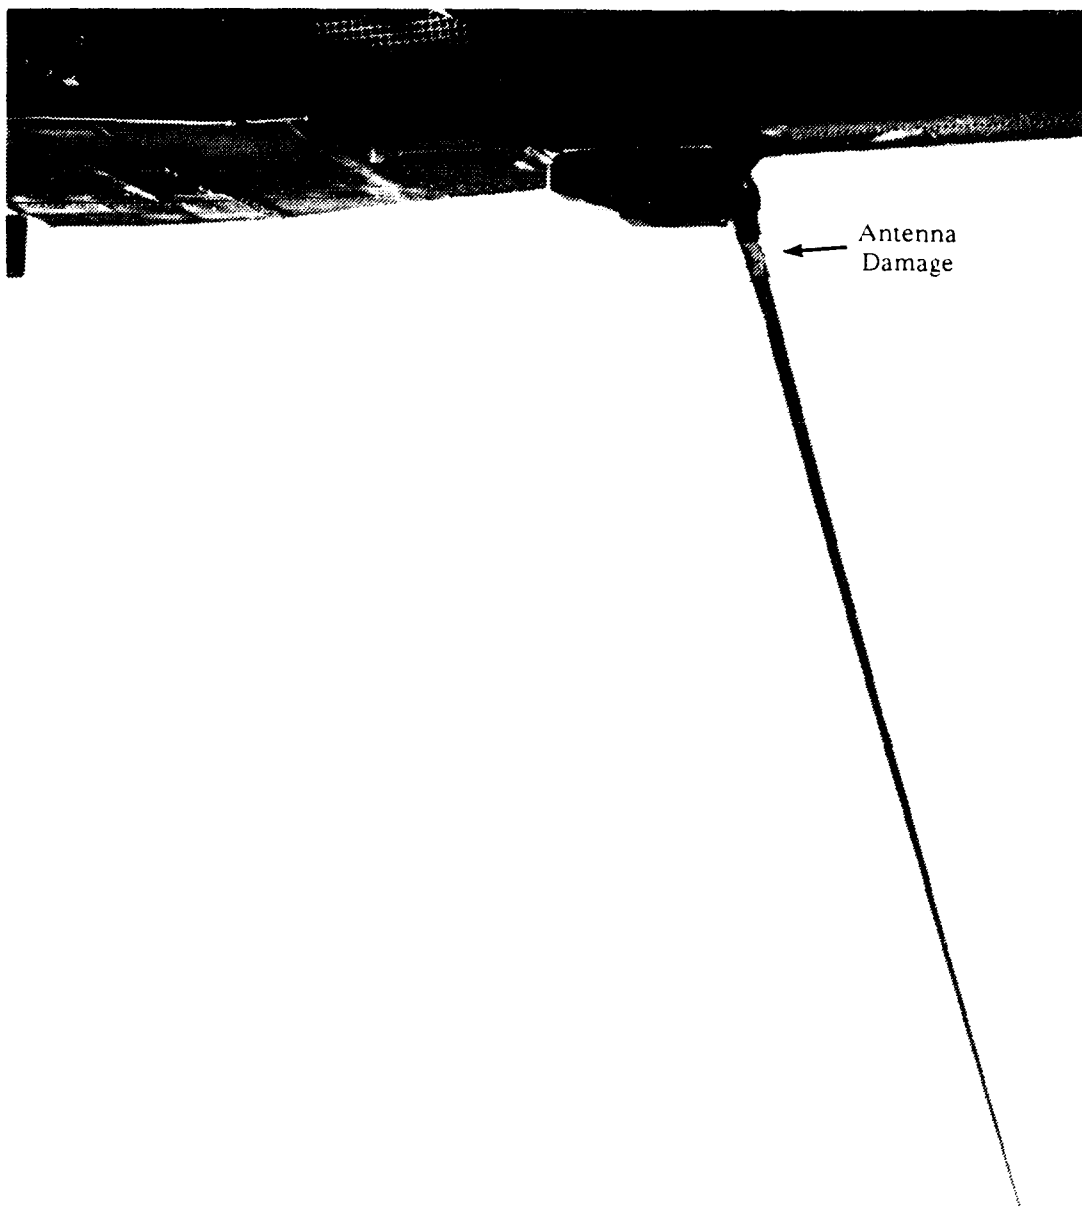
Figure F-2. ECM Antenna Extended Post-Failure (Flight #3)

10. The ice accretion, ice shedding and oscillation characteristics of the extended ECM antenna were evaluated over a total of 3.1 hours during flights one through three. The effect of ECM antenna ice accretion on the operation of the ECM system was not assessed. The behavior of the ECM antenna was not observed during flights one and two since the forward camera was unserviceable. A 2 in. thick ice accretion along the lower 8 ft of the antenna was observed by the chase aircraft after exiting the icing conditions on flight one; no excessive oscillations were noted, retraction was normal and the ice shed after landing (fig. F-1, app F). After exiting the icing conditions on flight two, a uniform ice accretion of about 1 in. was observed; there were no excessive antenna oscillations and the ice shed after landing. During the initial part of flight three the ECM antenna oscillated laterally at approximately 4 Hz with a tip amplitude of about  $\pm 6$  in. After 20 minutes of icing the oscillation rapidly increased to a tip amplitude of  $\pm 2$  ft with visible movement of the actuator assembly and its mounting structure. After a further 13 minutes the oscillations suddenly stopped and the antenna hung slightly off-center, with only small oscillations, until retraction (fig. F-2). After exiting the icing conditions the chase aircraft observed a uniform 1 1/2 - 2 in. ice accretion along the lower 8 ft of the antenna with 1/2 in. of ice on the upper 1 ft. During retraction the antenna hesitated at 30 degrees extension before stopping at 5 degrees extension with the tip displaced 6 in. laterally from the cradle (fig. F-3). The ANTENNA RETRACTED advisory light remained out and the ANTENNA EXTENDED warning illuminated during approach and landing.

| <p>After a natural icing test flight of 1.4 hr. duration at -14.0° C with an average LWC of 2.27 g/m<sup>3</sup>, the ECM antenna failed to fully retract. During the test flight the ECM antenna had oscillated laterally. After approximately 33 minutes, the antenna stopped oscillating and hung slightly to the right of the normal extended position.</p> <p>Post Flight inspection revealed a debonding between the aluminum ECM antenna and the fiberglass insulation bushing at it's base. Various patches of paint were missing from a spot about 3 feet from the antenna tip. (Continued on attached sheet)</p> | |
