AIRFIELD PAVEMENT EVALUATION

PISCO AND LA JOYA AIR BASES, PERU

AIRFIELD PAVEMENT EVALUATION
OF
PERUVIAN AIR BASES

PREPARED FOR
TACTICAL AIR COMMAND (TAC)

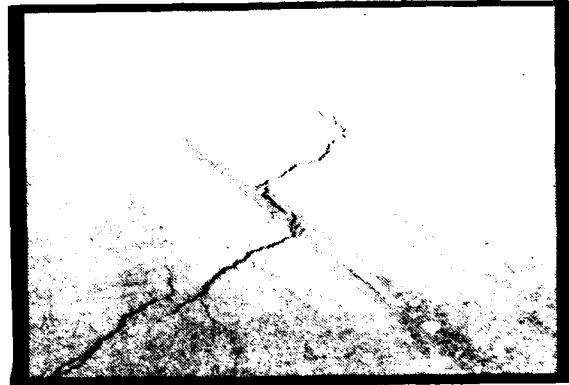
The only obvious distresses on the Parallel Taxiway are some environmentally-related block cracks limited to one paving lane between ladder Taxiways 4 and 5. The only other distresses are the same type of diagonal cracks that were present on the runway. These cracks appear to follow the same pattern and continue along the same geological disturbance path. The recommended maintenance for this type of cracking is to seal the cracks and watch for any further deterioration.

PHOTO 4-7: Diagonal cracks extending across the entire taxiway. Cracks are most likely a result of earth movement and not aircraft loadings. Recommend the cracks be sealed.

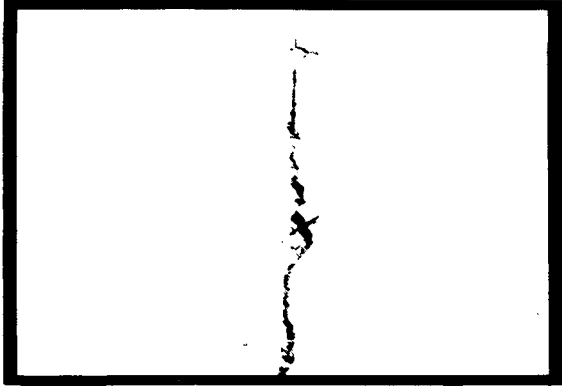
The second primary problem throughout the aprons is the joint spalling. Joint sealant is virtually non-existent, which has allowed a passageway for incompressibles to enter the pavement joints. These incompressibles restrict movement when concrete expands, thus resulting in spalled edges. Recommend the spalled edges be sawcut a minimum of three inches deep, and the unsound material removed. Upon removal, the joint should be formed and the material replaced with concrete mix.

PHOTOS 10 & 11: Spalled joints on PCC apron. Joint sealant missing in most of the PCC. Recommend the distresses be sawcut, material removed, and replaced with new PCC.

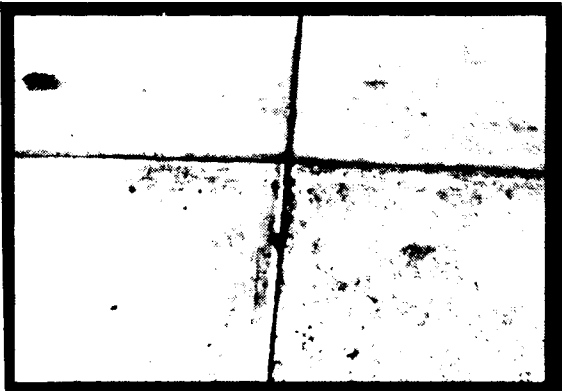
PHOTO 15: Nonexistent joint sealant typical of many PCC pavements.

Joint sealant is missing in most of the PCC features. It is essential to extend the pavement life. Recommend all the joints be cleaned and sealed following the spall repairs.

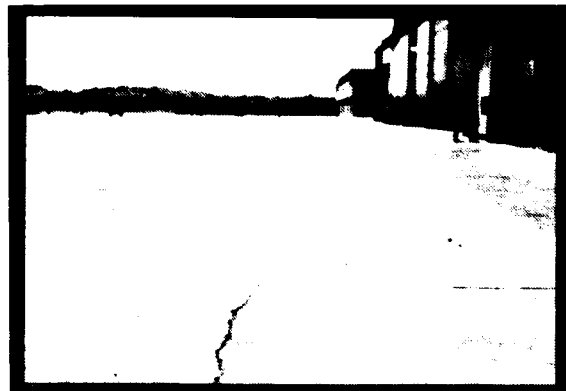
PHOTO 17: Evenly spaced cracks extending the length of the apron and isolated to a row of slabs. This type of distress is associated with the vibration and consolidation during construction. Recommend the cracks be cleaned and sealed.

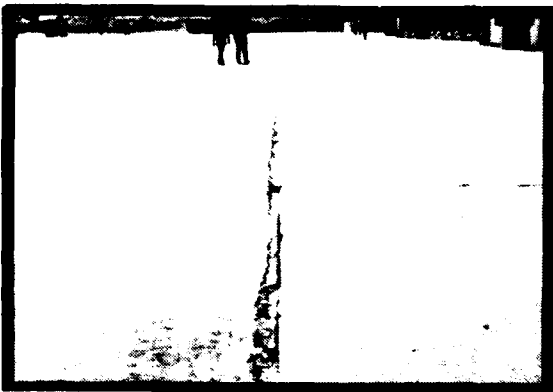
PHOTO 15: Spalled transverse joints which may be caused from incompressibles prohibiting slab movement resulting in joint spalls.

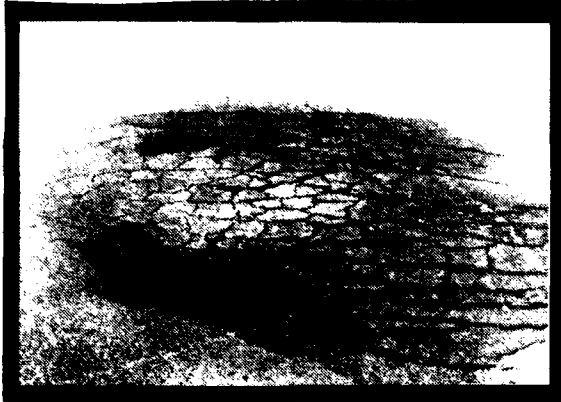
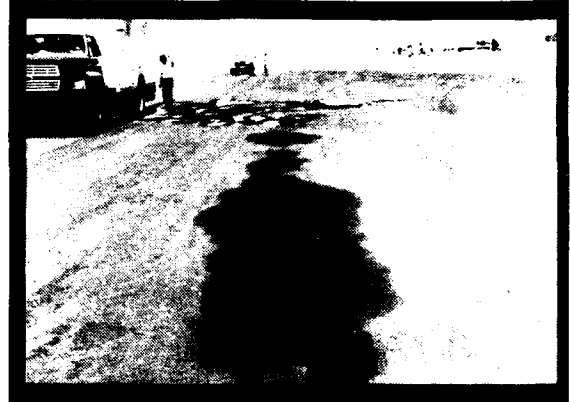
The other significant taxiway distresses are limited to the AC at the intersection of the Parallel Taxiway and the main parking apron (the south end of Feature T04A). Only 2 inches of AC protects the base course in this area. Isolated depressions and alligator cracking are evidence of pavement failure. Recommend the general area (approximately 800 square feet) be structurally repaired by enhancing the supporting soils and replacing the AC surface course.

PHOTOS 1-4: Pavement overloading is indicated by alligator cracks, block cracks, and depressions. These are common at the intersection of the Parallel Taxiway and the apron. Recommend this area be replaced.

d. The south area of Feature T4A is structurally distressed. Recommend this area, approximately 800 square feet, be rebuilt.

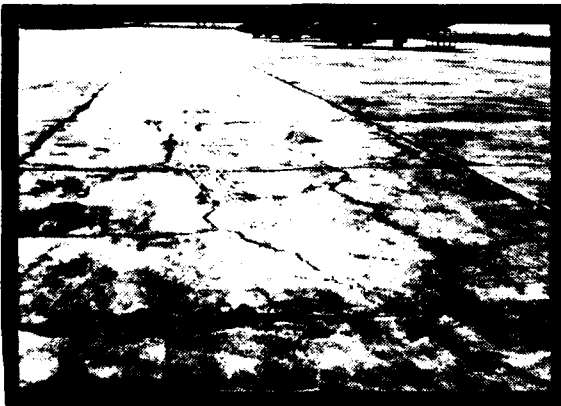
PHOTO 7: Typical shattered slabs concentrated on the apron taxi route. These slabs should be replaced.

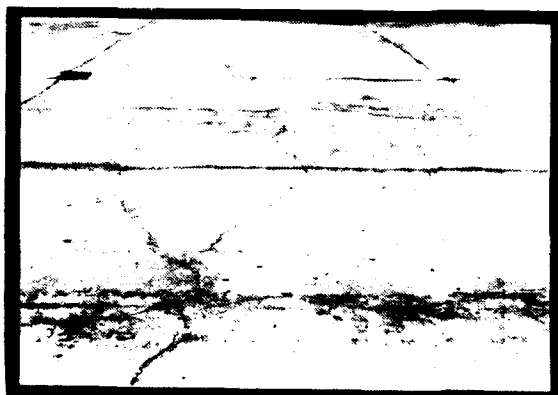
The PCC taxiway sections are generally in GOOD condition with the exception of two, which are in VERY POOR and FAILED condition. One is a small section of PCC near the intersection of Taxiway 2 and the Parallel Taxiway (Feature T10A). In this section, nearly all the PCC slabs have shattered due to overloading the pavement. The PCC thickness is between seven and eight inches and supporting soils are relatively weak. Recommend this area be replaced. The second area is the PCC (part of Feature A03B) connecting the main apron to the adjacent AC taxiway. It is in VERY POOR condition. Again, shattered slabs, spalled joints, and intersecting cracks are typical throughout. Recommend this area be replaced.

PHOTO 5: Failed PCC feature as indicated by extensive shattered slabs. Recommend the area be replaced.

c. Most PCC slabs on Feature T10A are shattered. Recommend this feature be replaced.

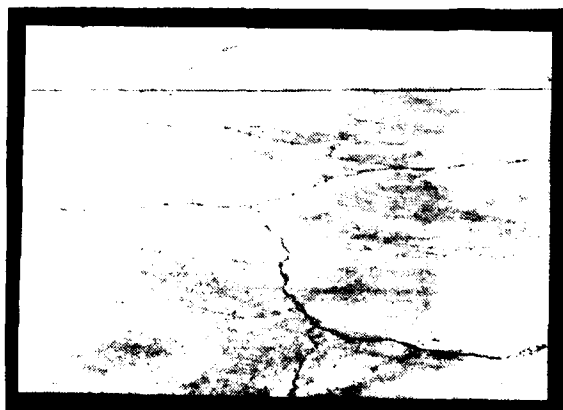
PHOTO 9: Typical shattered PCC slabs on apron.

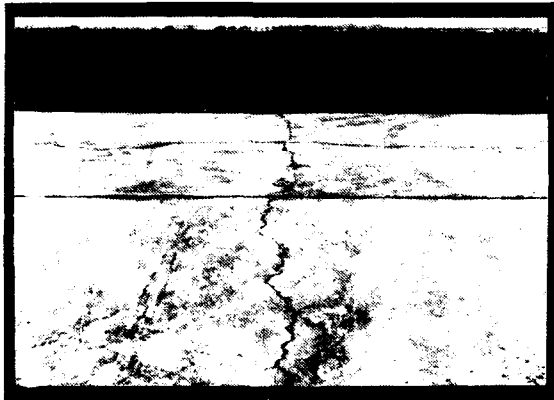
PHOTO 13: Cracks formed where joints should have been cut to control the cracking. Recommend the cracks be cleaned and sealed.

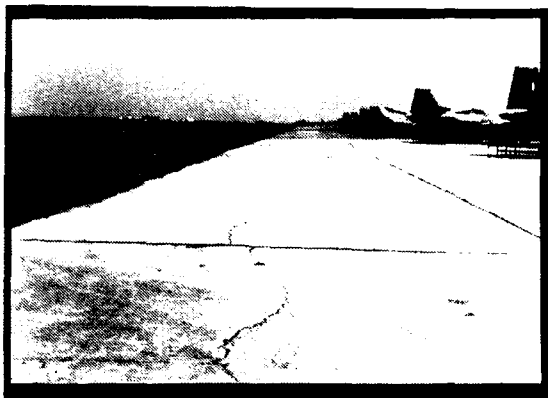
PHOTO 12: Typical longitudinal cracks extending the entire length of the apron. Recommend the cracks be cleaned and sealed.
