## Richard B. Russell Dam and Lake

Savannah River, Georgia And South Carolina

# Final Foundation Report Volume 2 of 2

RICHARD B. RUSSELL PROJECT  
SAVANNAH RIVER, GEORGIA AND SOUTH CAROLINA  
FINAL FOUNDATION REPORT  
CONCRETE DAM, EMBANKMENTS, AND POWERHOUSE

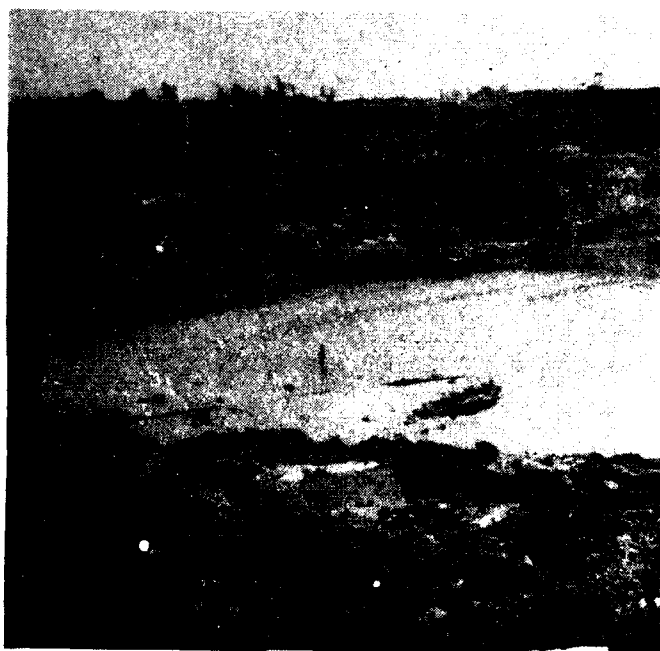
Photo 19 - Looking west into west retaining wall foundation area - near horizontal wall seam is at El. 307 (September 1978)

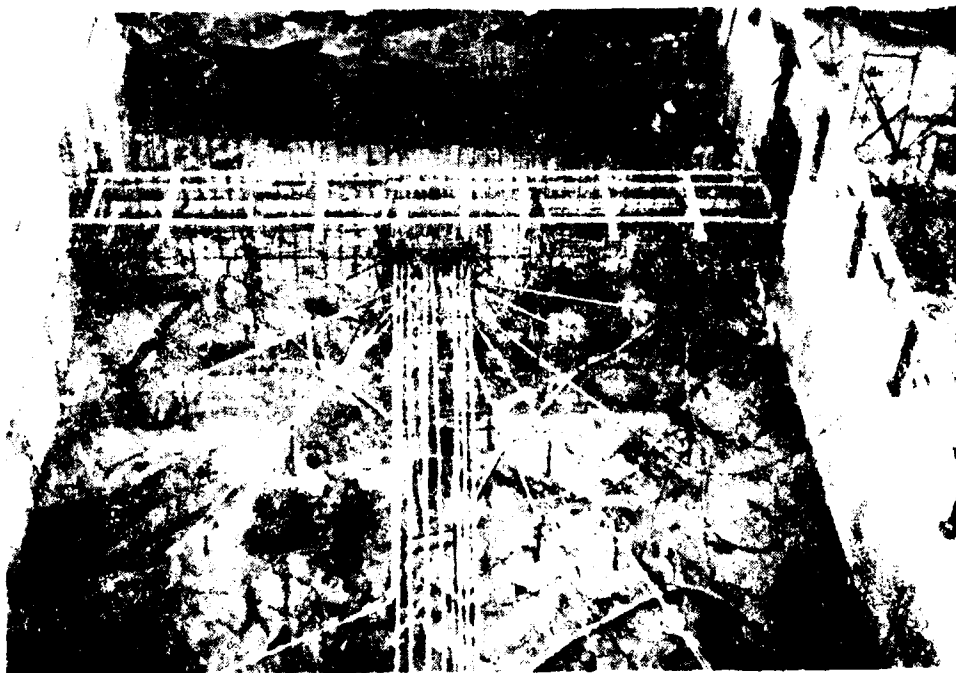
Photo 3 - Leak in rawwatering pipe - Monolith 1. (November 1979)

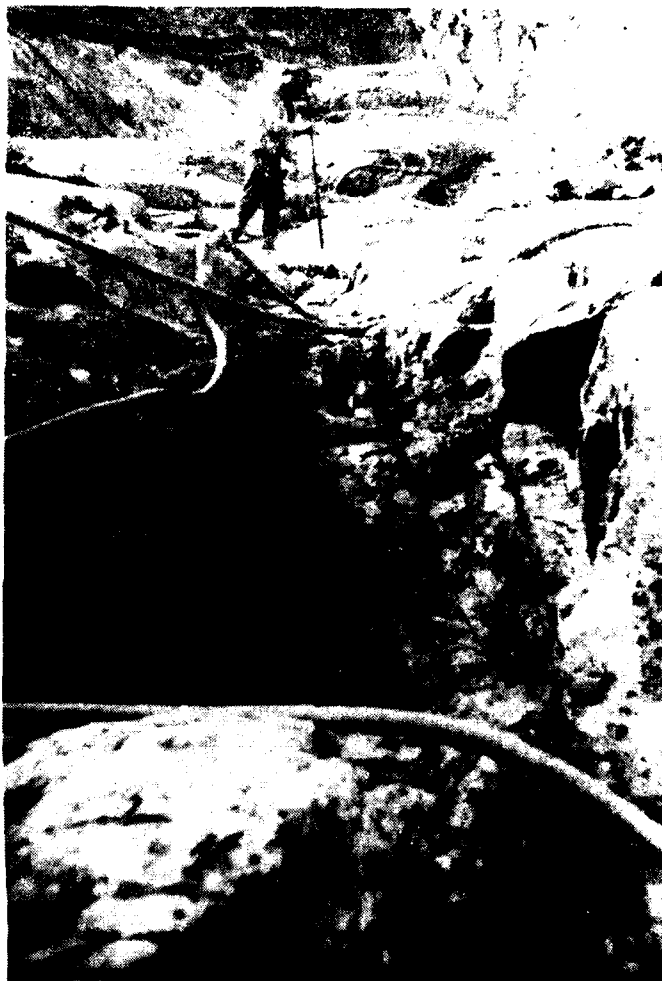
Photo 136 - Foundation conditions, Georgia west - approximately Stations 9+00 to 10+00. Some additional excavation was done in this area.

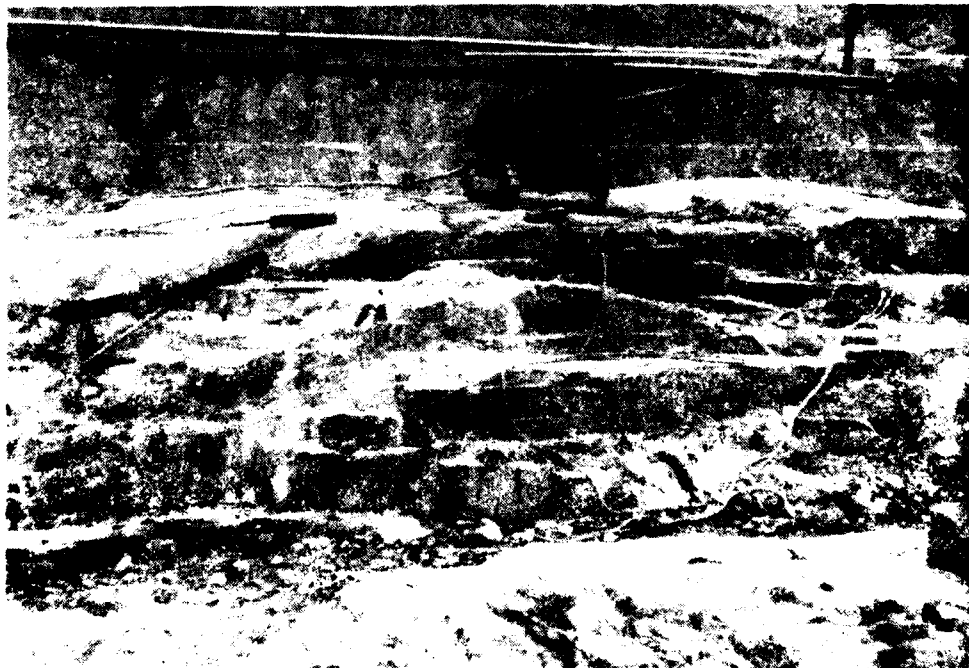
Photo 142 - Crout leaks at Station 12+10. Note gray streaks in center of photo where thin grout ran over the stairsteps.

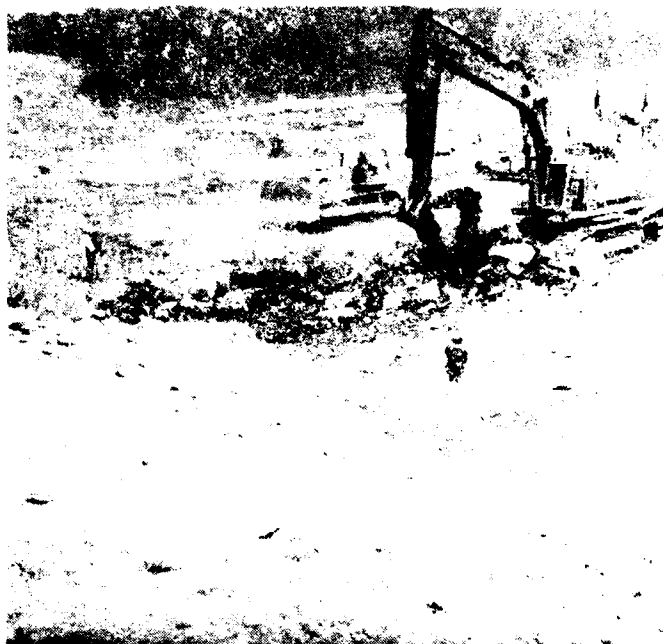
Photo 15a - Excavation of broken material in Moonlith 5 near joint with Moonlith 4. Material has not been blasted (September 1978).
