## Enhanced Preliminary Assessment Report:

Fairfield Army Housing Units  
Fairfield, Connecticut

October 1989

Environmental Research Division  
Argonne National Laboratory  
Argonne, Illinois 60439

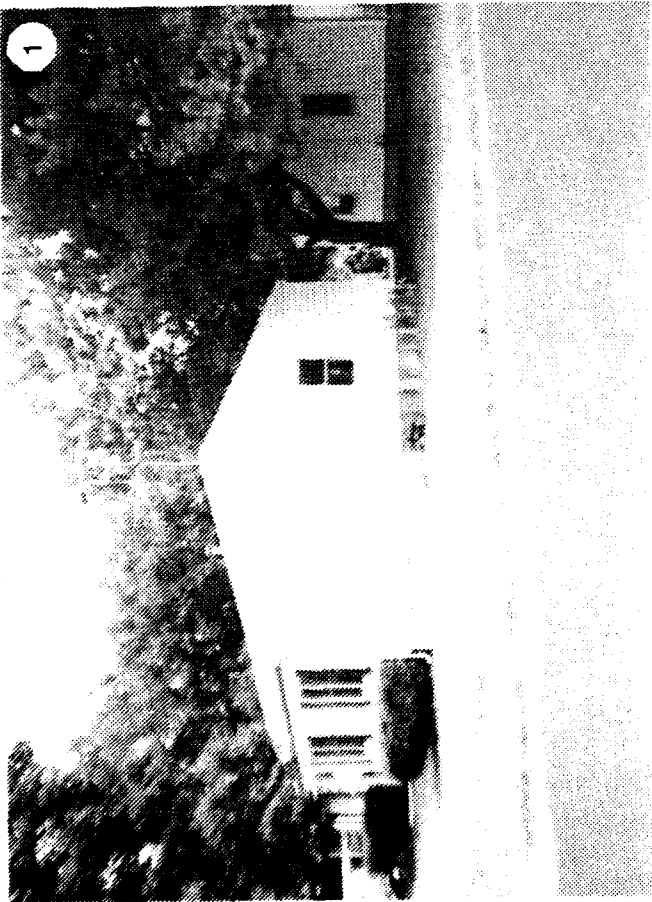
1. Entrance to the housing facility.
2. Capehart-style home.
3. Electrical transformer mounted near the top of a utility pole; transformers are the responsibility of the Fairfield Power Company, with the utility pole erected on government-easement land.
