# Embankment Criteria, Performance, and Foundation Report

**Waco Lake  
Bosque River, Texas  
Brazos River and Tributaries, Texas**

January 1990

SUBJECT: Waco Lake, Texas, Embankment Criteria and Performance Report

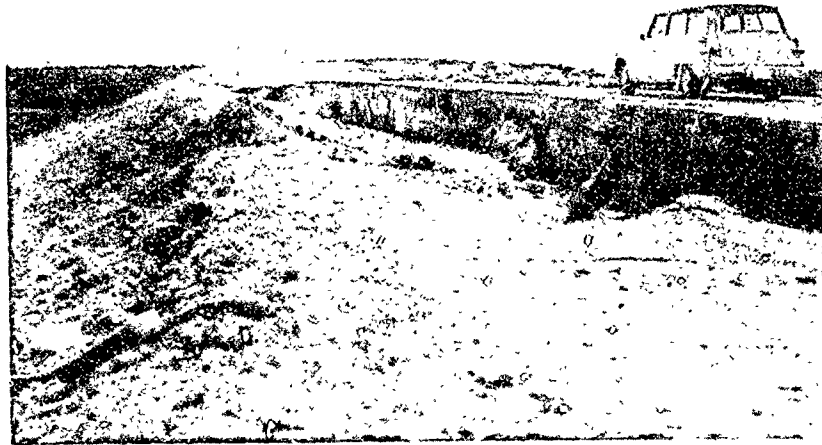
1-05. Foundation Slide. A major slide involving part of the embankment and its foundation occurred in October 1961, during construction of the first major portion of embankment under Contract No. 60-82 (See Plate 47 and Photos 6 and 7). The portion of embankment affected was between Stations 50 and 65. According to the classification system of the U.S. Committee on Large Dams, (ASCE/USCOLD, 1975), the slide was a "Type 3 Accident"; a slump that took place before any water was impounded. A detailed description of the slide is given in paragraph 5.02.

PHOTO 6. Crest of dam, slide area about sta 55+00, Oct 61.

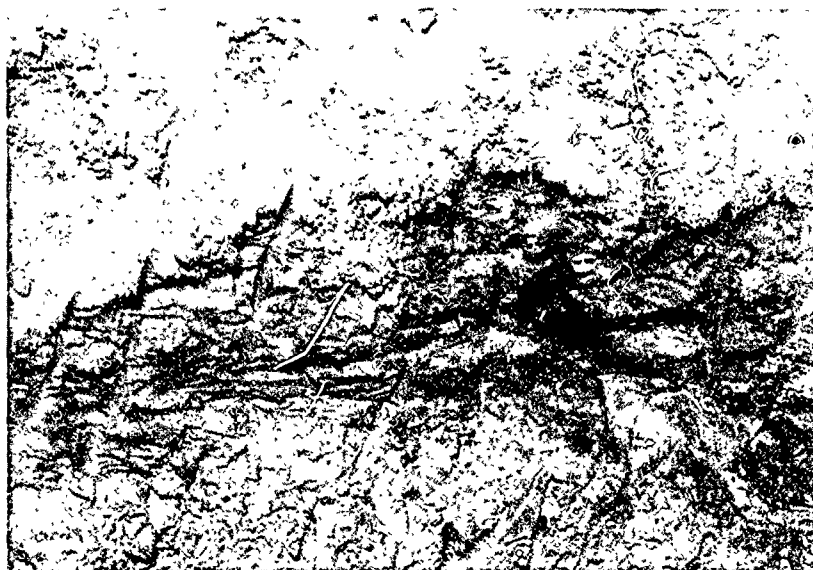
PHOTO 8. Pepper shale/Del Rio shale contact in inspection hole at sta 58+60.

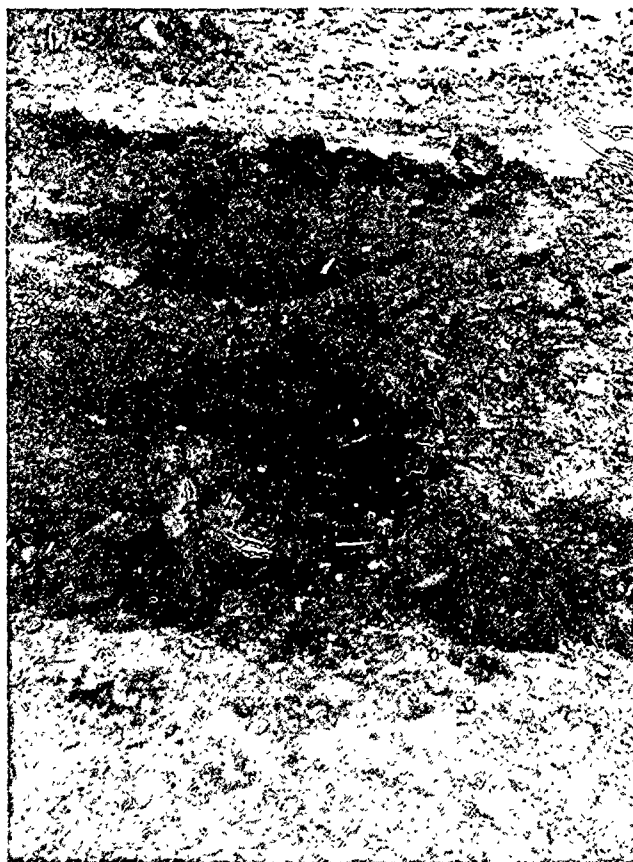
PHOTO 9. South Fault in South Fault trench excavation, downstream. Pepper shale on left against Eagle Ford shale on right.

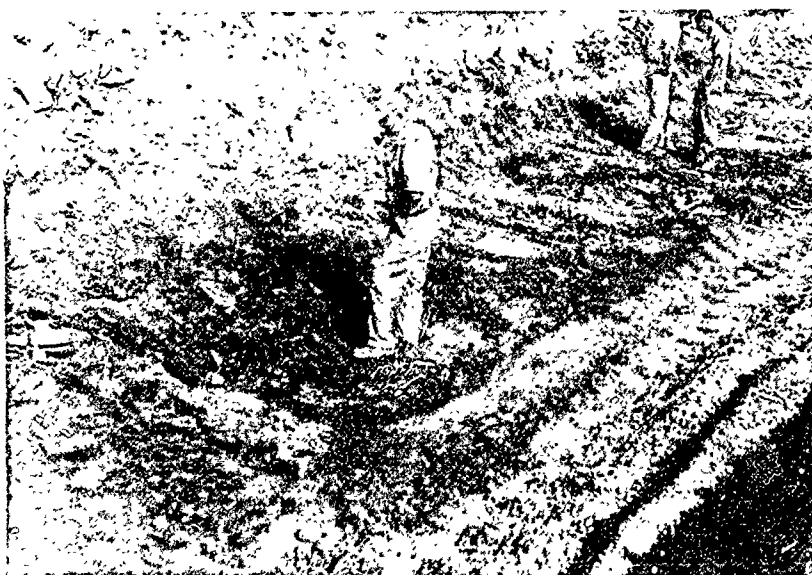
PHOTO 11. Upturned Eagle Ford shale on the down-thrown side of the South Fault in the upstream fault excavation.

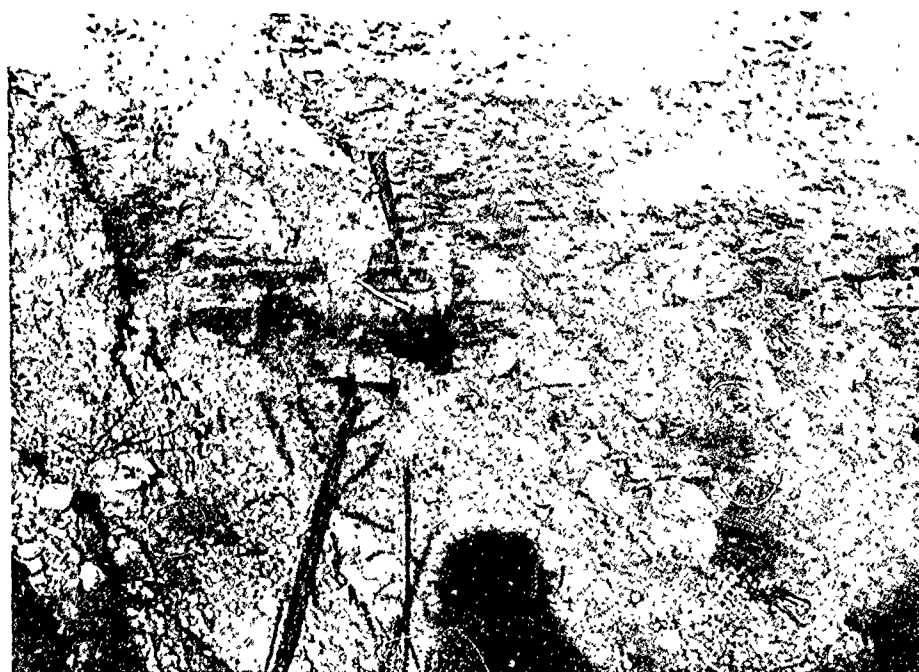
PHOTO 13. Oxidized sandstone seam in the Pepper shale  
in the middle inspection trench 1100 feet  
D/S from dam axis station 55+00.

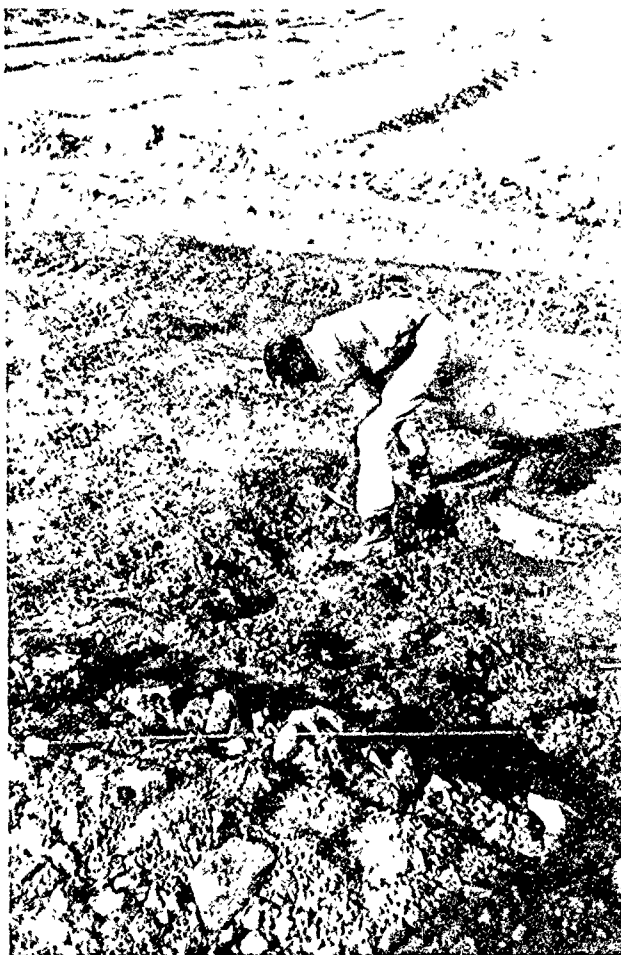
| <u>Exhibit</u> | <u>Photo No.</u> | <u>Title</u> |
|---|---|---|
| 8 | 14 | Eagle Ford shale (left)/overburden contact in the embankment foundation; vicinity of station 20+00 on centerline. |

PHOTO 14. Eagle Ford shale (left)/overburden contact in the embankment foundation; vicinity of station 20+00 on centerline.

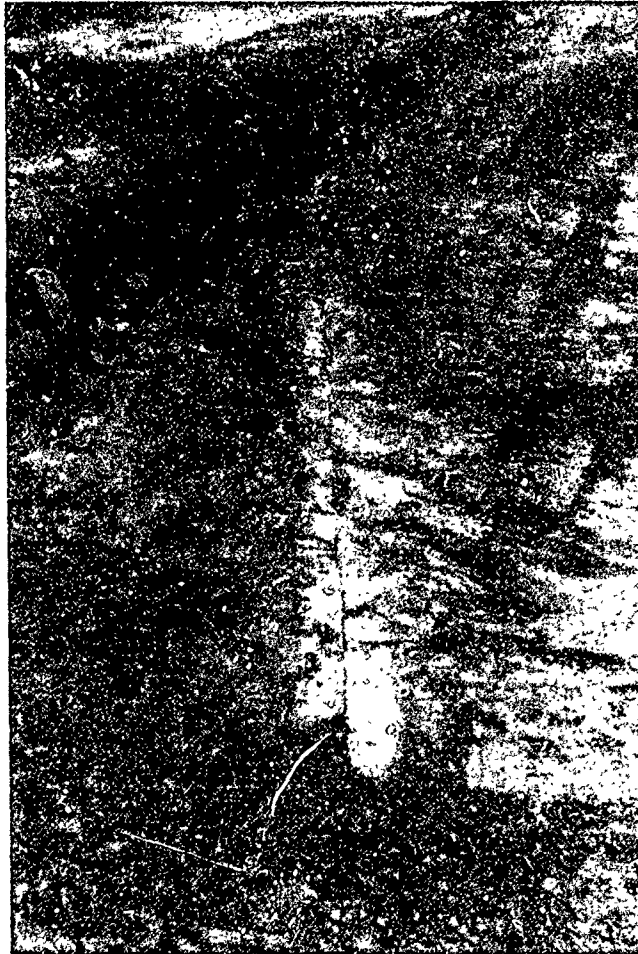
| <u>Exhibit</u> | <u>Photo No.</u> | <u>Title</u> |
|---|---|---|
| 9 | 15 | Vertical joint with weathering halo in the Eagle Ford shale; embankment foundation about station 32+00, D/S. |

PHOTO 15. Vertical joint with weathering halo in the Eagle Ford shale; embankment foundation about station 32+00, D/S.

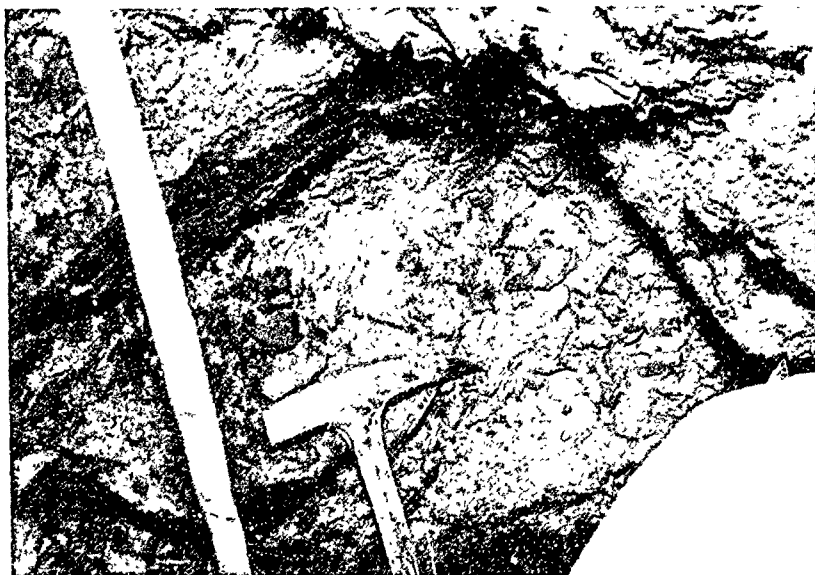
| <u>Exhibit</u> | <u>Photo No.</u> | <u>Title</u> |
|---|---|---|
| 10 | 17 | Slickenside 2-1/2 feet below and nearly paralleling the failure plane in inspection hole sta. 58+20. |

PHOTO 17. Slickenside 2-1/2 feet below and nearly paralleling the failure plane in inspection hole sta 58+20.
