WRDC-TR-89-4112

COMPUTER TOMOGRAPHY OF ELECTRONICS

Boeing Aerospace Company  
P. O. Box 3999  
Seattle WA 98124

Interim Report For Period August 1988 - May 1989

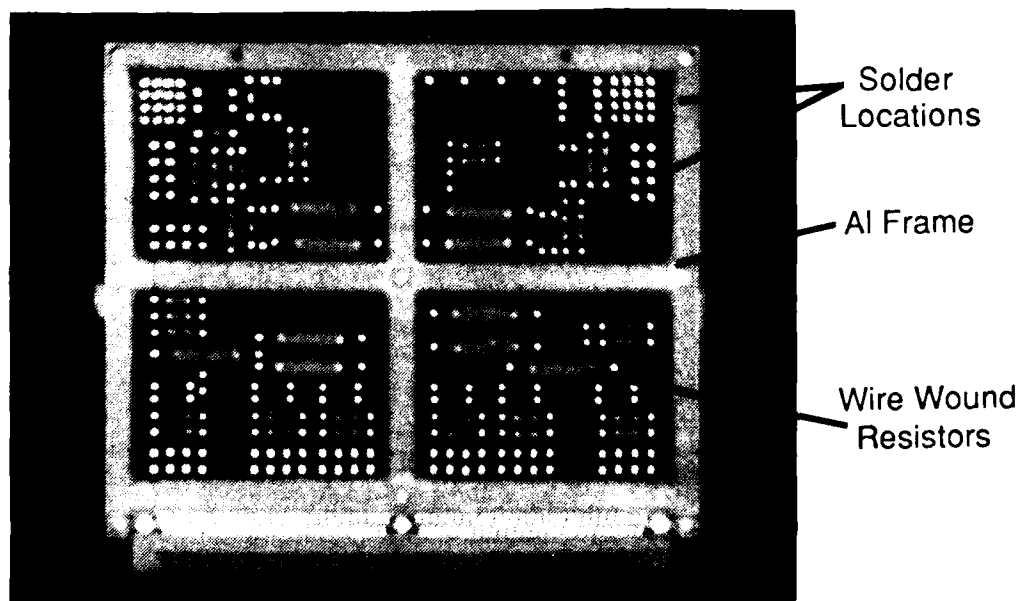
Figure 3.2-3 CT scan of the Figure 3.2-2 circuit board from System A showing solder locations

Figure 3.2-3 shows a scan that was taken at the upper plane level of the board on System A with a 1.5 mm (0.060 inch) slice thickness. This image is free of major streak artifacts, considering the high aspect ratio of the board the aluminum frame and several high Z solder locations. The system does not have the resolution to identify details about the solder locations like voiding, cracking and solder balls.

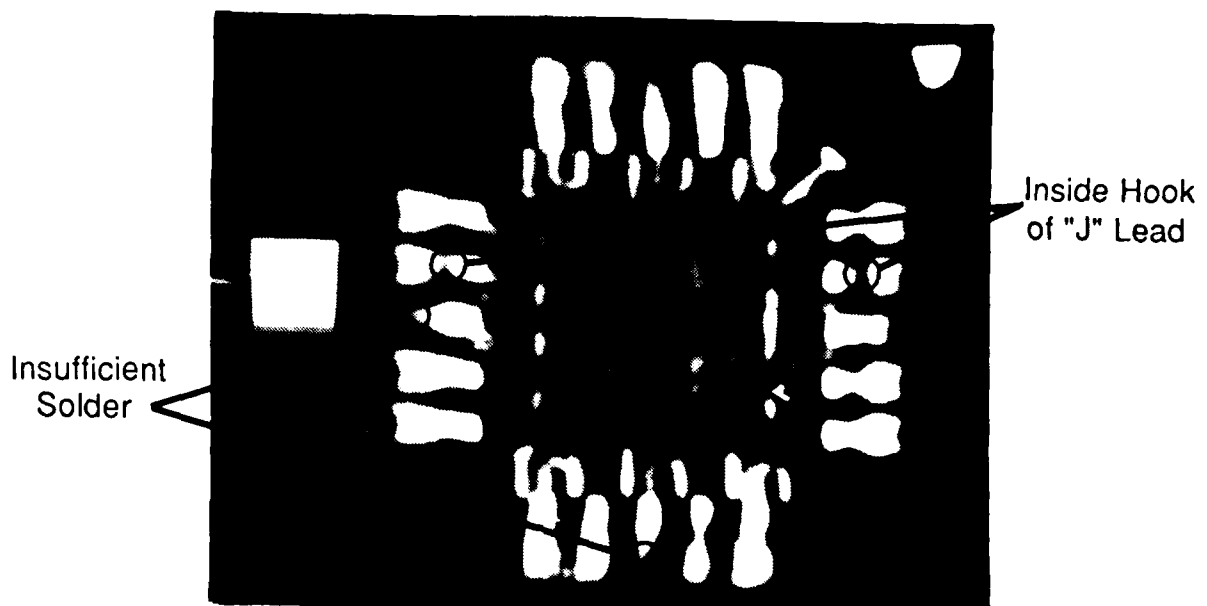
Figure 3.2-8 Enlarged image of top LCC in Figure 3.2-7 from System B

identify voiding and cracking of solder. Using the image analysis capabilities of System B, the top LCC was enlarged in software and is shown in Figure 3.2-8. Note the differences in the amount of solder contained on the pads.

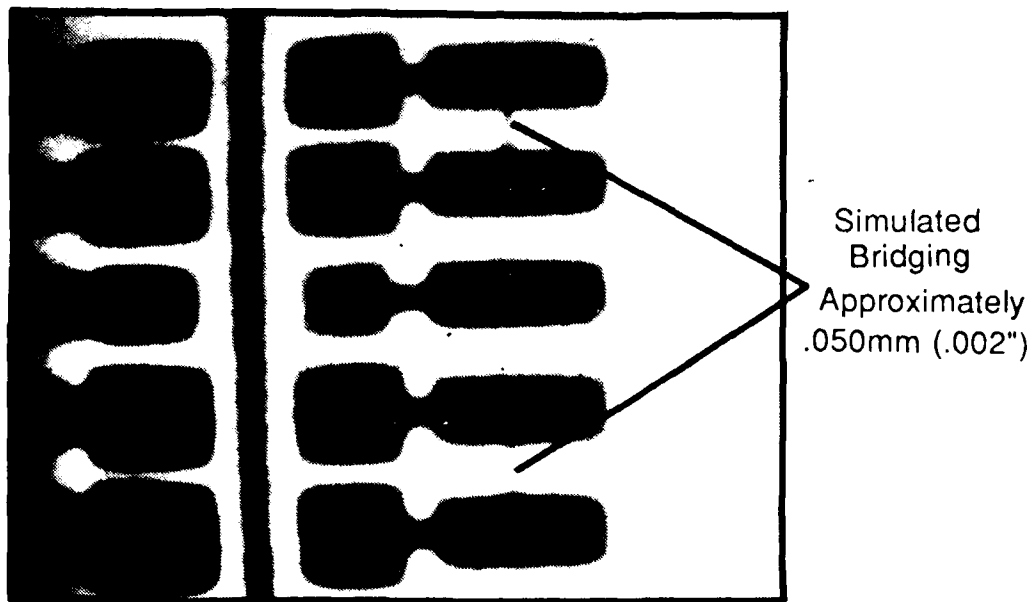
Figure 3.2-10 Laminogram showing bridging from System G

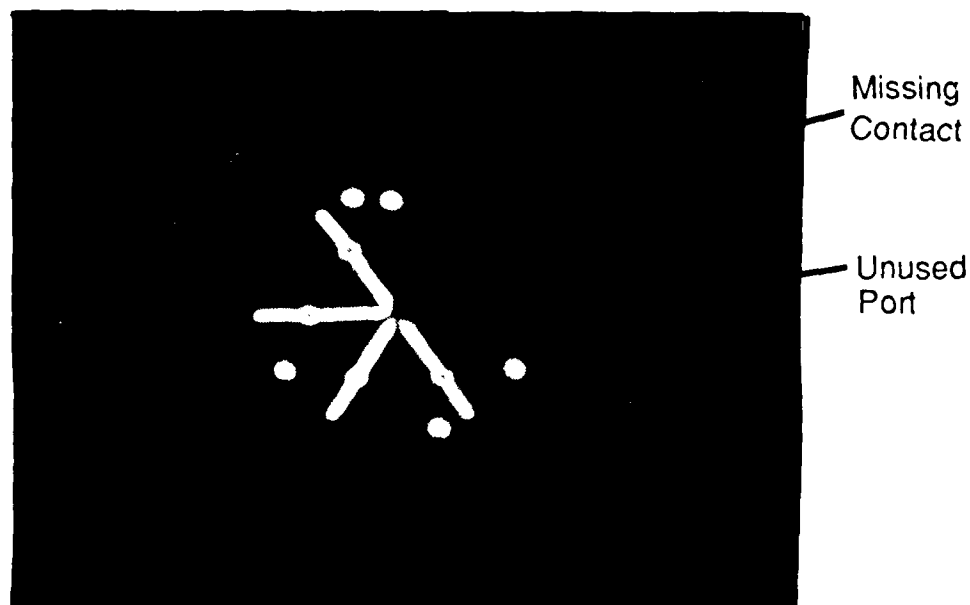
Figure 3.3-10 CT scan of the Figure 3.3-8 RF relay showing 4 good contacts from System E

Figure 3.3-9 is an exploded view drawing of the relay. A scan taken on System E, shown in Figure 3.3-10, shows 4 good contacts and one missing (the relay has 5 good contacts, as seen in Figure 3.3-9). Figure 3.3-11 identifies the defective contact, which might be difficult to determine using destructive analysis due to the contact size and orientation within the stainless steel enclosure.

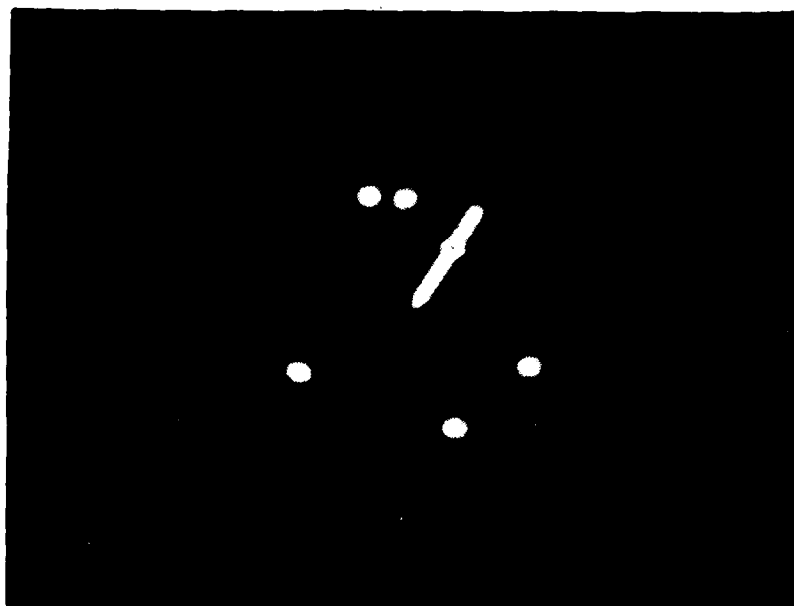
Figure 3.3-11 CT scan of the Figure 3.3-8 RF relay showing bad contact from System E

Although one might recommend an electrical functional test to identify which pole is faulty, it would be more time consuming to determine whether the fault is in the electromagnet, springs, insulators, contacts, or connectors. These images clearly indicate that the problem is mechanical. CT analysis could be used by Receiving and Inspection to return the component to the vendor before any production and testing costs were incurred. Another option is to conduct an electrical test in conjunction with CT scanning to better isolate the fault.

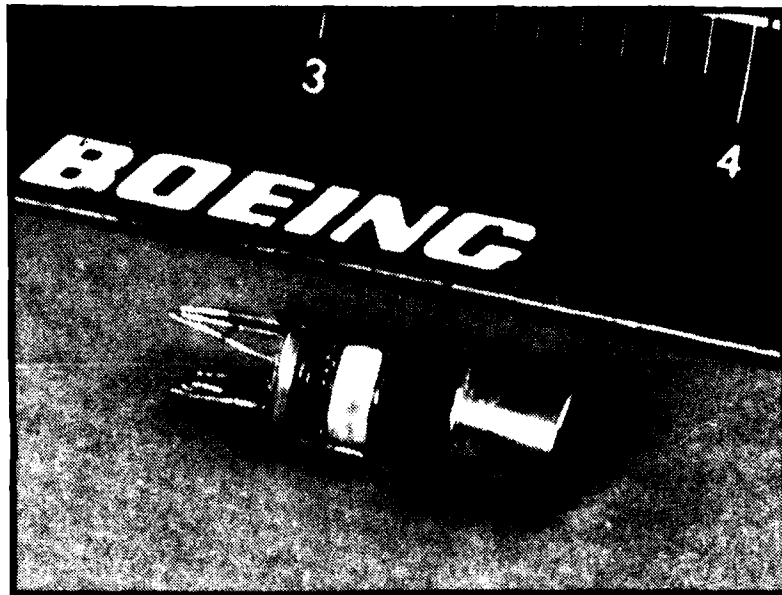
Figure 4.2-2 Relay analyzed by failure analysis

are questionable as to whether the information is worth the expense. The relay example of Figure 4.2-1 was scanned on System B to identify the welded contact, and while the resolution failed to clearly distinguish the welded contacts (the contacts are approximately 0.4 mm [0.016 inch] thick), analysis of the scans inferred that there was a weld.
