**Task Order 2  
Enhanced Preliminary Assessment**

**BENNETT ARMY  
NATIONAL GUARD FACILITY  
DENVER, COLORADO**

January 1990

USATHAMA Task Order 2  
ENHANCED PRELIMINARY ASSESSMENT REPORT  
BENNETT ARMY NATIONAL GUARD FACILITY  
DENVER, COLORADO

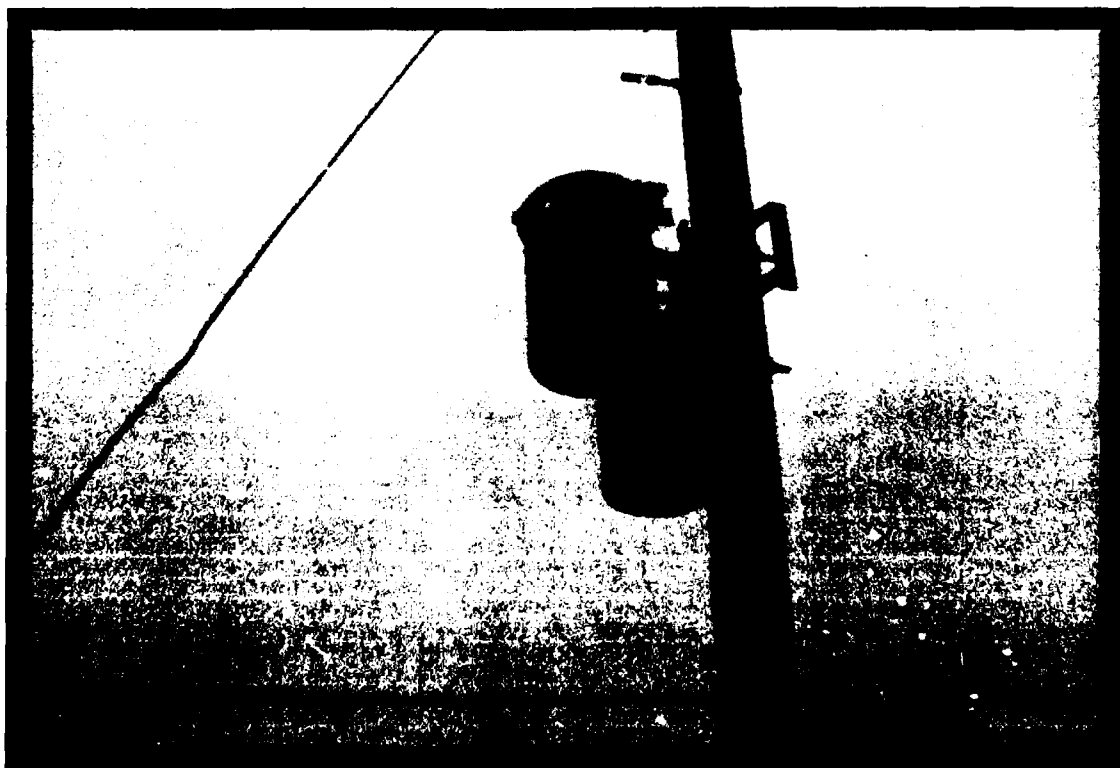
**5. TRANSFORMERS**

There are two pole-mounted transformers at the site. Both units have been severely damaged and are marked with numerous bullet holes. Presumably, most of the dielectric fluid has escaped (see photo 5). Given the age of the facility, it is possible that both may have contained polychlorinated biphenyls (PCBs).

It is expected that the fluid that leaked from the damaged transformers has seeped into the ground. No staining was visible. Some residual fluid may still be present on interior surfaces of the transformers.
