**Task Order 2  
Enhanced Preliminary Assessment**

**DEFENSE MAPPING AGENCY (DMA)  
HERNDON, VIRGINIA**

December 1989

Roy F. Weston, Inc.  
West Chester,  
Pennsylvania 19380

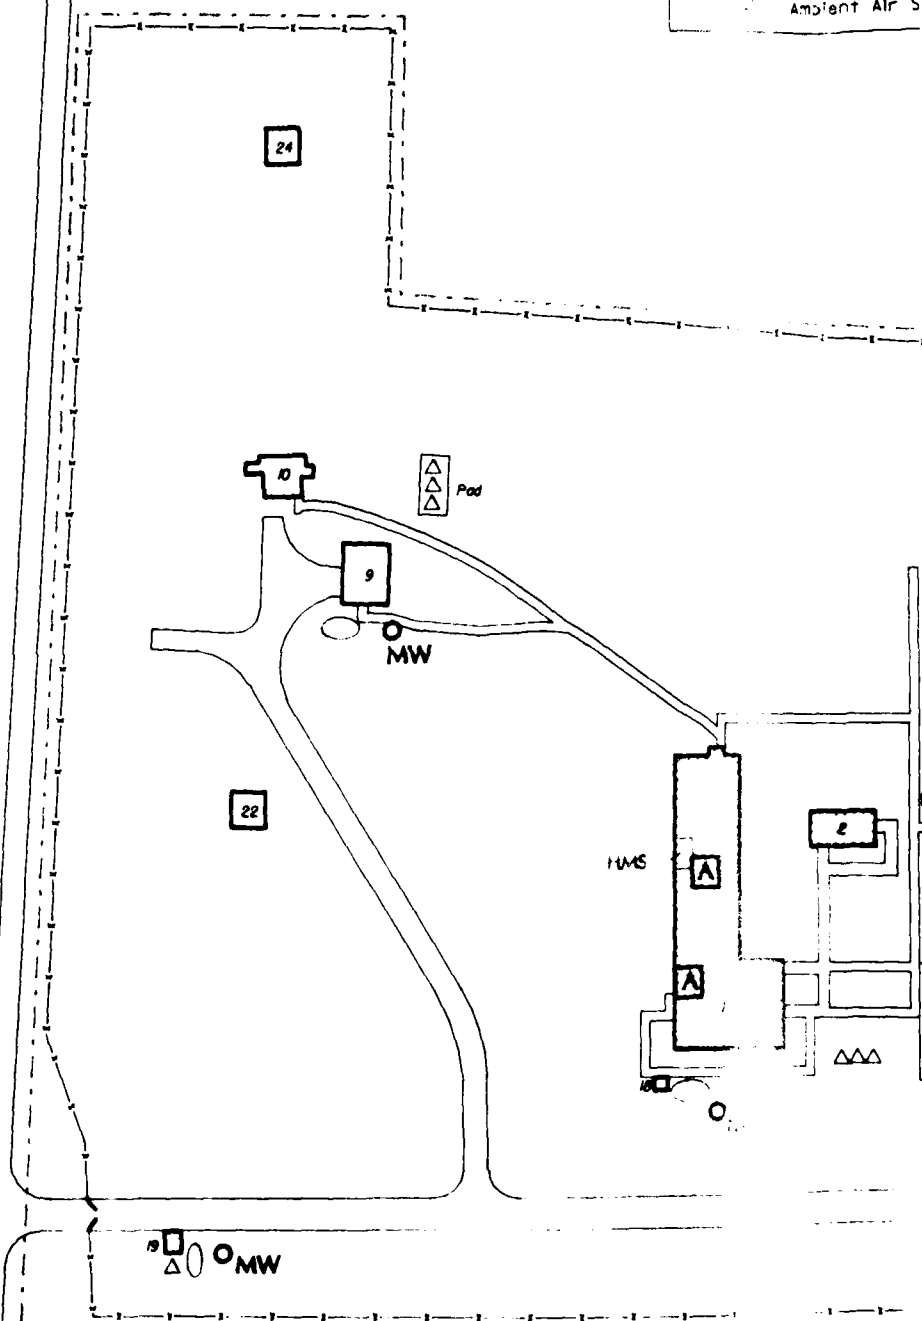
Figure ES-1  
Property Information  
Composite

No environmental conditions were observed on the DMA property that appear to present an immediate substantial threat to human health or the environment. However, the ESOs discussed in Section 3 have the potential to affect human health or the environment. The recommendations concerning each item follow and are summarized in Table ES-1. Recommended sampling locations are shown in Figure ES-1.

The former paint/oil storage shed could have been a source for a release of hazardous materials to the environment. Surface soil samples should be taken in the area after the location of the shed has been determined.

The condition of electrical transformers should be monitored to ensure their continued integrity. However, the condition of the transformers is not a major concern due to their low PCB content.

Two soil borings should be dug adjacent to and downgradient of the sewage filter bed. One soil sample from each boring, at a level approximately 2 ft below the bottom of the filter bed, should be collected and analyzed for VOCs. A monitor well should be installed in one of the soil borings and a groundwater sample taken and analyzed for VOCs. This work will confirm whether past practices involved the disposal of hazardous materials via the septic system.

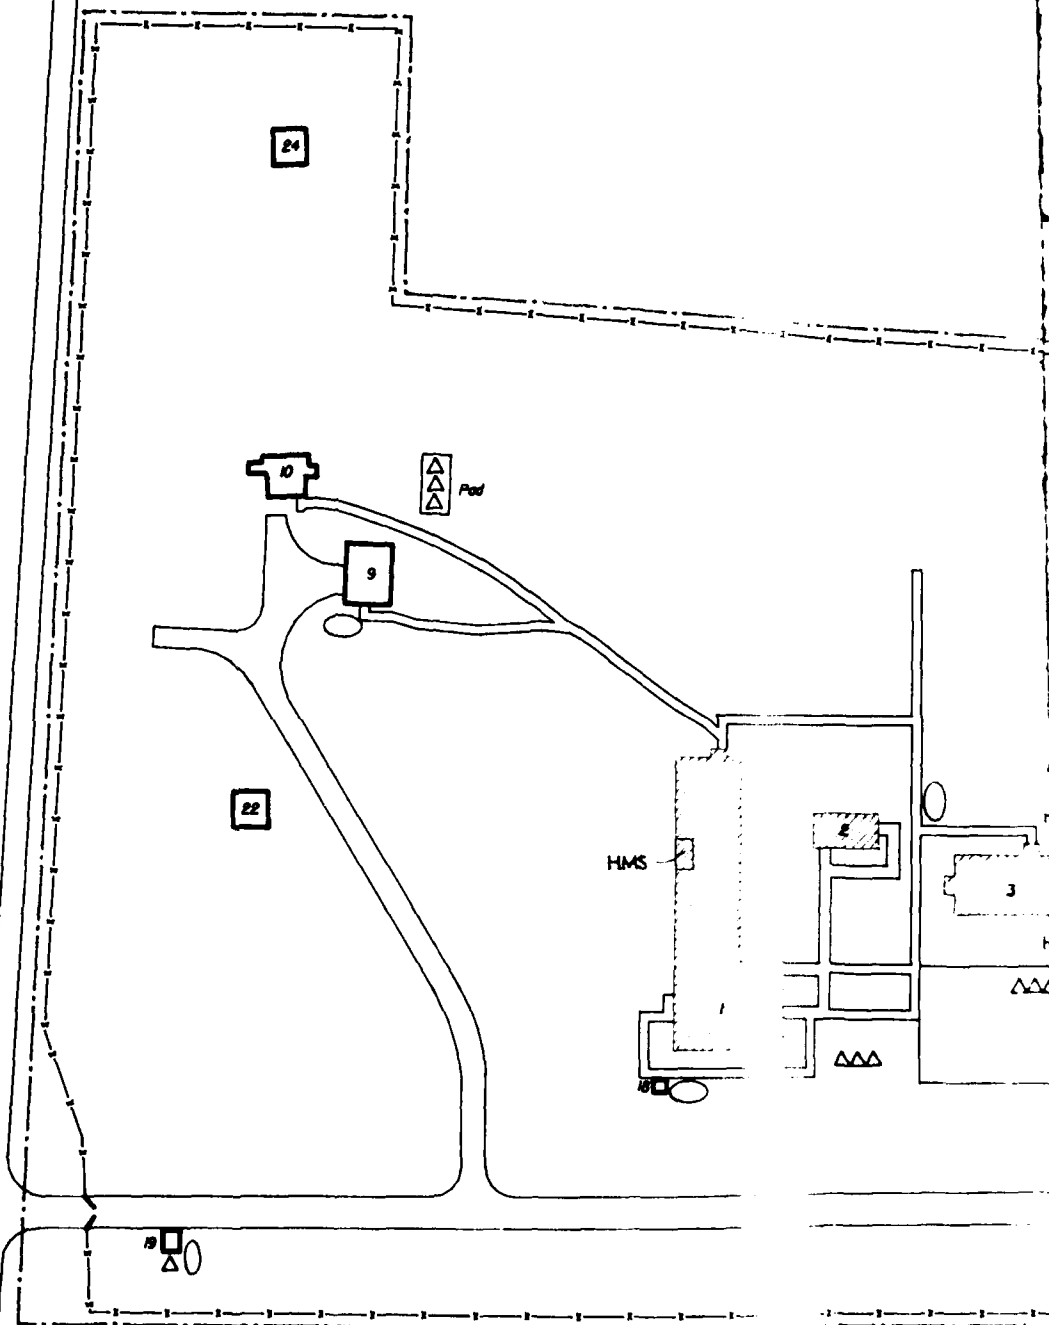
Figure 3-1  
Environmentally Significant  
Operations

- Underground storage tanks.
- Hazardous materials storage and solvent handling and use.
- Asbestos in structures.
- Electrical transformers.
- The septic system.
- Use of pesticides and herbicides.

The two tanks at Buildings 3 and 4 could not be effectively leak tested and there was some breakage or corrosion associated with the fill pipes. Accordingly, there is a possibility that underground storage tanks on the facility may have released some of their contents to soils.

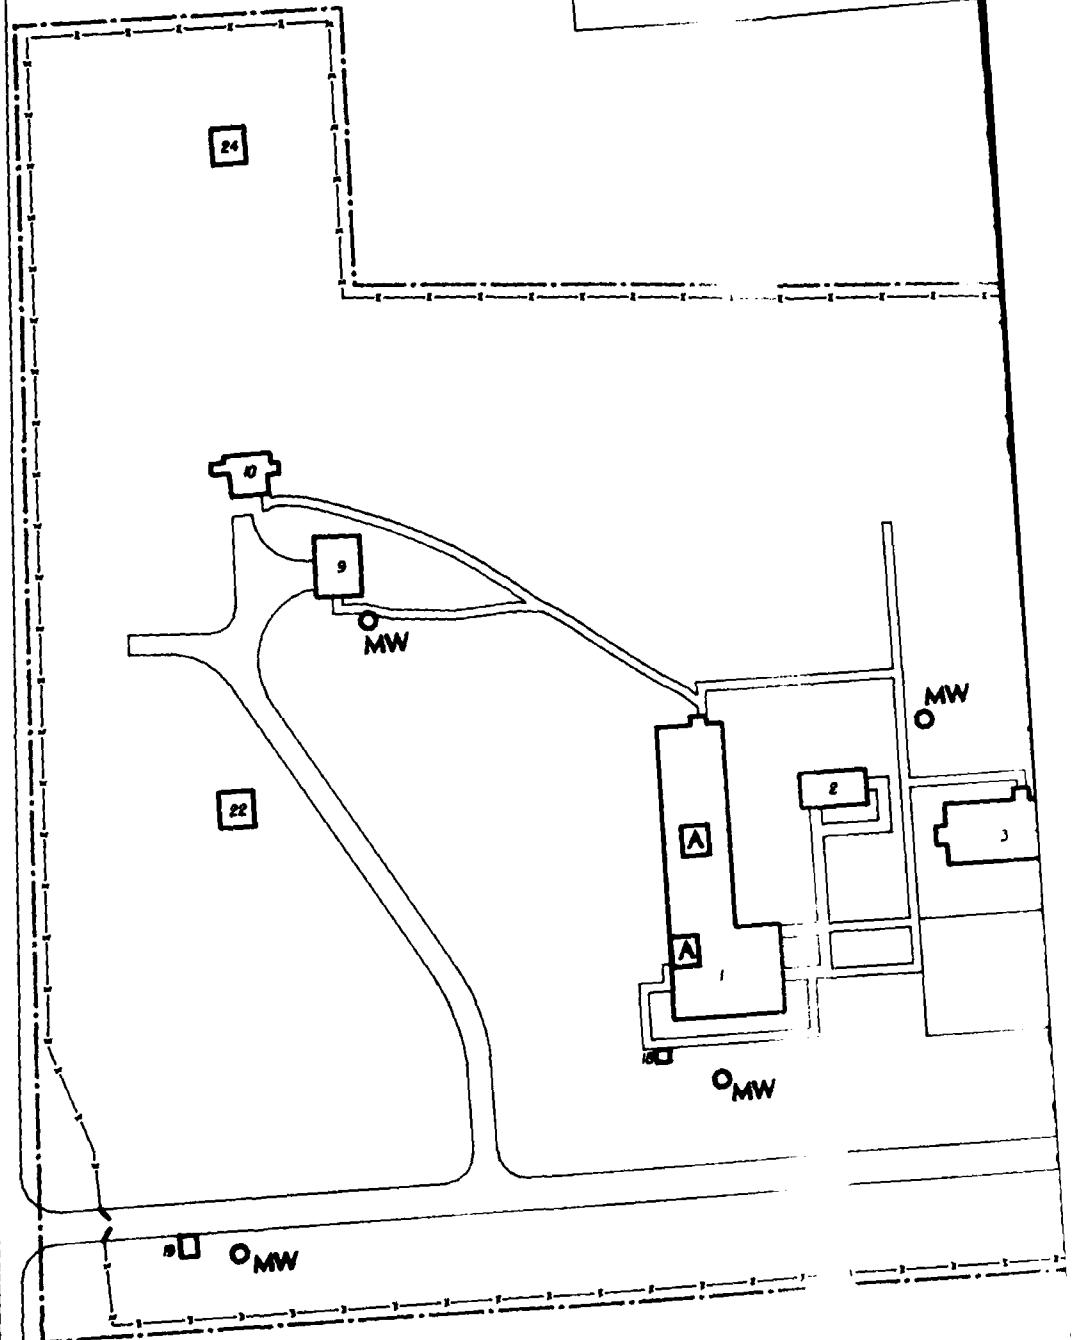
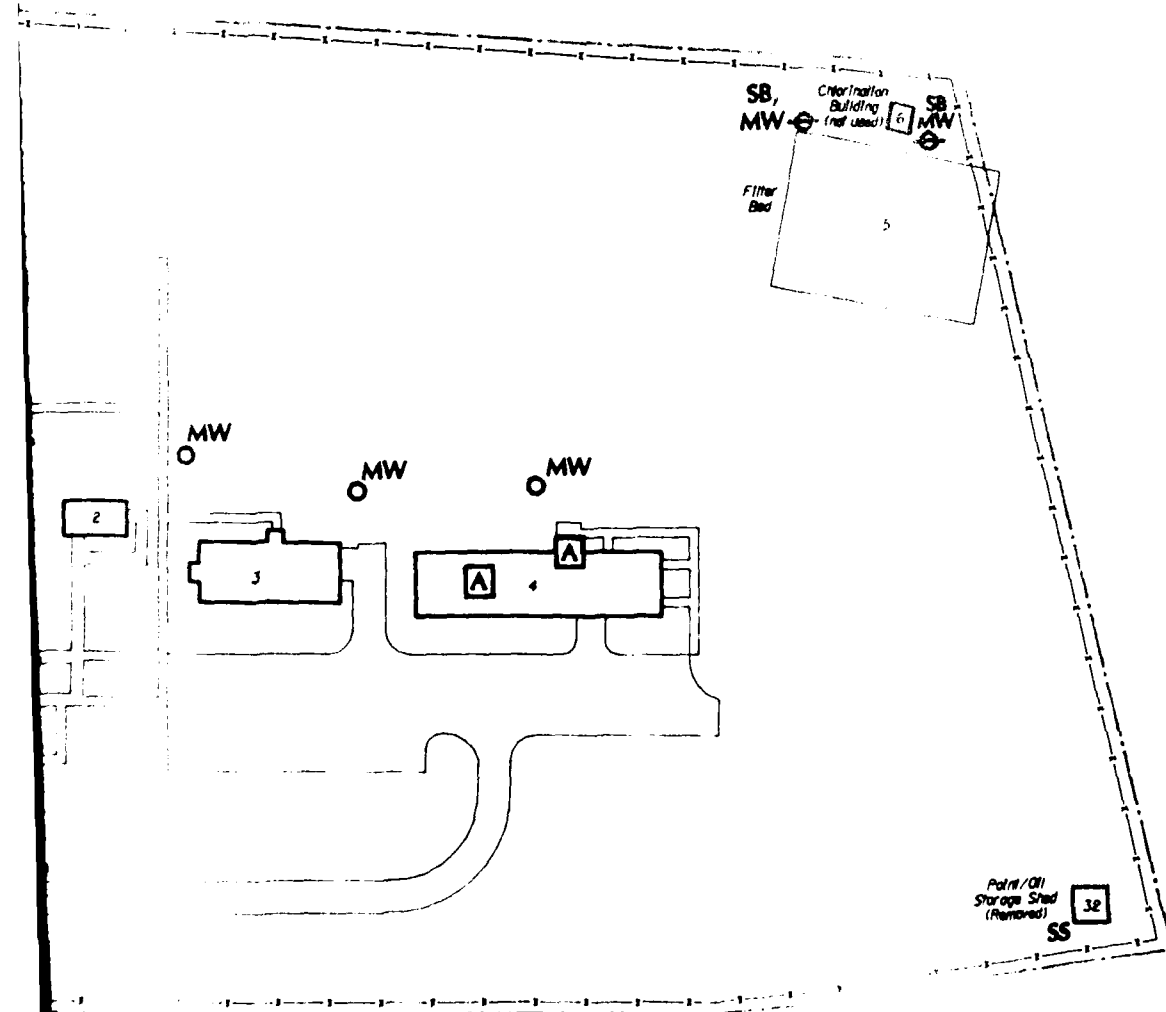
## Figure 5-1 Recommended Sampling Locations

No conditions were observed on the property that appear to present an immediate substantial threat to human health or the environment. However, the ESOs discussed in Section 3 have the potential to affect human health or the environment. The recommendations concerning each ESO follow and are summarized in Table 5-1. Recommended sampling locations are shown in Figure 5-1.

The former paint/oil storage shed could have been a source for a release of materials to the environment. Surface soil samples should be taken in the area after its former location has been determined in the field.

Asbestos materials should be maintained in good condition. Indoor ambient air monitoring should be conducted in the Building 1 boiler room and work area and the Building 4 boiler room and work area to confirm that no asbestos material is being released.

The condition of electrical transformers should be monitored to ensure their continued integrity. However, the condition of the transformers is not a major concern because of their low PCB content.

Two soil borings should be dug adjacent to and downgradient of the sewage filter bed. One soil sample from each boring, at a level approximately 2 ft below the bottom of the filter bed, should be collected and analyzed for VOCs. A monitor well should be installed in one of the soil borings and one groundwater sample taken and analyzed for VOCs. This work will confirm whether past practices involved the disposal of hazardous materials via the septic system.
