Aircraft Structures Technical Memorandum 515

FLUTTER INVESTIGATIONS ON A TRANSAVIA  
PL12/T-400 AIRCRAFT (U)

A. GOLDMAN, C.D. RIDER and P. PIPERIAS

JULY 1989

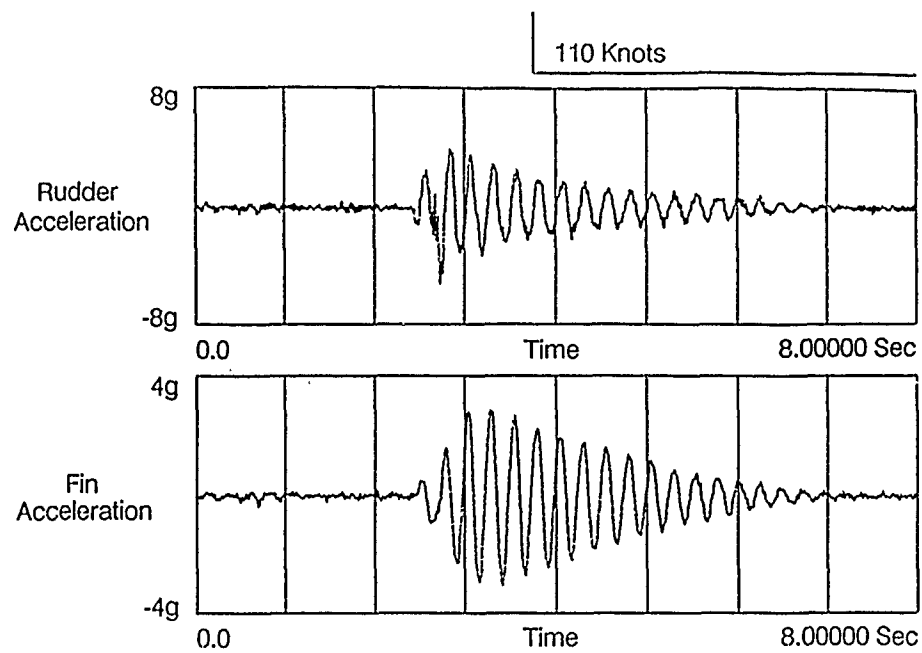
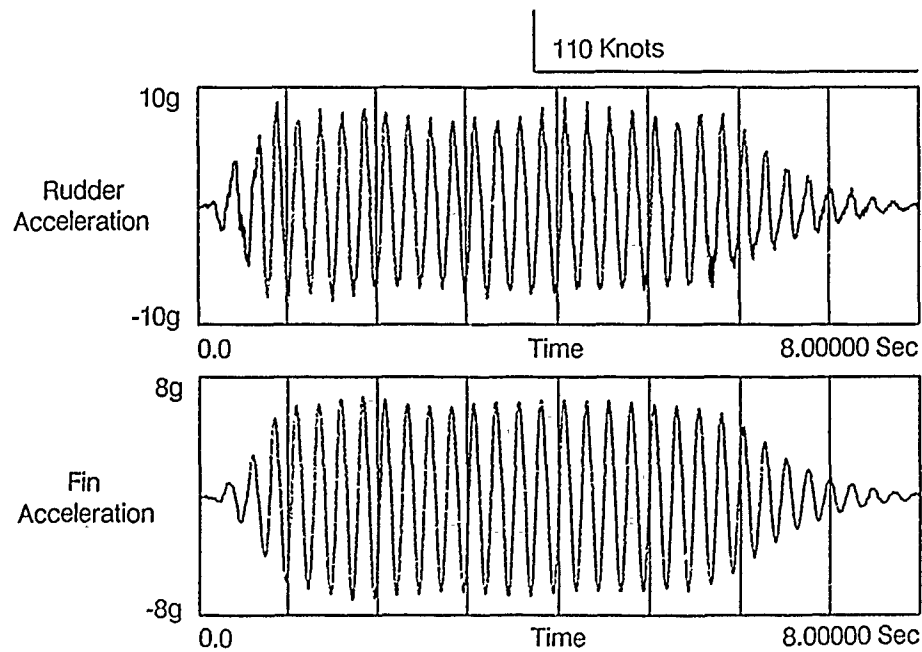
FIG 3. FLIGHT AT 110 KNOTS WITH INADEQUATE MASS BALANCE

Figure 3 shows the recorded data at 110 knots from the accelerometers on the fin and rudder. The amplitude indicated is acceleration measured in units of "g", "g" being the acceleration due to gravity and approximately equal to 9.8 metres/sec<sup>2</sup>. The displacement is readily derived knowing that the frequency is approximately 4 Hz. The relationship between acceleration and displacement is:-

The upper two traces show that the rudder oscillations applied, corresponding to 120 millimetres peak-to-peak amplitude measured at the trailing edge, were inadequate to overcome the frictional damping. When the applied amplitude exceeded 250 millimetres, the oscillations became self-sustaining as shown by the two lower traces.

In Figure 3 it will be seen that it required a considerable input on the rudder to initiate a self-sustaining flutter. The amplitudes indicated on Fig. 3, and all other similar figures are in acceleration units.

Using the relationship shown in para. 3 it will be seen that it was necessary to oscillate the rudder through more than 250 mm peak-to-peak amplitude measured at the trailing edge. In the upper two traces of Figure 3 it will be seen that an amplitude of approximately 120 mm was inadequate excitation.

The flight tests were suspended pending further investigations of the adequacy of the mass balance system.

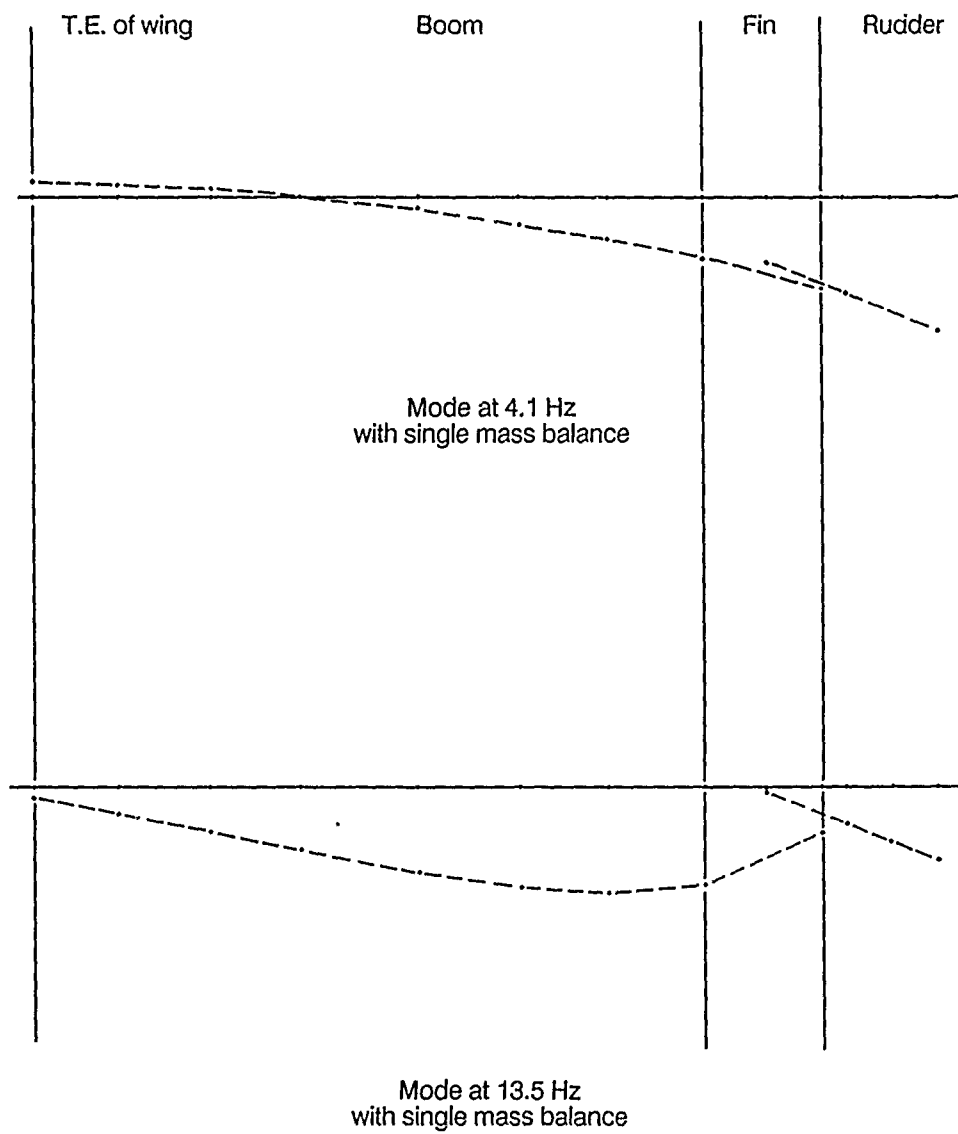
FIG 4. LATERAL MODES OF VIBRATION

In order to evaluate the effectiveness of the mass balance weights attached to the rudders, a ground vibration test was undertaken. This demonstrated that the zero static balance was insufficient to prevent the rudder from moving in the wrong direction when subjected to large amplitude vibrations in the lateral direction at the boom bending frequency.

Figure 4 shows the two mode shapes of concern.

An additional mass of approximately 500 gms was attached to the existing mass to correct this deficiency. The change in lateral bending frequency in the fundamental mode was not detectable. The frequency of the second lateral bending mode also remained constant at 13.5 Hz. However, the resonant frequency of the mass balance arm itself was measured at 14 Hz vertically and 16.6 Hz horizontally. This was considered to be too low as there was some concern about the effectiveness of the mass balance in controlling the mode at 13.5 Hz, and a resonant frequency of 16.6 Hz in the mass balance arm could possibly cause problems. The requirement is that the frequency be at least 1.5 times the highest frequency that it may couple with (Ref. 2).

A redesign of the mass balance system was suggested using two concentrated masses on stiffer arms placed on opposite sides of the rudder. On fitting the redesigned mass balanced rudder, the modal analysis indicated that the nodal line of the 13.5 Hz mode was still aft of the rudder hinge and the rudder would operate to attenuate the mode.

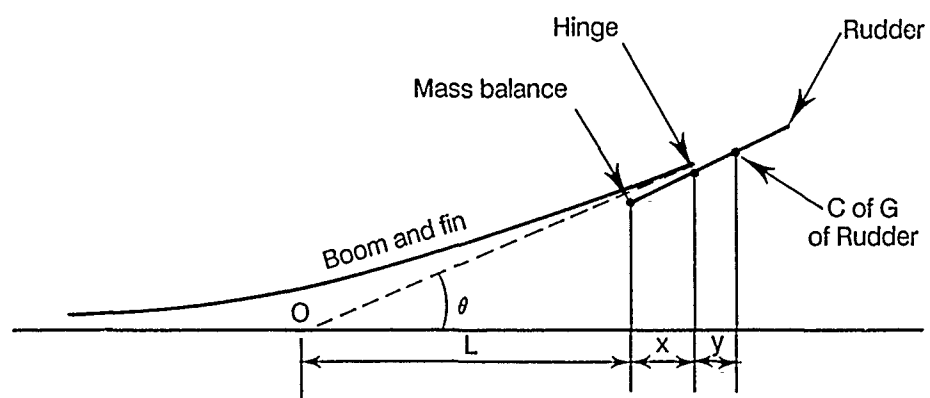
FIG 6. BENDING MODE AT 4 Hz

For dynamic balance of the inertia forces it is necessary to consider the acceleration experienced by the mass balance and the control surface, (Ref. 3). Referring to Figure 6, which represents the first bending mode of the tail boom, it will be seen that, for dynamic balance, the inertia force on the massbalance weight will need to equal the inertia force on the rudder.

The acceleration experienced by each component is approximately proportional to the distance of the centre of gravity of each from the centre of rotation of the mode under consideration.

If  $L$  is large, at least 10 times, compared with  $x$  and  $y$  the static balance is satisfactory. In this case, the centre of rotation of the rudder hinge is such that  $L$  is approximately 4 times  $x$  or  $y$ . Hence the need to consider the mode shape when balancing control surfaces.

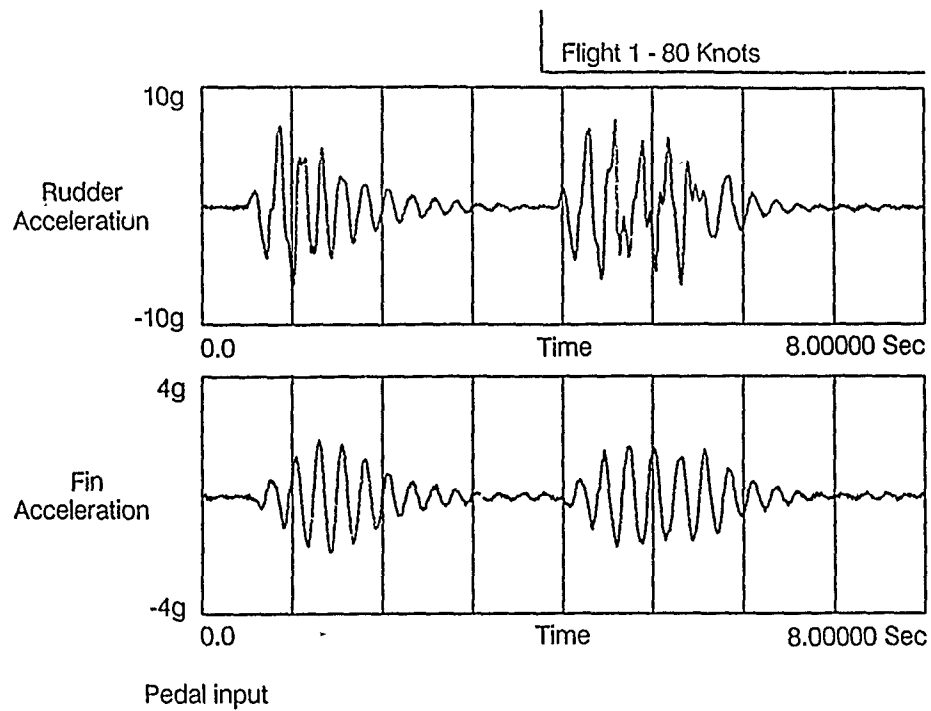
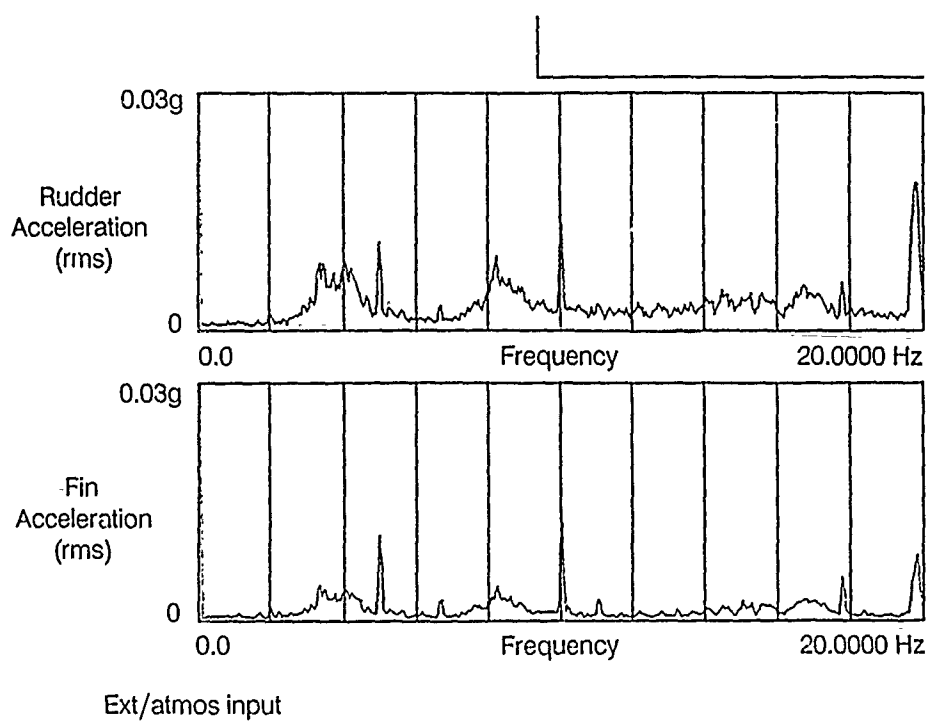
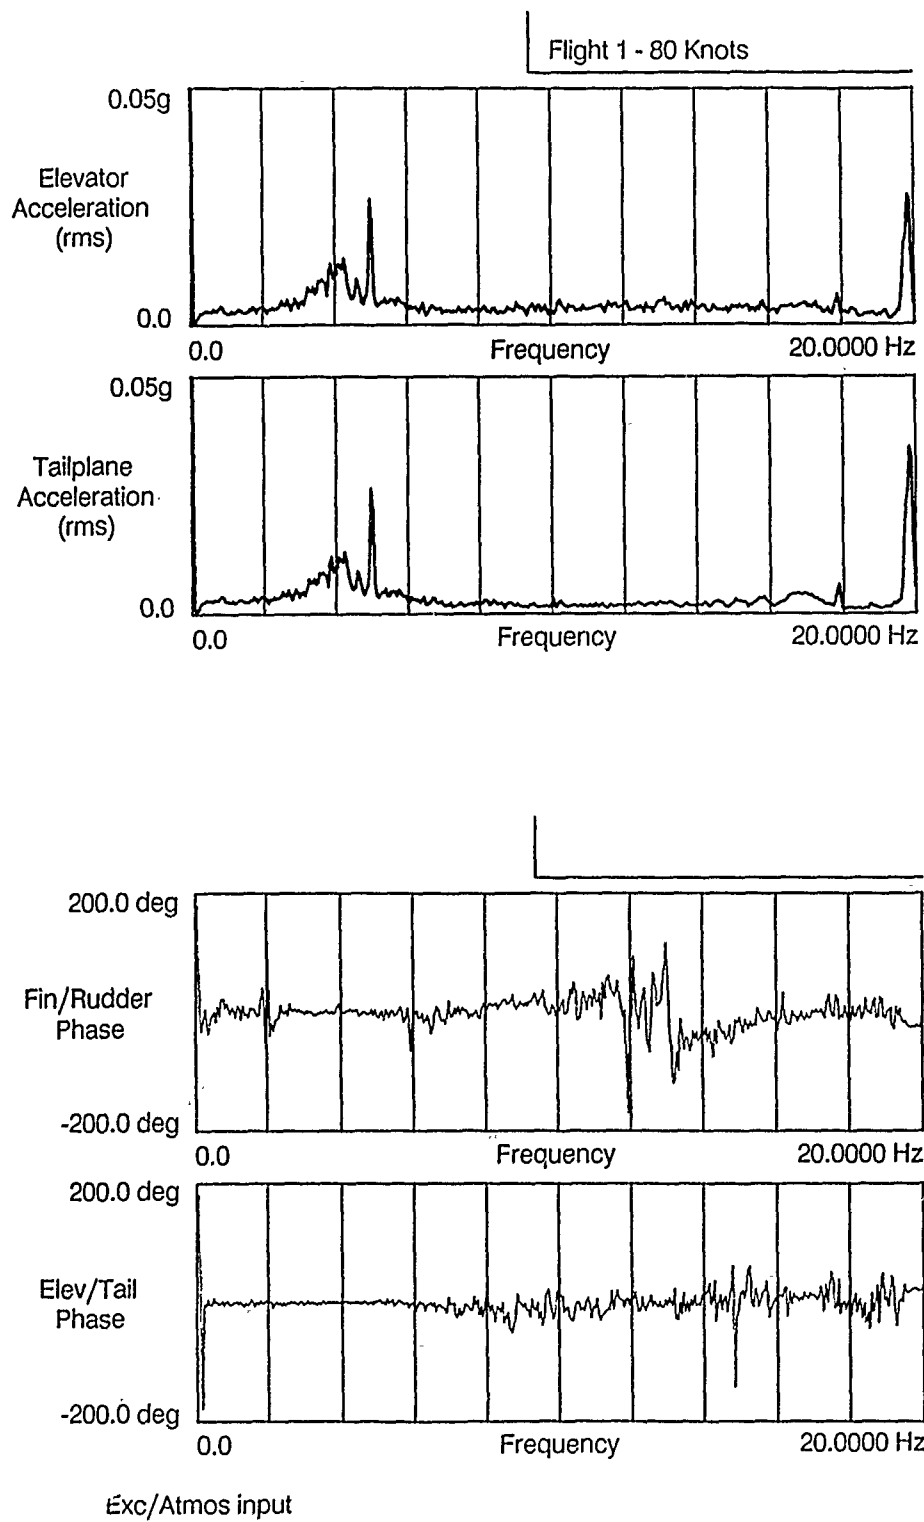
FIG 7a. FLIGHT 1 - 80 KNOTS

Following the fitting of adequate mass balance to the rudder, it will be seen from Figures 7 to 11 that it was not possible to excite this mode of flutter with rudder oscillations up to 800 mm in amplitude. These amplitudes, of course, are in absolute terms and include the fin motion.

The large response, measured at most locations and test points, at a frequency of approximately 5 Hz, is a mechanical vibration originating at the engine. The vibration is non-sinusoidal as it also gives rise to the harmonics at 10, 15 and 20 Hz.

At no speed was there any indication of a mode of vibration becoming unstable or losing damping. The phase relationship between the fin and rudder shows some undesirable features around 13 Hz in flights 1 to 3 and again in flight 9. However, the associated vibration levels are so low that it is not considered to be a reliable indicator of a problem. That the exciter operated sufficiently to shake the structure was confirmed by the pilot's observation. The response to the exciter is only a fraction of that excited by the pilot's pedal operations at the lower speeds. However, it does indicate that the turbulence present in the atmosphere was equal to
