## Task Order 2 Enhanced Preliminary Assessment

KAPALAMA MILITARY RESERVATION  
HONOLULU, HAWAII

ENHANCED PRELIMINARY ASSESSMENT REPORT

Kapalama Military Reservation  
Honolulu, Hawaii

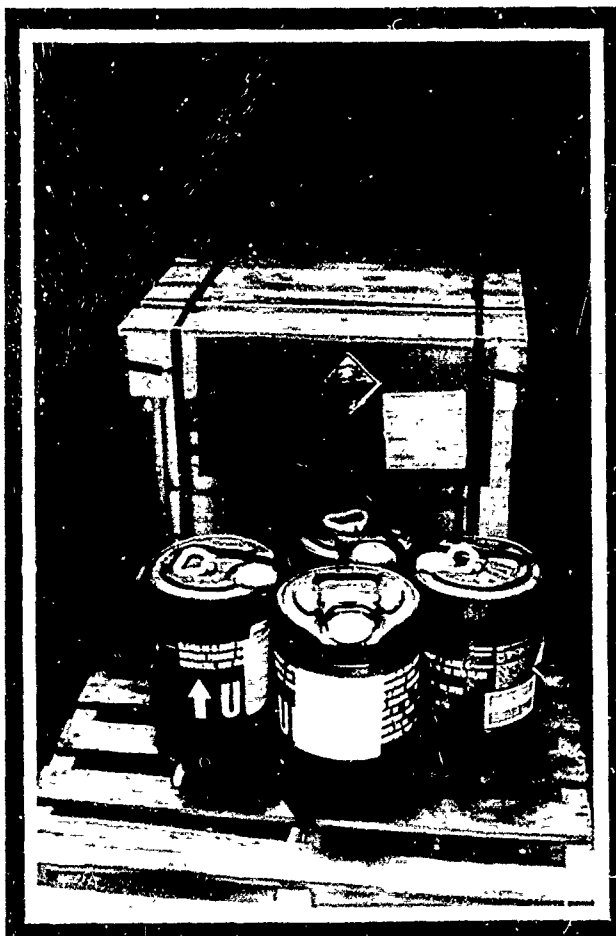
11. Battery Acid

**CONTENTS OF BUILDING 917**

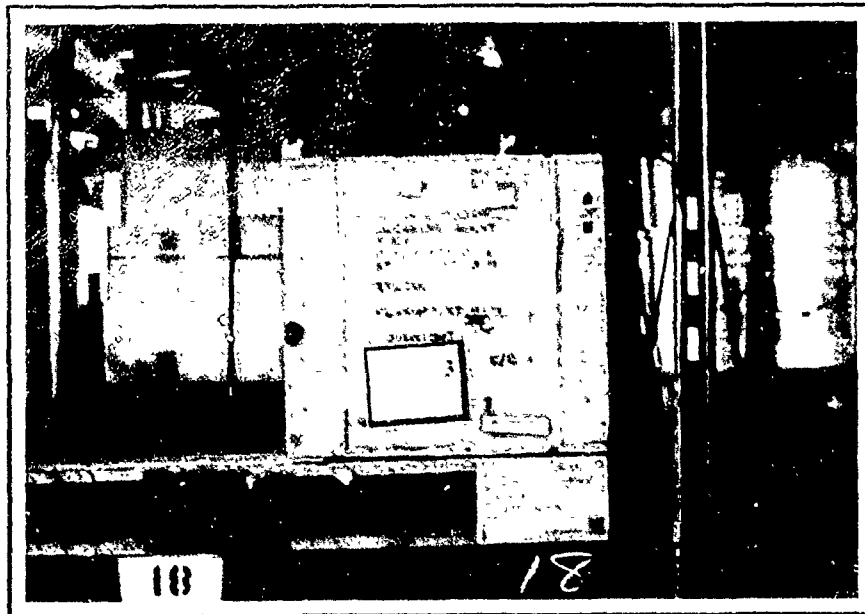
13. Aromatic Solvents

CONTENTS OF BUILDING 917 (CONTINUED)

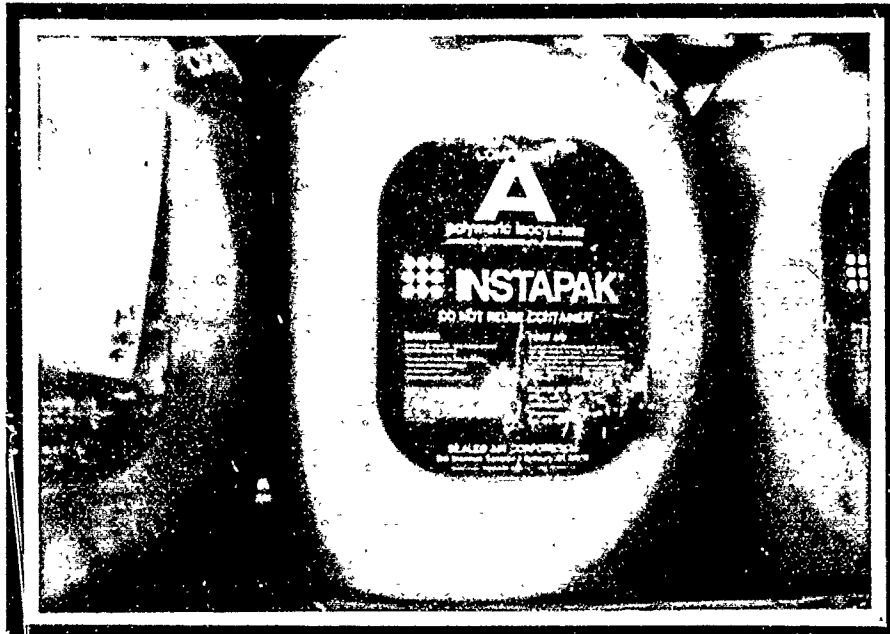
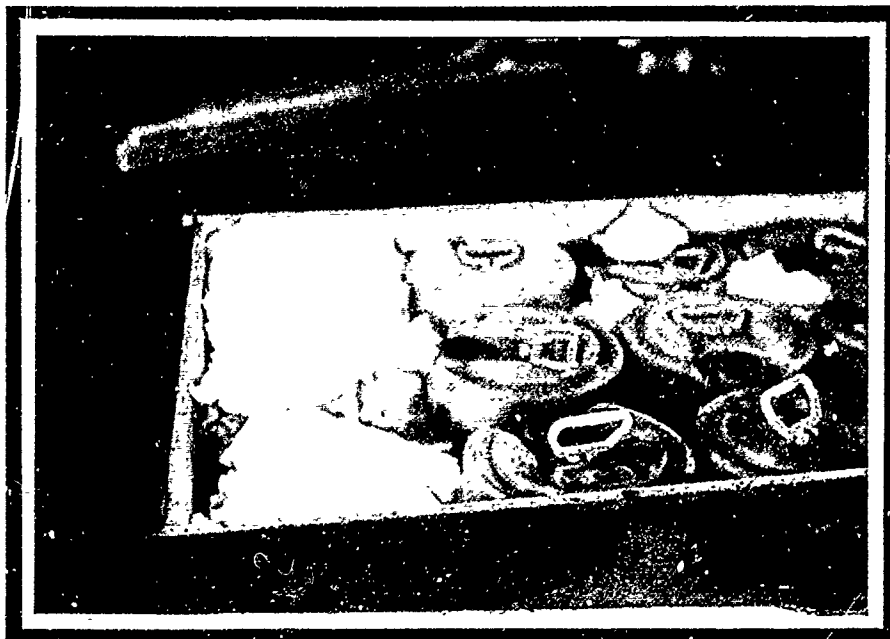
There is no evidence of past or present spills in this area. The packaging operation could have caused contamination of the floor surface by the material being shipped. A potential spill from the outside drum storage area would likely enter the storm sewer system.

FOAM PACKAGING AREA, BUILDING 924

| ESOs | Location | Concern | Recommended Activity | Number of Samples Recommended | Location | Sample Type | Analysis |
|---|---|---|---|---|---|---|---|
| Building 924 - Canvas Repair Area & Packing Area | Phase III/<br>Western Ceded Area | Pesticides<br>RCRA Metals | Site investigation | 1 | Floor near packaging area | Destructive | Pesticides/<br>Herbicides<br>RCRA Metals |

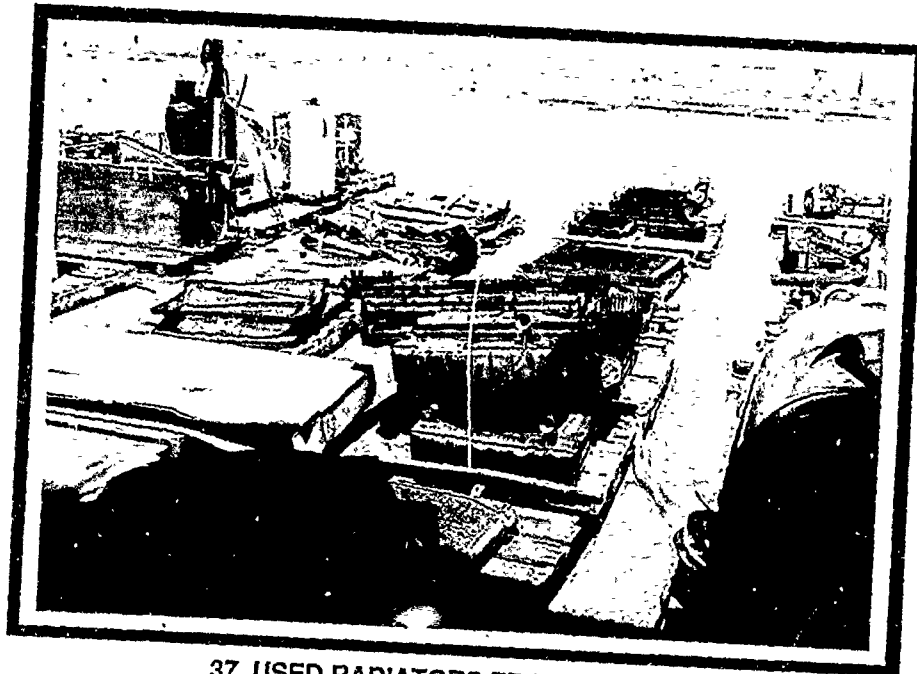
37. USED RADIATORS FROM VEHICLES

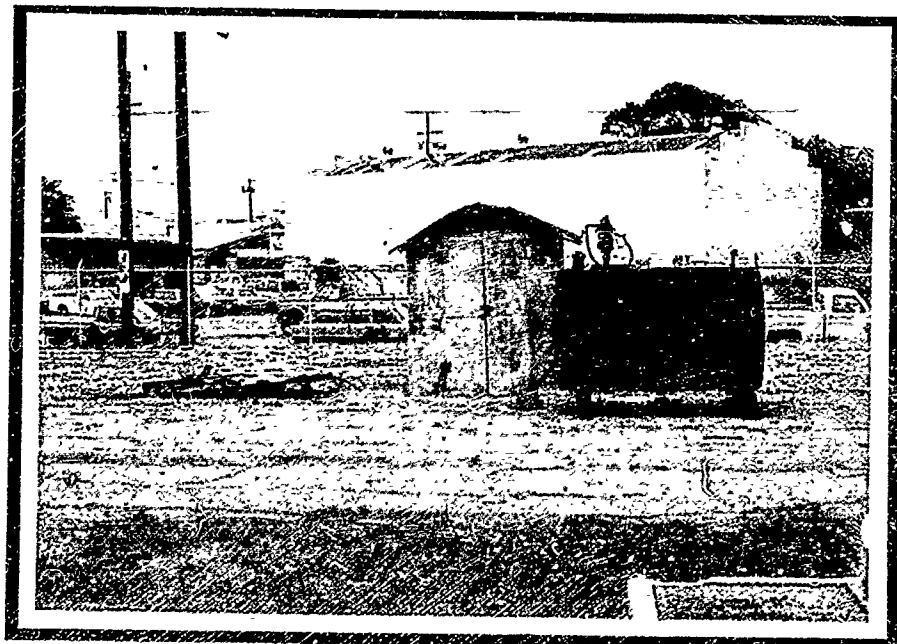
- approximately 300-gal kerosene tank adjacent to a grassy area.
  - 5,000-gal propane tank adjacent to Building 925.
  - 500-gal propane tank adjacent to Building 921 reported by personnel but not observed during site visit; 150-gal propane tank adjacent to Building 922.

40. KEROSENE STORAGE TANK

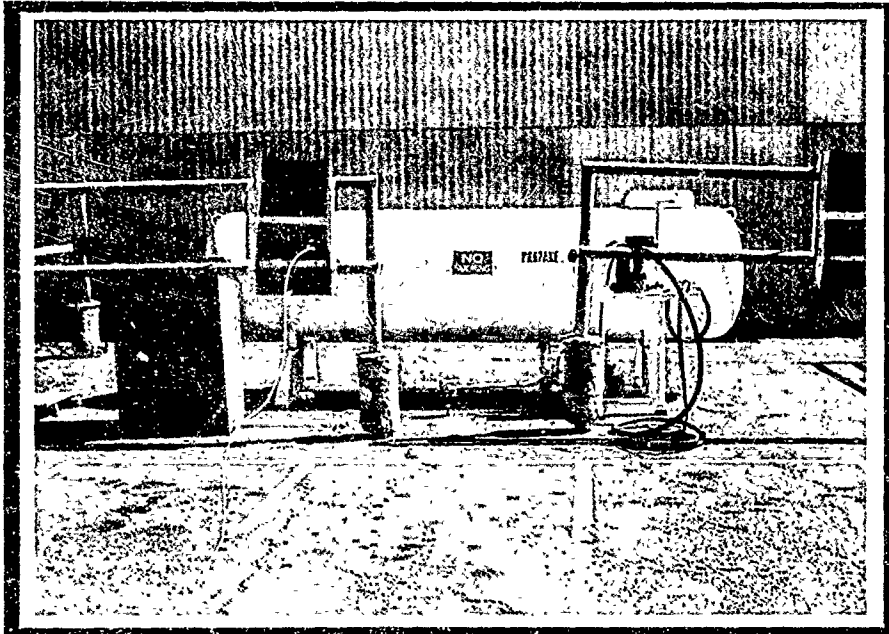
41. PROPANE STORAGE TANK NEAR BUILDING 925

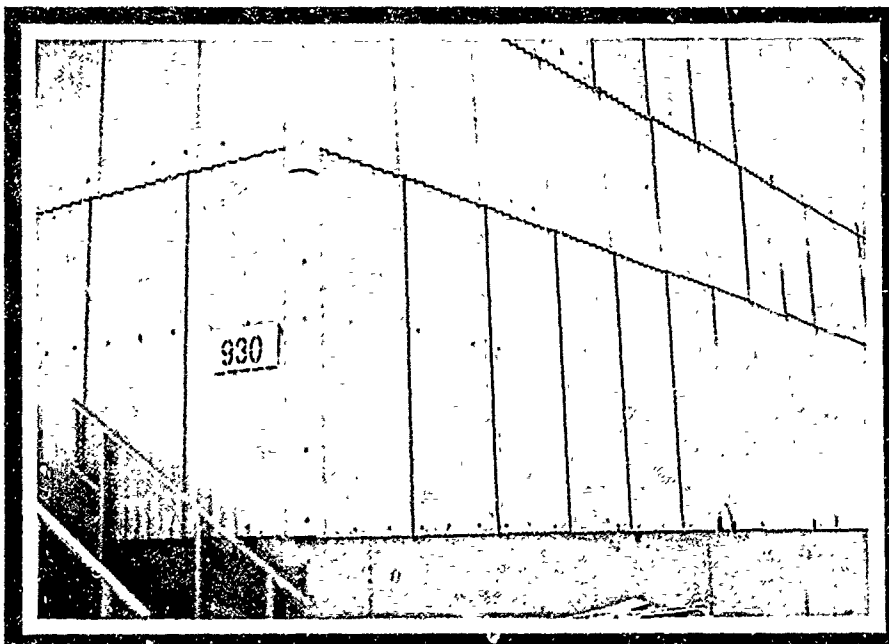
- Asbestos - numerous onsite buildings constructed with Transite siding and other asbestos-containing material. Some siding material is broken along the lower side of buildings.

42. GENERAL CONDITION OF TRANSITE SIDING

Wipe, destructive, and dust sampling of building interiors is recommended for most of the primary ESOs discussed in Section 3. The presence of asbestos materials in certain buildings in the Phase II area has been confirmed by previous sampling, therefore, sampling for asbestos is recommended only for Phase III buildings.

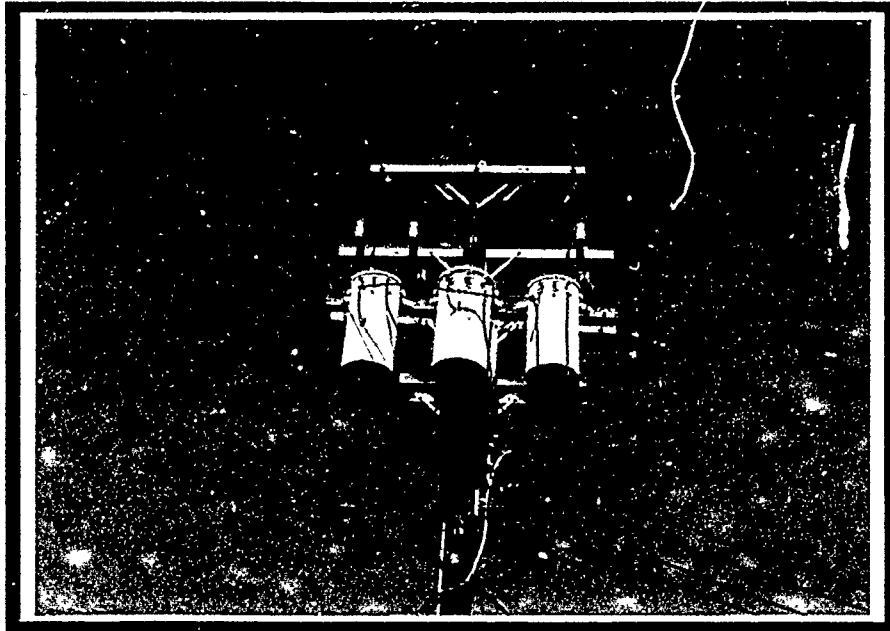
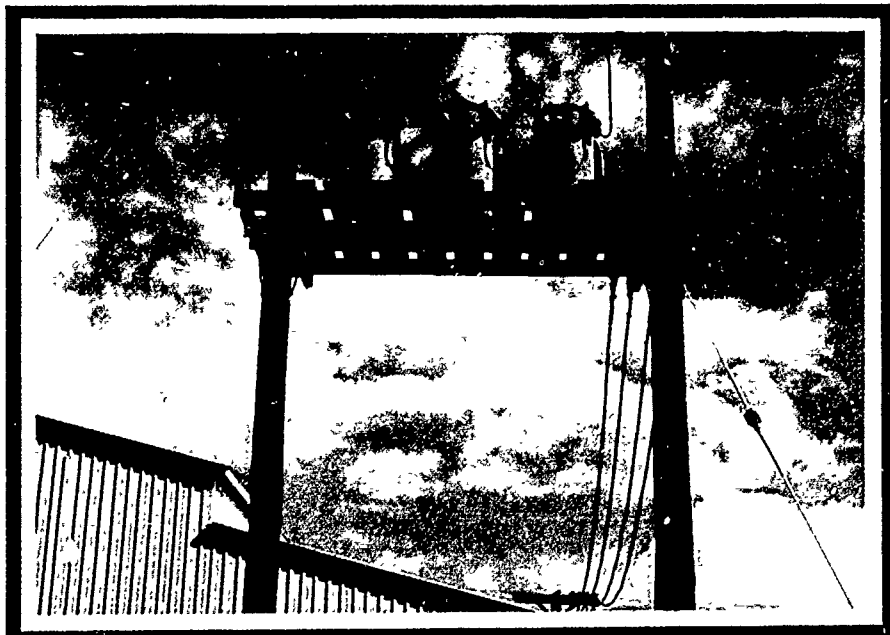
- Transformers - approximately 40 transformers, two pad mounted, the remainder pole mounted. Fluids have not been tested for polychlorinated biphenyls (PCBs) content. Two apparent minor leaks observed.

## TRANSFORMERS

All transformers on the property potentially contain PCBs and two of them appear to have leaked in the past. An inventory should be made of all transformers remaining on the property (except Phase I), and each transformer should be sampled for PCBs.

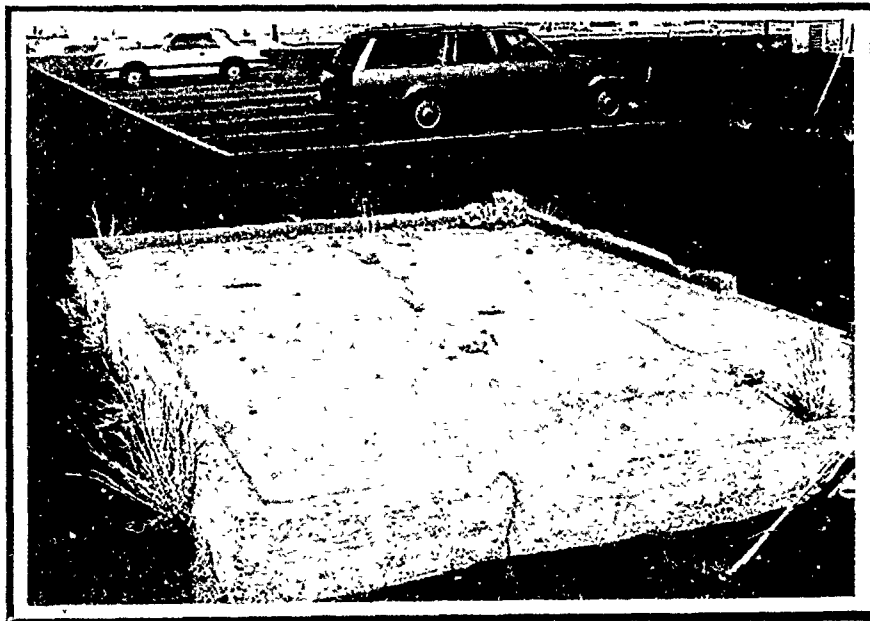
49. CONCRETE PAD NEAR BUILDING 923
