MTL TR 90-30

METALLURGICAL ANALYSIS OF LEAKING TRAY PACKS

KUAN S. LEI
GEO-CENTERS, INC.
NEWTON, MA

May 1990

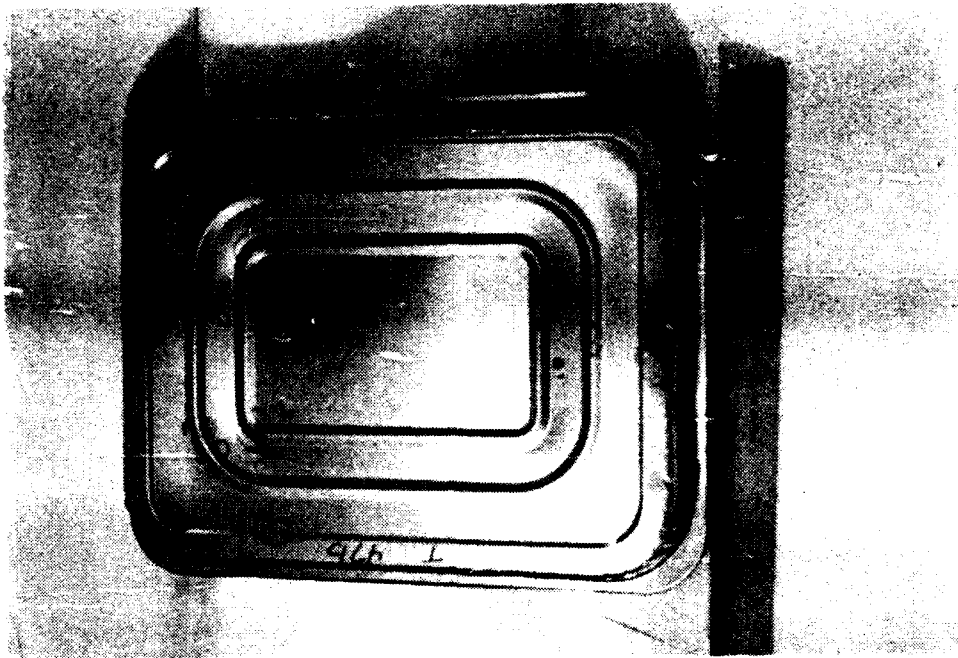
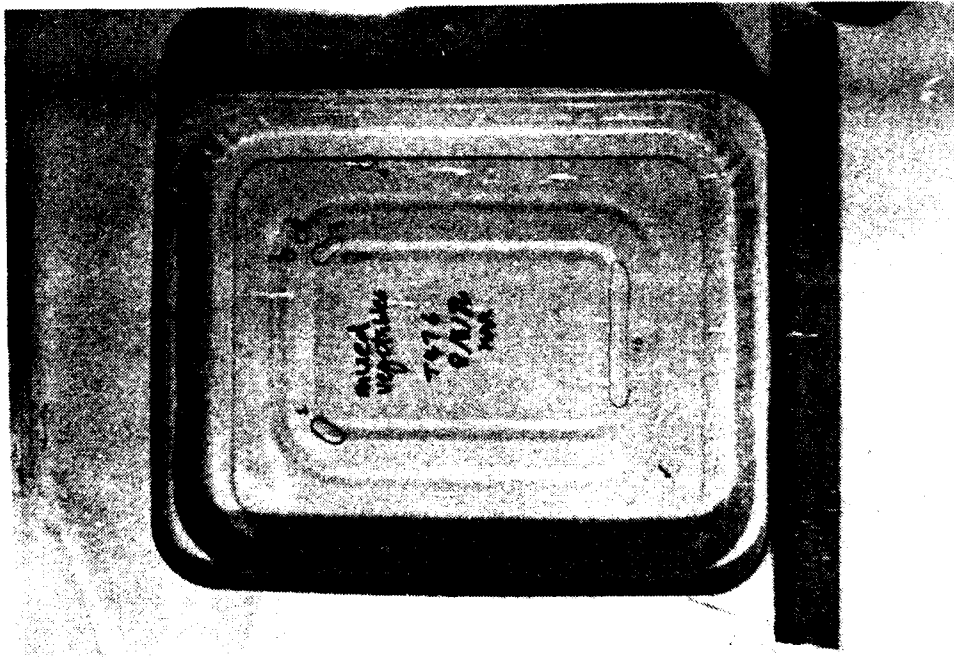
Figure 2. Circled 'gray spots' on the exterior and interior of used tray (T476).

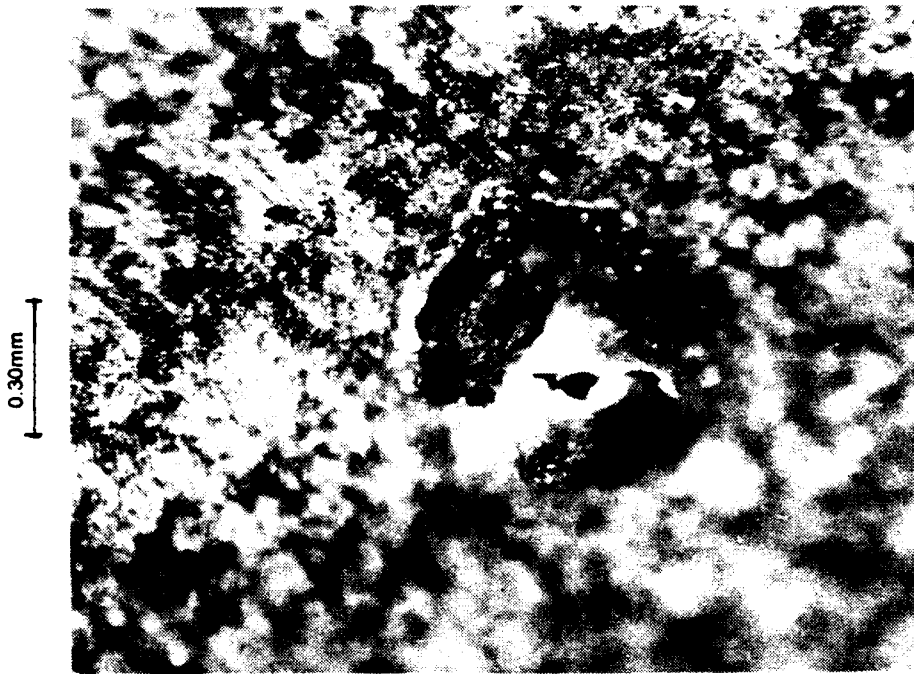
Sixteen trays previously containing various food stuffs were visually examined. Gray spots and pin holes were found on 11 of them regardless of the contents (see Table 1). One gray spot was probed with a sharp pencil and examined under the optical microscope (see Figure 3). There was no evidence of corrosion products in the probed area. Four tray packs with gray spots (two contained cut green beans, one contained mixed vegetables, and one contained creamed ground beef) were selected for closer examination under the optical microscope. These trays were opened and the contents removed. The containers were then cleaned with soapy water, sectioned, and examined. Figure 4 is an example where all the gray spots on the exterior of the tray had corresponding coating defects inside the tray, but not all the interior coatings defects had corresponding gray spots on the exterior surface (see Figure 5). The average size of the gray spots is 0.5mm in diameter, and the corresponding coating defects are always larger. The defects on the interior coating that correlate with gray spots exist as either blisters (see Figure 6) or pits. The pits appear to be associated with the tray pack containing meat, while blisters were found only on the vegetable-containing tray packs. The blistering between primer and topcoat, or through both coatings, may be due to attack by water and/or salt solution via electrochemical action at cathodic areas of the TFS where an alkaline reaction occurs ($O_2 + H_2O + 4e^- \rightarrow 4OH^-$).

Figure 3. Optical photomicrographs of a pencil probed 'gray spots' on the exterior and interior of tray (T312).

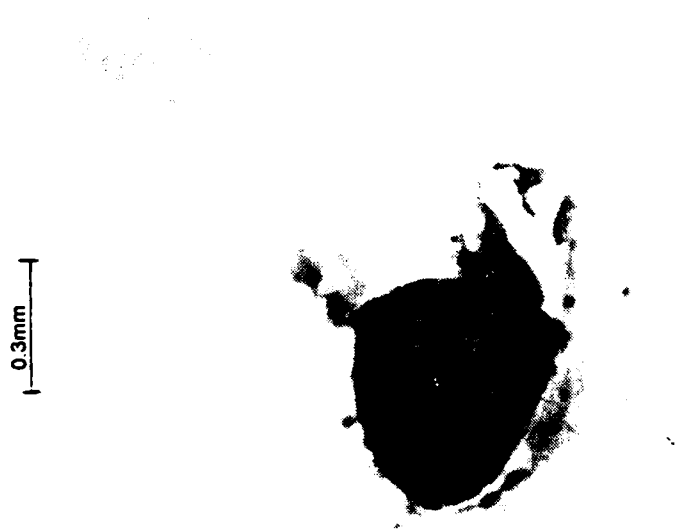
Figure 5. A half-thru pit normal appearance w/o defect on the exterior and a pit observed at the opposing position on the interior of the tray (T144).

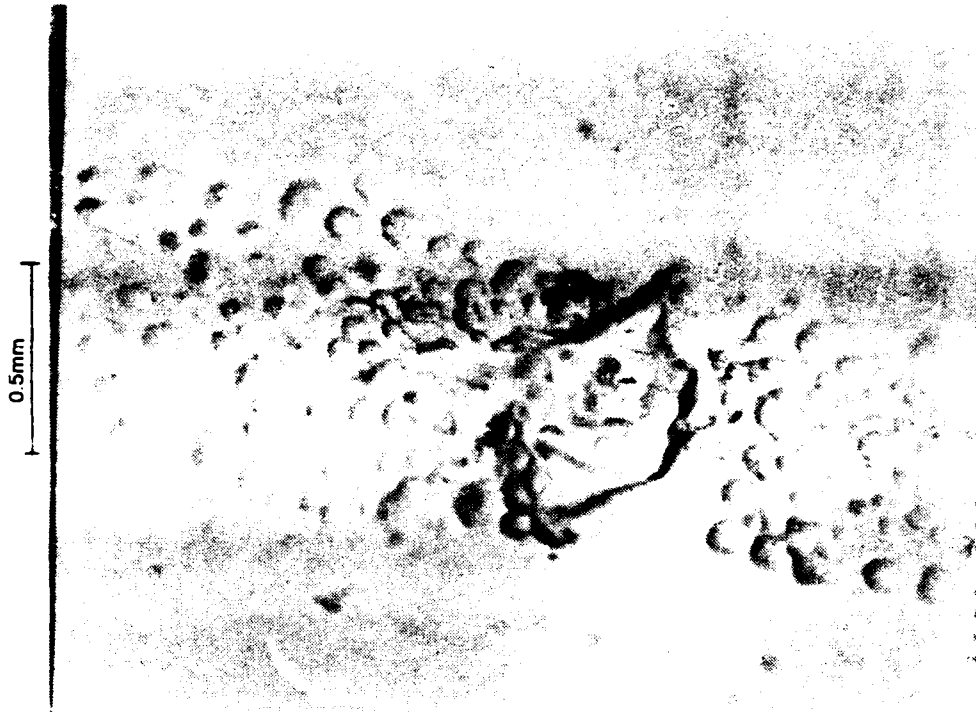
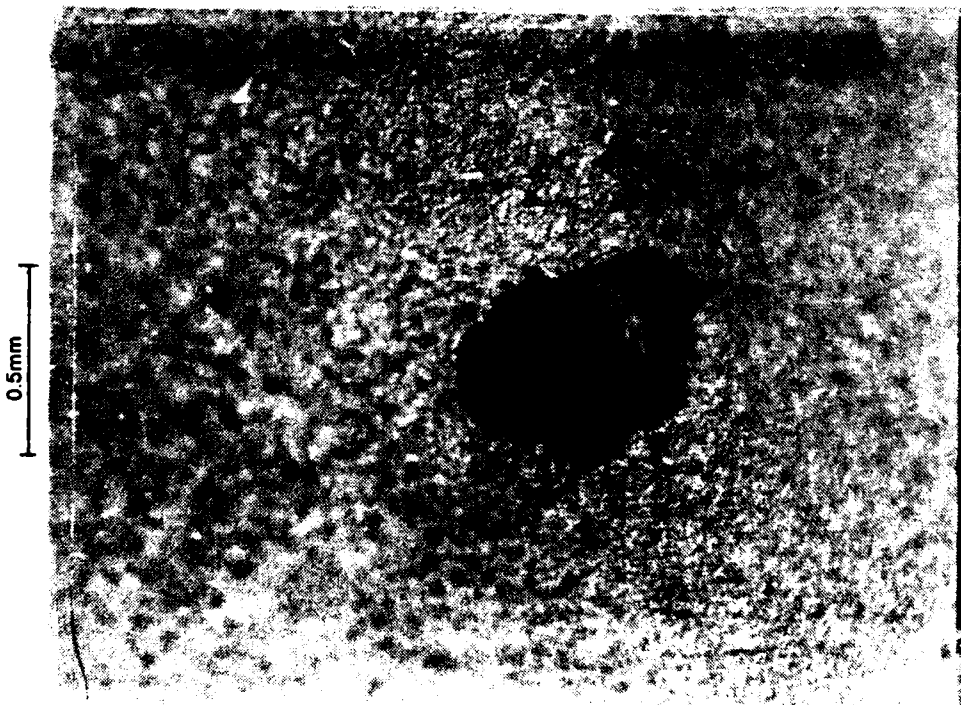
Figure 6. Blisters and pits on the interior surface corresponding to the 'gray spots' on the exterior side of the tray.

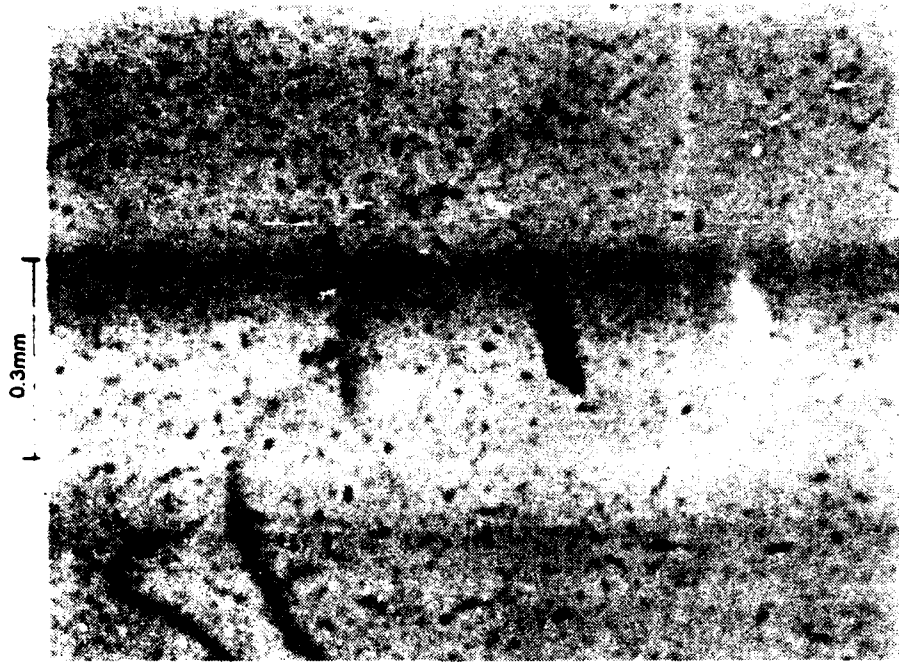
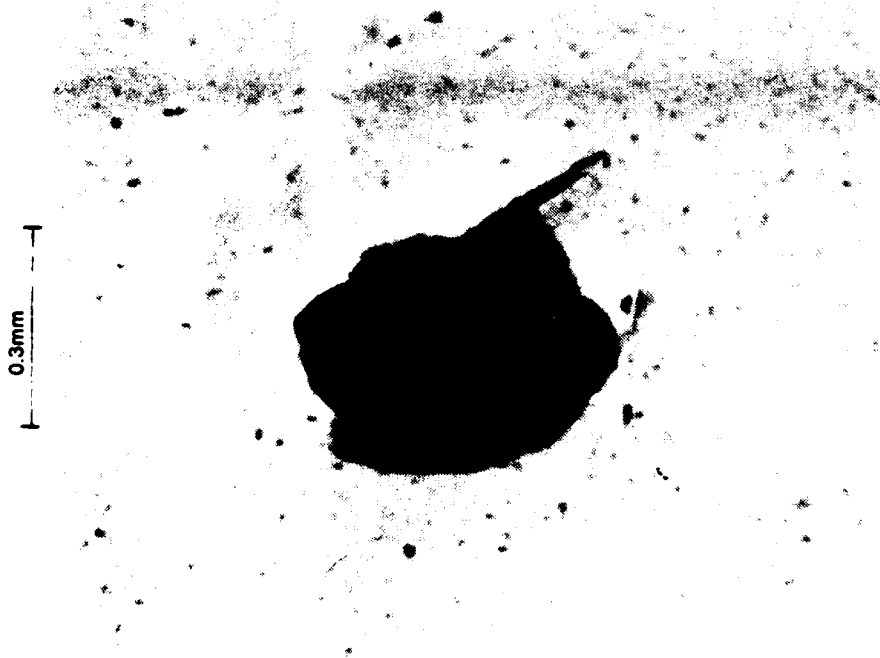
In order to elucidate the gray spot morphology, SEM examination was carried out on an interior coating blister area (see Figure 7a) which corresponded to the gray spot on the exterior surface of the tray. By repeated application of acetone and methyl ethyl ketone to one of the blisters, it was possible to remove the vinyl and epoxy coatings and reveal the pit which had formed in the steel (see Figure 7b). A final ultrasonic treatment also removed the exterior epoxy coating exposing a through-hole, as shown in Figure 8. The pit was hemispherical in shape and a mud crack pattern, typical for an iron oxide, was observed on the wall of the pit (see Figure 9).

Figure 7. A pit covered by a broken sheath on the interior of a tray before and after acetone wash (T134).

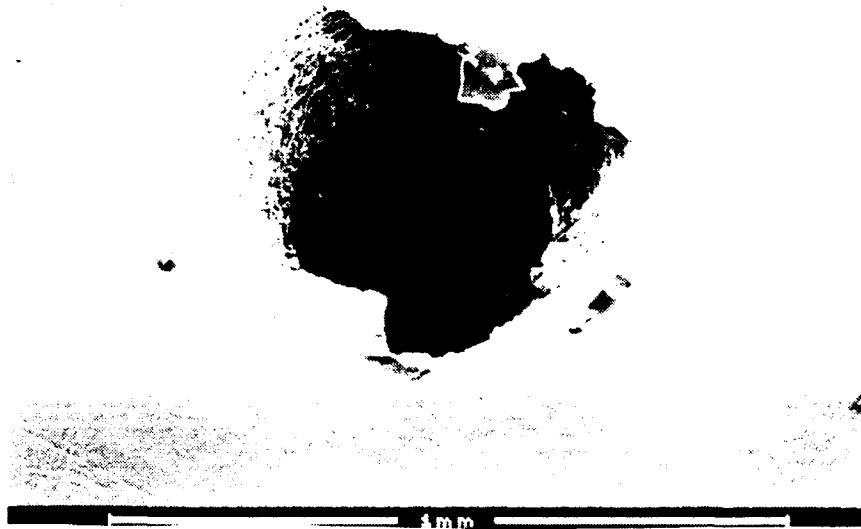
Figure 8. A thru-hole pit on the interior of a tray after ultrasonic cleaning (T134).

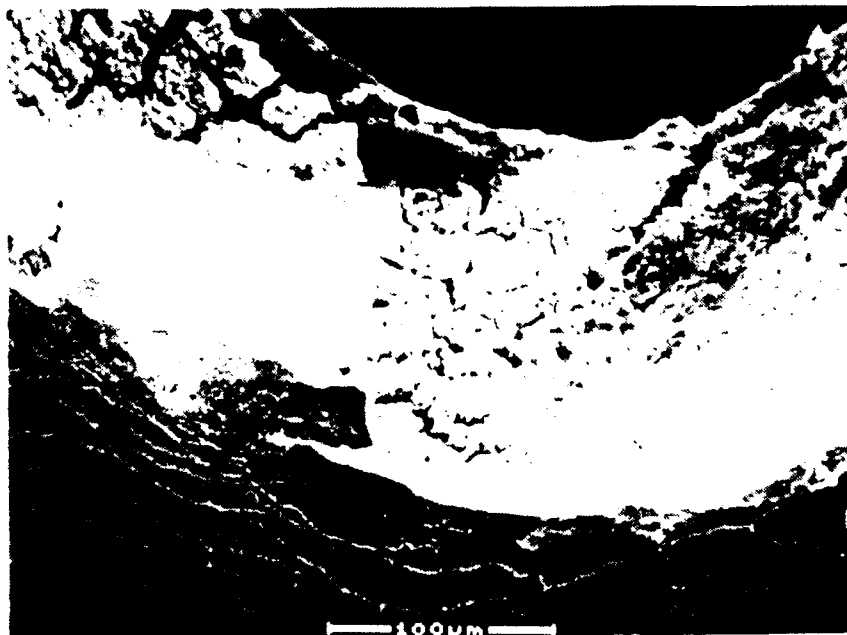
Figure 9. Detailed view of a pit wall after ultrasonic cleaning (T134).

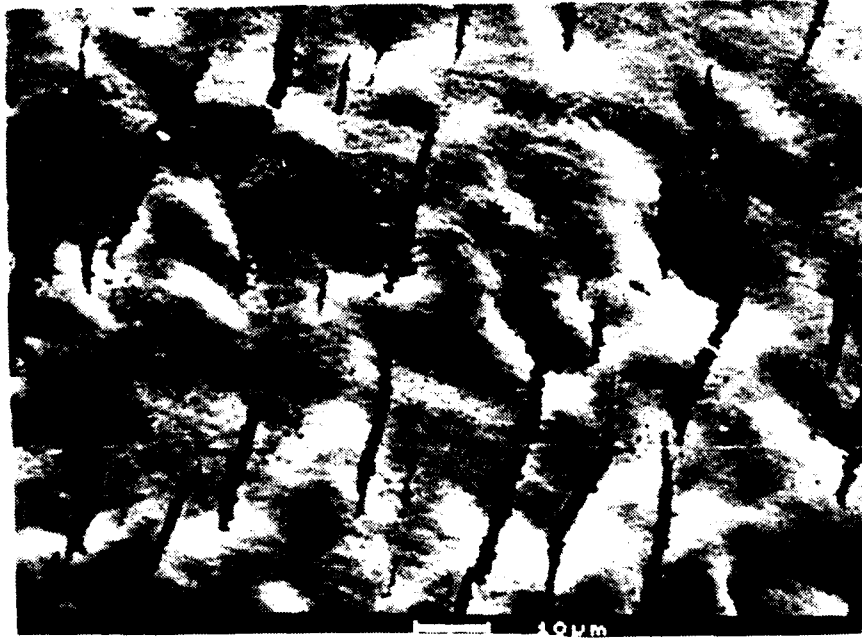
It should be noted that since the white vinyl coating is relatively soft, it is susceptible to mechanical damage and is then permeable to water. The epoxy coating beneath the vinyl is hard and brittle and contains internal stresses generated during the curing cycle. Also, the coatings are applied to the tin-free steel sheet prior to stamping into the desired tray pack form. Because of the nature of the epoxy, it is likely that the stamping operation will cause cracks to form in the epoxy coating particularly in areas of high stress. These cracks could be concealed by the soft ductile vinyl overlay.

In order to confirm the above, the epoxy layer was examined by SEM after the vinyl overlay was removed chemically with acetone and methyl ethyl ketone. Figure 10 shows that many small cracks 10 to 15 μm long are present in the epoxy coating. These cracks are located in highly stressed areas (corners, edges, and sidewalls) and are aligned in a preferred orientation corresponding to a circumferential direction.

Figure 10. Microcracks in the epoxy layer at the stressed area in the interior of a virgin tray after vinyl topcoat removal.

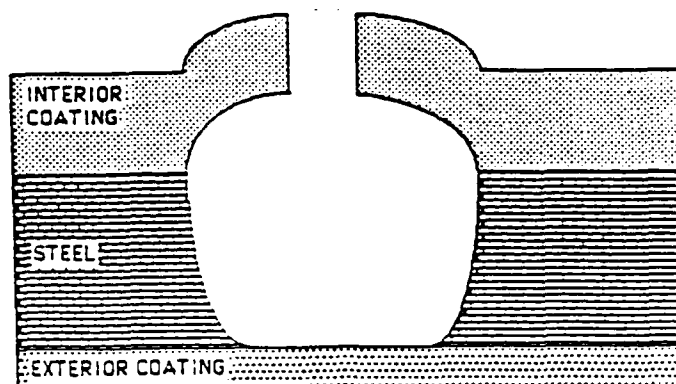
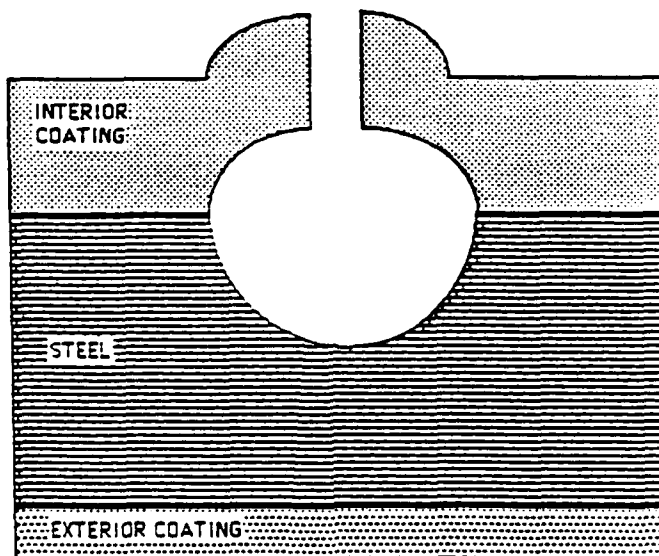
A review of our findings clearly shows that leakers are a consequence of corrosion which initiates in the interior of the tray pack at the coating/steel interface and proceeds outward to the exterior surface where either a gray spot or pin hole is observed. All of the food stuffs contain water and salt, an aggressive environment. Chloride ions and H_2O penetrate into the vinyl coatings followed by localized mass transport of ions through coating defects. This process is continued into and through the epoxy coating at pores or cracks with follow-on substrate (steel) ionic/electronic charge transfer reactions (corrosion) occurring at the coating/metal interface. Corrosion beneath an organic coating is a special example of an occluded corrosion cell where a pocket of liquid is isolated from the bulk liquid (as in pitting, crevice corrosion, or stress corrosion cracking) and chemical changes occur in the liquid resulting in intensification of localized corrosion. Until corrosion (pitting) proceeds through the entire steel thickness, there is no evidence of a gray spot at the exterior clear epoxy/metal interface. This difference is shown schematically in Figures 11a and 11b.

Figure 11. Schematic models showing the formation of blister/pit on the interior with 'gray spots' or no 'gray spots' on the exterior of the tray.
