NASA Technical Memorandum 102681  
USAAVSCOM Technical Report 90-B-003

# Behavior of Composite/Metal Aircraft Structural Elements and Components Under Crash Type Loads--What Are They Telling Us?

Huey D. Carden, Richard L. Boitnott, and  
Edwin L. Fasanella

May 1990

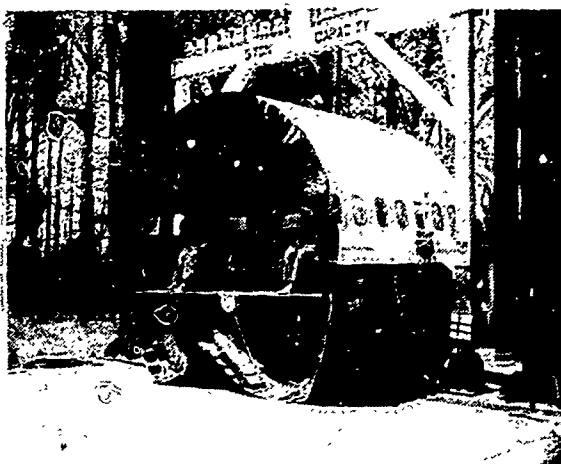
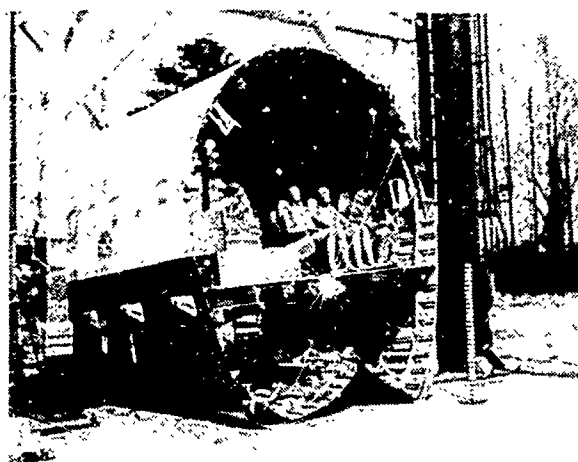
**Dynamic tests.** Structural damage of the transport aircraft structures resulting for the 20 ft/s drop tests is shown in figure 8(a) and (b). The damage to the transport sections was confined to the lower fuselage below the floor level. Under the vertical impact of 20 ft/s, all seven of the frames ruptured near the bottom impact point. Plastic hinges formed in each frame along both sides of the fuselage about 50 degrees up the circumference from the bottom contact point (See figure 8(c)). The crush of the lower fuselage was approximately 22-23 inches at the front end and 18-19 inches at the rear for the section taken from forward of the wing location (figure 8(a)) whereas for the aft section (figure 8(b)) the crushing was about 14 inches in front and 18 inches in the rear. Although the aircraft structures are metal and the failures discussed above involve plastic deformations with some tearing of the metal rather than brittle fractures, the general observed failure pattern and locations for the transport fuselage sections will be shown to be quite similar to the results of the composite frames and subfloors discussed later.

(a) Section from forward of wing.

(b) Section from aft of wing.

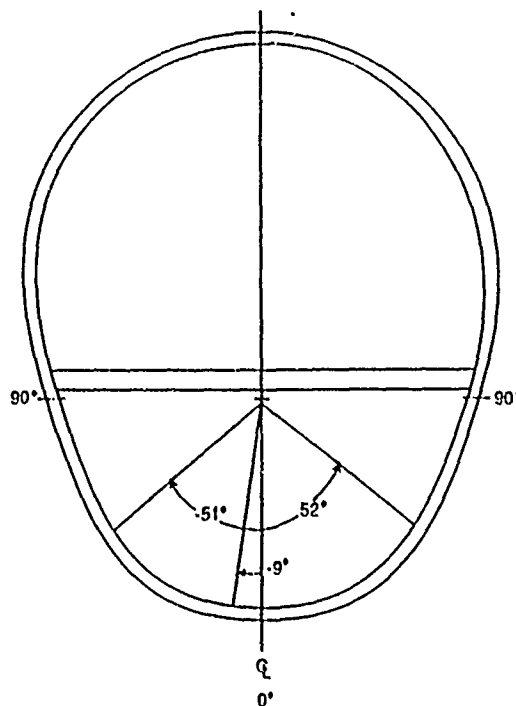
(c) Angular location of failures.

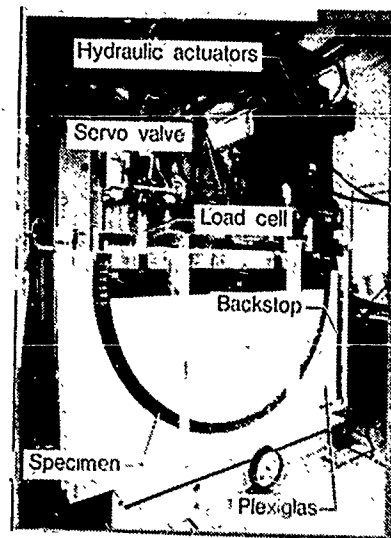
**Static tests.** Results from the static test of a semi-circular frame with a Z cross-section<sup>27</sup> are presented in Figure 11. A photograph of the static test apparatus in figure 11(a) shows that the splice plate was at the load point. Consequently, the frame failed just outside the doubler splice plate area by a complete fracture across the Z-section. Load-deflection data and the location of failures of the frame are shown in figure 11(b). The load-deflection data show a saw-toothed behavior of loading and unloading. The load increased linearly until initial failure, then falls off to under 600 pounds force. Subsequent loading of the frame after initial failure was at a new, reduced stiffness. Second and third fractures occurred up the side again at about 54 and 58 degrees under continued loading as may be noted in the sketch at the right of figure 11(b). Photographic data in figure 10(c) shows that the initial failure was induced by a local buckling of the frame which occurred at about 18 degrees from the bottom loading point outside the splice plate area.

(a) Static test apparatus.

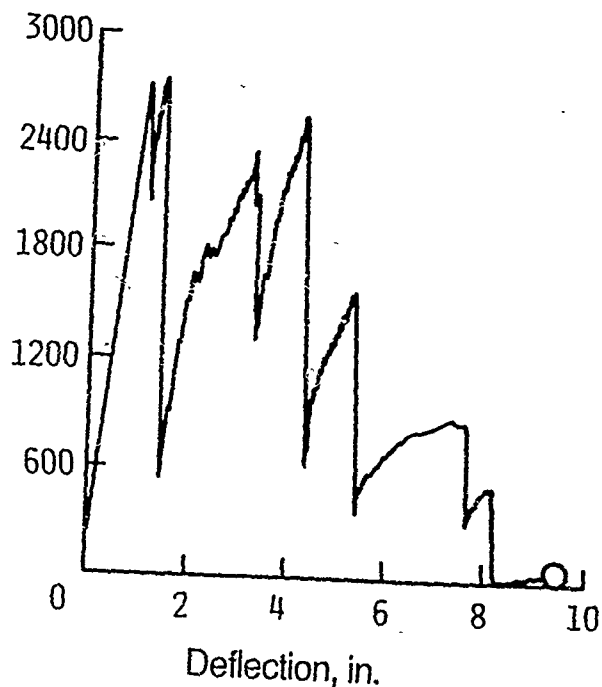
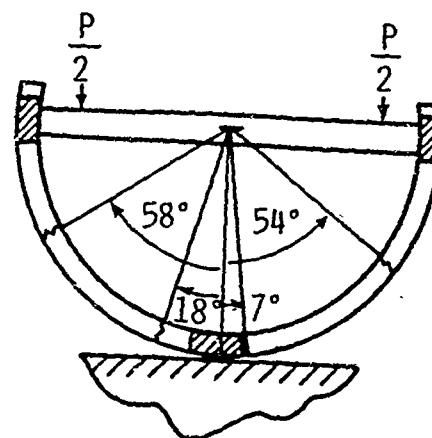
Furthermore, a comparison of the analytical cases (figure 12(a)) with the actual static load-deflection of the Z-section (figure 11(b)) indicates very similar load-deflection behavior patterns as discussed above. Although the Z-frame had no skin, if the ends jam together (as they did in several cases), the boundary is effectively between the skin stiffened case and a guided boundary. Thus, the predicted maximum moment location in the simple beam-frame model at about 50 degrees (See figure 12(b)) agrees well with the 54 and 58 degree failure locations in the experiment with the Z-section frame.

(b) Load-displacement and failure locations.

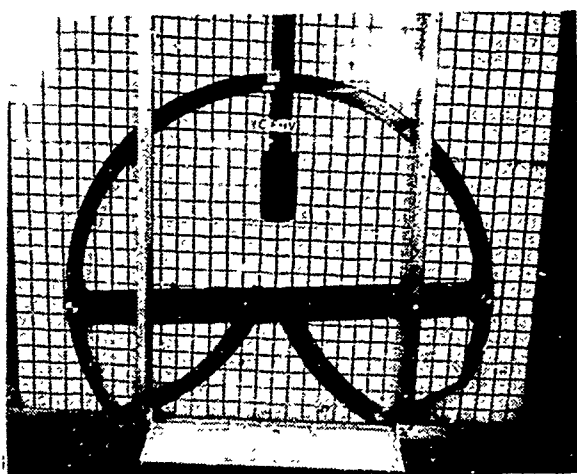
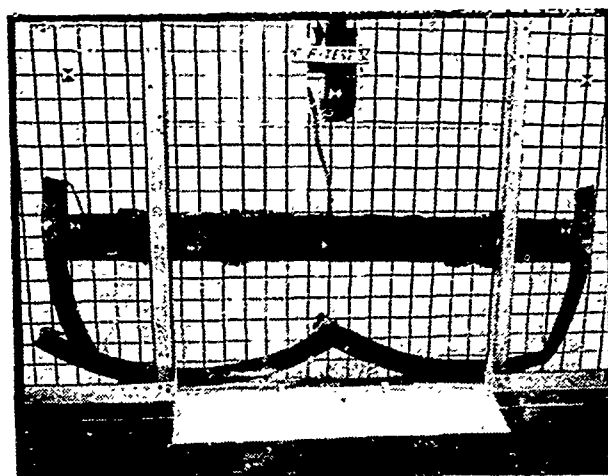
**Dynamic tests.** Results from reference 29 on the dynamic studies of the response of composite frames are shown in Figure 13. Photographs of the failed Z-frames in the drop apparatus are shown in Figure 13(a). It should be noted, the splice plates joining the segments of the frame are 45 degrees up the circumference from the point of impact. As shown in figure 13(b), complete failures (fractures) of the Z-section frames occurred at the bottom and approximately 60 degrees from the bottom. It appears that the presence of the splice plates moved the top failure points up a few degrees (to about the 60 degree locations).

(a) Photographs of failed frames.

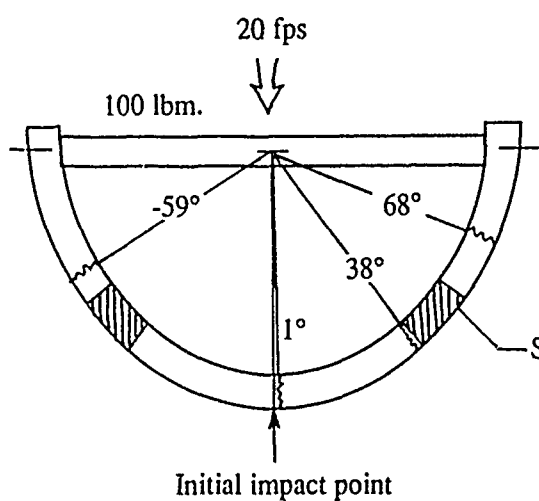
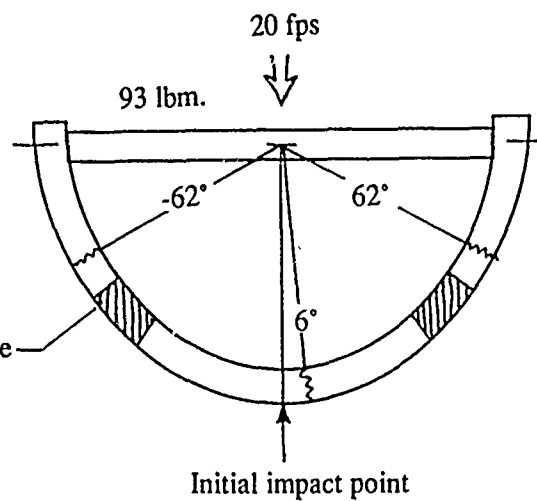
(b) Location of failures in frames.

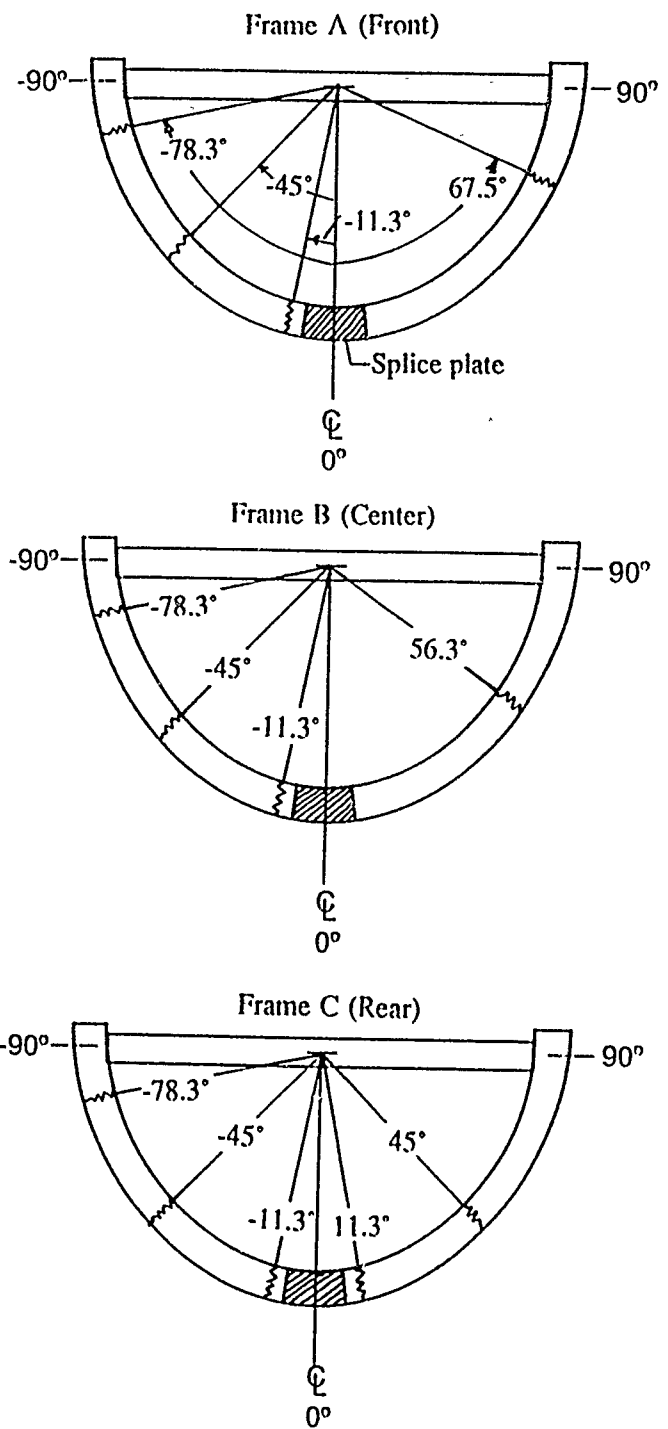
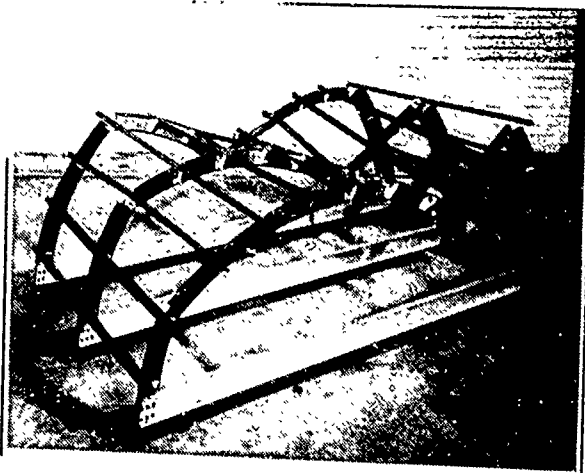
**Static tests.** Experimental results<sup>30</sup> of the skeleton subfloor specimen following a static test are shown in Figure 14. As noted in figure 14(a) and (b), failures on the three Z-section frames occurred at 13 discrete locations. Unlike the unnotched single Z-frame, the failures in this specimen occurred at notches (which served as stress risers) in the frame through which the stringer passed. However, as shown in figure 14(b) the failures were still near the point of load application (approximately 11 degrees) and at other circumferential locations of approximately 45 to 67 degrees. In the absence of skin material, twisting and bending out-of-plane occurred with the frames. The stringers had only a minimal effect on the subfloor response and that was to maintain the lateral spacing of the three Z-frames.

(a) Failed composite skeleton subfloor.

(b) Failure locations.

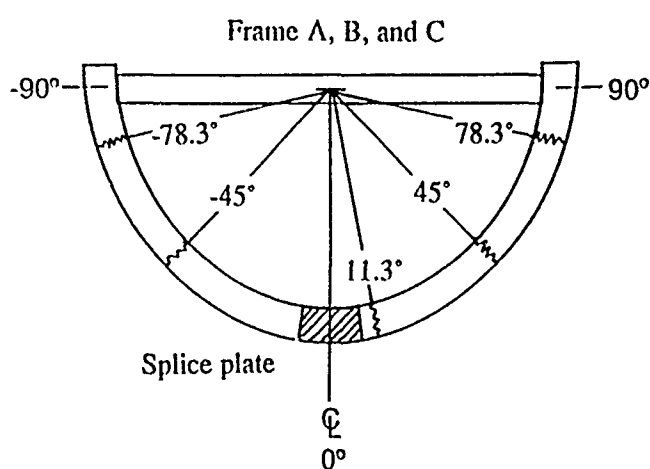
**Dynamic tests.** A photograph of a skeleton subfloor after an impact test onto a concrete surface at 20 feet per second is shown in Figure 15. In the dynamic test of the skeleton subfloor, fractures were produced at notches in the frames (Figure 15(a)). The locations, shown in figure 15(b), were also near the point of impact (about 11 degrees because of the splice plate) and at three other locations up the circumference of the frames (55 degrees and 78 degrees) totalling 15 fractures for all three frames. The impact energy exceeded the energy absorbed by the local fractures and the floor bottomed out during the impact. The normalized circumferential strain distribution measured on the flange of the front frame during the dynamic test just before first failure is shown in Figure 15(c). A comparison of the measured distribution to the predicted moment distribution of Figure 12(b) and (c) shows essentially identical shape between the single frame and skeleton frame distributions. Maximum values at 0 degrees and at approximately 50 to 55 degrees for the experiment agree well with the analytically predicted locations on the frame.

(b) Failure locations.

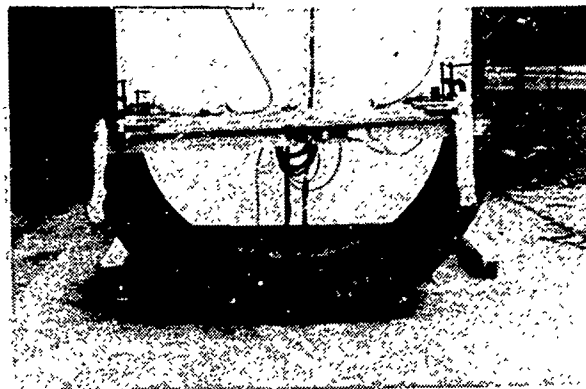
Impact results for the subfloor with skin after an impact of 20 feet per second are shown in Figure 16. A photograph of the subfloor specimen after the test is shown in Figure 16(a). Points of failure of the frames in this specimen are indicated in figure 16(b). Again the points of failure are at or near the impact point (within 12 degrees) and circumferentially at about 56 degrees up both sides of the frame on the middle and back frame and 45, 12 and 22.5 degrees on the front frame. It was observed that the subfloor impacted first on the front area which possibly explains the 12 and 22.5 degree fractures being different from the other locations. Again all three frames were involved in the failures. Some delamination of the frames from the skin was evident but the skin remained intact. Normalized strain distribution (just prior to first failure) measured on the skin at the location of the front frame during the dynamic test showed essentially identical shape as the single frame and skeleton frame distributions. As was the case for the skeleton subfloor maximums at 0 degrees and at approximately 50 to 55 degrees for the experiment agree well with the analytically predicted locations on the frame.

(a) Failed composite skinned subfloor.

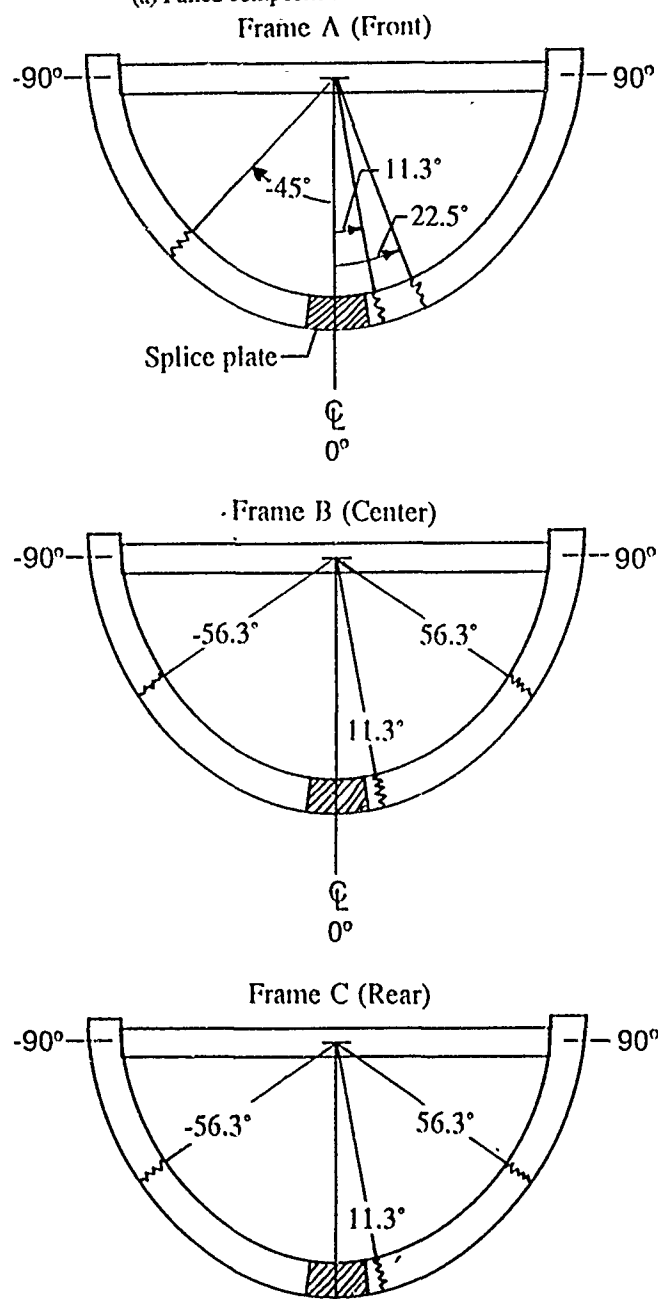
(b) Location of failures.

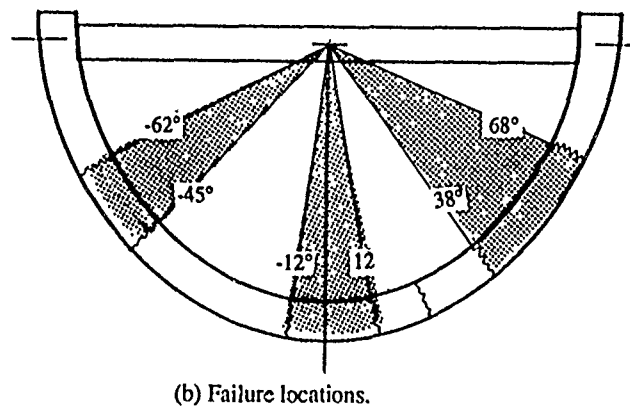
The response behavior determined during the studies of full-scale aircraft sections, fuselage frames, and subfloors are summarized in figure 18. Normalized moment distribution on a representative frame of the various specimens are shown in Figure 18(a). Figure 18(b) shows the failure locations which were noted from static and dynamic tests. The visual impression is quite striking among the various specimens. The structures all share in common the generally circular or cylindrical shape, the normal loading situations, and what appears to be a similar pattern of failure behavior. Analytical models of frame structures under vertical loads have moment distributions which have maximums at the point of loading and at approximately 45 to 50 degrees (depending on boundary conditions) around the circumference from the ground contact point. Failures of the structures were noted at these same locations. Such observations may help dynamists gain a clearer understanding of what to expect from such structures in crash loading situations, may guide designers of new structures to account for the vertical crash loads, and allow increased energy absorption to be included in the new designs. Additionally, the observations may help analysts to model the aircraft structures more adequately for predicting the failure responses and behavior under crash situations. The latter task is a difficult and challenging one, not only for composite structures but for metal structures as well. Studies are currently underway to improve the analysis capabilities of current codes and to add composite elements to finite element libraries such as the DYCAST program. In addition, new analysis approaches are being explored through grants to universities as an extension of NASA Langley Research Center's in-house efforts.

(b) Failure locations.
